CONDITION REPORT

Report No: 2016204425

DATE
18/12/2023

Vehicle Type	PASSENGER VEHICLE	Registered Owner	MFC
Manufacturer	JEEP	Registration Number	KD11KLGP
Model	WRANGLER	Register Number	
VIN	1C4BJWJG2CL265719	Date Of First Licensing	
Engine Number		Last COR	
Doors	3	License Expiry Date	31/05/2023
Color	RED	Power / Displacement	
Year Model		Paint Finish	TWO COAT UNI
Km Reading	113,057 KM	Fuel	PETROL
Cab / Body Type	STATION WAGON	Transmission	MANUAL

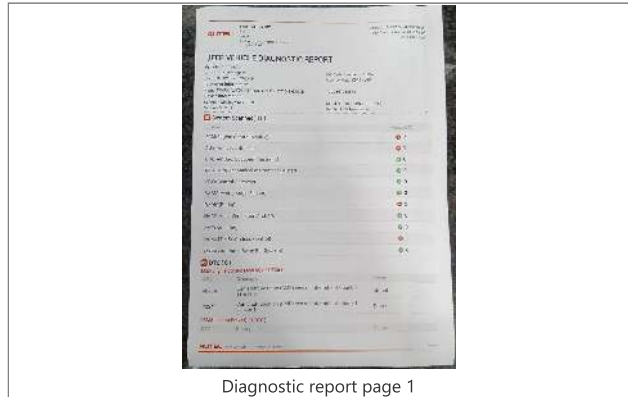
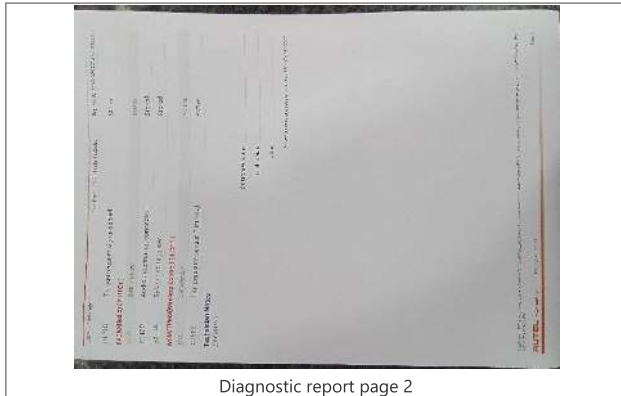
No	System	Code	Description	Status
1	ECM(ENGINE CONTROL MODULE)	P0369	CAMSHAFT POSITION(CMP) SENSOR INTERMITTENT-BANK 1

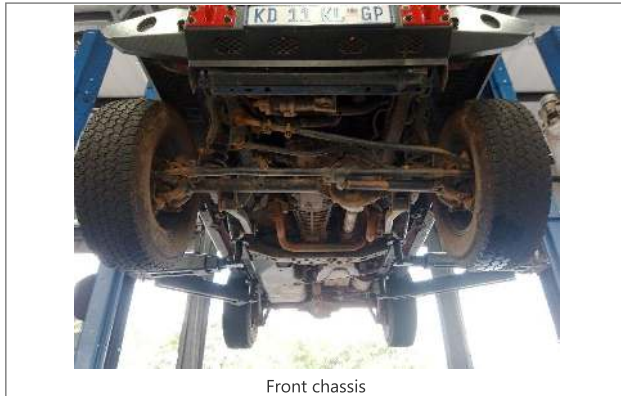
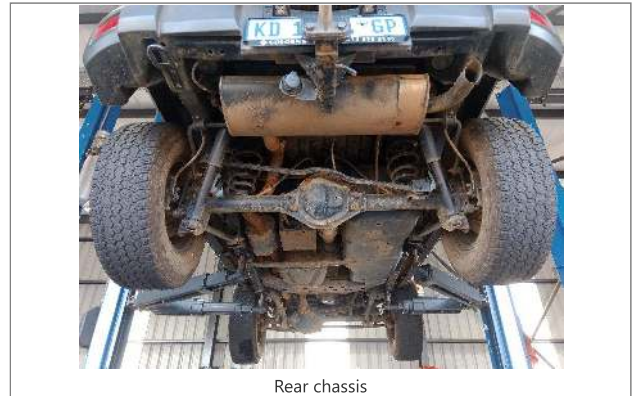
Undercarriage: Vehicle undercarriage dirty. Signs of surface rust on undercarriage

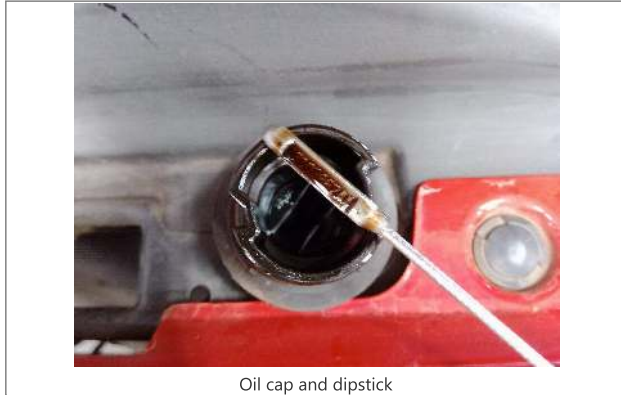
Oil cap and dipstick

Damage	Repair Way
Engine Oil Sweat	Repair
Engine Wiring Defective	Repair
Seat Front Left Damaged	Repair
Seat Front Right Dirty	Repair
Front Bumper Paintwork • Scratched	Repair
Rear Fender Left Paintwork • Scratched	Repair
Rear Fender Right Paintwork • Scratched	Repair
Door Front Left Paintwork • Scratched	Repair
Rear bumper Paintwork • Scratched	Repair
Windscreen Chipped	Repair
Steering Stopper Left Defective	Replace
Steering Stopper Right Defective	Replace
Control Arm Bush(es) Front Axle Right Defective	Replace
Engine mountings Cracked	Replace
Gearbox Oil Sweat	Repair
Differential Oil Sweat	Repair
Radiator Cradle Dented	Repair
Triangle Missing	Replace
Tyre pressure warning light intermittent	Repair
