## CONDITION REPORT

Report No:  
2017296379  
DATE  
09/09/2026

| Manufacturer | VOLKSWAGEN | Registration Number | MS95SSGP |
| Model | POLO VIVO 1.4 55KW TRENDLINE 5-DR [2019-2021] | Register Number | |

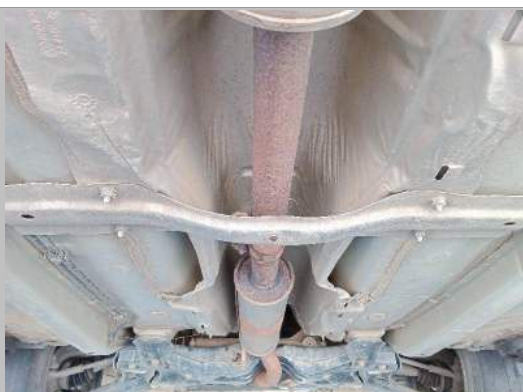
CENTER CROSS MEMBER

| Damage | Repair Way |
|---|---|
| Center exhaust cross member bracket damaged | Replace |

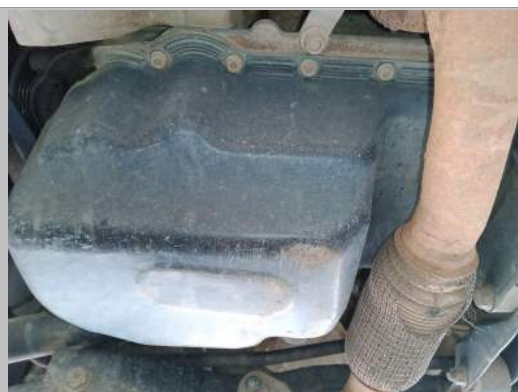
ENGINE OIL SUMP

| Damage | Repair Way |
|---|---|
| Engine oil sump dented | Repair |

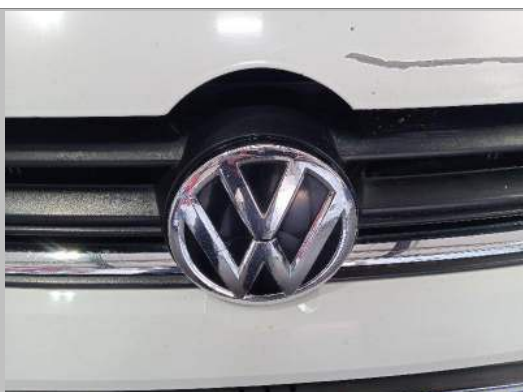
FRONT EMBLEM

| Damage | Repair Way |
|---|---|
| Front emblem cracked | Replace |

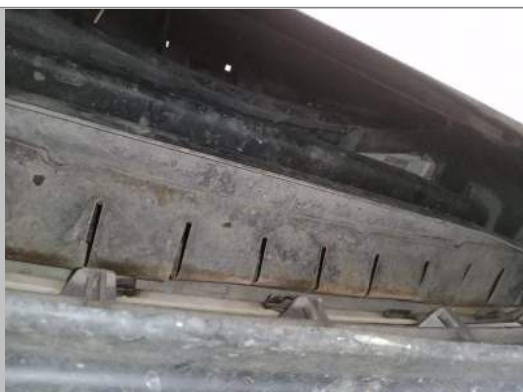
FRONT BUMPER STIFFENER

| Damage | Repair Way |
|---|---|
| Front bumper stiffener damaged | Replace |

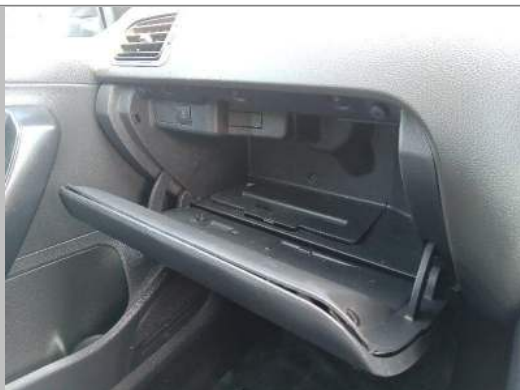
| Damage | Repair Way |
|---|---|
| Center Console / Cubbyhole + Lid Damaged | Replace |

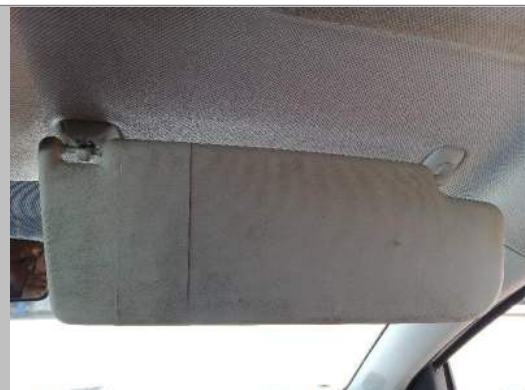
| Damage | Repair Way |
|---|---|
| Sun Visor Right Dirty | Repair |

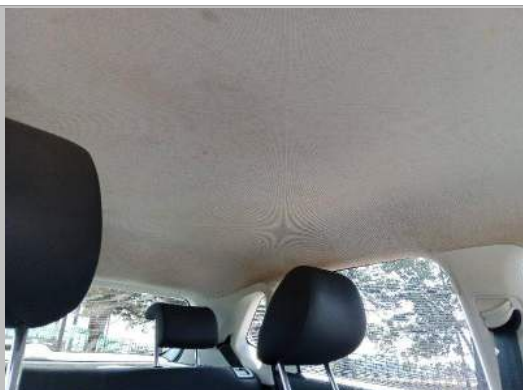
| Damage | Repair Way |
|---|---|
| Hood Lining Dirty | Repair |

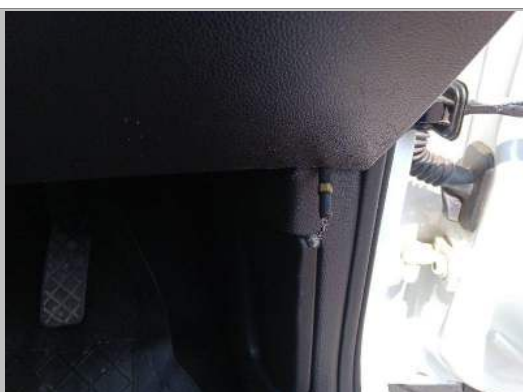
| Damage | Repair Way |
|---|---|
| Bonnet cable Damaged | Replace |

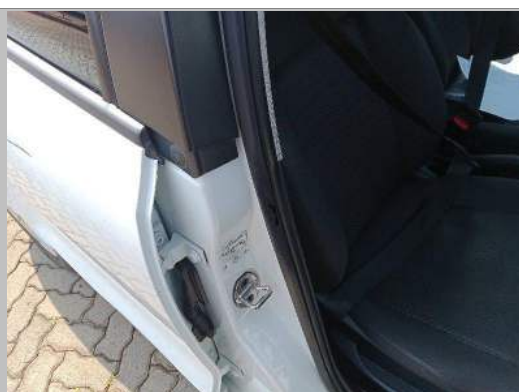
| Damage | Repair Way |
|---|---|
| Door Sealing Rubber Front Right Damaged | Replace |

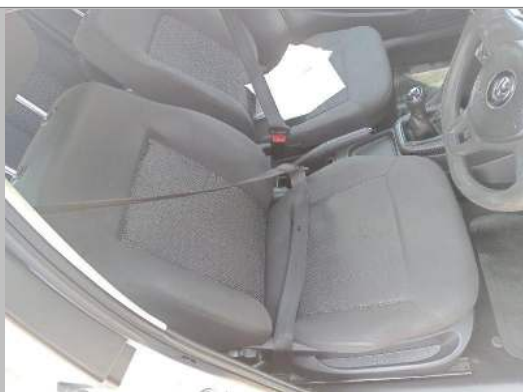
| Damage | Repair Way |
|---|---|
| Seat Front Right Dirty | Repair |

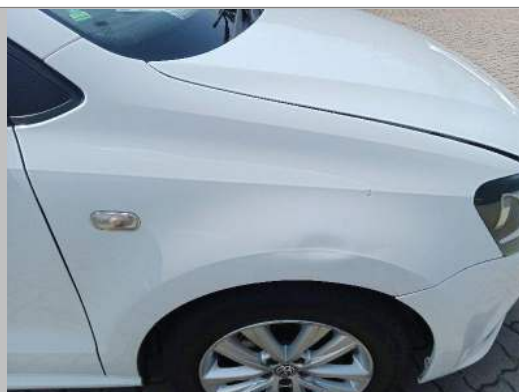
| Damage | Repair Way |
|---|---|
| Front Fender Right Damaged | Repair |

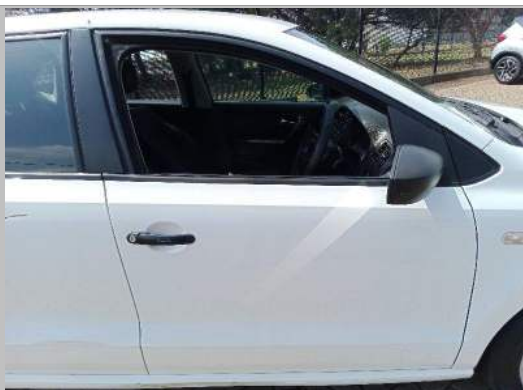
| Damage | Repair Way |
|---|---|
| Door Front Right Paintwork • Scratched | Repair |

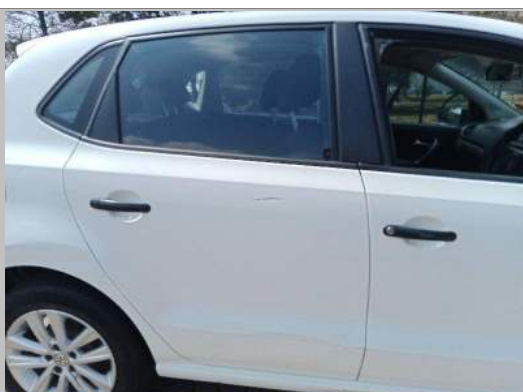
| Damage | Repair Way |
|---|---|
| Door Rear Right Damaged | Repair |

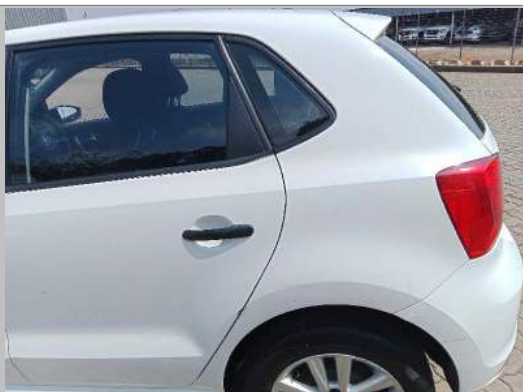
| Damage | Repair Way |
|---|---|
| Rear Fender Left Damaged | Repair |

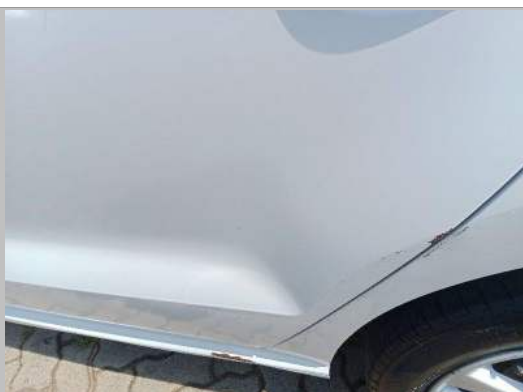
| Damage | Repair Way |
|---|---|
| Door Rear Left Paintwork • Scratched | Repair |

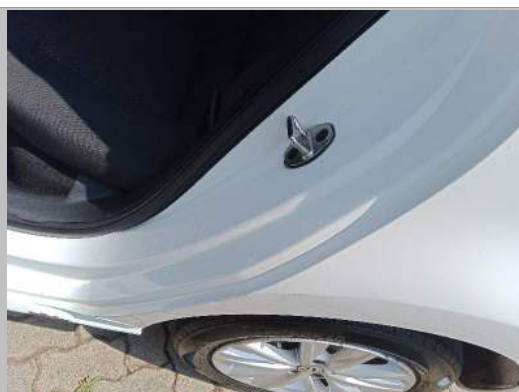
| Damage | Repair Way |
|---|---|
| C • Pillar Left Dented | Repair |

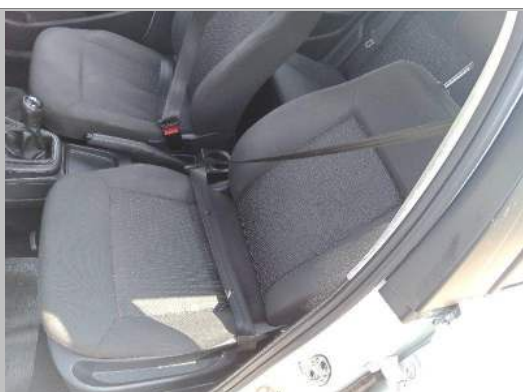
| Damage | Repair Way |
|---|---|
| Seat Front Left Dirty | Repair |

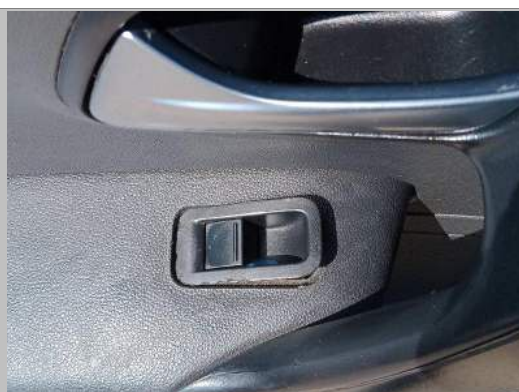
| Damage | Repair Way |
|---|---|
| Switch Electrical Window Winder front left Damaged | Replace |

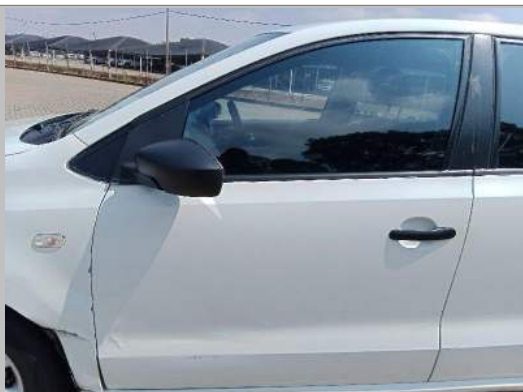
| Damage | Repair Way |
|---|---|
| Door Front Left Damaged | Repair |

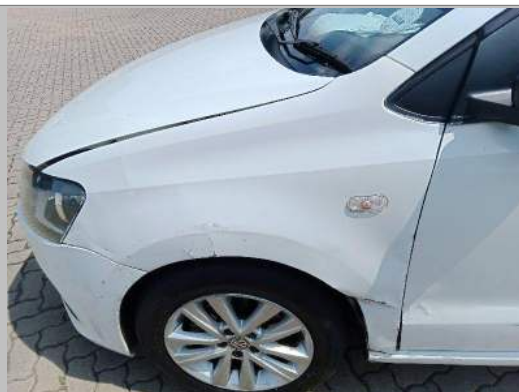
| Damage | Repair Way |
|---|---|
| Front Fender Left Damaged | Replace |

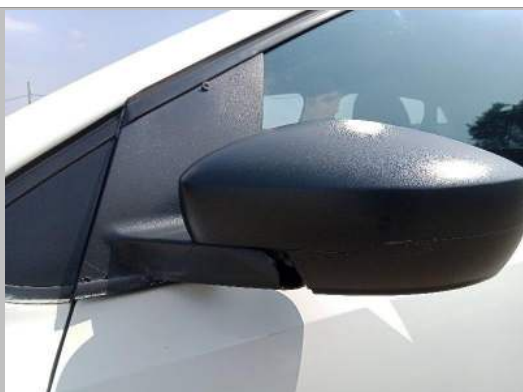
| Damage | Repair Way |
|---|---|
| Side Mirror Left Damaged | Replace |

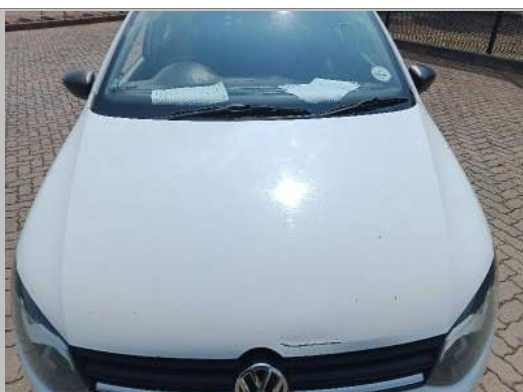
| Damage | Repair Way |
|---|---|
| Bonnet Damaged | Repair |

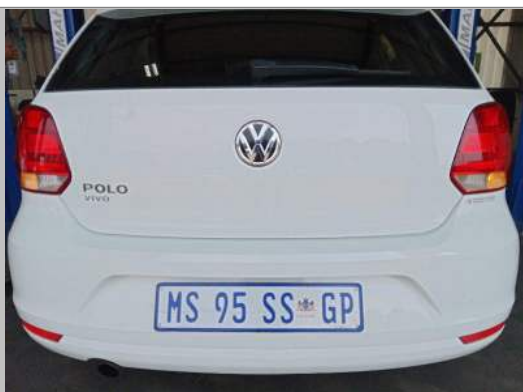
| Damage | Repair Way |
|---|---|
| Rear bumper Paintwork • Scratched | Repair |

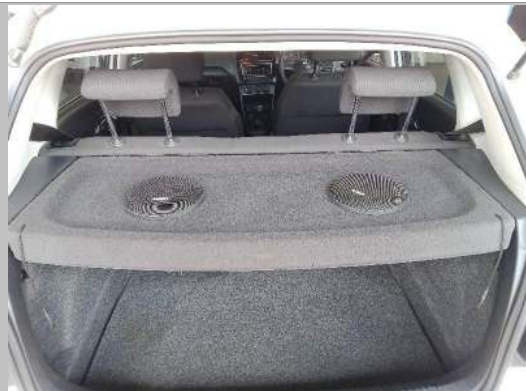
| Damage | Repair Way |
|---|---|
| Parcel Tray Damaged | Replace |

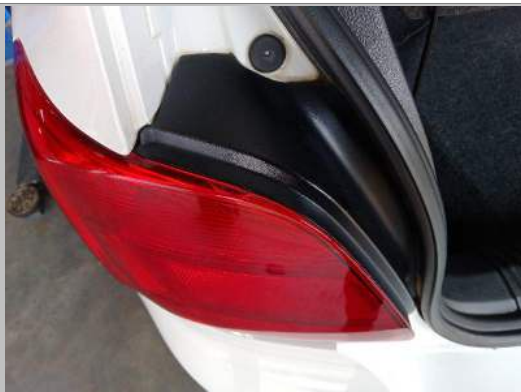
| Damage | Repair Way |
|---|---|
| Tail Light Left Cracked | Replace |

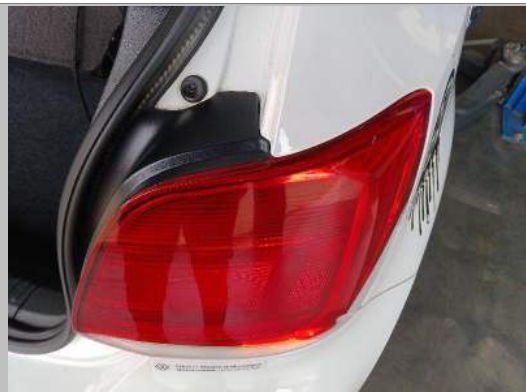
| Damage | Repair Way |
|---|---|
| Tail Light Right Cracked | Replace |

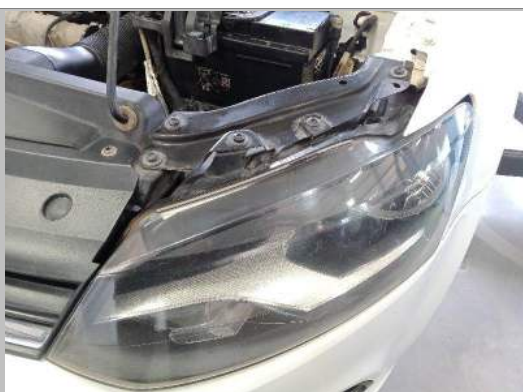
| Damage | Repair Way |
|---|---|
| Headlight Left Damaged | Replace |

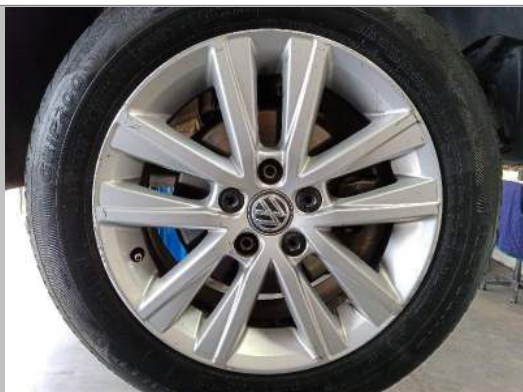
| Damage | Repair Way |
|---|---|
| Rim Front Right Scratched | Repair |

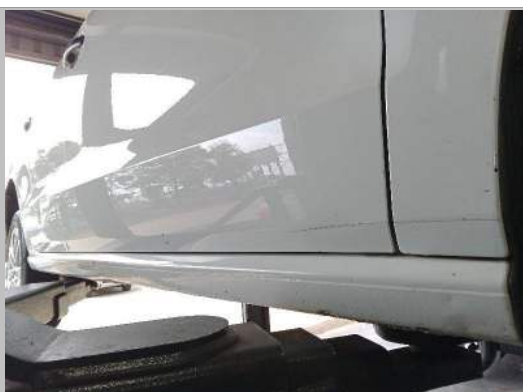
| Damage | Repair Way |
|---|---|
| Sill Panel Right Damaged | Repair |

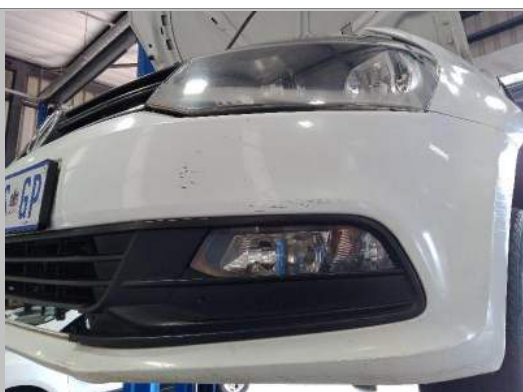
| Damage | Repair Way |
|---|---|
| Front Bumper Damaged | Repair |

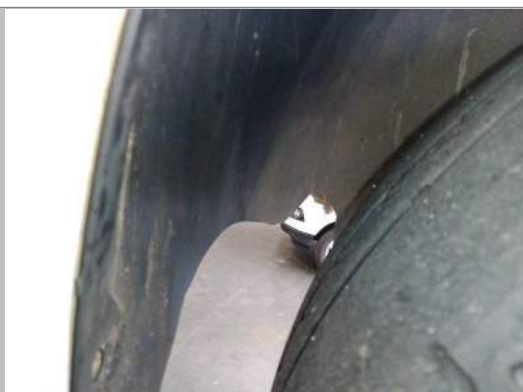
| Damage | Repair Way |
|---|---|
| Front Fender Left / Inner Tray Damaged | Replace |

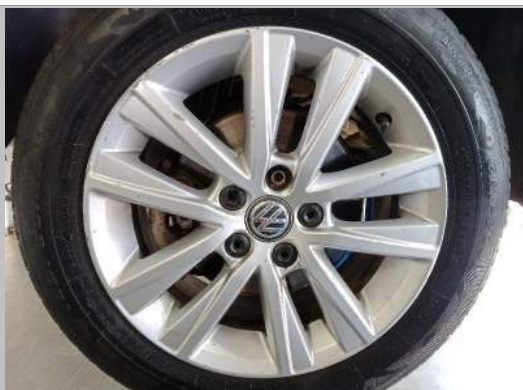
| Damage | Repair Way |
|---|---|
| Rim Front Left Scratched | Repair |

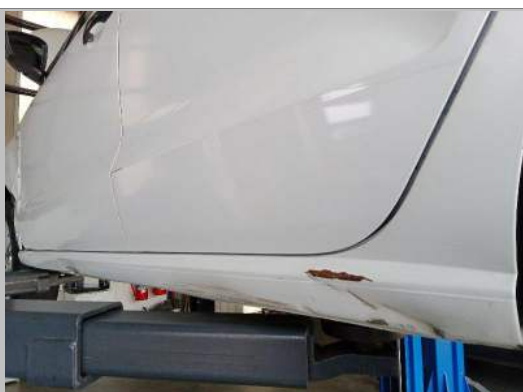
| Damage | Repair Way |
|---|---|
| Sill Panel Left Damaged | Repair |

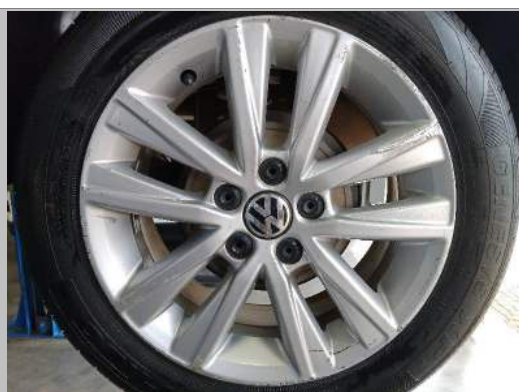
| Damage | Repair Way |
|---|---|
| Rim Rear Left Scratched | Repair |

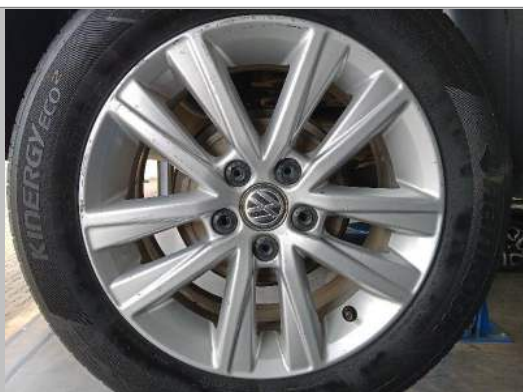
| Damage | Repair Way |
|---|---|
| Rim Rear Right Scratched | Repair |

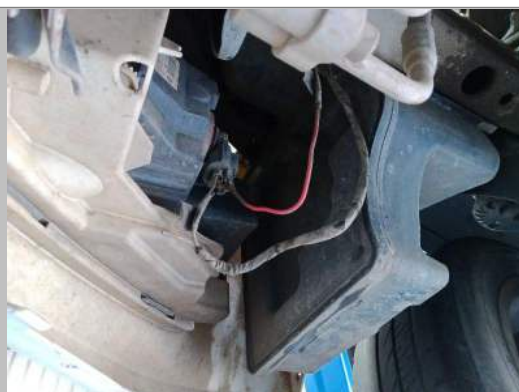
| Damage | Repair Way |
|---|---|
| Engine Wiring Defective | Repair |

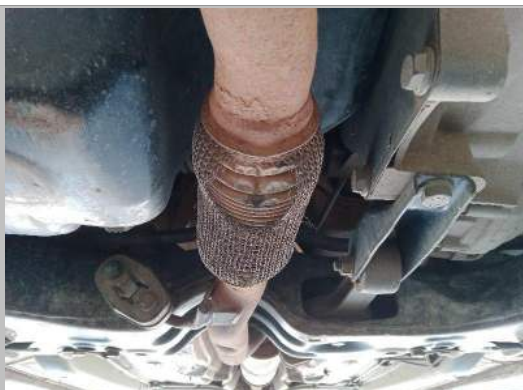
| Damage | Repair Way |
|---|---|
| Engine to silencer pipe Damaged | Repair |

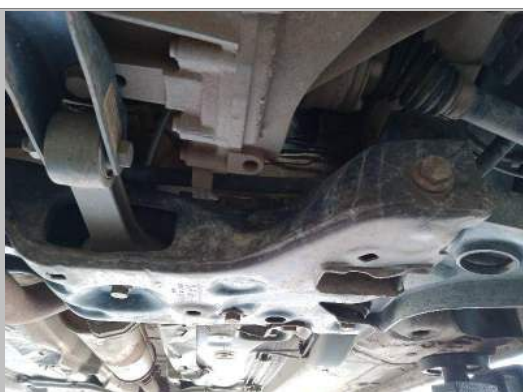
| Damage | Repair Way |
|---|---|
| Sub Frame Damaged | Repair |

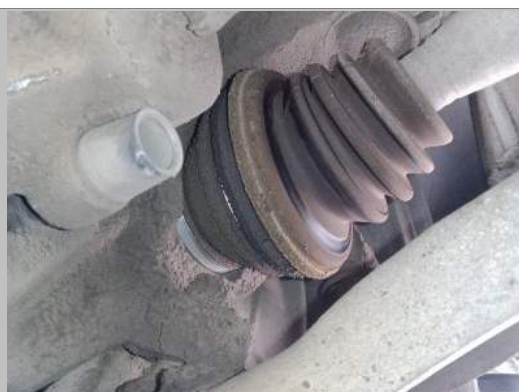
| Damage | Repair Way |
|---|---|
| CV Joint(s) Boot(s) Front Right (inner/outer) Damaged | Replace |

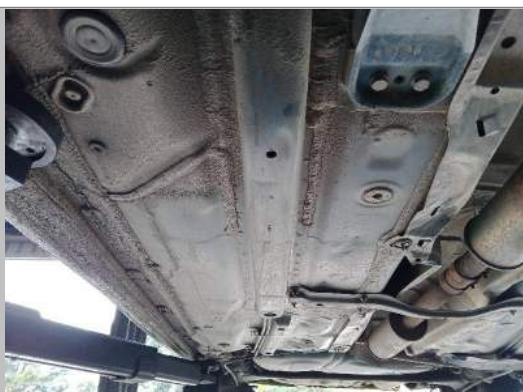
| Damage | Repair Way |
|---|---|
| Chassis Damaged | Repair |

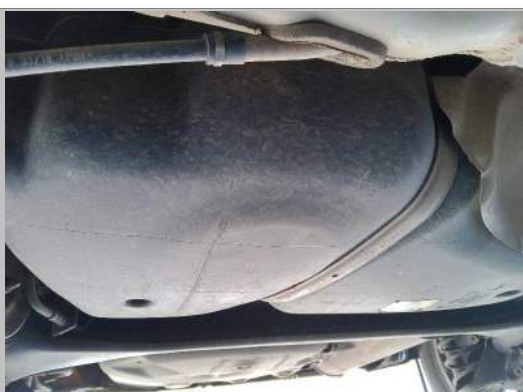
| Damage | Repair Way |
|---|---|
| Fuel Tank Damaged | Repair |

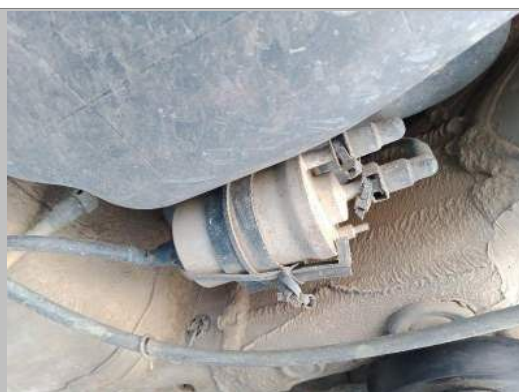
| Damage | Repair Way |
|---|---|
| Fuel Lines Damaged | Repair |

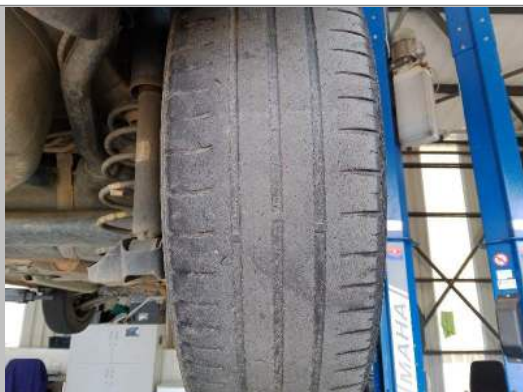
| Damage | Repair Way |
|---|---|
| Tyre Rear Right Worn | Replace |

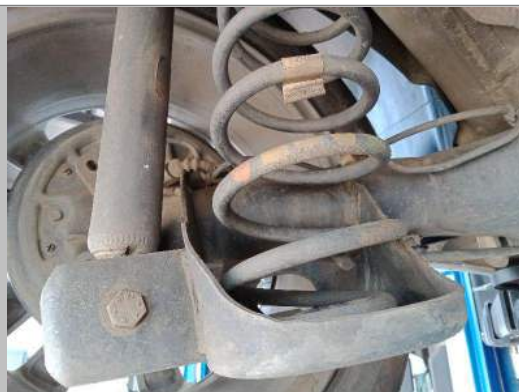
| Damage | Repair Way |
|---|---|
| Rear Axle Damaged | Repair |

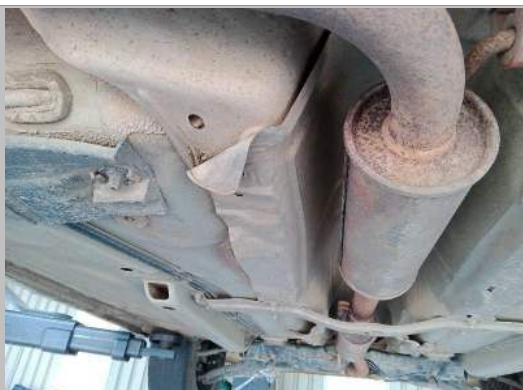
| Damage | Repair Way |
|---|---|
| Belly plates Damaged | Repair |

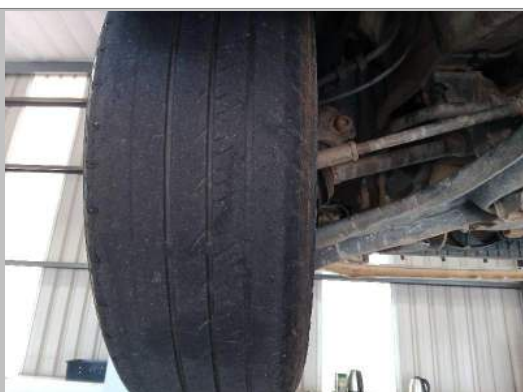
| Damage | Repair Way |
|---|---|
| Tyre Front Left Worn | Replace |

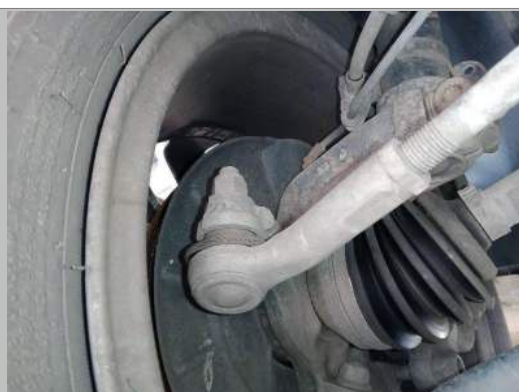
| Damage | Repair Way |
|---|---|
| Tie Rod End left Cracked | Replace |

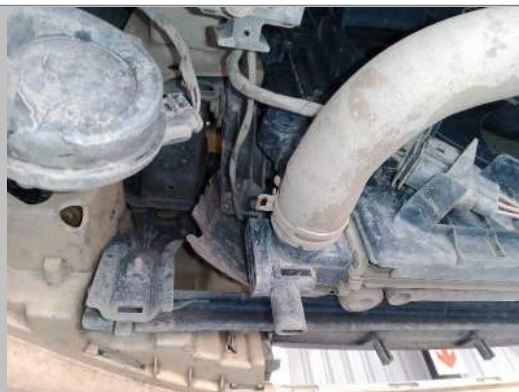
| Damage | Repair Way |
|---|---|
| Radiator Cradle Damaged | Replace |

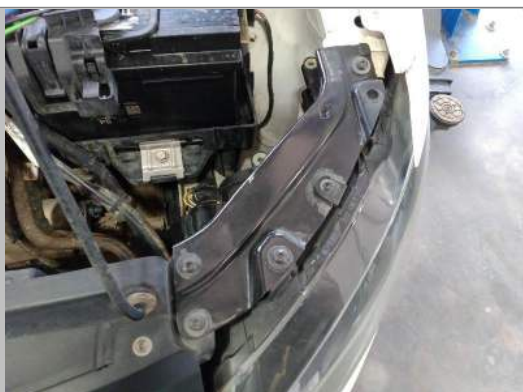
| Damage | Repair Way |
|---|---|
| Bonnet slam plate (Shock tower/ Inner tray) Dented | Repair |
