## CONDITION REPORT

Report No:  
2017287377  
DATE  
20/08/2026

| Manufacturer | VOLKSWAGEN | Registration Number | JX57BDGP |
| Model | POLO VIVO 1.4 55KW TRENDLINE 5-DR [2020-2022] | Register Number | |

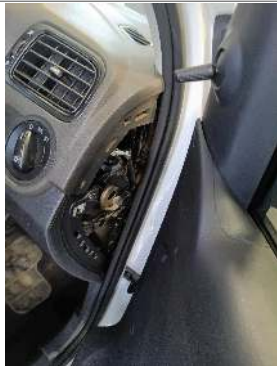
Sider cover missing

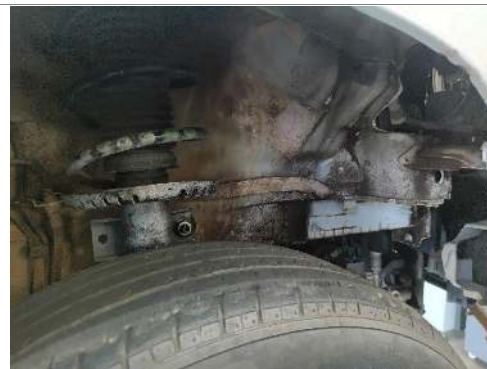
R/F fender liner missing

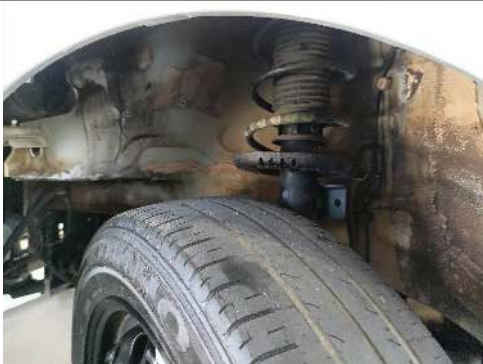
L/F fender liner missing

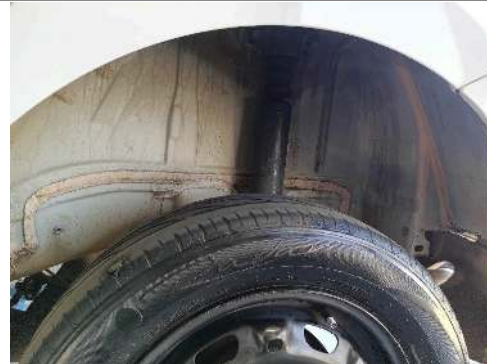
L/R fender liner missing

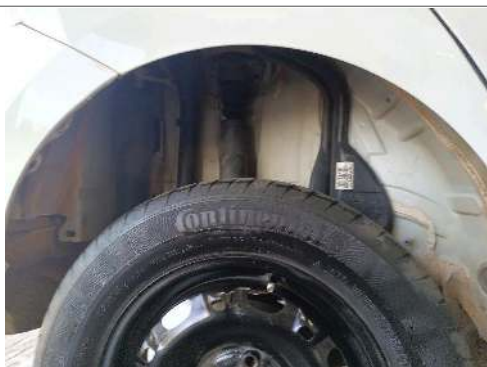
R/R fender liner missing

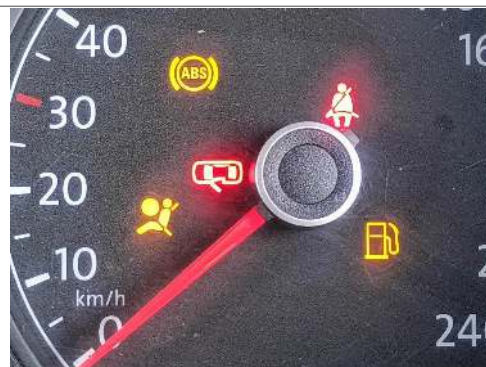
| Damage | Repair Way |
|---|---|
| Warning lights illuminated | Repair |

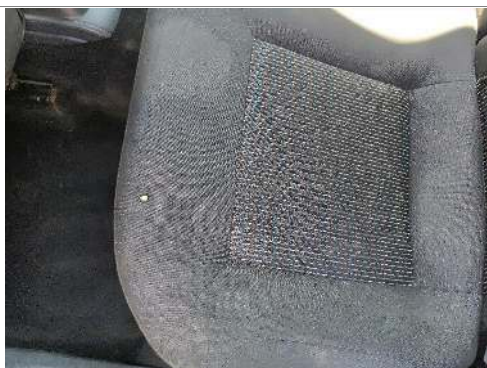
| Damage | Repair Way |
|---|---|
| Seat Rear Torn / Cut | Repair |

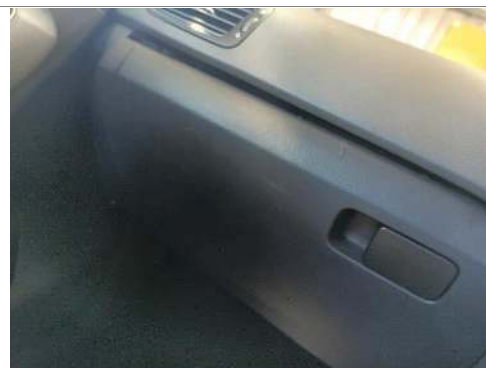
| Damage | Repair Way |
|---|---|
| Center Console / Cubbyhole + Lid Damaged | Repair |

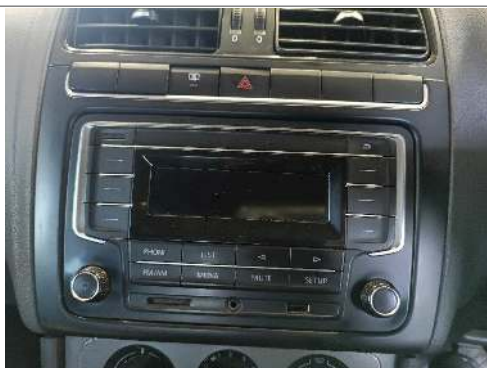
| Damage | Repair Way |
|---|---|
| Radio/CD/USB Defective | Repair |

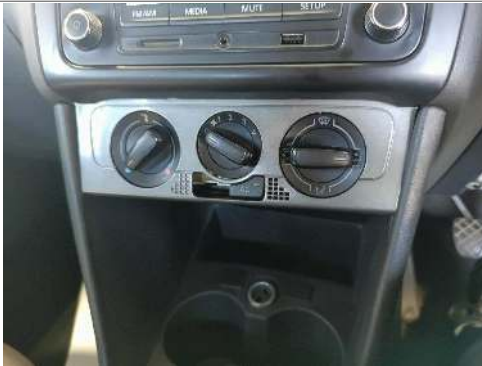
| Damage | Repair Way |
|---|---|
| Air Conditioner Insufficient | Repair |

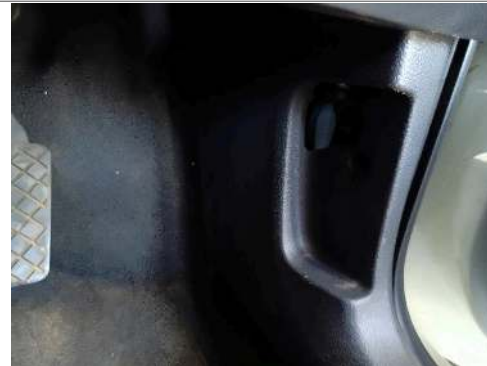
| Damage | Repair Way |
|---|---|
| Bonnet cable Missing | Repair |

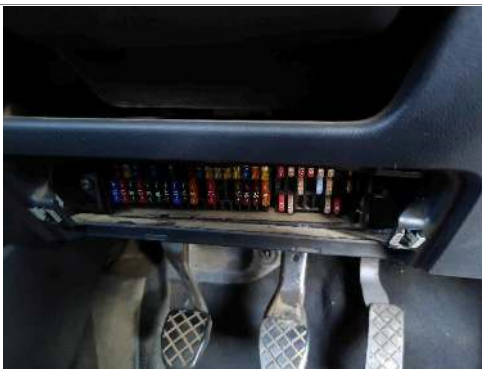
| Damage | Repair Way |
|---|---|
| Fuse box and fuses Defective | Repair |

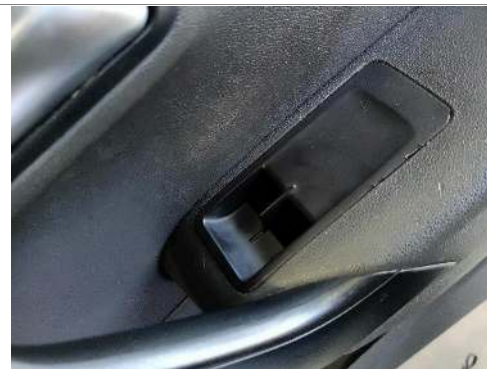
| Damage | Repair Way |
|---|---|
| Switch Electrical Window Winder front right Missing | Replace |

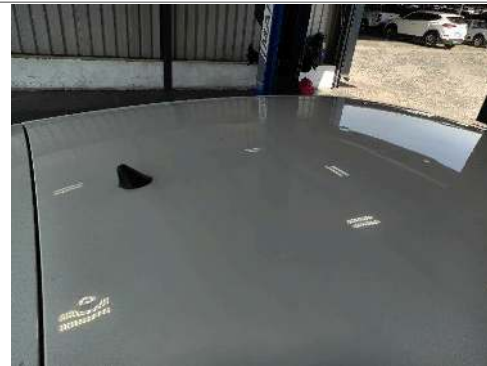
| Damage | Repair Way |
|---|---|
| Roof Dented | Repair |

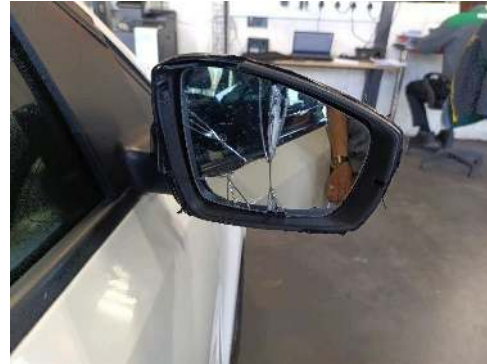
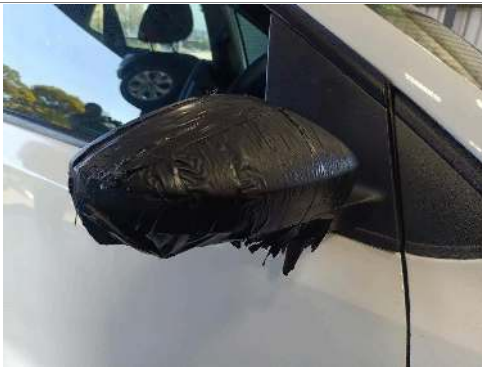
| Damage | Repair Way |
|---|---|
| Side Mirror Right Damaged | Replace |

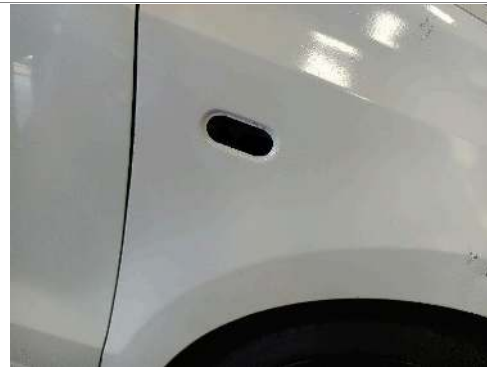
| Damage | Repair Way |
|---|---|
| Indicator Light Front Right Missing | Replace |

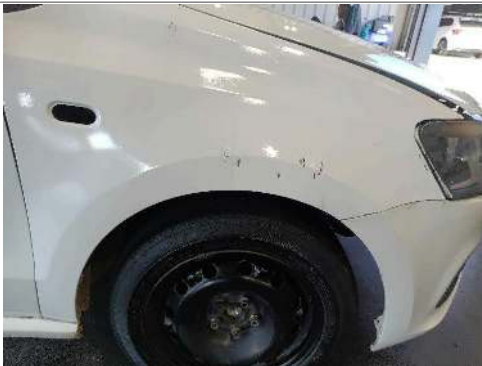
| Damage | Repair Way |
|---|---|
| Front Fender Right Residual Traces of Repair | Repair |

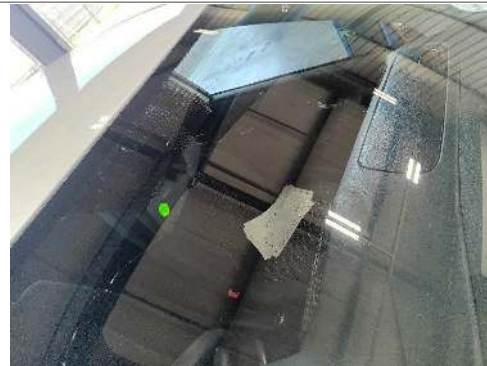
| Damage | Repair Way |
|---|---|
| Windscreen Cracked | Replace |

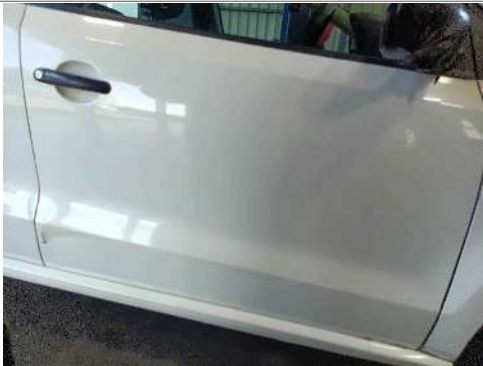
| Damage | Repair Way |
|---|---|
| Door Rear Right Dented | Repair |

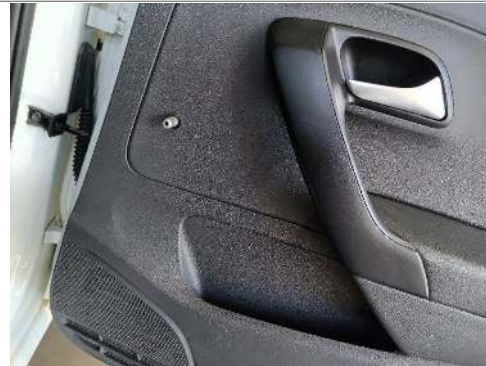
| Damage | Repair Way |
|---|---|
| Window Winder rear right Missing | Replace |

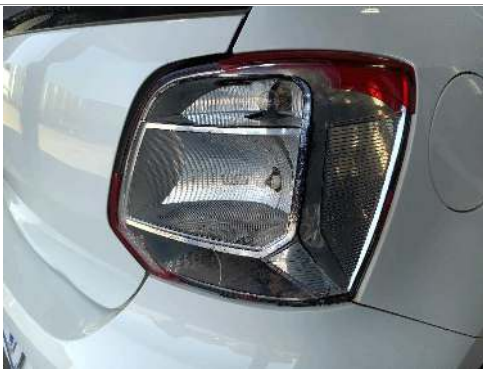
| Damage | Repair Way |
|---|---|
| Tail Light Right Damaged | Replace |

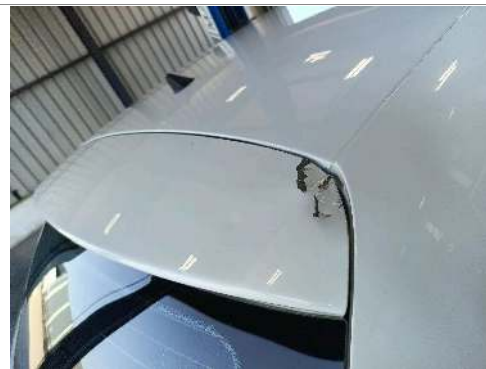
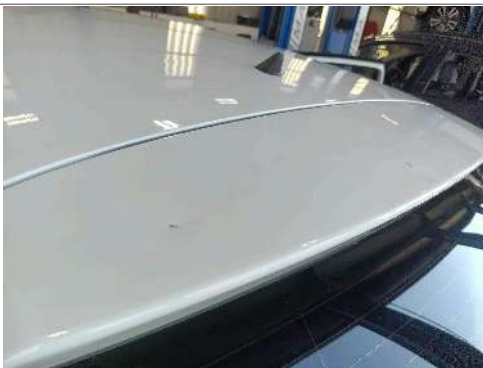
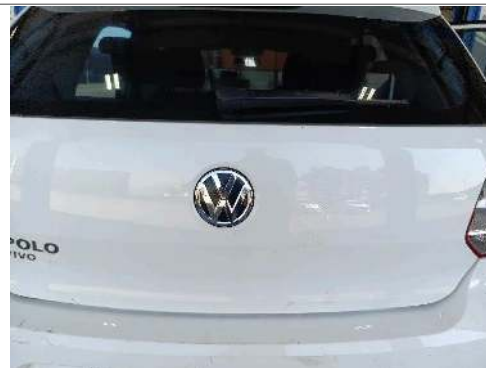
| Damage | Repair Way |
|---|---|
| Boot Lid / Hatch door Dented | Repair |
| Boot does not open, electronics malfunction | Repair |

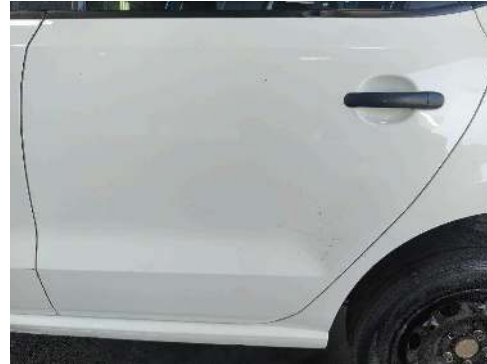
| Damage | Repair Way |
|---|---|
| Door Rear Left Paintwork • Scratched | Repair |

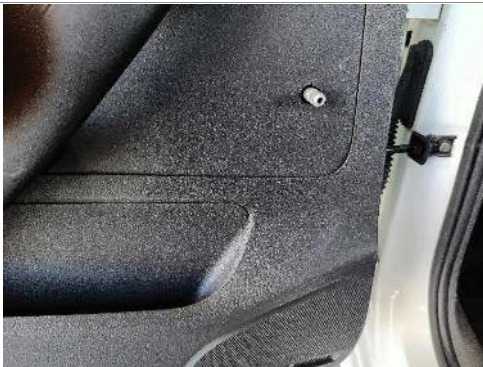
| Damage | Repair Way |
|---|---|
| Window Winder rear left Missing | Replace |

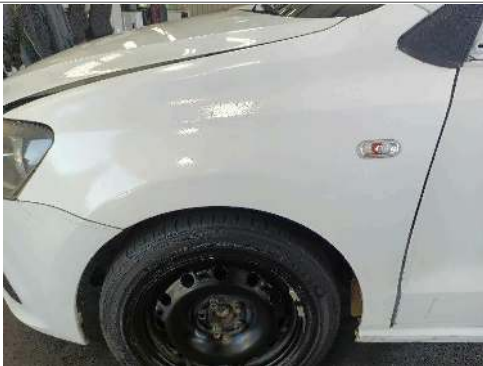
| Damage | Repair Way |
|---|---|
| Front Fender Left Residual Traces of Repair | Repair |

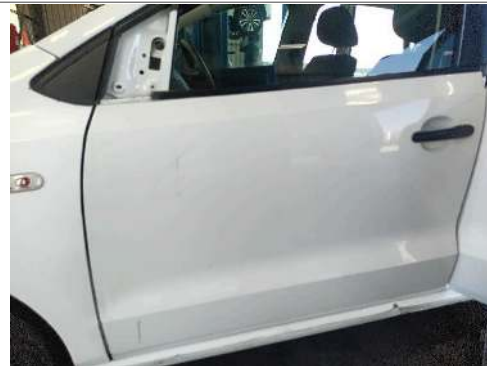
| Damage | Repair Way |
|---|---|
| Door Front Left Paintwork • Scratched | Repair |

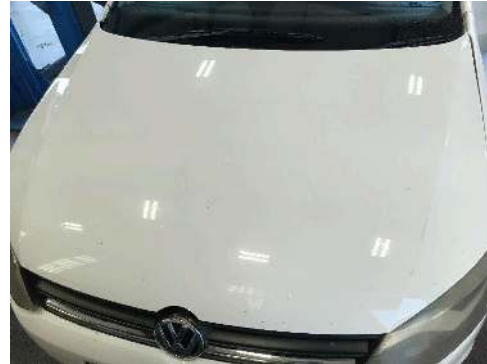
| Damage | Repair Way |
|---|---|
| Bonnet Paintwork • Scratched | Repair |

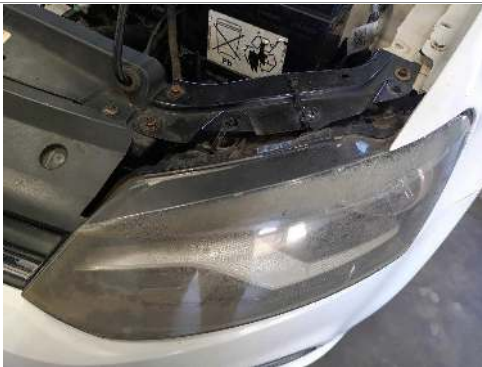
| Damage | Repair Way |
|---|---|
| Headlight Left Damaged | Replace |

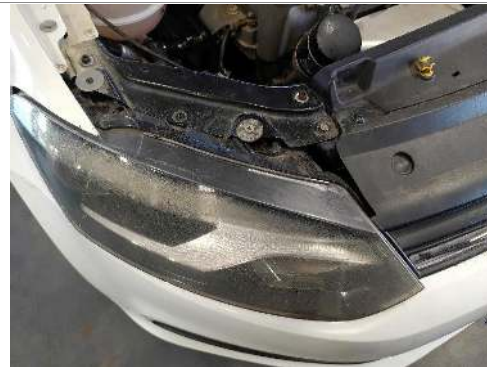
| Damage | Repair Way |
|---|---|
| Headlight Right Damaged | Replace |

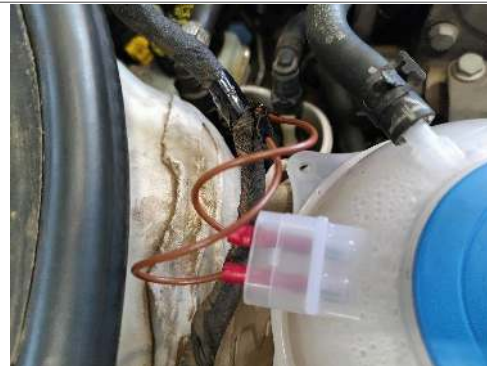
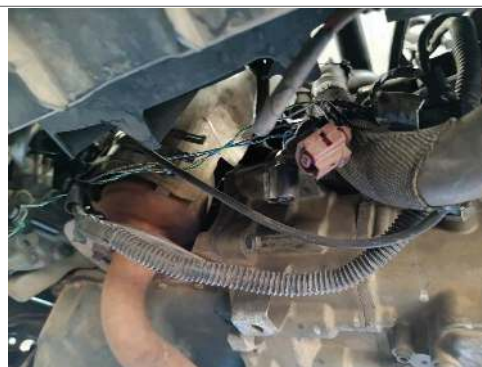
| Damage | Repair Way |
|---|---|
| Engine Wiring Defective | Repair |

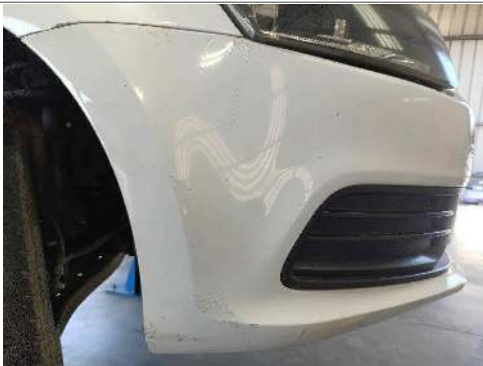
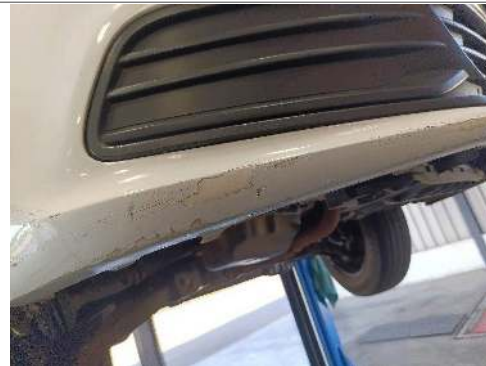
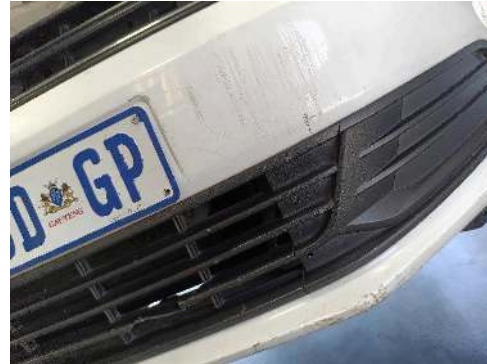
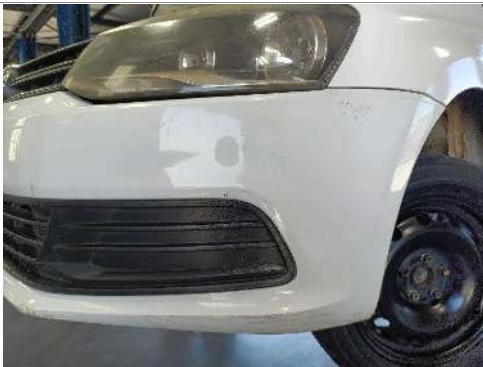
| Damage | Repair Way |
|---|---|
| Front Bumper Paintwork • Scratched | Repair |

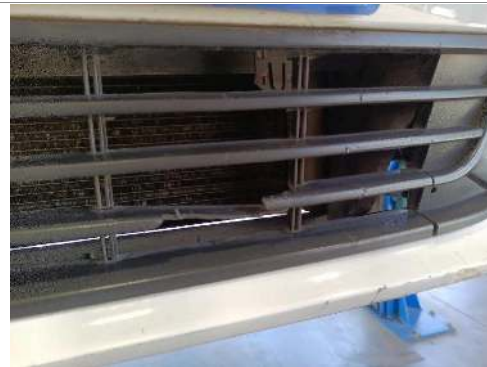
| Damage | Repair Way |
|---|---|
| Grill Damaged | Replace |

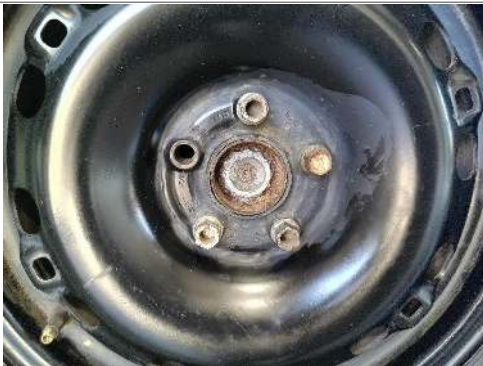
| Damage | Repair Way |
|---|---|
| Bolt(s) / Nut(s) Front Wheel Left Missing | Replace |

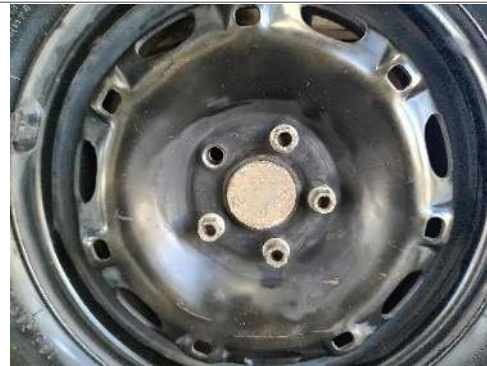
| Damage | Repair Way |
|---|---|
| Bolt(s) / Nut(s) Rear Wheel Left Missing | Replace |

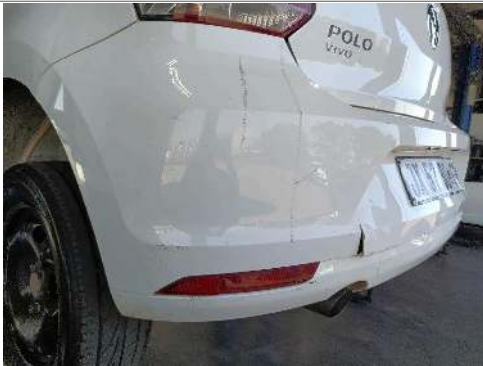
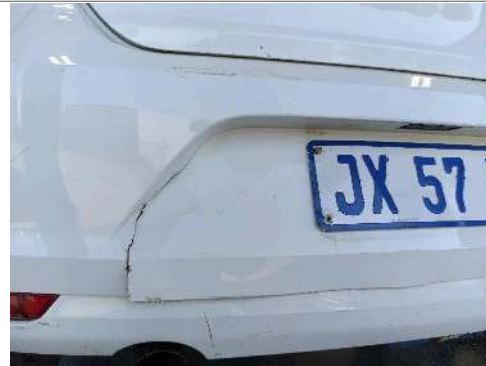
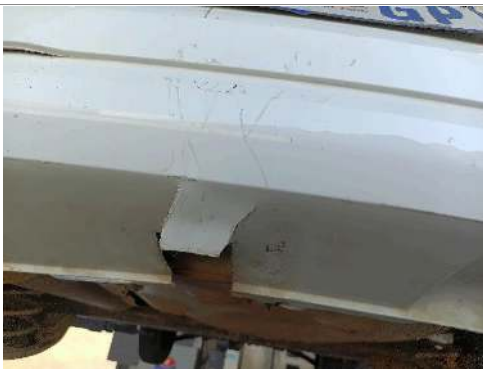
| Damage | Repair Way |
|---|---|
| Rear bumper Damaged | Repair |

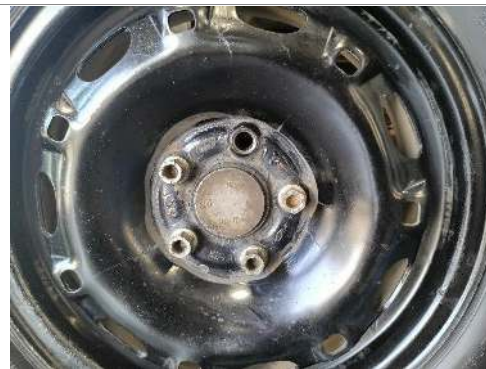
| Damage | Repair Way |
|---|---|
| Bolt(s) / Nut(s) Rear Wheel Right Missing | Replace |

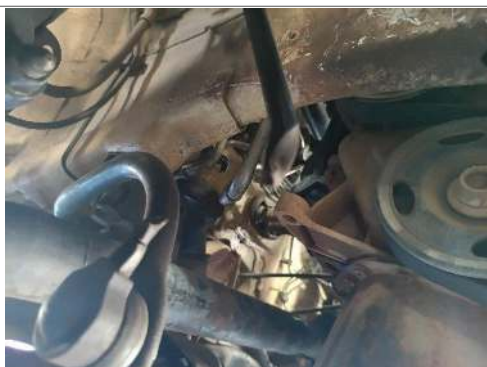
| Damage | Repair Way |
|---|---|
| Stabilizer Mounting Front Right Damaged | Replace |

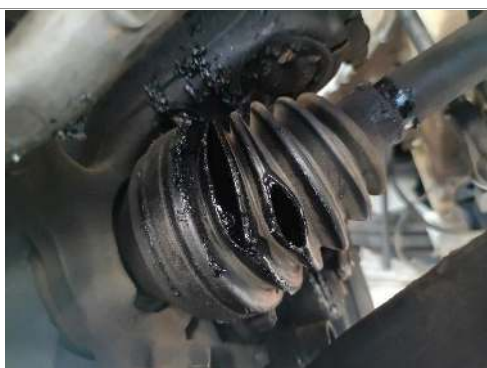
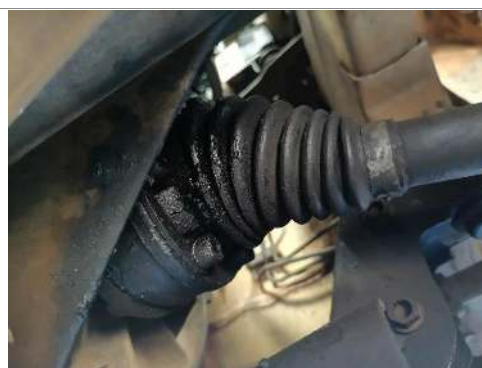
| Damage | Repair Way |
|---|---|
| CV Joint(s) Boot(s) Front Left (inner/outer) Damaged | Replace |

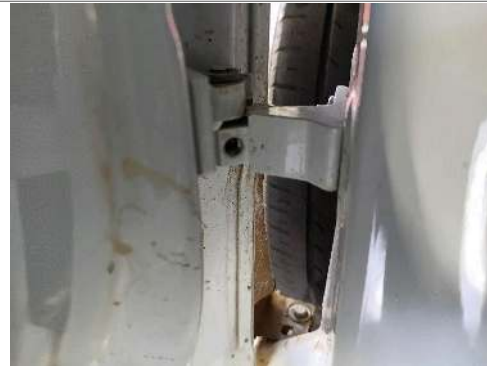
| Damage | Repair Way |
|---|---|
| Door Hinges Front Left Defective | Replace |

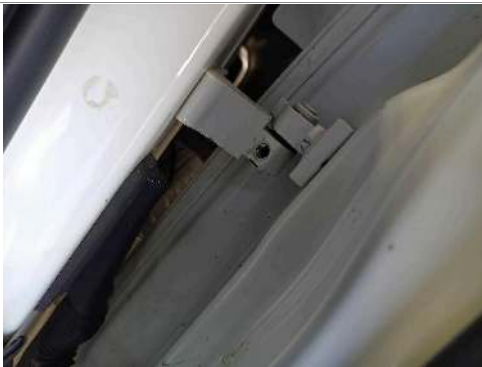
| Damage | Repair Way |
|---|---|
| Door Hinges Front Right Defective | Replace |
