MFC Auction House  
M57 Pretoria Rd, Glenmarais, KEMPTON PARK  
Gauteng

DEKRA MFC  
M57 Pretoria Rd - 1619  
KEMPTON PARK - GT  
08610 33572

## CONDITION REPORT

Report No: 2016207780

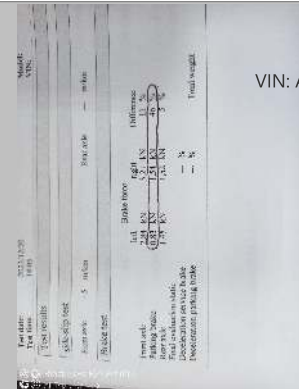
| Damage | Repair Way |
|---|---|
| Parking Brake Performance Left / Right Difference out of legal range | Repair |

| | Left | Right | | |
|---|---|---|---|---|
| Emergency / Parking | 0.8 | 1.5 | - | |

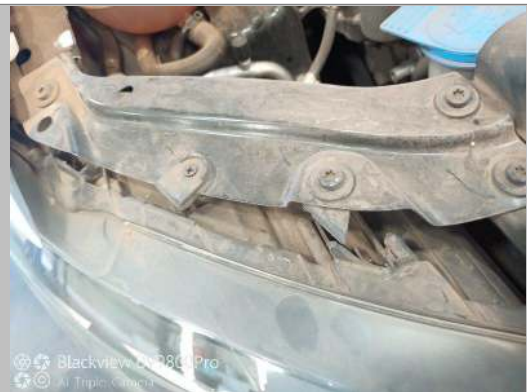
| Damage | Repair Way |
|---|---|
| Headlight Right Damaged | Replace |

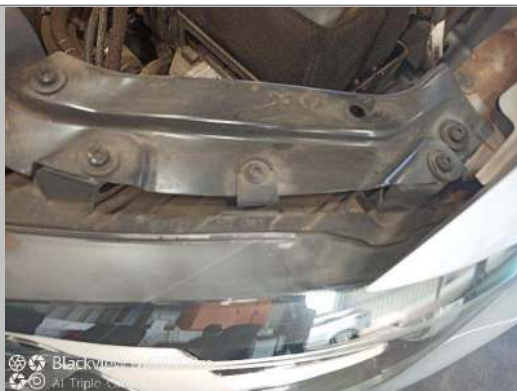
| Damage | Repair Way |
|---|---|
| Headlight Left Damaged | Replace |

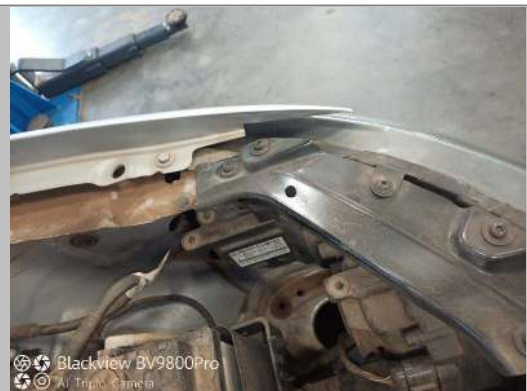
| Damage | Repair Way |
|---|---|
| Bonnet slam plate (Shock tower/ Inner tray) Dented | Repair |

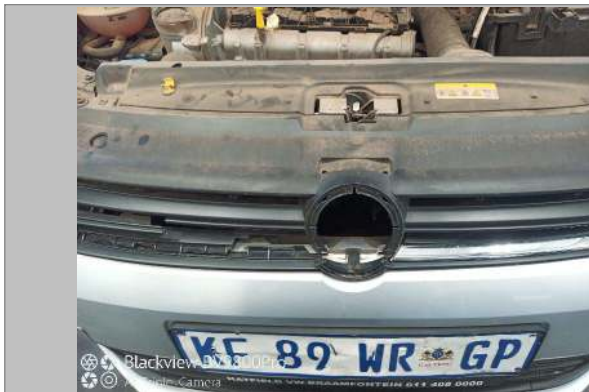
| Damage | Repair Way |
|---|---|
| Grill Damaged | Repair |

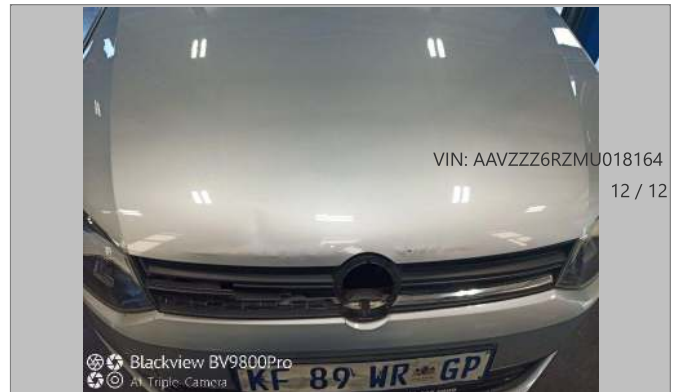
| Damage | Repair Way |
|---|---|
| Bonnet Dented | Repair |

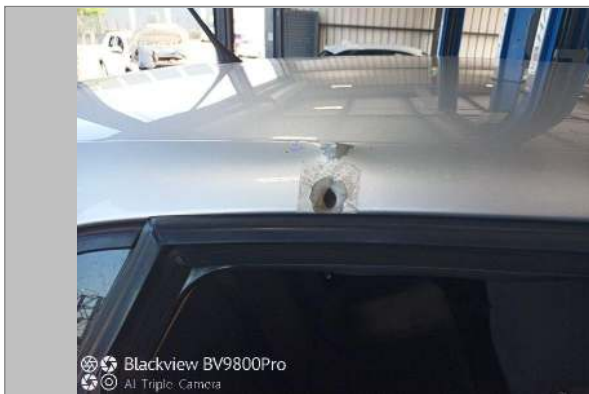
| Damage | Repair Way |
|---|---|
| A • Pillar Right Damaged | Repair |

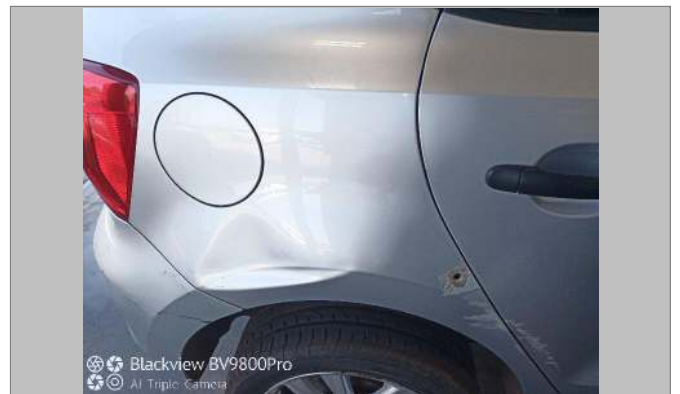
| Damage | Repair Way |
|---|---|
| Rear Fender Right Damaged | Repair |

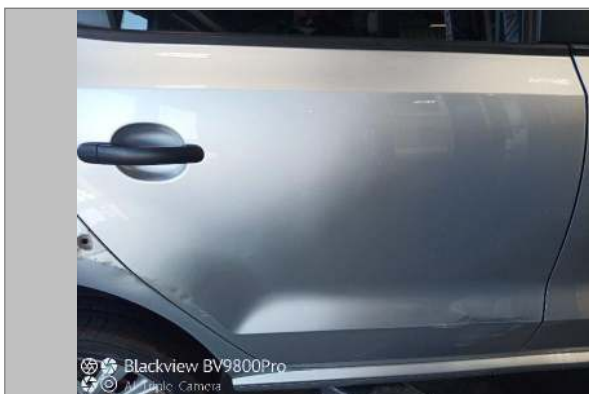
| Damage | Repair Way |
|---|---|
| Door Rear Right Paintwork • Scratched | Repair |

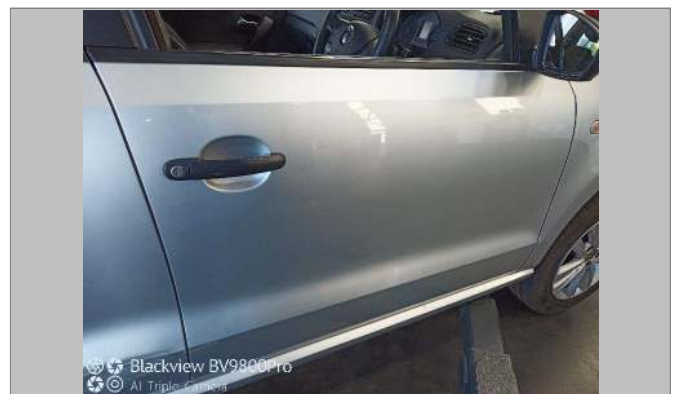
| Damage | Repair Way |
|---|---|
| Door Front Right Paintwork • Scratched | Repair |

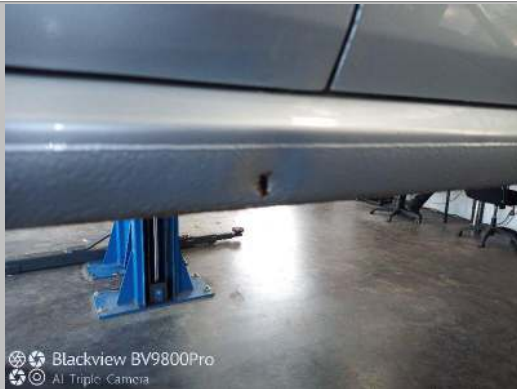
| Damage | Repair Way |
|---|---|
| Sill Panel Right Damaged | Repair |

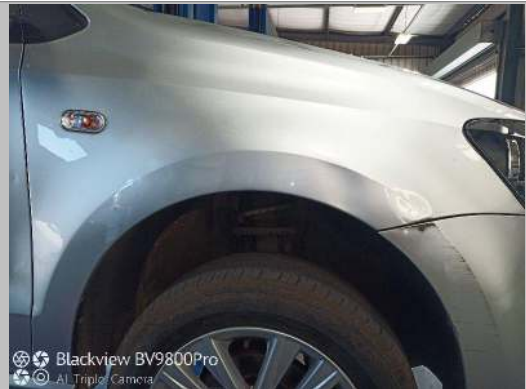
| Damage | Repair Way |
|---|---|
| Front Fender Right Dented | Repair |

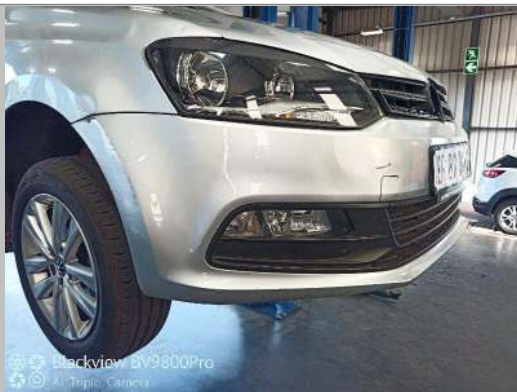
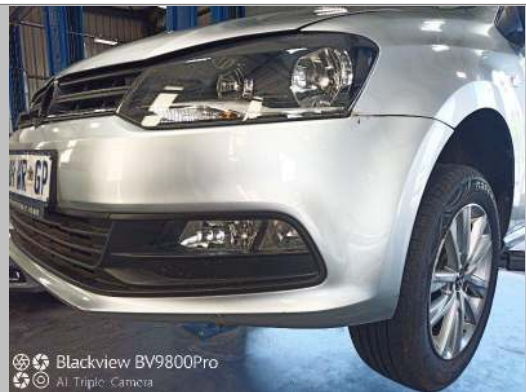
| Damage | Repair Way |
|---|---|
| Front Bumper Paintwork • Scratched | Repair |

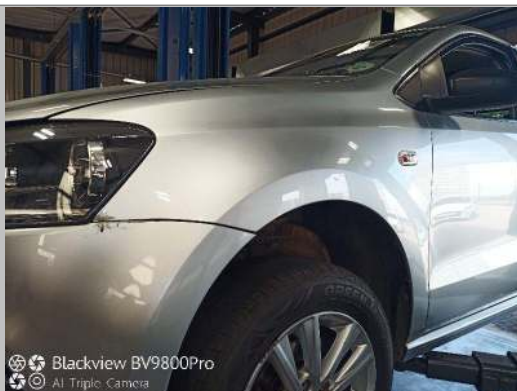
| Damage | Repair Way |
|---|---|
| Front Fender Left Dented | Repair |

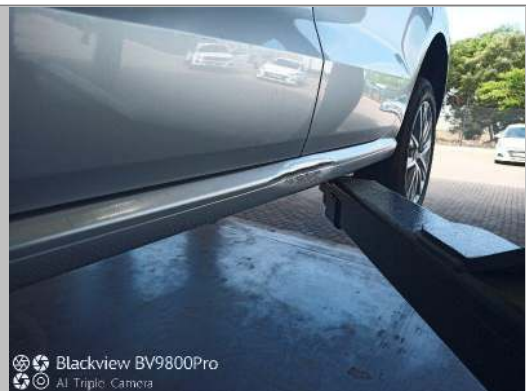
| Damage | Repair Way |
|---|---|
| Sill Panel Left Dented | Repair |

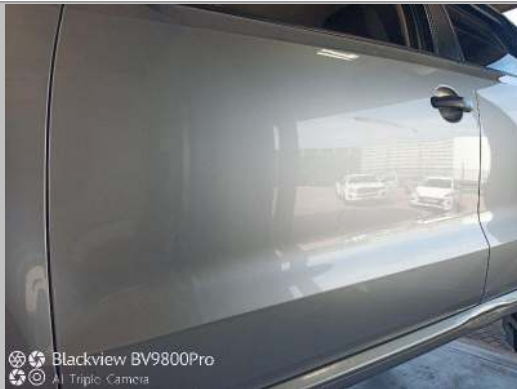
| Damage | Repair Way |
|---|---|
| Door Front Left Paintwork • Scratched | Repair |

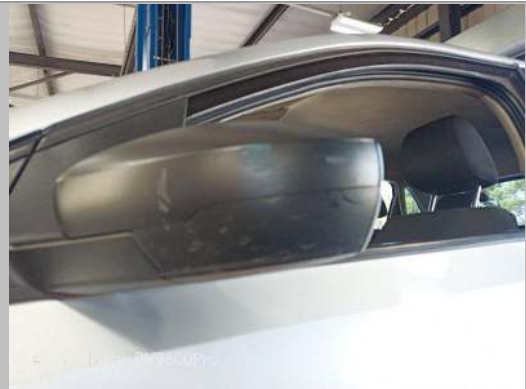
| Damage | Repair Way |
|---|---|
| Side Mirror Left Paintwork • Scratched | Repair |

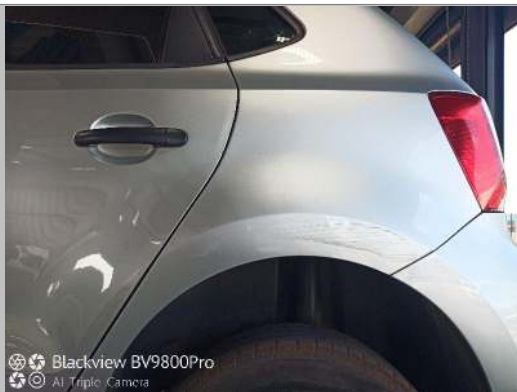
| Damage | Repair Way |
|---|---|
| Rear Fender Left Paintwork • Scratched | Repair |

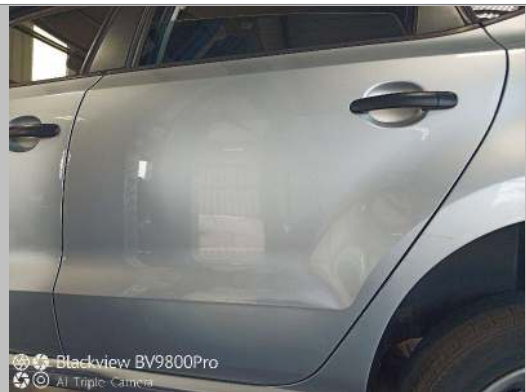
| Damage | Repair Way |
|---|---|
| Door Rear Left Paintwork • Scratched | Repair |

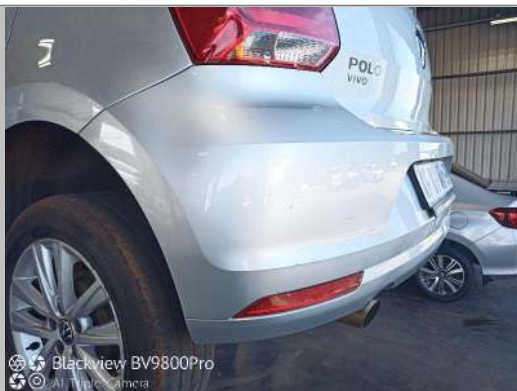
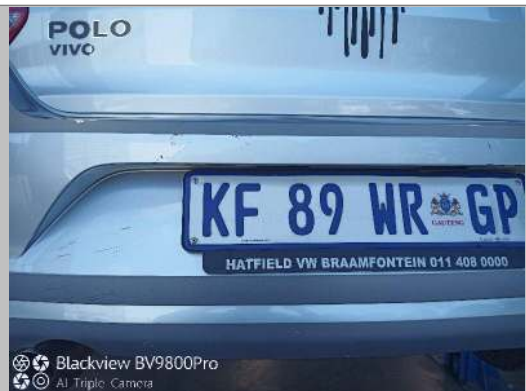
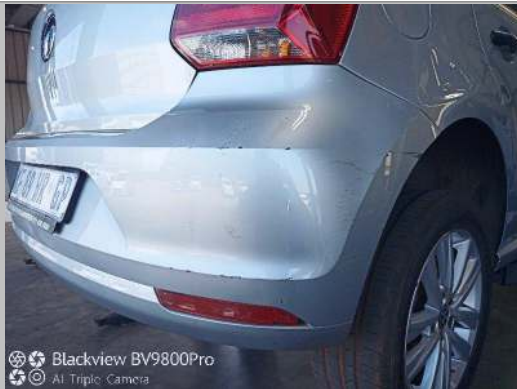
| Damage | Repair Way |
|---|---|
| Rear bumper Paintwork • Scratched | Repair |

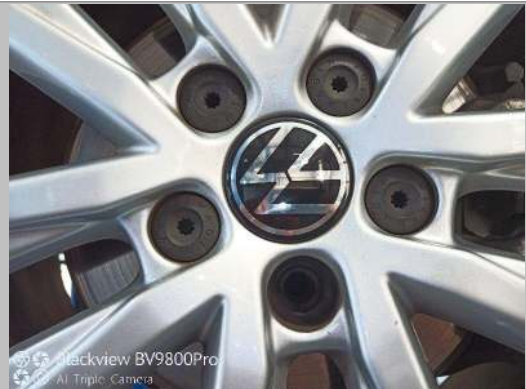
| Damage | Repair Way |
|---|---|
| Bolt(s) / Nut(s) Front Wheel Right Missing | Replace |

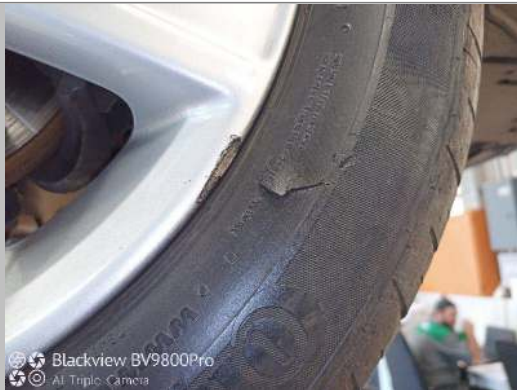
| Damage | Repair Way |
|---|---|
| Tyre Front Right Torn / Cut | |

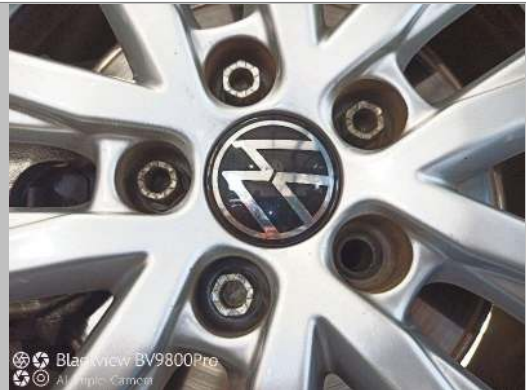
| Damage | Repair Way |
|---|---|
| Bolt(s) / Nut(s) Front Wheel Left Missing | Replace |

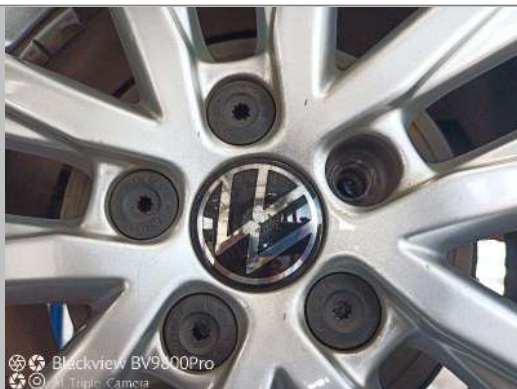
| Damage | Repair Way |
|---|---|
| Bolt(s) / Nut(s) Rear Wheel Left Missing | Replace |

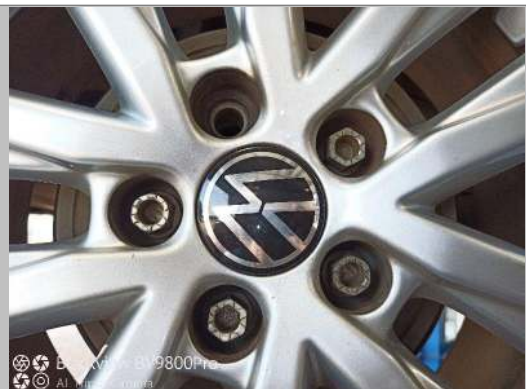
| Damage | Repair Way |
|---|---|
| Bolt(s) / Nut(s) Rear Wheel Right Missing | Replace |
