MFC Auction House
M57 Pretoria Rd, Glenmarais, KEMPTON PARK
Gauteng

Vehicle Type	PASSENGER VEHICLE	Registered Owner	MFC
Manufacturer	VOLKSWAGEN	Registration Number	NPG12839
Model	POLO VIVO	Register Number	
VIN	AAVZZZ6RZNU002327	Date Of First Licensing	
Engine Number		Last COR	
Doors	5	License Expiry Date	22/12/2023
Color	WHITE	Power / Displacement	
Year Model		Paint Finish	C - COMMON
Km Reading	23,417 KM	Fuel	PETROL
Cab / Body Type	HATCHBACK	Transmission	MANUAL

CONDITION REPORT

Report No: 2016210374

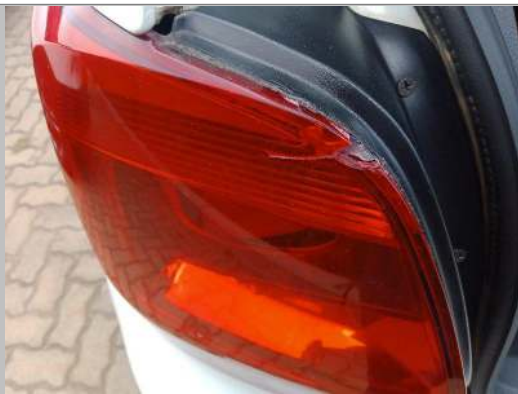
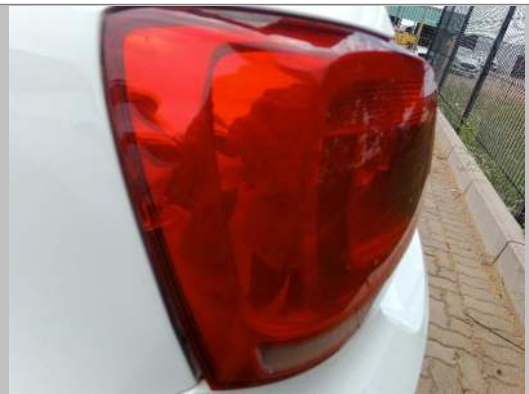
Damage	Repair Way
Tail Light Left Cracked	Replace
Front Bumper Paintwork • Scratched	Repair
Front Fender Right Paintwork • Scratched	Repair
Rear Fender Right Paintwork • Scratched	Repair
Door Front Left Dented	Repair
Door Front Right Paintwork • Scratched	Repair
Door Rear Left Dented	Repair
Door Rear Right Damaged	Repair
Rear bumper Paintwork • Scratched	Repair
Sill Panel Left Dented	Repair
Sill Panel Right Damaged	Repair
