## CONDITION REPORT

Report No:  
2017138036  
DATE  
27/01/2026

| Manufacturer | VOLKSWAGEN | Registration Number | LG99CJGP |
| Model | POLO VIVO 1.4 55KW TRENDLINE 5-DR<br>[2022-2024] | Register Number | |

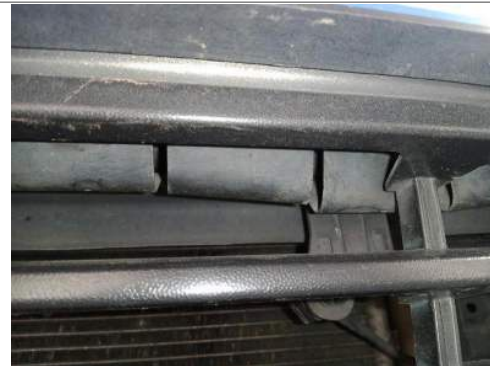
| Damage | Repair Way |
|---|---|
| Body and Exterior | Front bumper stiffener damaged |

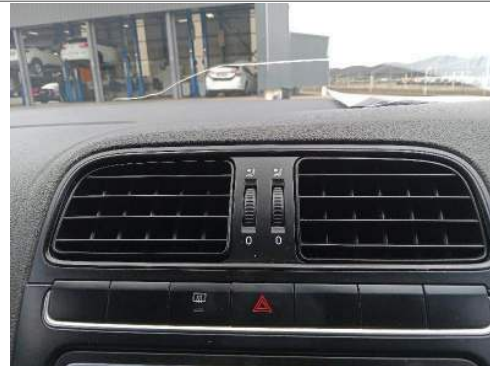
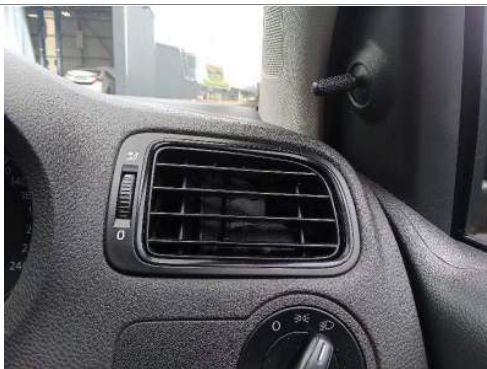
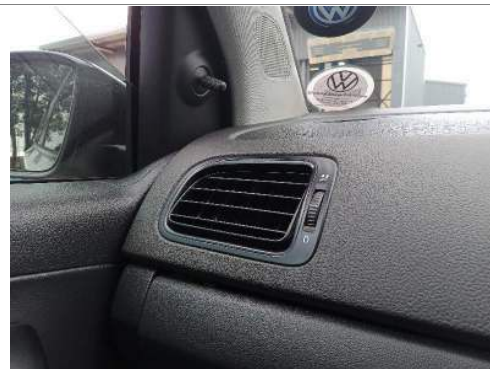
| Damage | Repair Way |
|---|---|
| Central Air Vent Damaged | Replace |

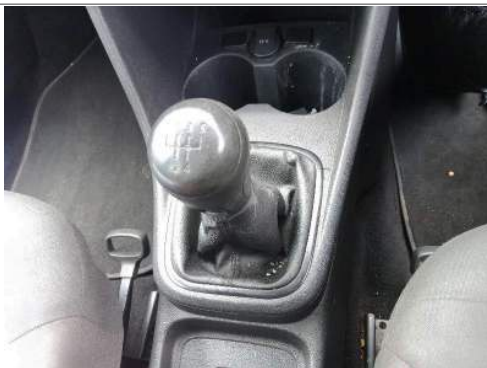
| Damage | Repair Way |
|---|---|
| Gear Selections Malfunction | Repair |
| Road test | Gearbox faulty |

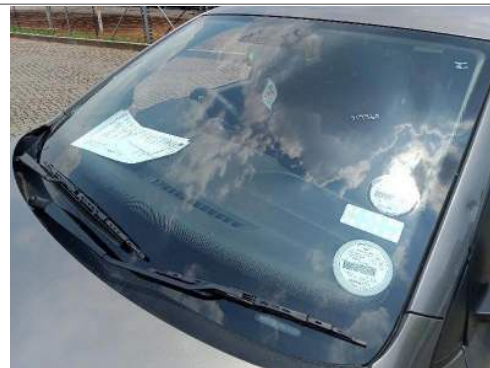
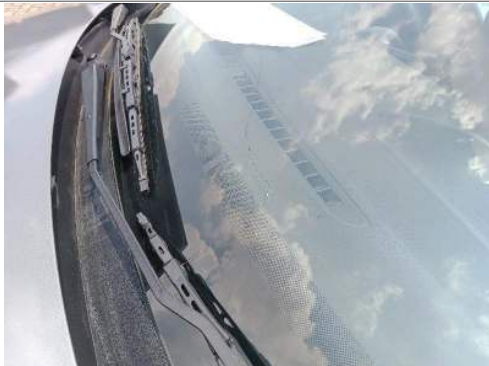
| Damage | Repair Way |
|---|---|
| Windscreen Cracked | Replace |

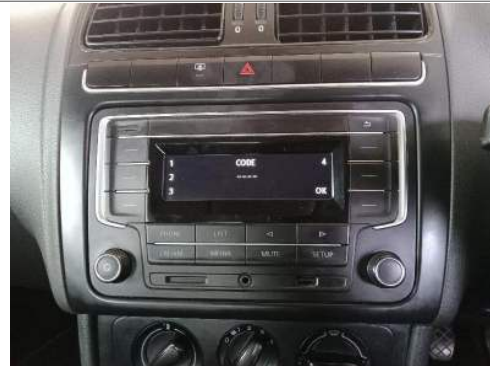
| Damage | Repair Way |
|---|---|
| Radio/CD/USB Defective | Repair |

Electrical Components and Instruments: Radio needs authentication code to operate.

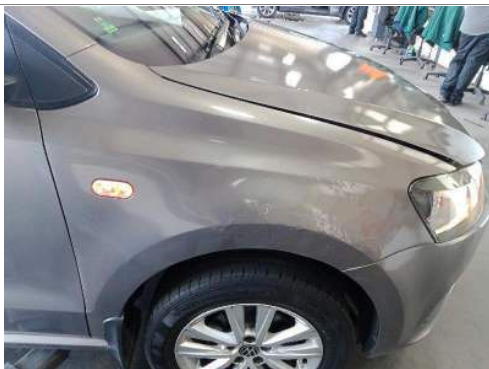
| Damage | Repair Way |
|---|---|
| Front Fender Right Damaged | Repair |

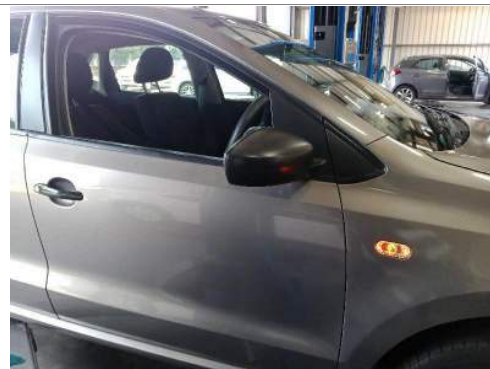
| Damage | Repair Way |
|---|---|
| Door Front Right Residual Traces of Repair | Repair |

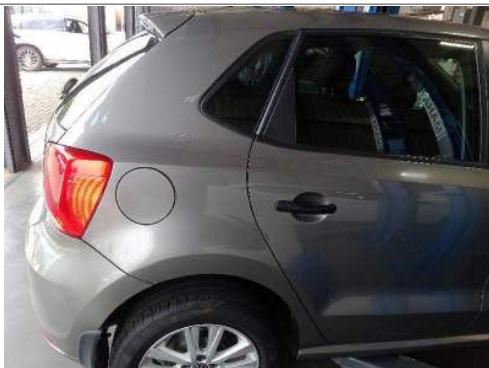
| Damage | Repair Way |
|---|---|
| Rear Fender Right Residual Traces of Repair | Repair |

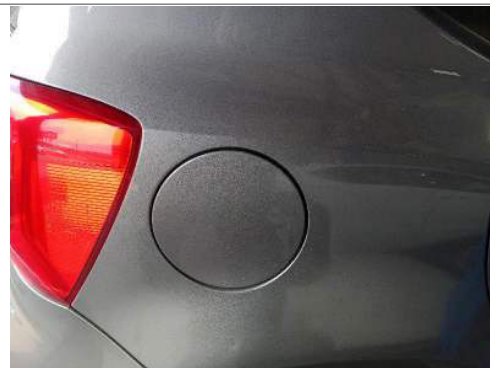
| Damage | Repair Way |
|---|---|
| Fuel Flap Damaged | Repair |

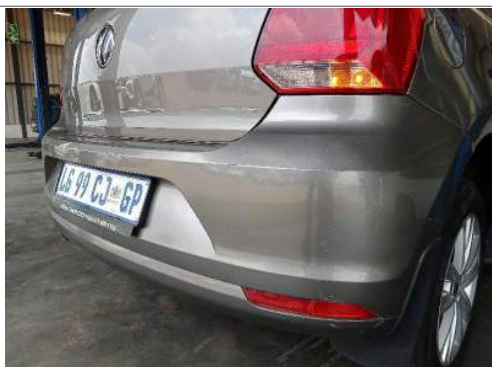
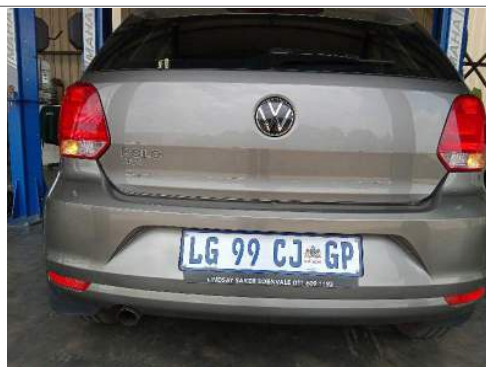
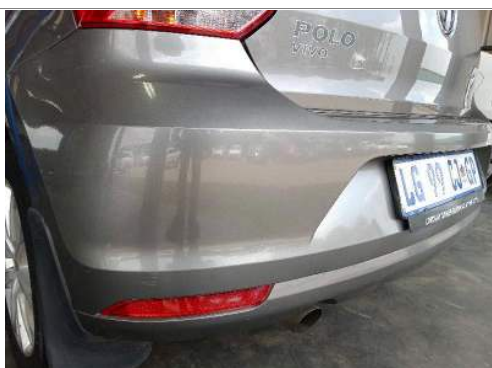
| Damage | Repair Way |
|---|---|
| Rear bumper Damaged | Repair |

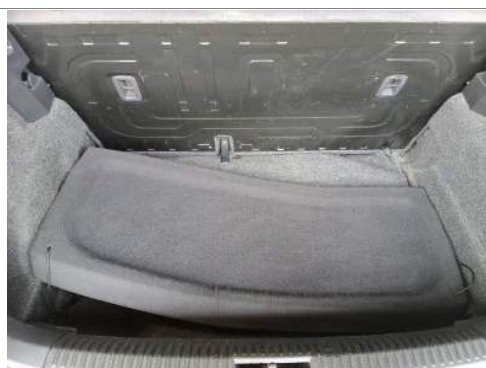
| Damage | Repair Way |
|---|---|
| Parcel Tray Damaged | Repair |

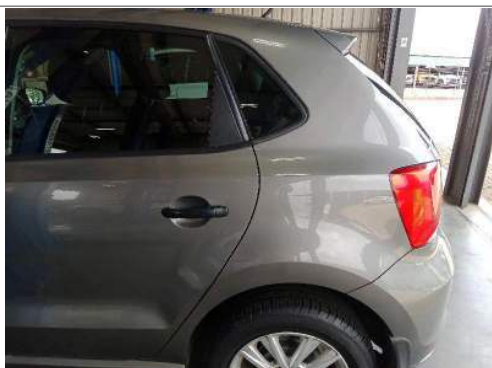
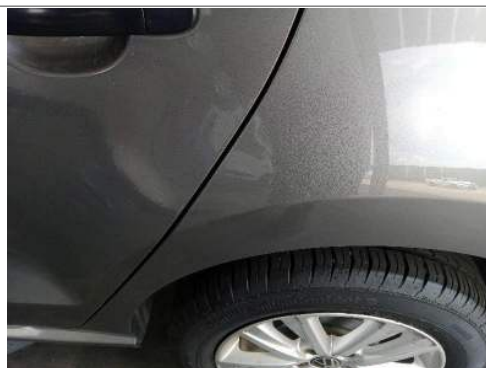
| Damage | Repair Way |
|---|---|
| Rear Fender Left Dented | Repair |

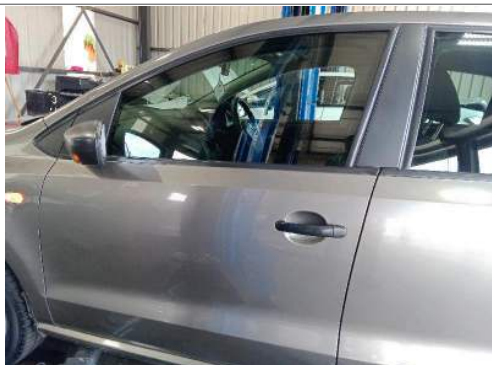
| Damage | Repair Way |
|---|---|
| Door Front Left Residual Traces of Repair | Repair |

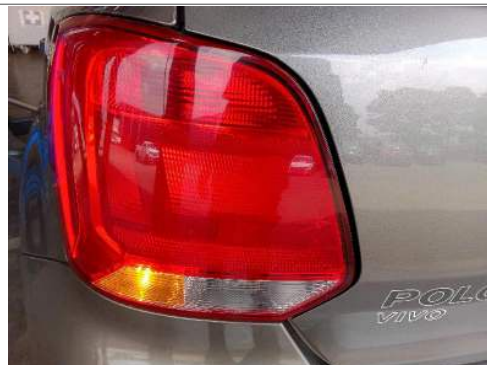
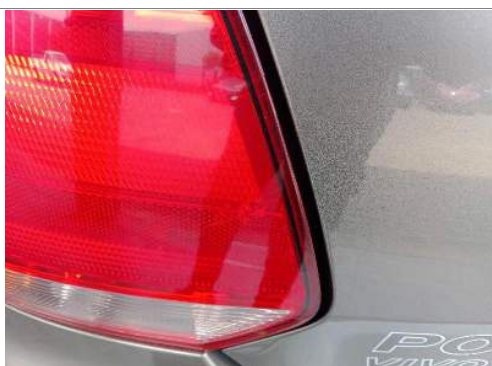
| Damage | Repair Way |
|---|---|
| Tail Light Left Cracked | Replace |

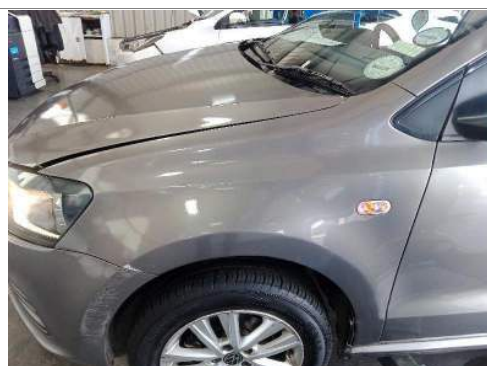
| Damage | Repair Way |
|---|---|
| Front Fender Left Residual Traces of Repair | Repair |

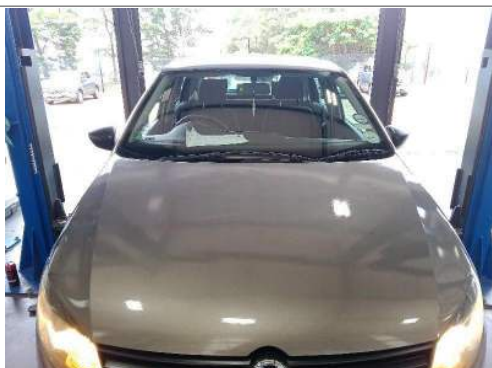
| Damage | Repair Way |
|---|---|
| Bonnet Residual Traces of Repair | Repair |

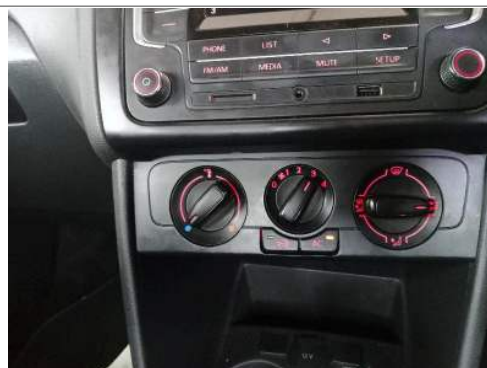
| Damage | Repair Way |
|---|---|
| Air Conditioner Insufficient | Replace |

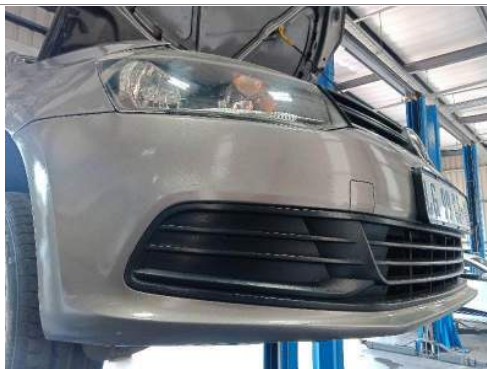
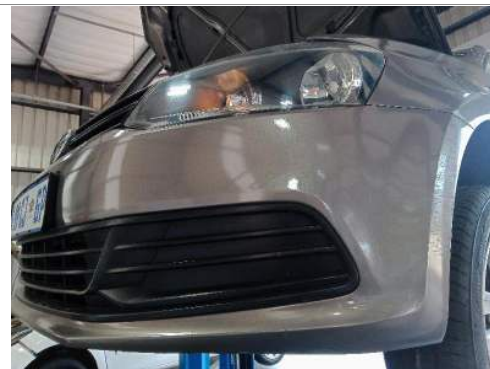
| Damage | Repair Way |
|---|---|
| Front Bumper Residual Traces of Repair | Repair |

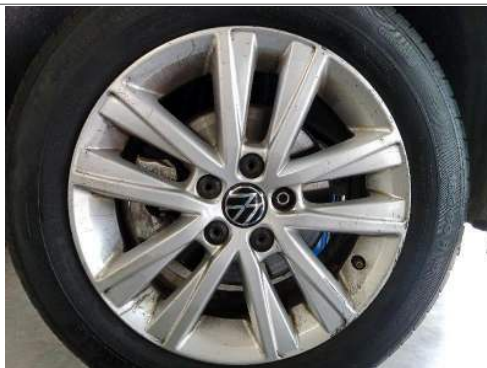
| Damage | Repair Way |
|---|---|
| Rim Front Left Scratched | Repair |

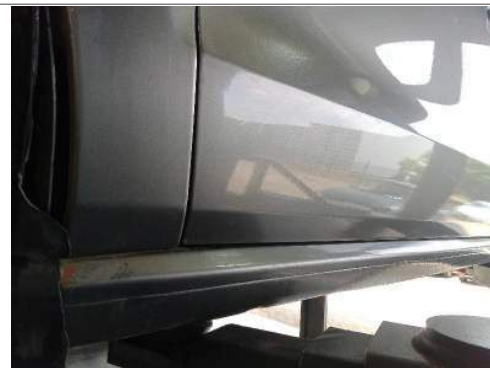
| Damage | Repair Way |
|---|---|
| Sill Panel Left Dented | Repair |

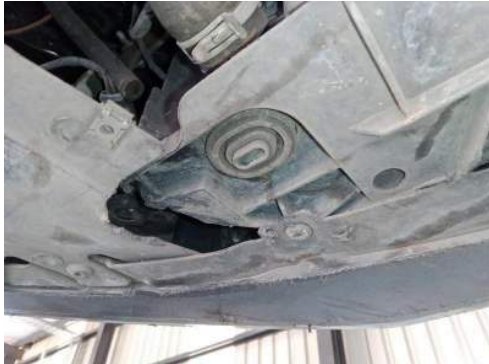
| Damage | Repair Way |
|---|---|
| Radiator Cradle Damaged | Repair |

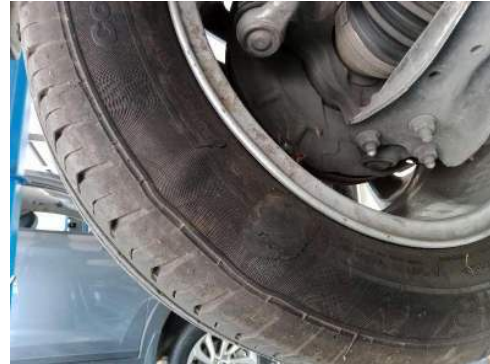
| Damage | Repair Way |
|---|---|
| Tyre Front Left Damaged | Replace |

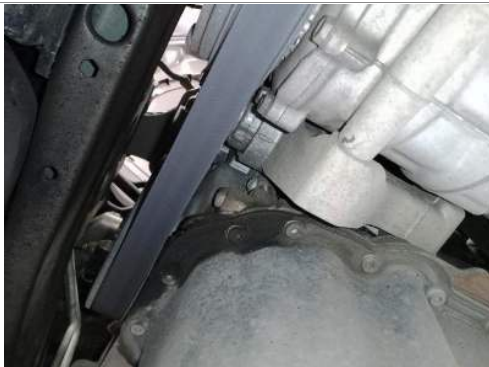
| Damage | Repair Way |
|---|---|
| Engine Oil Sweat | Repair |

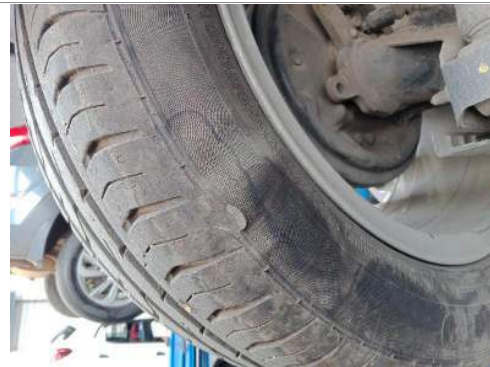
| Damage | Repair Way |
|---|---|
| Tyre Rear Left Damaged | Replace |

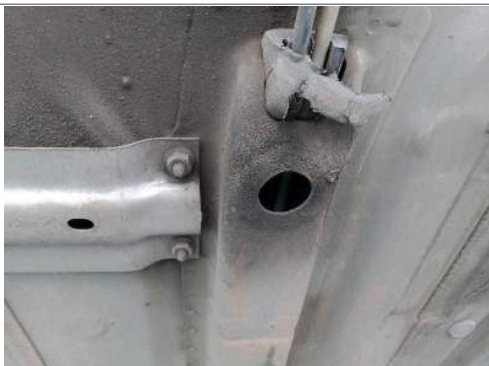
| Damage | Repair Way |
|---|---|
| Chassis Dented | Repair |

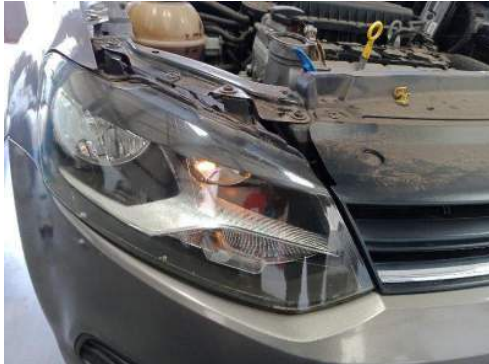
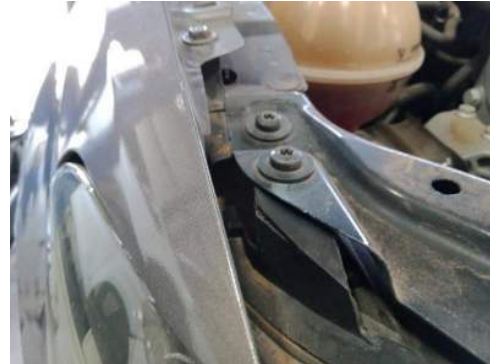
| Damage | Repair Way |
|---|---|
| Headlight Right Damaged | Replace |
