CONDITION REPORT

Report No: 2016204900

MFC Auction House
M57 Pretoria Rd, Glenmarais, KEMPTON PARK
Gauteng

Vehicle Type	PASSENGER VEHICLE	Registered Owner	MFC
Manufacturer	VOLKSWAGEN	Registration Number	HM30RFGP
Model	POLO VIVO	Register Number	
VIN	AAVZZZ6SZEU022520	Date Of First Licensing	
Engine Number		Last COR	
Doors	4	License Expiry Date	18/12/2023
Color	SILVER	Power / Displacement	
Year Model		Paint Finish	TWO COAT UNI
Km Reading	292,163 KM	Fuel	PETROL
Cab / Body Type	SEDAN	Transmission	MANUAL

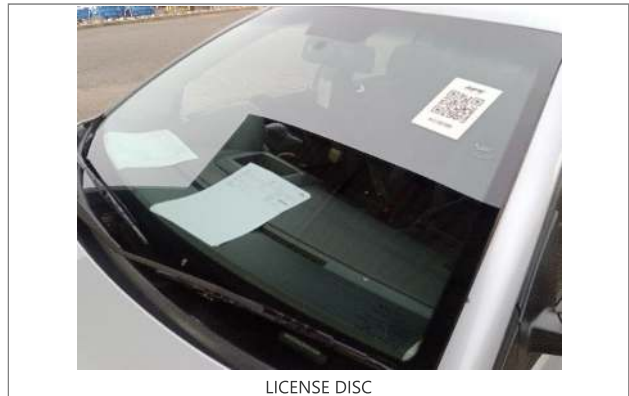
General Comments: VEHICLE HAS NO LICENSE DISC
 Engine Compartment: Computer box strapped with cable ties. Engine bay dirty. Brake fluid level ok. Oil pan dented. Rust inside expansion bottle.
 Electrical Components and Instruments: Hooter not working.
 Lights: Left number plate light not working Front left dim light not working.
 Interior: Vehicle interior dirty and some interior panels scratched. Boot sealing rubber damaged.
 Body • Exterior: Dents and scratches on some body panels. Spray work on some body panels. Some body panels misaligned. Stone chips on some body panels.
 Signs of impact impact damage to front of vehicle.

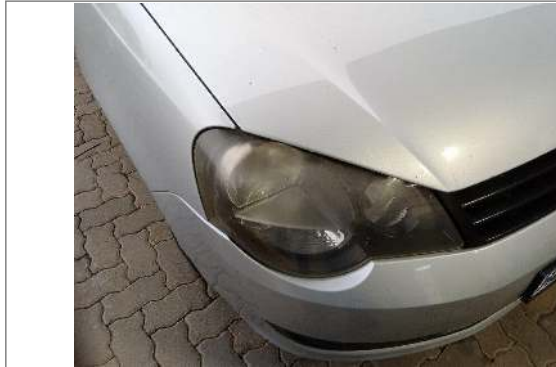
Damage	Repair Way
Engine Oil Leak	Repair
Engine Wiring Defective	Repair
Hoses Damaged	Replace
Radiator Defective	Replace
Central Air Vent Damaged	Replace
Center Console / Cubbyhole + Lid Defective	Repair
Interior Lights Malfunction	Repair
Headlight Left Defective	Replace
Headlight Right Defective	Replace
Seat Front Left Dirty	Repair
Seat Front Right Damaged	Repair
Seat Rear Defective	Repair
Seat Belt Rear Middle Defective	Repair
Hood Lining Dirty	Repair
Boot Carpet Defective	Repair
Mirror Adjusters Defective	Replace
Steering Wheel Trim Defective	Repair
Front Bumper Paintwork • Scratched	Repair
Bonnet Paintwork • Chipmarks	Repair
C • Pillar Left Dented	Repair
Front Fender Left Dented	Repair
Front Fender Right Dented	Repair
Rear Fender Left Paintwork • Scratched	Repair
Rear Fender Right Dented	Repair
Door Front Left Dented	Repair
Door Front Right Dented	Repair
Door Rear Left Dented	Repair
Door Rear Right Paintwork • Scratched	Repair

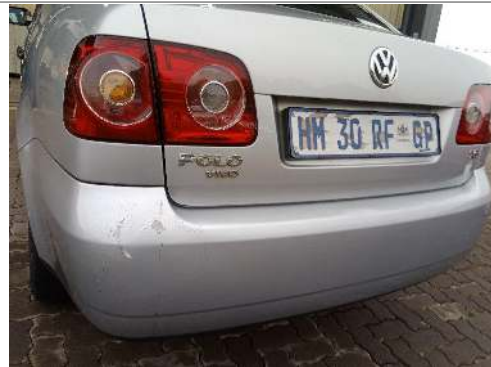
Rear bumper Damaged	Repair

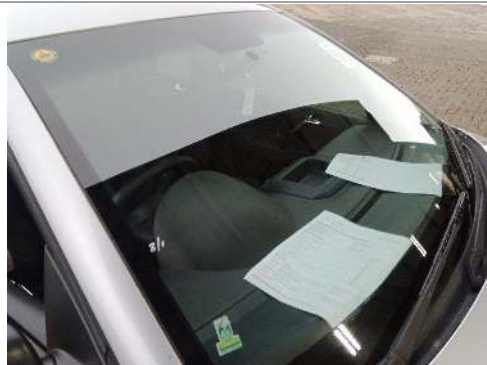
Damage	Repair Way
Inner Boot Floor Pan and Spare Wheel Well Dented	Repair
Sill Panel Left Dented	Repair
Rocker Panel Left Dented	Repair
Rocker Panel Right Dented	Repair
Windscreen Cracked	Replace
Steering Rack Boot Left Damaged	Replace
Shock Absorber Front Right Damaged	Replace
Control Arm(s) Front Axle Right Damaged	Replace
Control Arm Bush(es) Front Axle Left Damaged	
Control Arm Bush(es) Front Axle Right Cracked	Replace
Tyre Rear Left Worn	Replace
Tyre Rear Right Damaged	Replace
Chassis Dented	Repair
Sub Frame Scratched	Repair
Engine to silencer pipe Defective	Repair
Belly plates Damaged	Replace
Gearbox Oil Sweat	Repair
CV Joint(s) Front Left (inner/outer) Defective	Repair
CV Joint(s) Front Right (inner/outer) Defective	Repair
CV Joint(s) Boot(s) Front Left (inner/outer) Damaged	Replace
Warning lights illuminated on dashboard	Repair

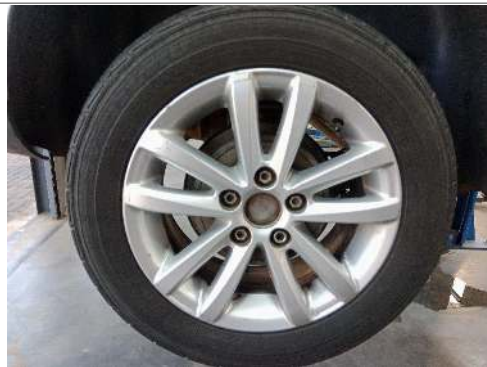
Tyre Rear Right

Size	Load/Speed Index	Manufacture	Model	Type*	Production Date	Tread Depth (mm)
Front Left	175/65 R14	82T	Eurovis	Roadstone	V	0322	4 mm
Front Right	175/65 R14	82T	Eurovis	Roadstone	V	0222	4 mm
Rear Left	185/60 R14	82H	Sumitomo	HTR	V	4620	0 mm
Rear Right	185/60 R14	82H	Sumitomo	HTR	V	4620	2 mm
Spare	175/65 R14	86T	RoadX	Rxmotion	V	3819	4 mm
