MFC Auction House
M57 Pretoria Rd, Glenmarais, KEMPTON PARK
Gauteng

Vehicle Type	PASSENGER VEHICLE	Registered Owner	MFC AUCTION HOUSE
Manufacturer	VOLKSWAGEN	Registration Number	JKK574MP
Model	POLO VIVO	Register Number	
VIN	AAVZZZ6SZGU014818	Date Of First Licensing	
Engine Number		Last COR	
Doors	5	License Expiry Date	30/11/2020
Color	WHITE	Power / Displacement	
Year Model		Paint Finish	TWO COAT UNI
Km Reading	524,347 KM	Fuel	PETROL
Cab / Body Type	HATCHBACK	Transmission	MANUAL

CONDITION REPORT

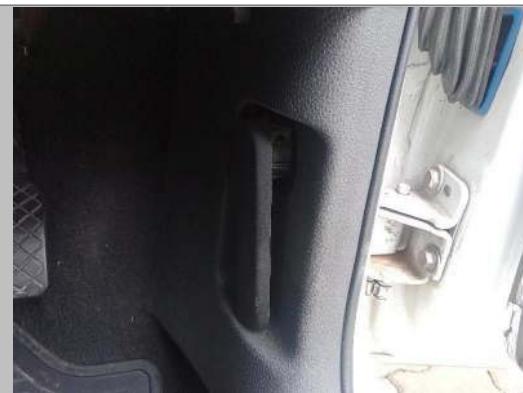
Belly plates Damaged	Replace
CV Joint(s) Front Left (inner/outer) Defective	Replace
CV Joint(s) Front Right (inner/outer) Defective	Replace
CV Joint(s) Boot(s) Front Left (inner/outer) Defective	Replace
Gear Selections Malfunction	Repair
Clutch Operation Insufficient	Replace
Rear right shock absorber weak	Replace
Body and Exterior	Dents and scratches on some body panels
Body and Exterior	Some body panels misaligned
Body and Exterior	Poor residual traces of repair on some body panels
Body and Exterior	Some body panels misaligned
Warning lights illuminated on dashboard	Repair
Interior	Aftermarket sound fitted to vehicle
Tyres and Rims	Spare wheel could not be checked
Engine	Engine bay dirty and battery loose
Engine	Computer box strapped with cable ties
Undercarriage	Vehicle undercarriage dirty.
Interior	Bonnet release handle loose
Interior	Vehicle interior dirty and some panels scratched
