CONDITION REPORT

Report No: 2016220526

MFC Auction House  
M57 Pretoria Rd, Glenmarais, KEMPTON PARK  
Gauteng

| Manufacturer | VOLKSWAGEN | Registration Number | FN41BFGP |

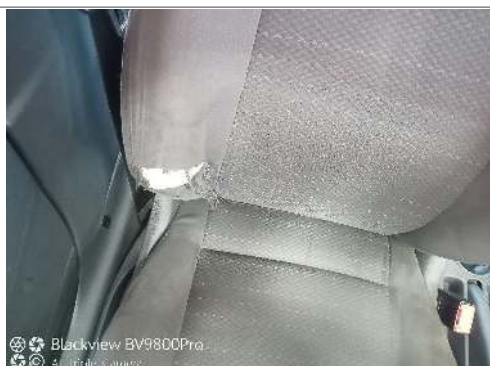
| Damage | Repair Way |
|---|---|
| Seat Front Right Torn / Cut | Repair |

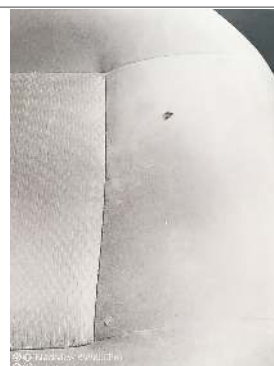
| Damage | Repair Way |
|---|---|
| Seat Front Left Torn / Cut | Repair |

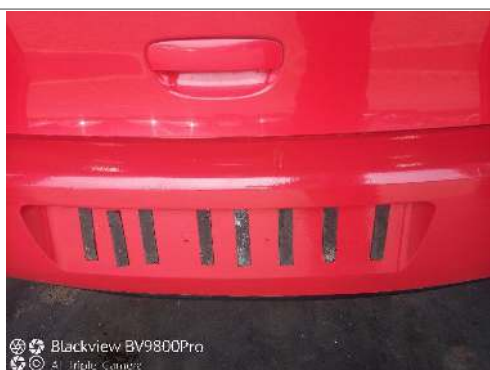
| Damage | Repair Way |
|---|---|
| Number Plate Rear Missing | Replace |

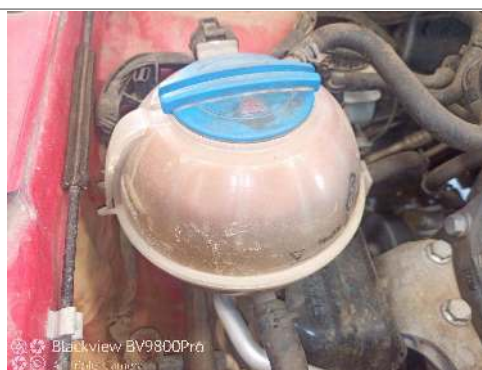
| Damage | Repair Way |
|---|---|
| Expansion Bottle Defective | Replace |

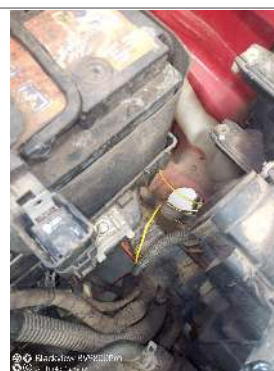
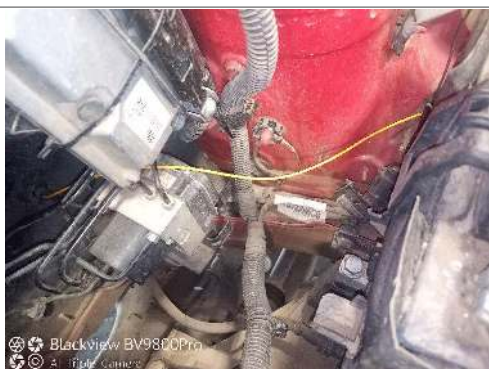
| Damage | Repair Way |
|---|---|
| Engine Wiring Defective | Repair |

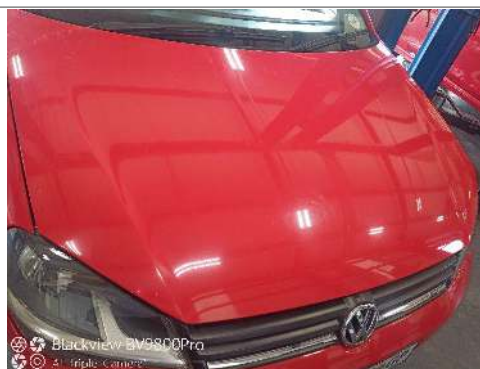
| Damage | Repair Way |
|---|---|
| Bonnet Paintwork • Chipmarks | Repair |

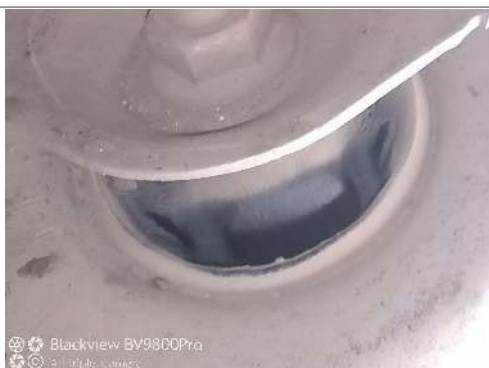
| Damage | Repair Way |
|---|---|
| Control Arm Bush(es) Front Axle Left Cracked | Replace |

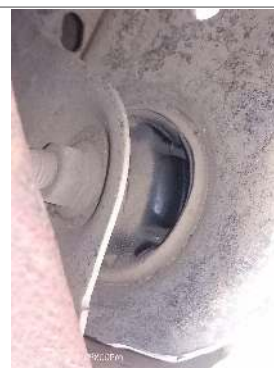
| Damage | Repair Way |
|---|---|
| Control Arm Bush(es) Front Axle Right Cracked | Replace |

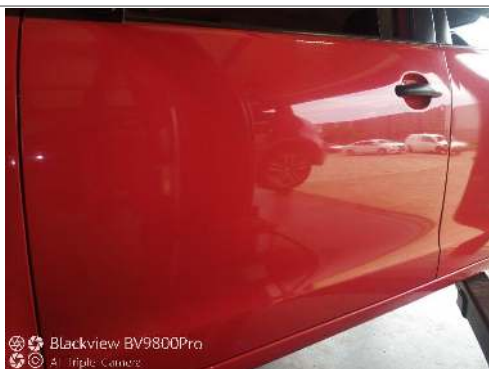
| Damage | Repair Way |
|---|---|
| Door Front Left Paintwork • Scratched | Repair |

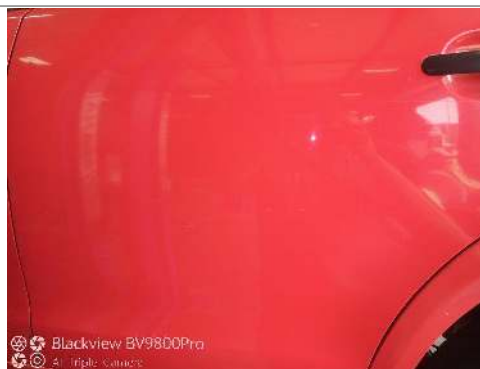
| Damage | Repair Way |
|---|---|
| Door Rear Left Paintwork • Scratched | Repair |

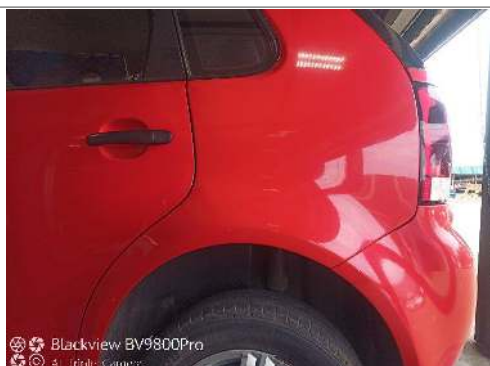
| Damage | Repair Way |
|---|---|
| Rear Fender Left Paintwork • Scratched | Repair |

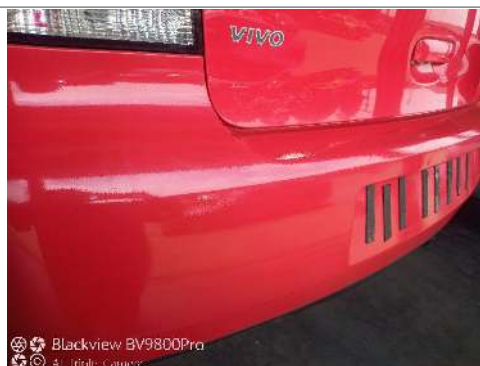
| Damage | Repair Way |
|---|---|
| Rear bumper Paintwork • Pitmarks | Repair |

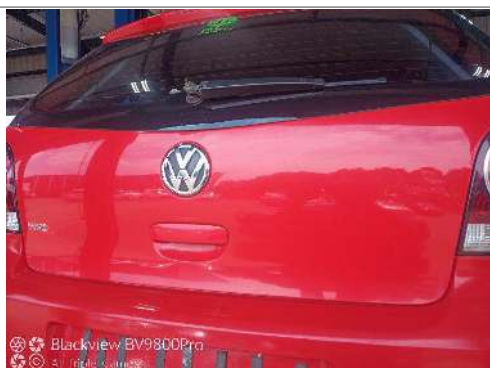
| Damage | Repair Way |
|---|---|
| Boot Lid / Hatch door Paintwork • Scratched | Repair |

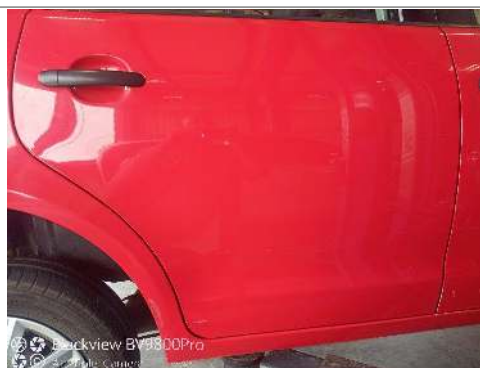
| Damage | Repair Way |
|---|---|
| Door Rear Right Paintwork • Scratched | Repair |

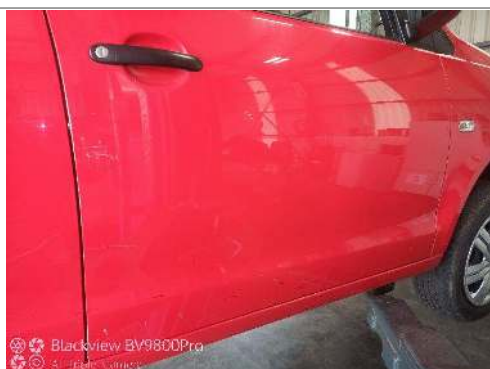
| Damage | Repair Way |
|---|---|
| Door Front Right Paintwork • Scratched | Repair |

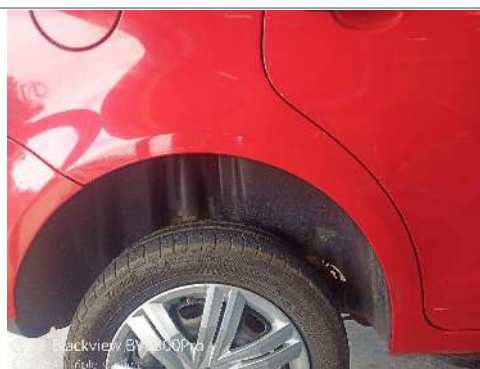
| Damage | Repair Way |
|---|---|
| Rear Fender Right Paintwork • Scratched | Repair |

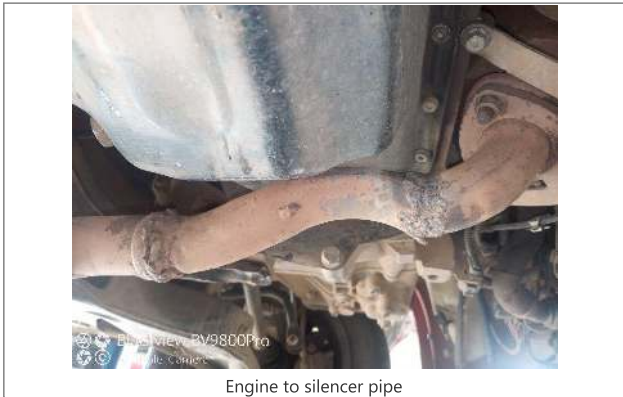
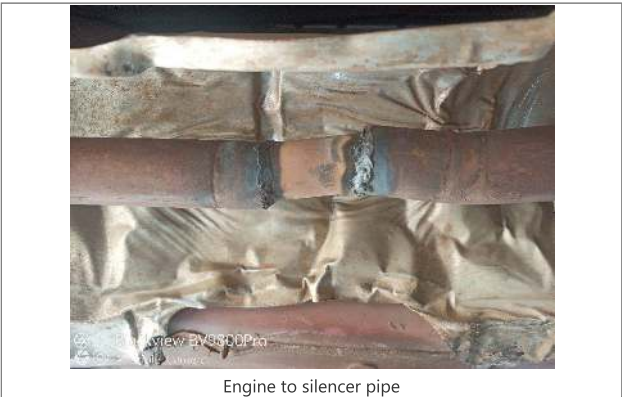
| Damage | Repair Way |
|---|---|
| Engine to silencer pipe Welded | Repair |

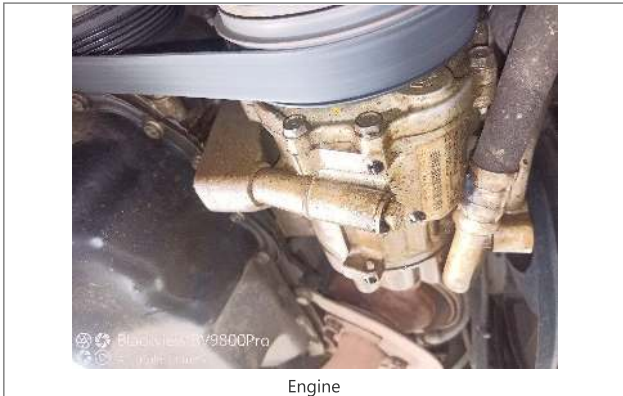
| Damage | Repair Way |
|---|---|
| Engine Oil Leak | Repair |

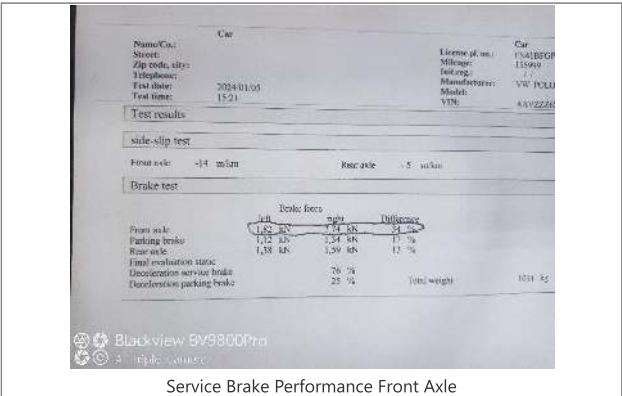
| Damage | Repair Way |
|---|---|
| Service Brake Performance Front Axle Left / Right | Repair |
| Difference out of legal range | Repair |
