## CONDITION REPORT

2017284338

| Manufacturer | VOLKSWAGEN | Registration Number | FS12CZGP |
| Model | POLO VIVO GP 1.4 63KW TRENDLINE 5-DR [2016-2018] | Register Number | |

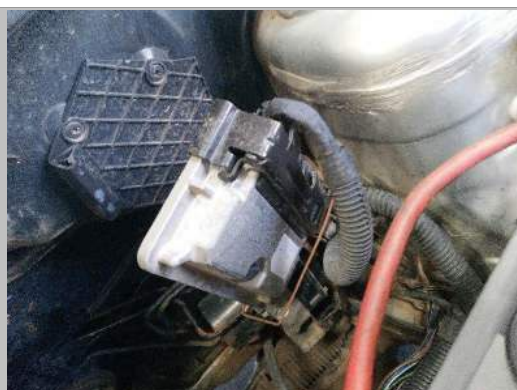
ECU is loose

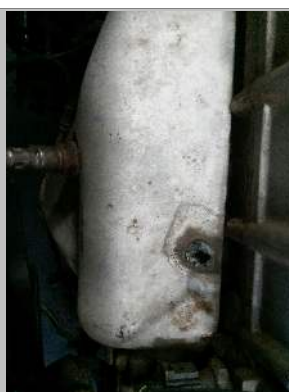
Engine heat shield damage

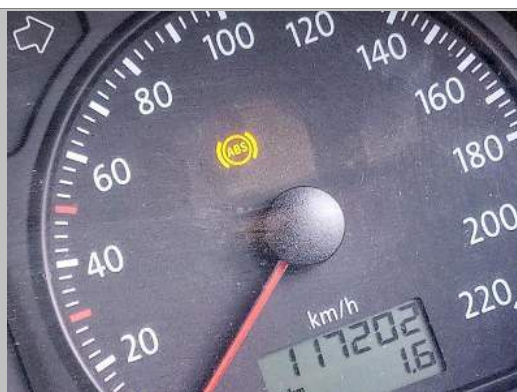
| Damage | Repair Way |
|---|---|
| ABS warning lights illuminated | Repair |

ABS warning lights illuminated

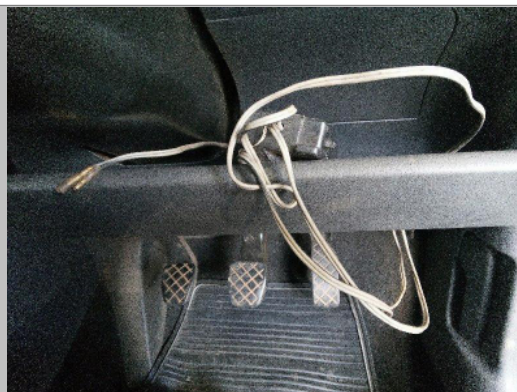
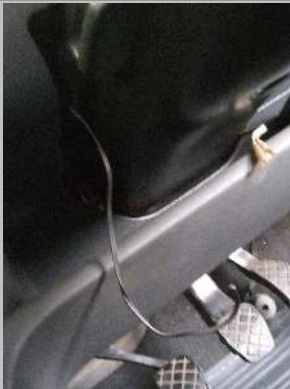
| Damage | Repair Way |
|---|---|
| Wiring connections Defective | Repair |

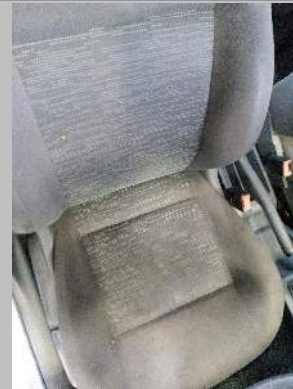
| Damage | Repair Way |
|---|---|
| Seat Front Right Torn / Cut | Repair |

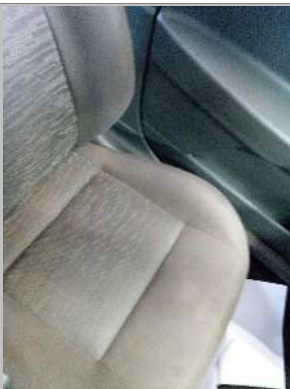
| Damage | Repair Way |
|---|---|
| Seat Front Left Torn / Cut | Repair |

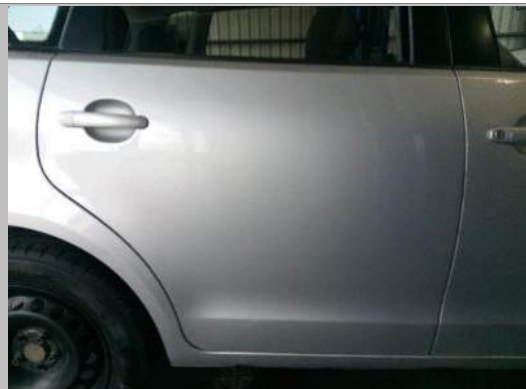
| Damage | Repair Way |
|---|---|
| Door Rear Right Paintwork • Scratched | Repair |

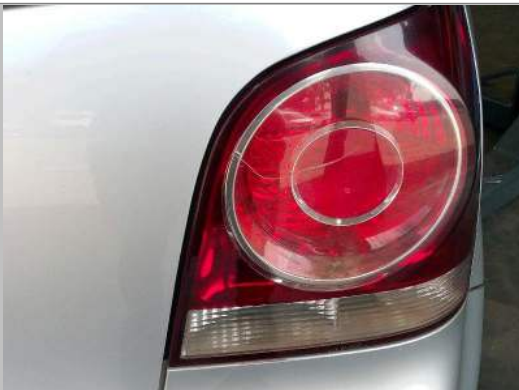
| Damage | Repair Way |
|---|---|
| Tail Light Right Cracked | Replace |

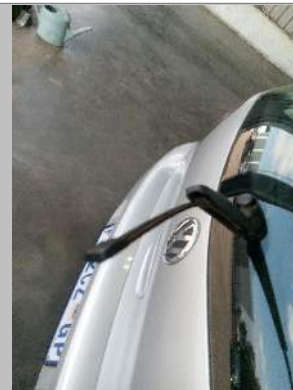
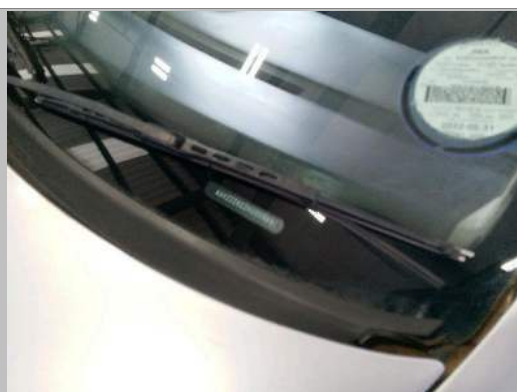
| Damage | Repair Way |
|---|---|
| Windscreen Wiper Worn | Replace |

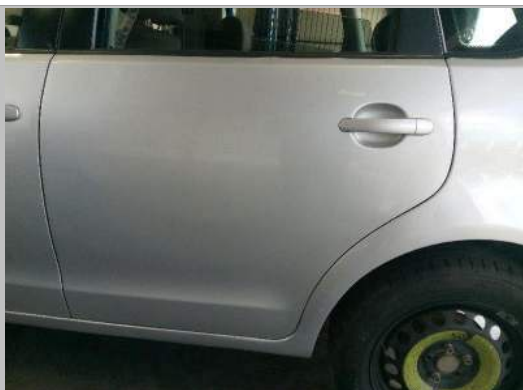
| Damage | Repair Way |
|---|---|
| Door Rear Left Paintwork • Scratched | Repair |

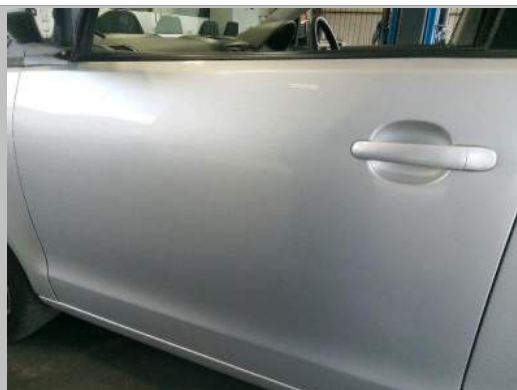
| Damage | Repair Way |
|---|---|
| Door Front Left Paintwork • Scratched | Repair |

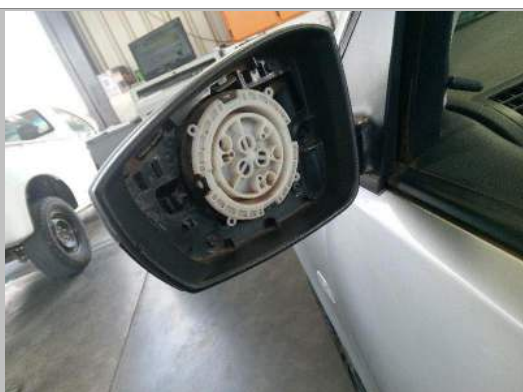
| Damage | Repair Way |
|---|---|
| Side Mirror Left Damaged | Replace |

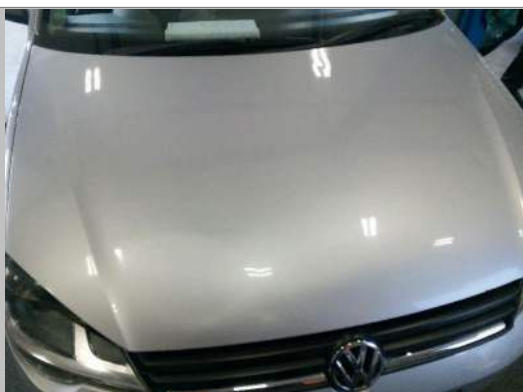
| Damage | Repair Way |
|---|---|
| Bonnet Dented | Repair |

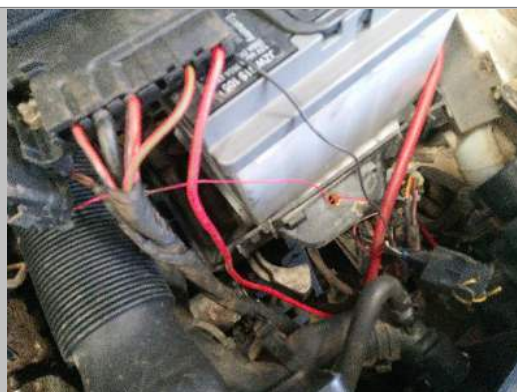
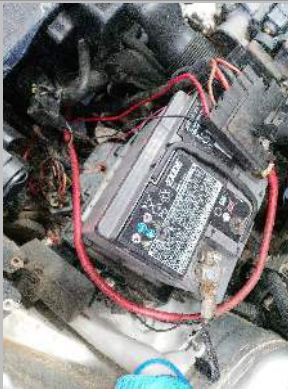
| Damage | Repair Way |
|---|---|
| Engine Wiring Defective | Repair |

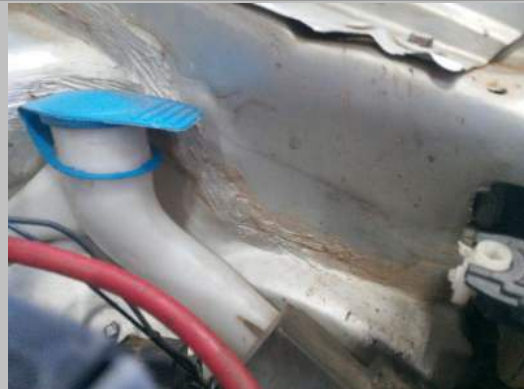
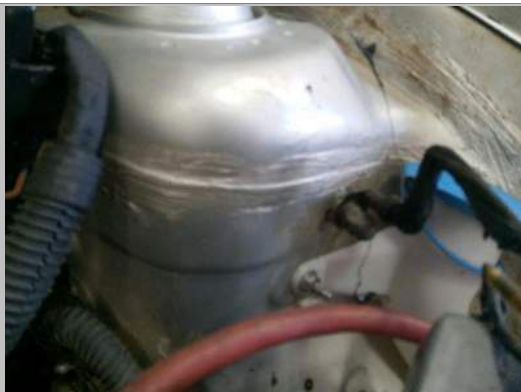
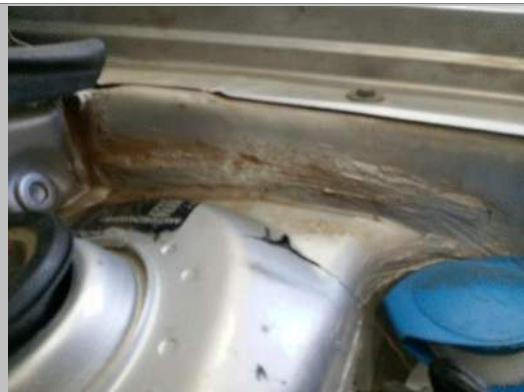
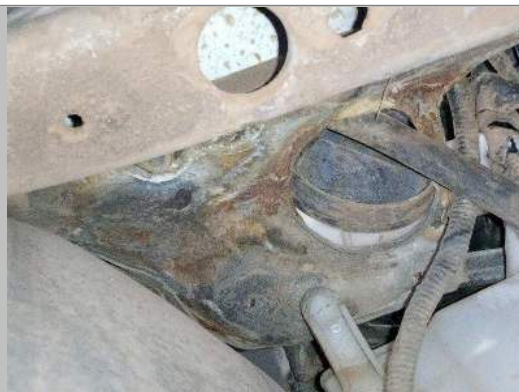
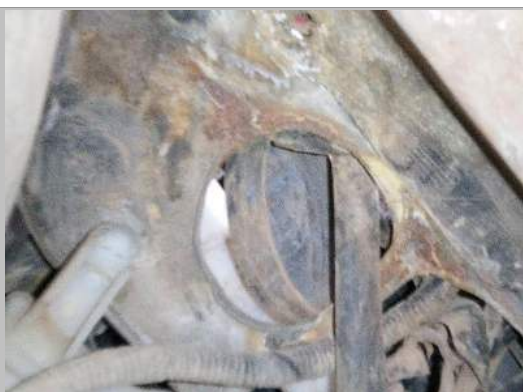
| Damage | Repair Way |
|---|---|
| Front Fender Left / Inner Tray Residual Traces of Repair | Repair |

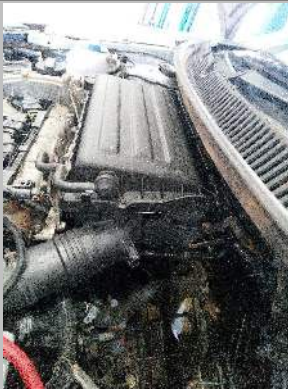
| Damage | Repair Way |
|---|---|
| Air cleaner Damaged | Repair |

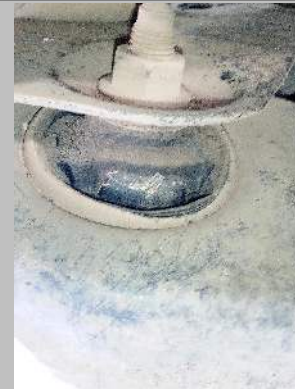
| Damage | Repair Way |
|---|---|
| Control Arm Bush(es) Front Axle Right Cracked | Replace |

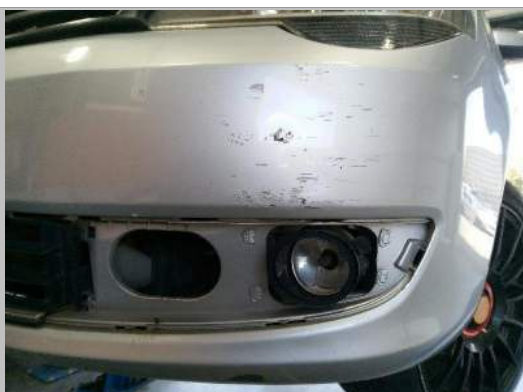
| Damage | Repair Way |
|---|---|
| Front Bumper Paintwork • Scratched | Repair |

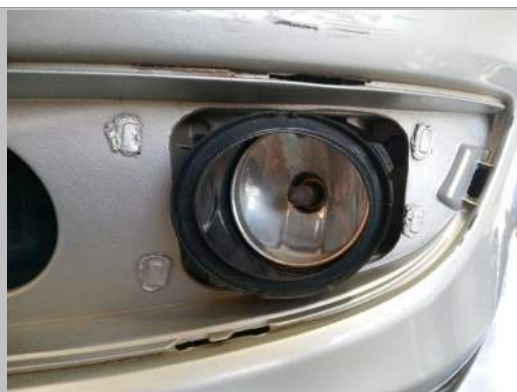
| Damage | Repair Way |
|---|---|
| Fog Light Front Left Damaged | Replace |

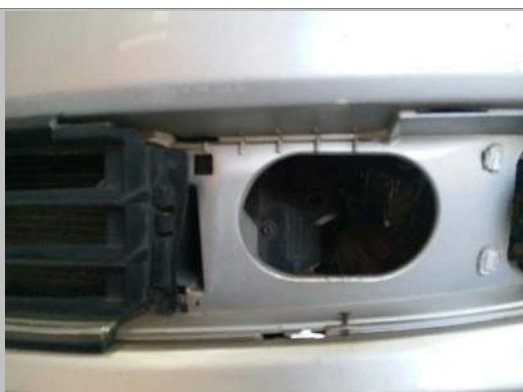
| Damage | Repair Way |
|---|---|
| Grill Damaged | Repair |

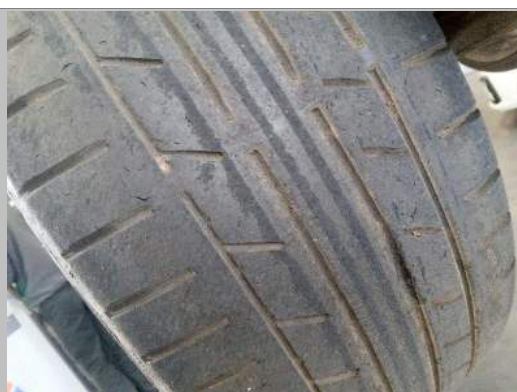
| Damage | Repair Way |
|---|---|
| Tyre Front Left Excessive Wear & Tear | Replace |

| | Size | Load/Speed Index | Manufacture | Model | Type* | Production Date | Tread Depth (mm) |
|---|---|---|---|---|---|---|---|
| Front Left | 215/45R17 | 91W | Continental | Contact | V | 2723 | 1 mm |

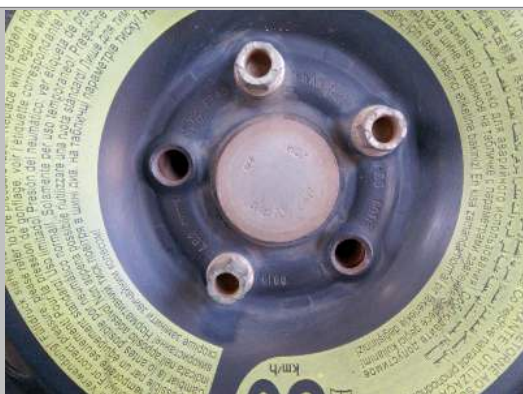
| Damage | Repair Way |
|---|---|
| Bolt(s) / Nut(s) Rear Wheel Left Missing | Replace |

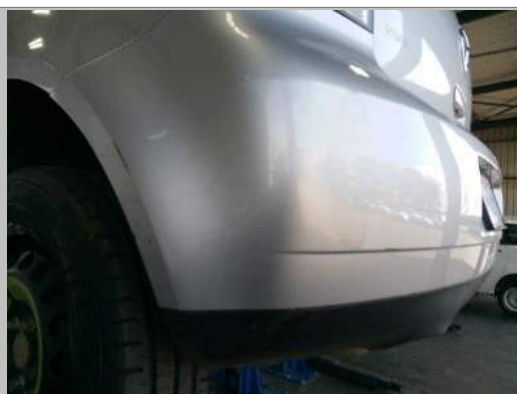
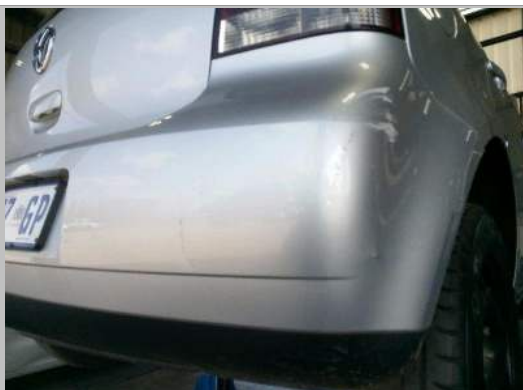
| Damage | Repair Way |
|---|---|
| Rear bumper Paintwork • Scratched | Repair |

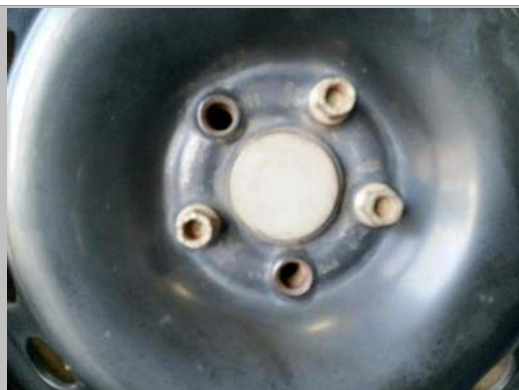
| Damage | Repair Way |
|---|---|
| Bolt(s) / Nut(s) Rear Wheel Right Missing | Replace |

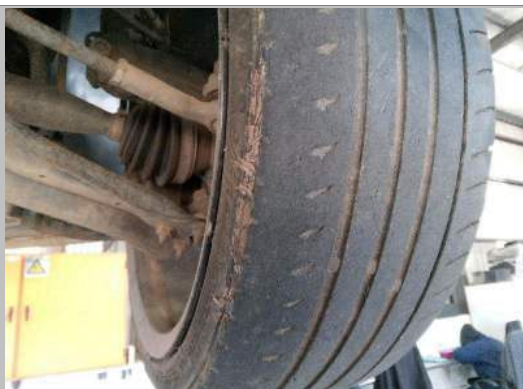
| Damage | Repair Way |
|---|---|
| Tyre Front Right Smooth | Replace |

| | Size | Load/Speed Index | Manufacture | Model | Type* | Production Date | Tread Depth (mm) |
|---|---|---|---|---|---|---|---|
| Front Right | 205/40R17 | 84W | Wanli | Sport | V | 1221 | 0 mm |

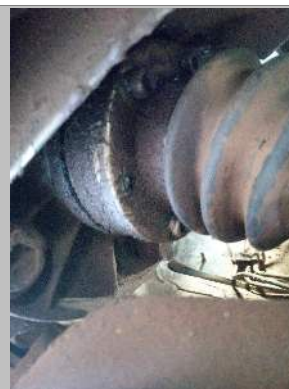
| Damage | Repair Way |
|---|---|
| CV Joint(s) Boot(s) Front Left (inner/outer) Damaged | Replace |

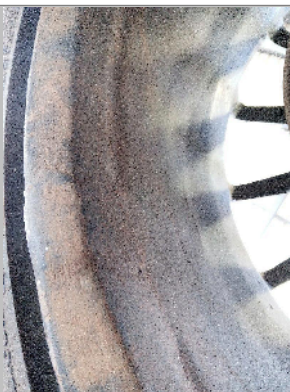
| Damage | Repair Way |
|---|---|
| Rim Front Left Damaged | Replace |

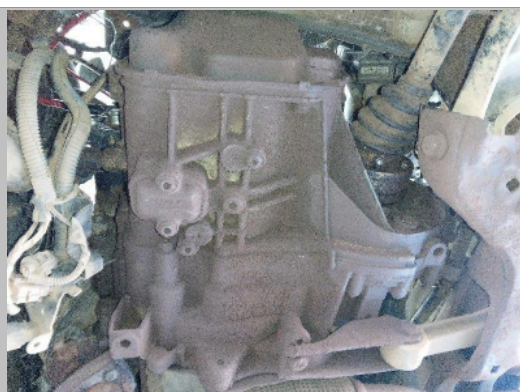
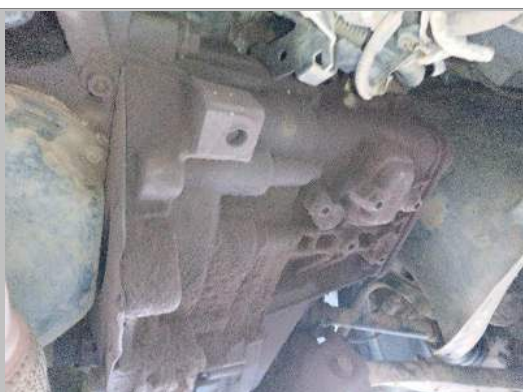
| Damage | Repair Way |
|---|---|
| Gearbox Oil Leak | Repair |
| Gearbox Noise Excessive | Repair |

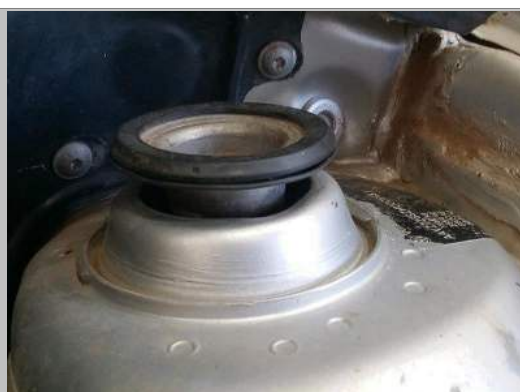
| Damage | Repair Way |
|---|---|
| Shock Absorber Mounting Front Left Loose / Excessive Play | Repair |

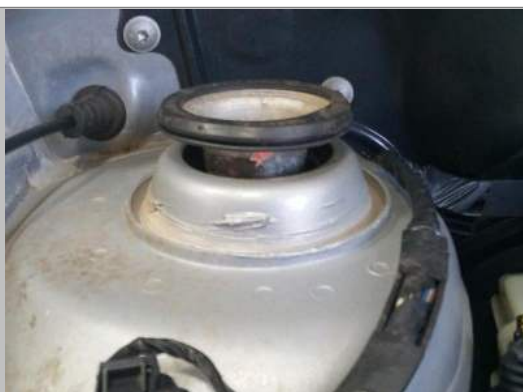
| Damage | Repair Way |
|---|---|
| Shock Absorber Mounting Front Right Loose / Excessive Play | Repair |

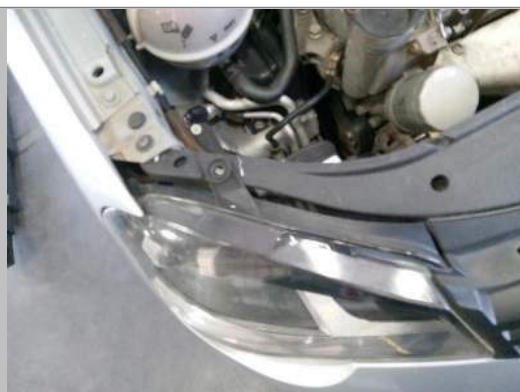
| Damage | Repair Way |
|---|---|
| Headlight Right Defective | Repair |
