CONDITION REPORT

Report No: 2016204981

MFC Auction House
M57 Pretoria Rd, Glenmarais, KEMPTON PARK
Gauteng

Vehicle Type	PASSENGER VEHICLE	Registered Owner	MFC
Manufacturer	VOLKSWAGEN	Registration Number	NB10655
Model	POLO VIVO	Register Number	
VIN	AAVZZZ6SZHU033010	Date Of First Licensing	
Engine Number		Last COR	
Doors	5	License Expiry Date	31/12/2018
Color	GOLDEN	Power / Displacement	
Year Model		Paint Finish	M - METALLIC
Km Reading	228,322 KM	Fuel	PETROL
Cab / Body Type	HATCHBACK	Transmission	MANUAL

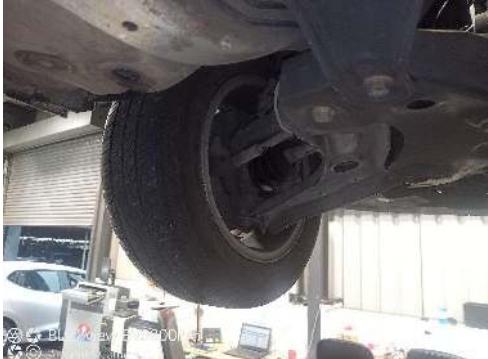
LF TYRE TREAD

Size	Load/Speed Index	Manufacture	Model	Type*	Production Date	Tread Depth (mm)
Front Left	185/60R14	82H	Continental	Contact	V	1622	3 mm
Front Right	175/70R14	84H	Dunlop	Sp sport	V	4516	2 mm
Rear Left	175/65R14	82T	Continental	Contact	V	0920	2 mm
Rear Right	185/60R14	82H	Continental	Contact	V	0921	3 mm
Spare	185/60R14	82H	Continental	Contact	V	////	1 mm

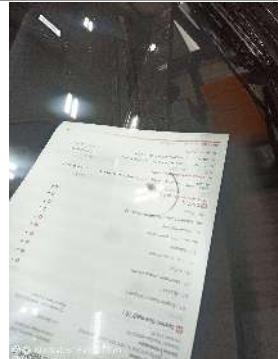
Damage	Repair Way
Engine Wiring Defective	Repair
Tail Light Right Cracked	Replace
Side Mirror Left Cracked	Repair
Front Bumper Paintwork • Scratched	Repair
Windscreen Chipped	Repair
Radiator Cradle Missing	Replace
Airbag light on	Repair
