CONDITION REPORT

Report No:  
2017297167  
DATE  
10/09/2026

MFC Auction House  
M57 Pretoria Rd, Glenmarais, KEMPTON PARK  
Gauteng

| Manufacturer | VOLKSWAGEN | Registration Number | LY45SDGP |

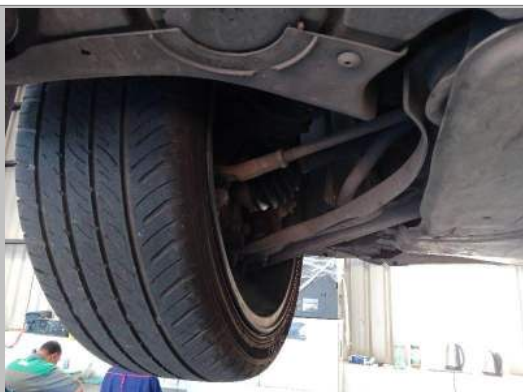
LF TYRE TREAD

| | Size | Load/Speed Index | Manufacture | Model | Type* | Production Date | Tread Depth (mm) |
|---|---|---|---|---|---|---|---|
| Front Left | 225/40Z R18 | 92W | Autogrip | P308 | V | 2324 | 2 mm |

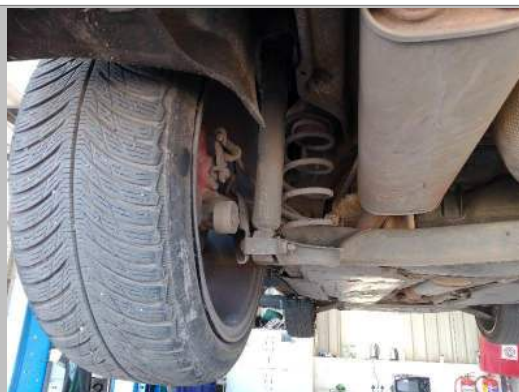
LR TYRE TREAD

| | Size | Load/Speed Index | Manufacture | Model | Type* | Production Date | Tread Depth (mm) |
|---|---|---|---|---|---|---|---|
| Rear Left | 215/40 R18 | 89V | Michelin | Pilot | V | 2621 | 1 mm |

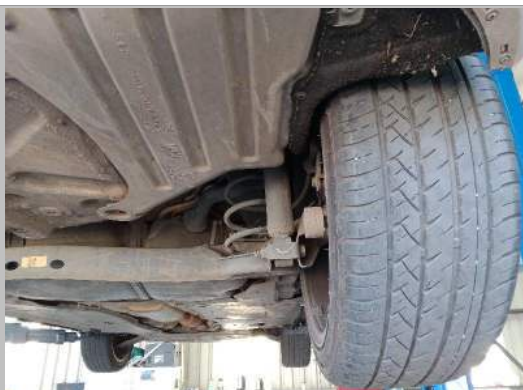
RR TYRE TREAD

| | Size | Load/Speed Index | Manufacture | Model | Type* | Production Date | Tread Depth (mm) |
|---|---|---|---|---|---|---|---|
| Rear Right | 215/40Z R18 | 89W | Fronway | Eurus | V | 0523 | 2 mm |

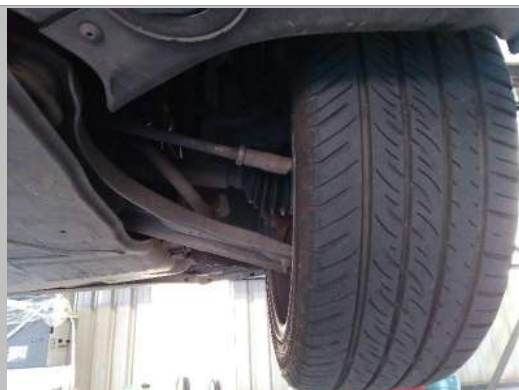
RF TYRE TREAD

| | Size | Load/Speed Index | Manufacture | Model | Type* | Production Date | Tread Depth (mm) |
|---|---|---|---|---|---|---|---|
| Front Right | 225/40Z R18 | 92W | Autogrip | P308 | V | 2324 | 2 mm |

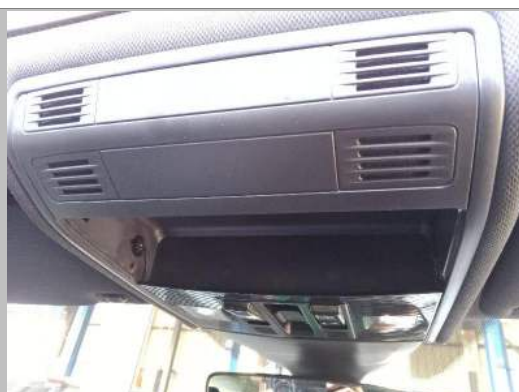
| Center Console / Cubbyhole + Lid Missing | Replace |

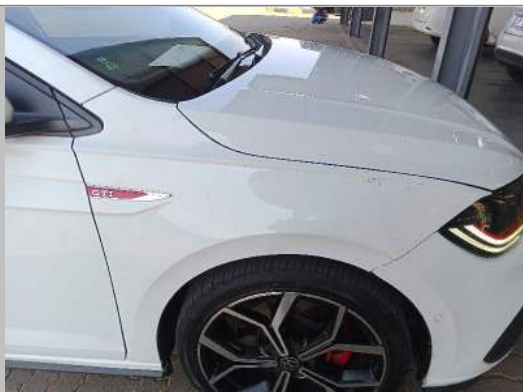
| Front Fender Right Damaged | Repair |

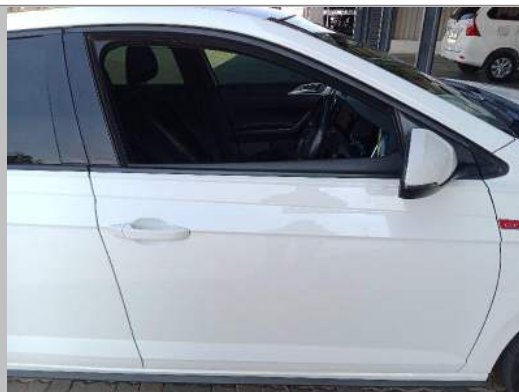
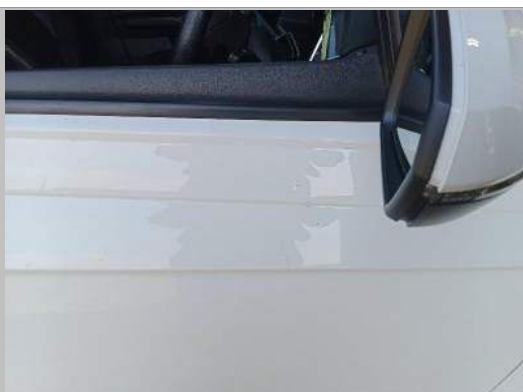
| Door Front Right Paintwork • Scratched | Repair |

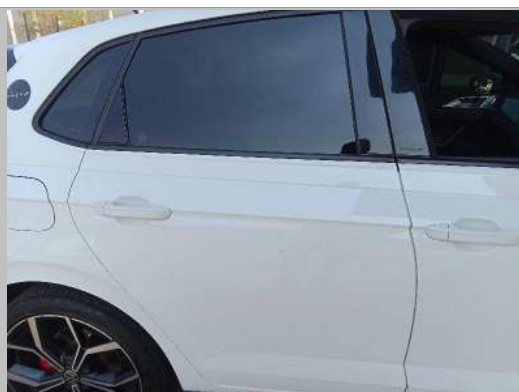
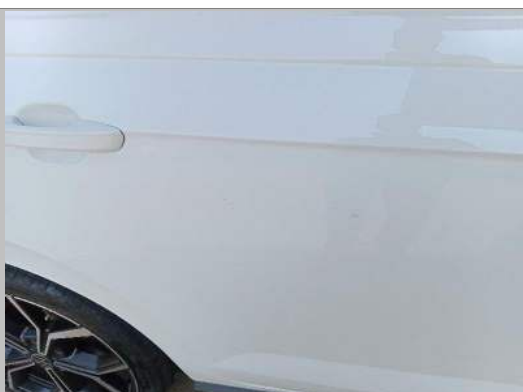
| Door Rear Right Paintwork • Scratched | Repair |

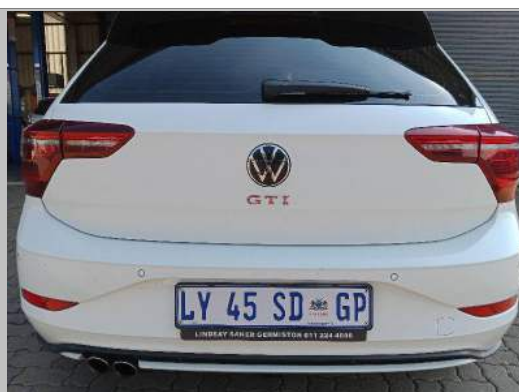
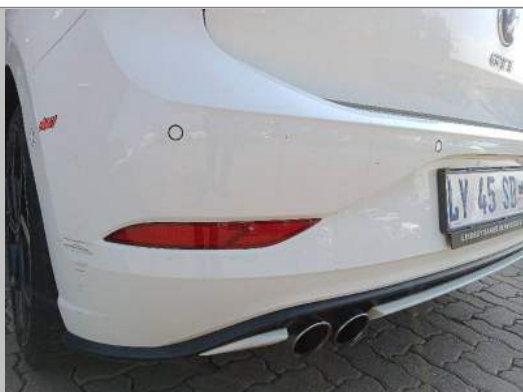
| Rear bumper Paintwork • Scratched | Repair |

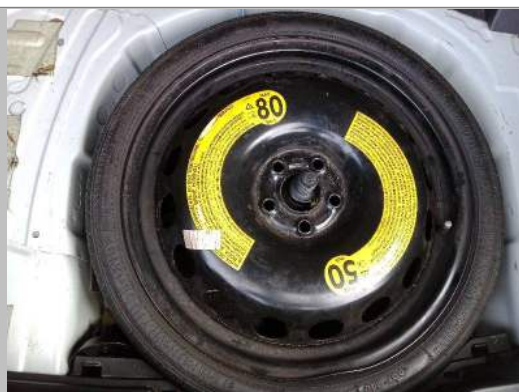
| Rim Spare Wheel Dented | Repair |

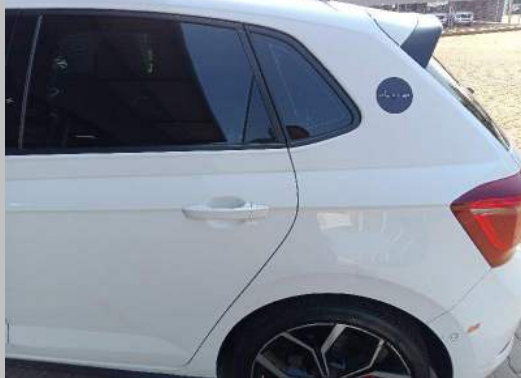
| Rear Fender Left Dented | Repair |

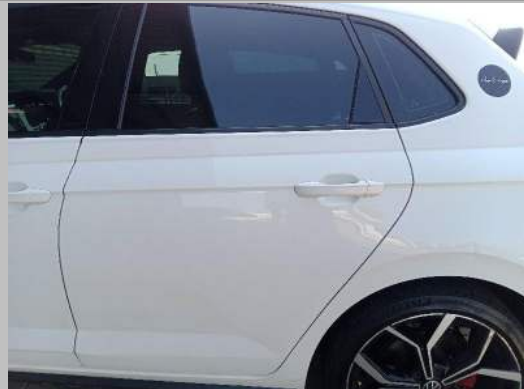
| Door Rear Left Paintwork • Scratched | Repair |

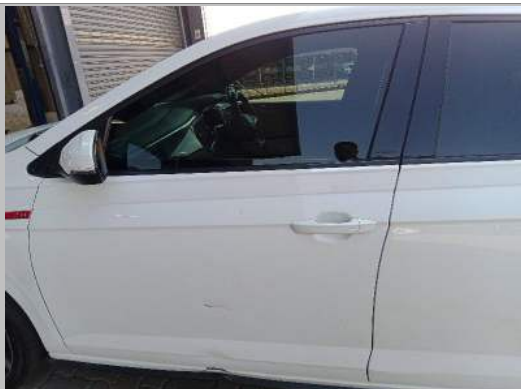
| Door Front Left Damaged | Repair |

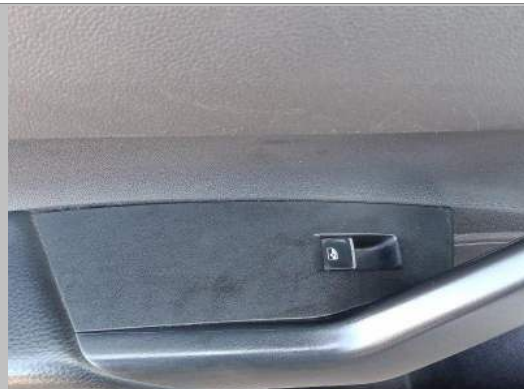
| Switch Electrical Window Winder front left Damaged | Replace |

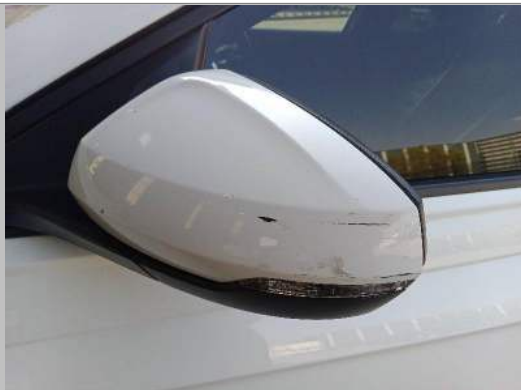
| Side Mirror Left Paintwork • Scratched | Repair |

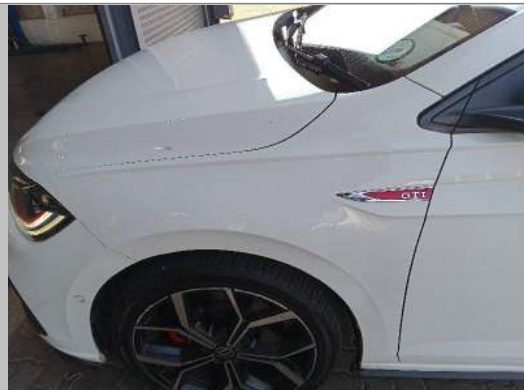
| Front Fender Left Damaged | Repair |

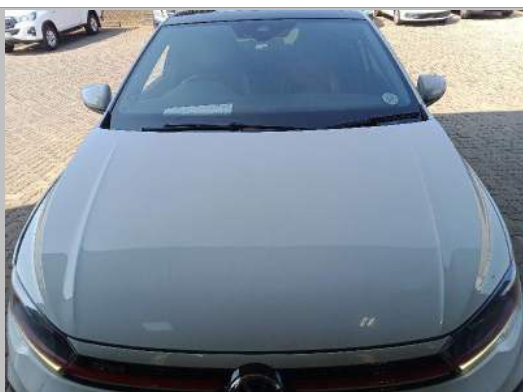
| Bonnet Damaged | Repair |

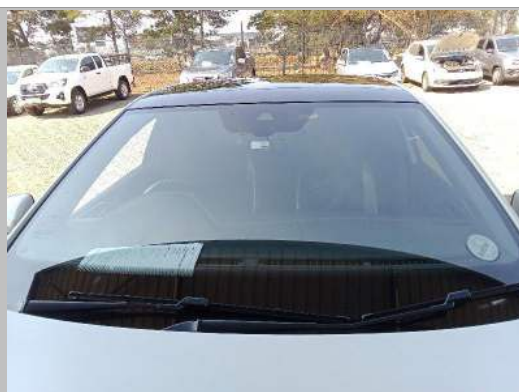
| Windscreen Cracked | Replace |

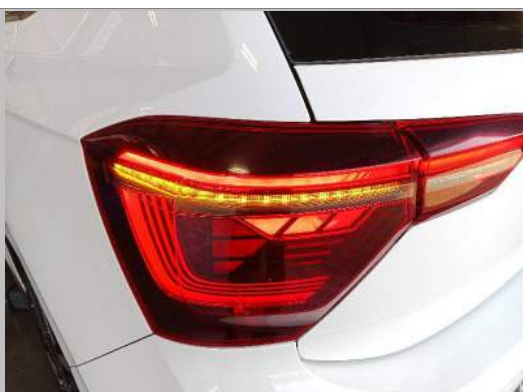
| Tail Light Left Cracked | Replace |

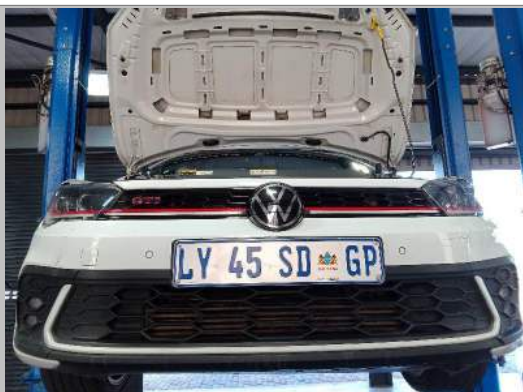
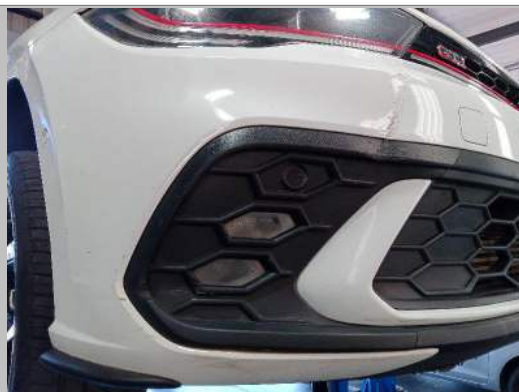
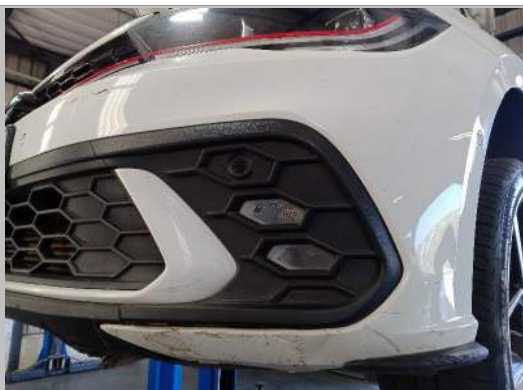
| Front Bumper Damaged | Repair |

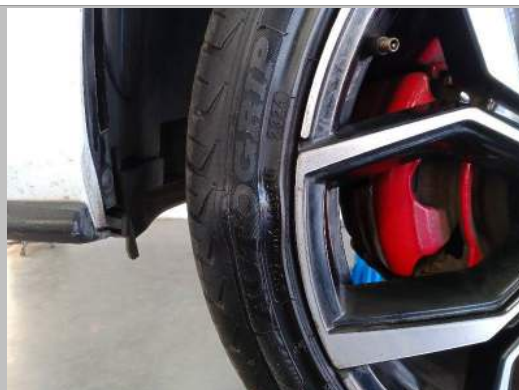
| Tyre Front Left Damaged | Replace |

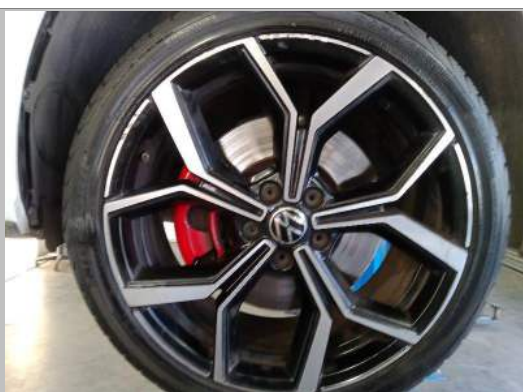
| Rim Front Left Scratched | Repair |

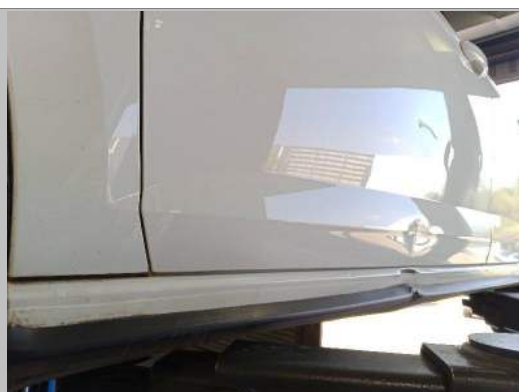
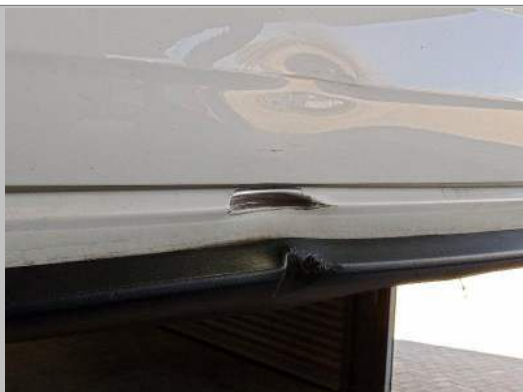
| Sill Panel Left Damaged | Repair |

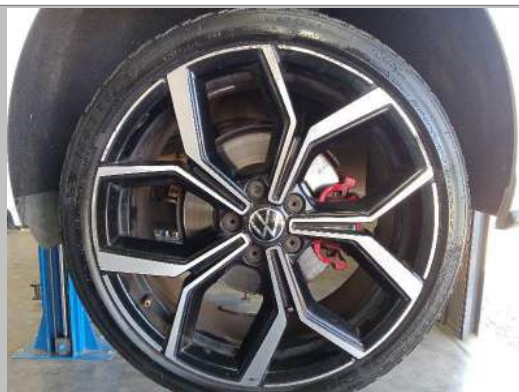
| Rim Rear Left Scratched | Repair |

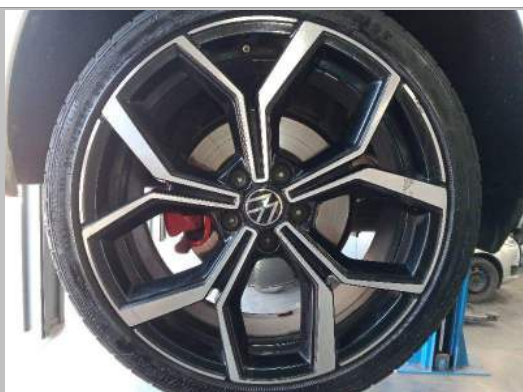
| Rim Rear Right Scratched | Repair |

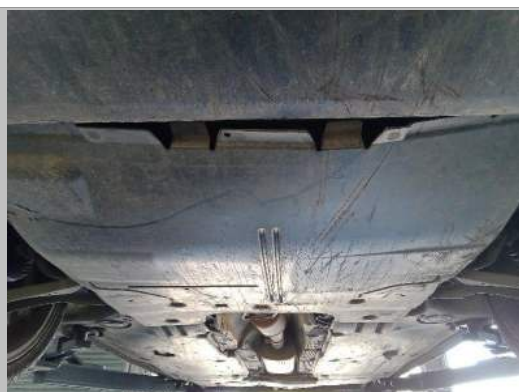
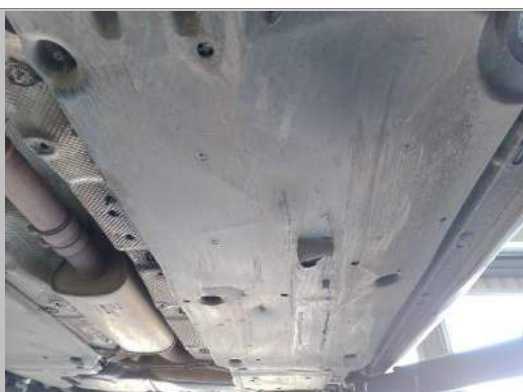
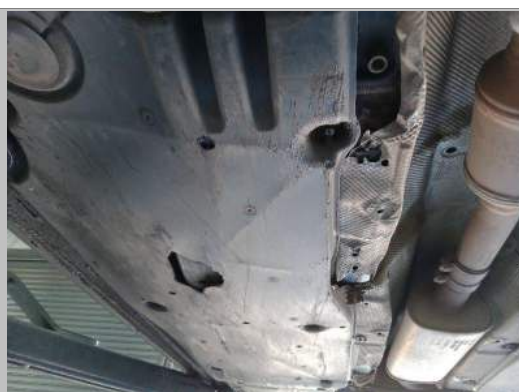
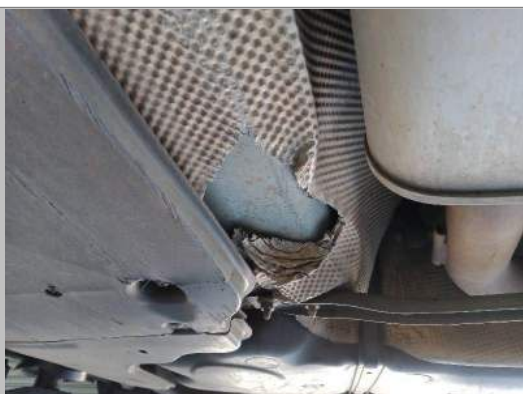
| Belly plates Damaged | Replace |
