## CONDITION REPORT

Report No: 2016175427

| Manufacturer | VOLKSWAGEN | Registration Number | JS82PDGP |
| Model | POLO TSI | Register Number | |

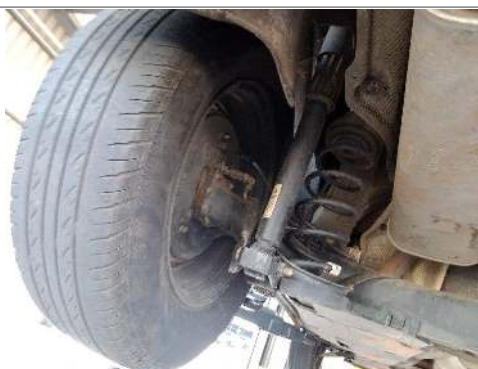
LR TYRE TREAD

| | Size | Load/Speed Index | Manufacture | Model | Type* | Production Date | Tread Depth (mm) |
|---|---|---|---|---|---|---|---|
| Rear Left | 185/70R14 | 88H | Hifly | HF201 | V | 0421 | 1 mm |

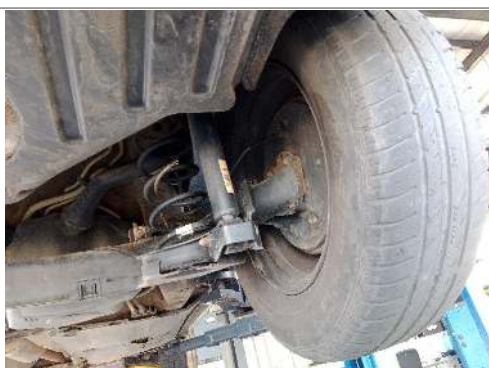
RR TYRE TREAD

| | Size | Load/Speed Index | Manufacture | Model | Type* | Production Date | Tread Depth (mm) |
|---|---|---|---|---|---|---|---|
| Rear Right | 185/70R14 | 88T | Gene | Altimax | V | 3718 | 1 mm |

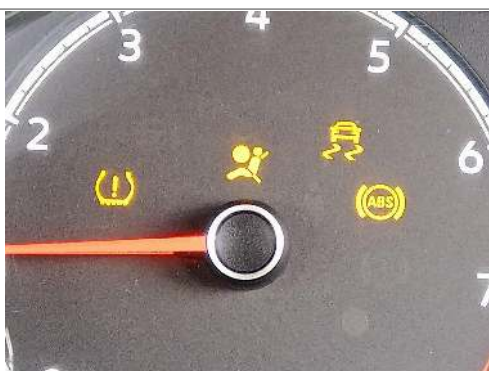
| Damage | Repair Way |
|---|---|
| Warning light illuminated. | Repair |

Warning light illuminated.

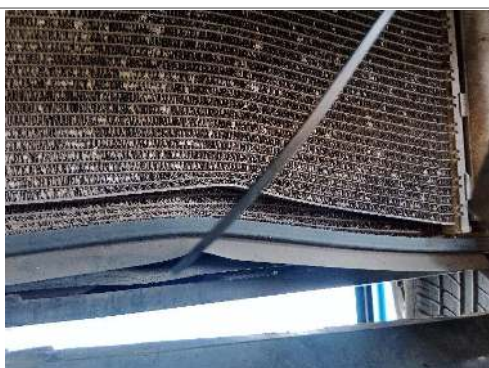
Aircon condenser dent.

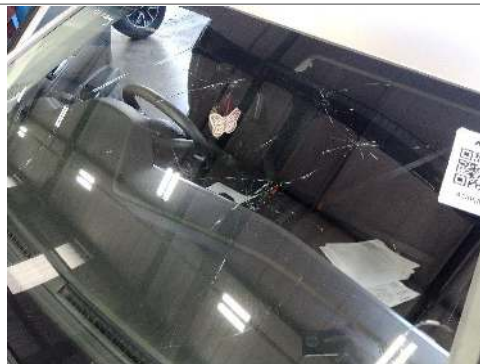
| Damage | Repair Way |
|---|---|
| Windscreen Cracked | Replace |

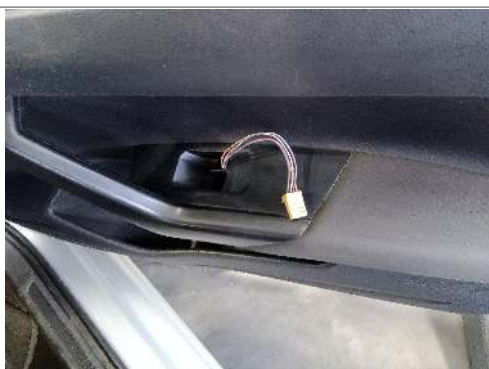
| Damage | Repair Way |
|---|---|
| Switch Electrical Window Winder front right Missing | Replace |

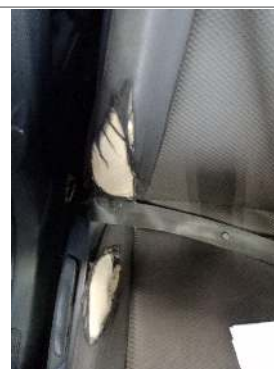
| Damage | Repair Way |
|---|---|
| Seat Front Right Torn / Cut | Replace |

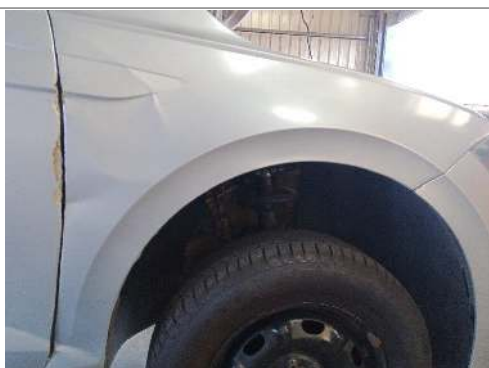
| Damage | Repair Way |
|---|---|
| Front Fender Right Damaged | Repair |

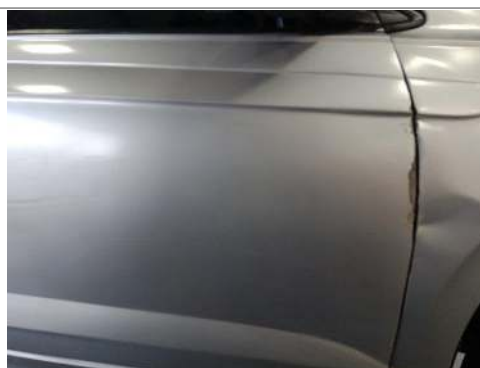
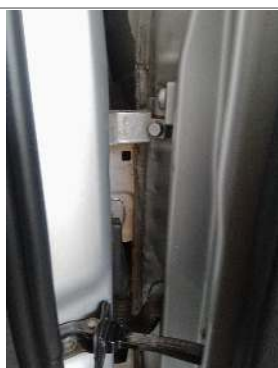
| Damage | Repair Way |
|---|---|
| Door Front Right Damaged | Repair |

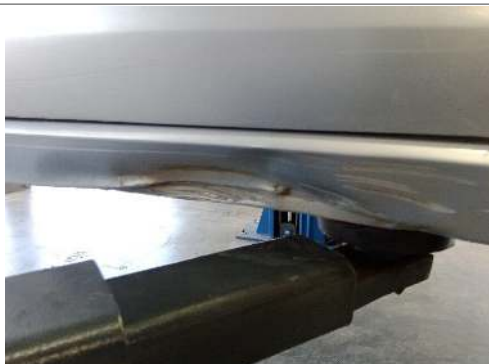
| Damage | Repair Way |
|---|---|
| Sill Panel Right Damaged | Repair |

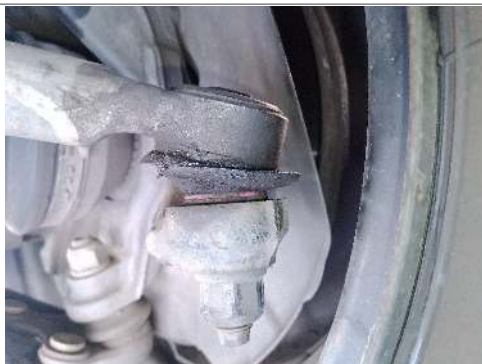
| Damage | Repair Way |
|---|---|
| Tie Rod End right Damaged | Replace |

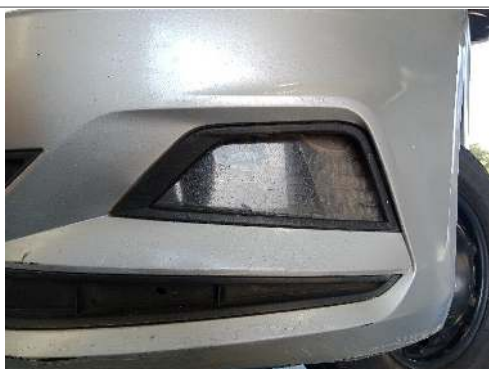
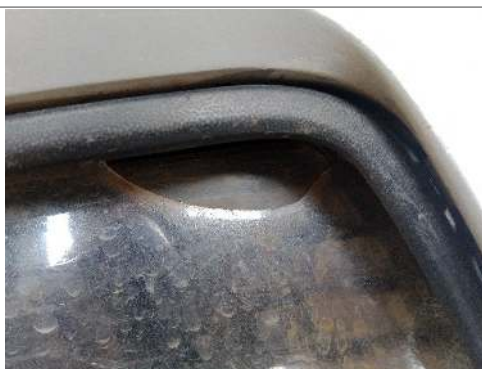
| Damage | Repair Way |
|---|---|
| Park Light Front Left Defective | Replace |

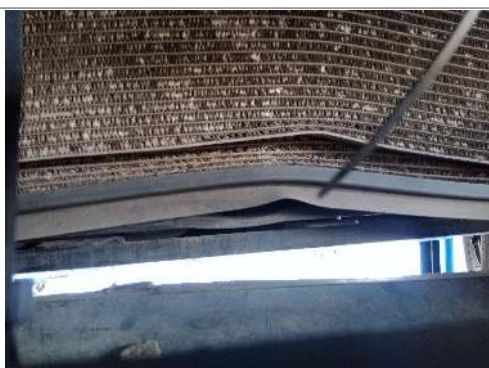
| Damage | Repair Way |
|---|---|
| Radiator Damaged | Replace |

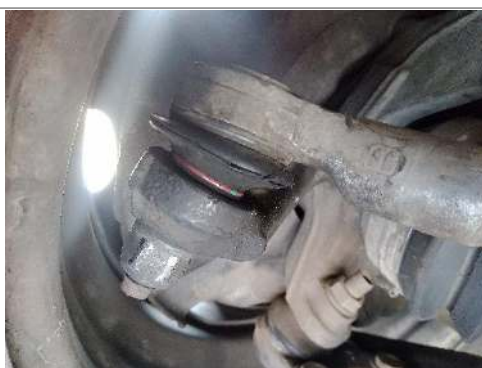
| Damage | Repair Way |
|---|---|
| Tie Rod End left Damaged | Replace |

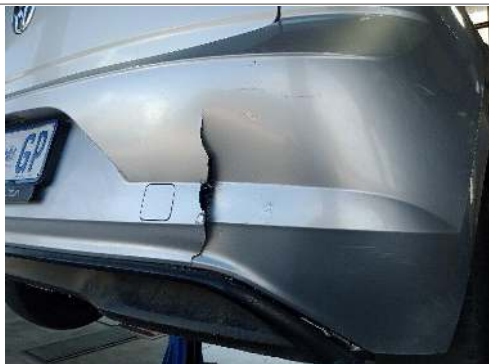
| Damage | Repair Way |
|---|---|
| Rear bumper Damaged | Repair |

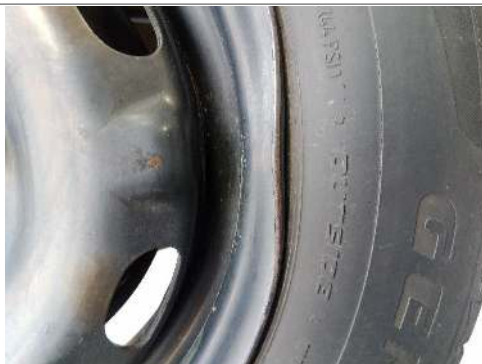
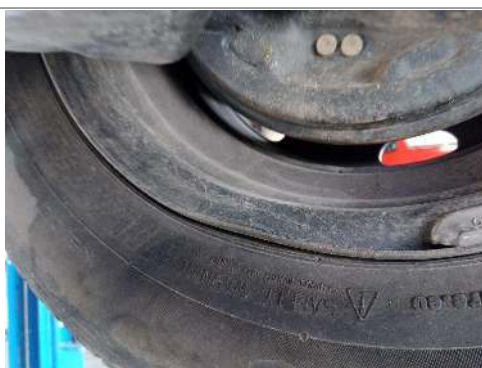
| Damage | Repair Way |
|---|---|
| Rim Rear Right Dented | Repair |

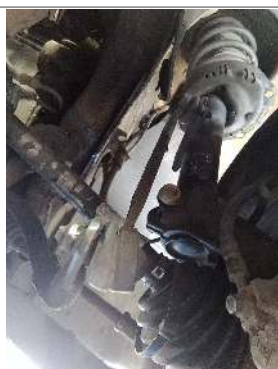
| Damage | Repair Way |
|---|---|
| Tie Rod left Damaged | Replace |

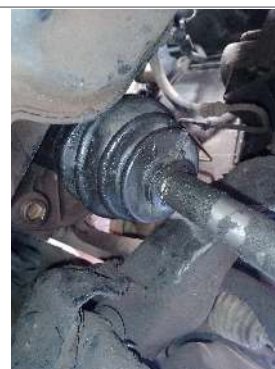
| Damage | Repair Way |
|---|---|
| CV Joint(s) Boot(s) Front Left (inner/outer) Damaged | Replace |

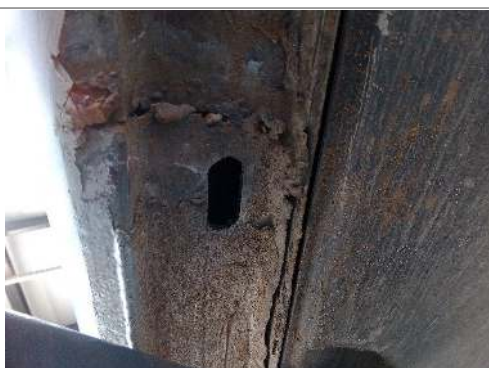
| Damage | Repair Way |
|---|---|
| Sill Panel Left Welded | Replace |

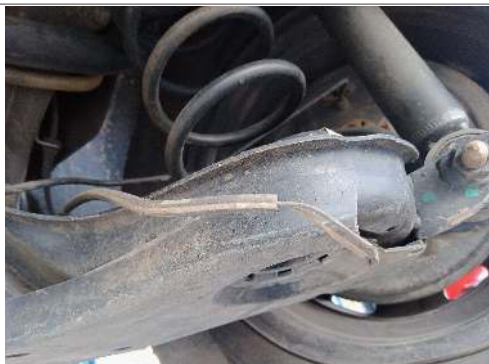
| Damage | Repair Way |
|---|---|
| Speed Sensor Damaged | Replace |

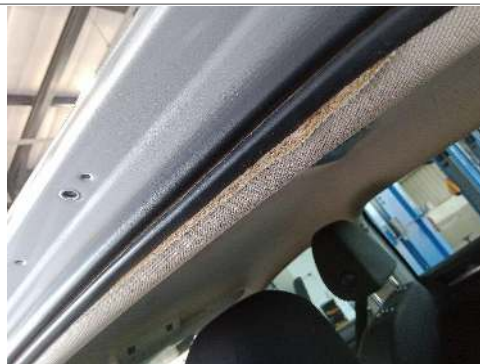
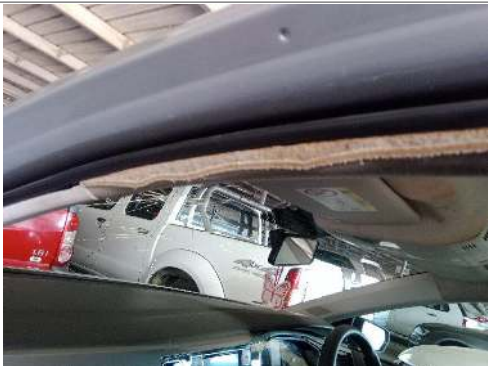
| Damage | Repair Way |
|---|---|
| Hood Lining Damaged | Repair |

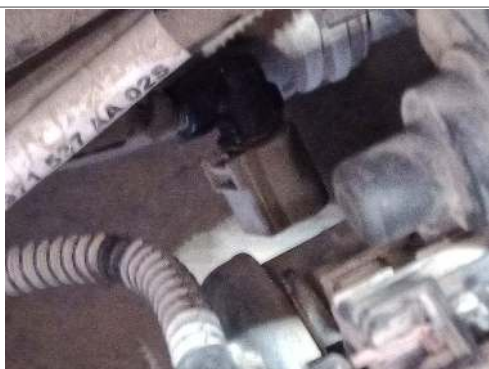
| Damage | Repair Way |
|---|---|
| Engine Wiring Damaged | Repair |

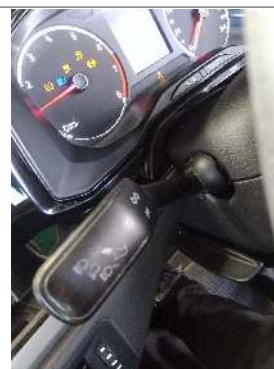
| Damage | Repair Way |
|---|---|
| Wiper Switch Damaged | Replace |

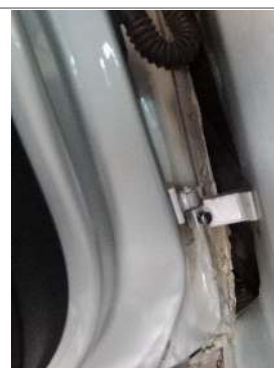
| Damage | Repair Way |
|---|---|
| Door Front Left Damaged | Replace |
