## CONDITION REPORT

Report No:  
2017298430  
DATE  
14/09/2026

| Manufacturer | VOLKSWAGEN | Registration Number | KG32ZVGP |
| Model | POLO 1.0 TSI 70KW COMFORTLINE 5-DR [2019-2021] | Register Number | |

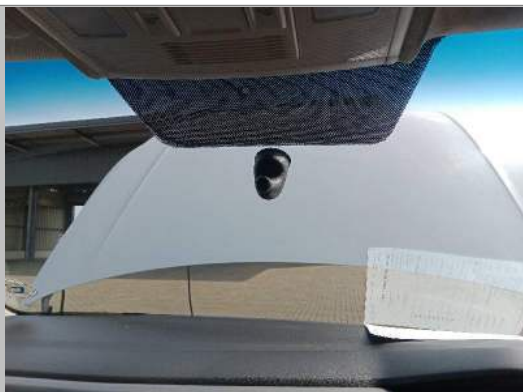
| Interior Mirror Missing | Repair |

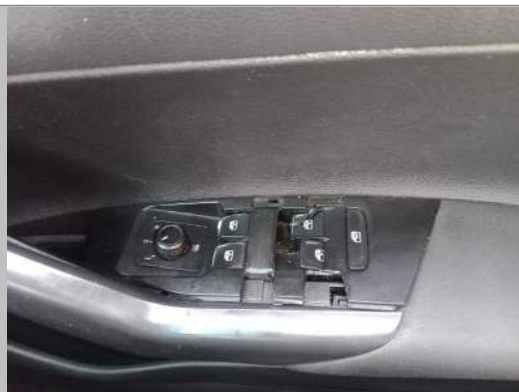
| Switch Electrical Window Winder front left Damaged | Replace |

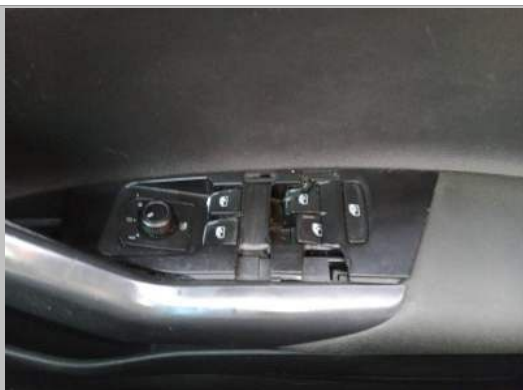
| Switch Electrical Window Winder front right Damaged | Replace |

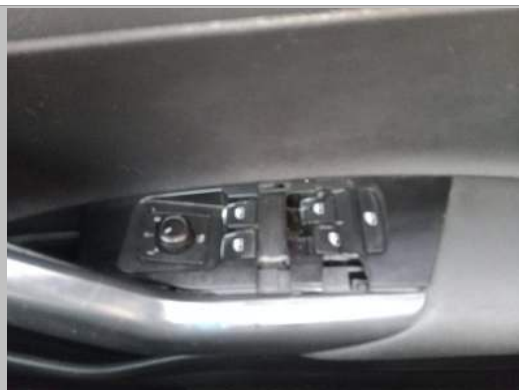
| Switch Electrical Window Winder rear left Damaged | Replace |

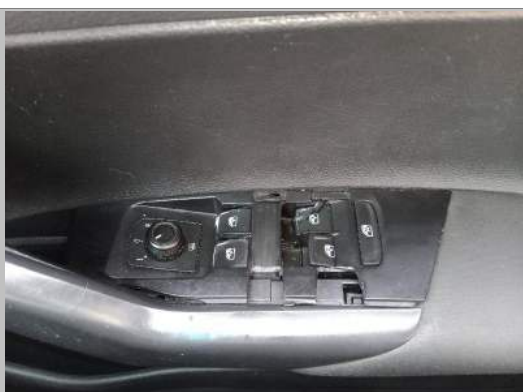
| Switch Electrical Window Winder rear right Damaged | Replace |

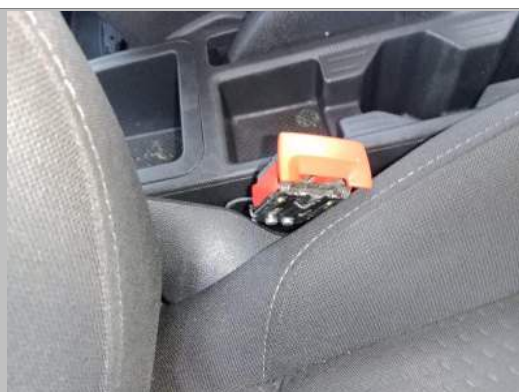
| Seat Belt Front Right Damaged | Repair |

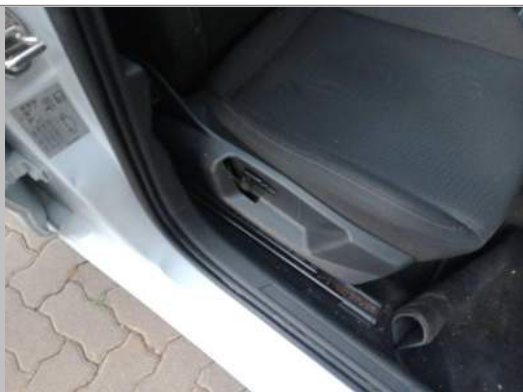
| Seat Front Right Damaged | Repair |

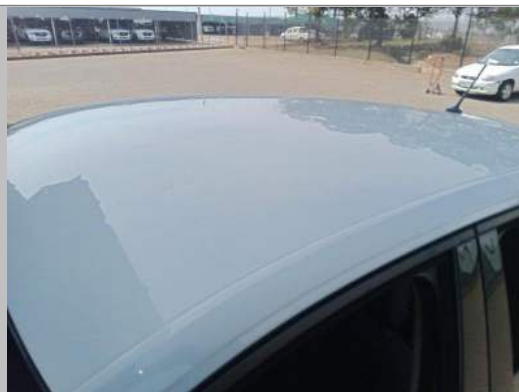
| Roof Dented | Repair |

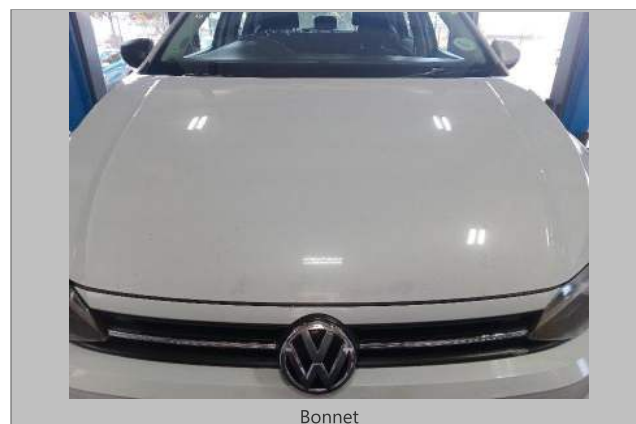
| Bonnet Dented | Repair |

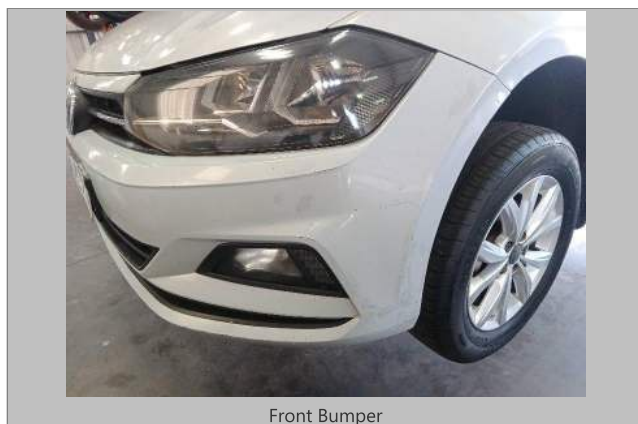
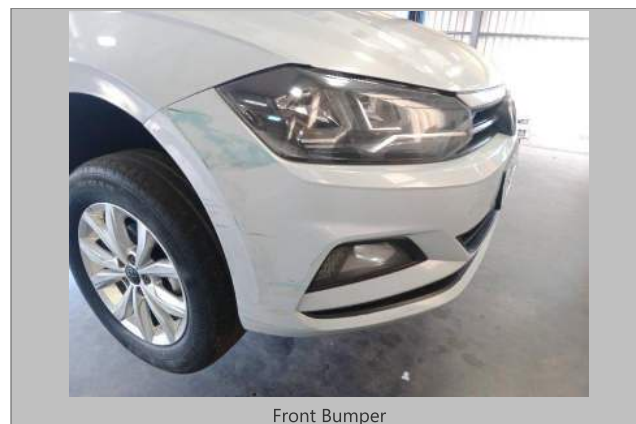
| Front Bumper Paintwork • Scratched | Repair |

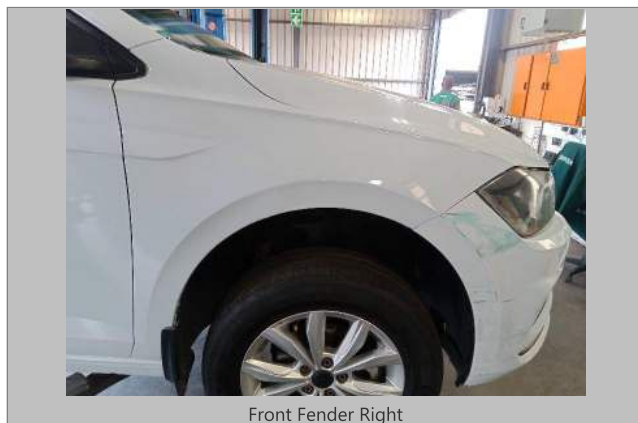
| Front Fender Right Residual Traces of Repair | Repair |

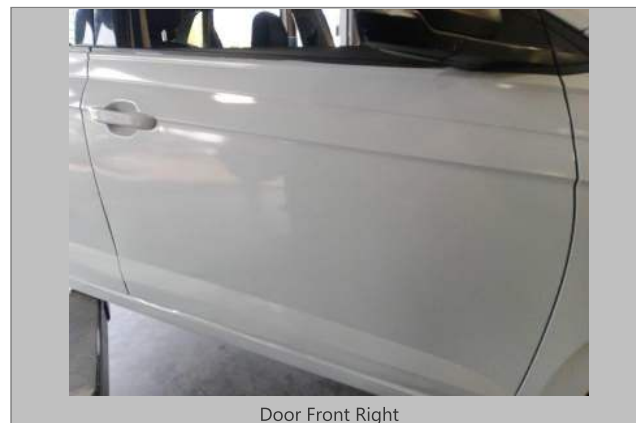
| Door Front Right Residual Traces of Repair | Repair |

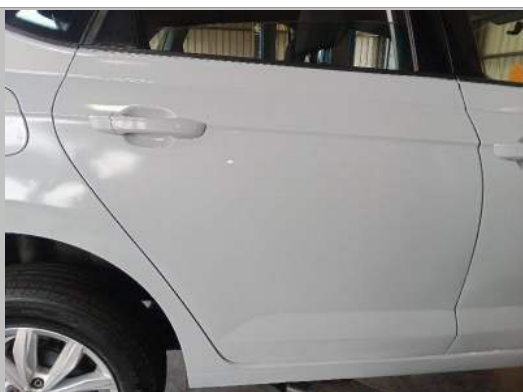
| Door Rear Right Residual Traces of Repair | Repair |

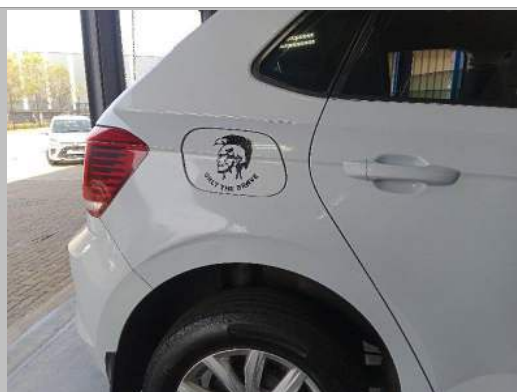
| Rear Fender Right Residual Traces of Repair | Repair |

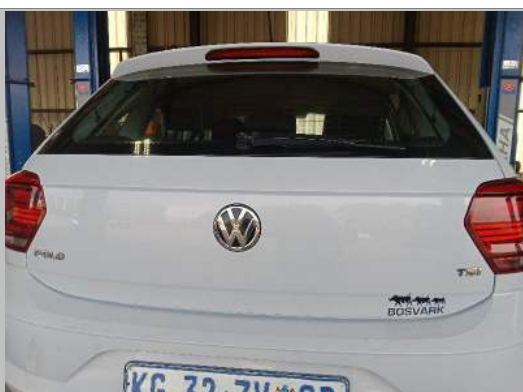
| Boot Lid / Hatch door Paintwork • Scratched | Repair |

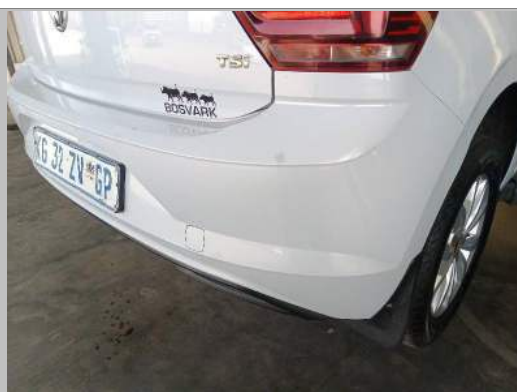
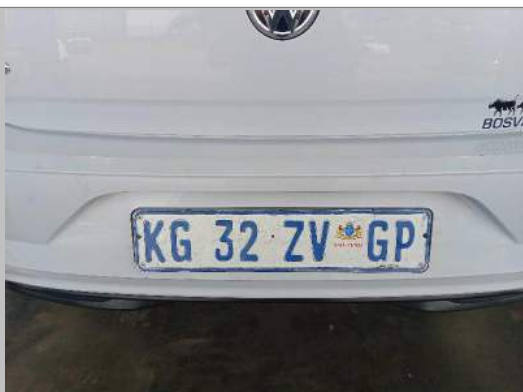
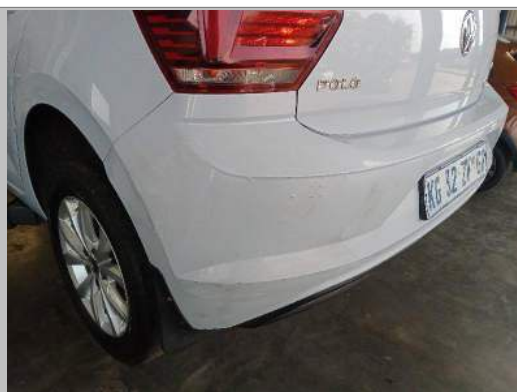
| Rear bumper Paintwork • Scratched | Repair |

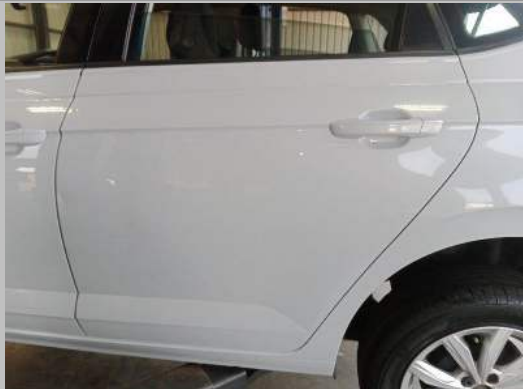
| Door Rear Left Paintwork • Scratched | Repair |

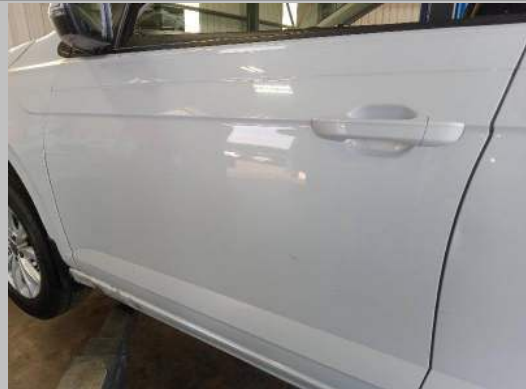
| Door Front Left Paintwork • Scratched | Repair |

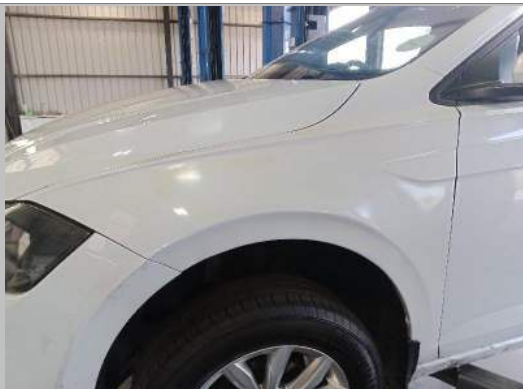
| Front Fender Left Residual Traces of Repair | Repair |

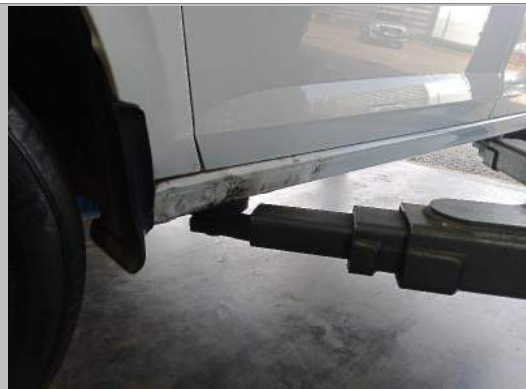
| Sill Panel Left Residual Traces of Repair | Repair |

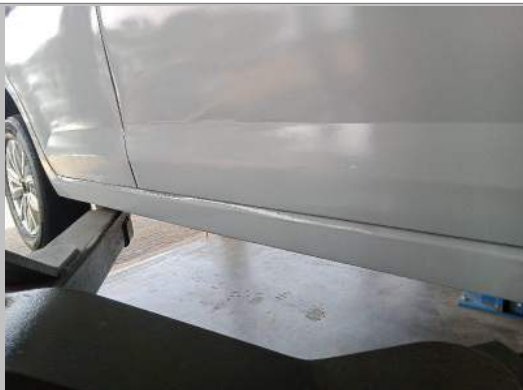
| Sill Panel Right Dented | Repair |

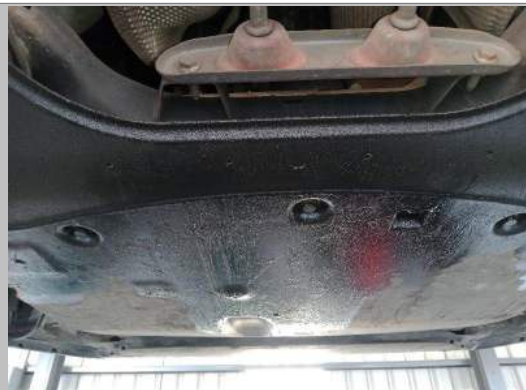
| Engine Oil Leak | Repair |

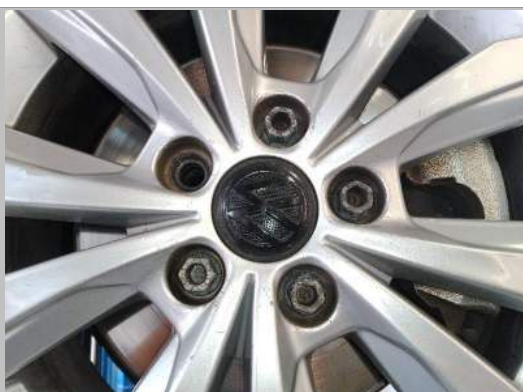
| Bolt(s) / Nut(s) Front Wheel Right Missing | Replace |

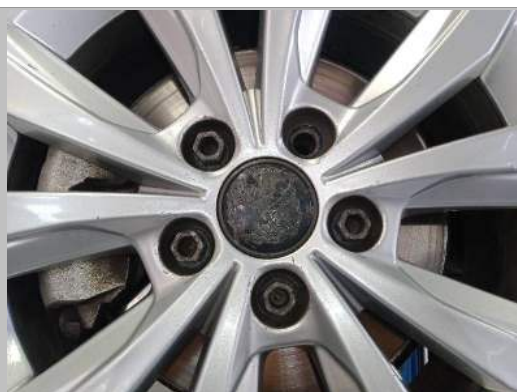
| Bolt(s) / Nut(s) Front Wheel Left Missing | Replace |

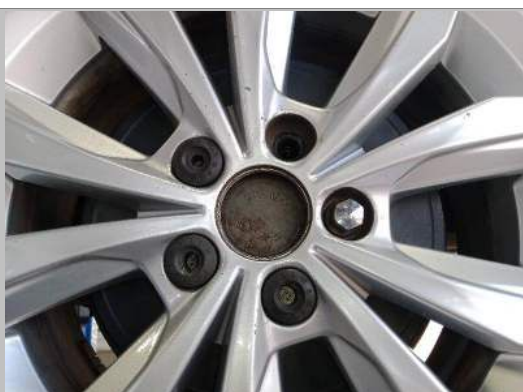
| Bolt(s) / Nut(s) Rear Wheel Left Missing | Replace |

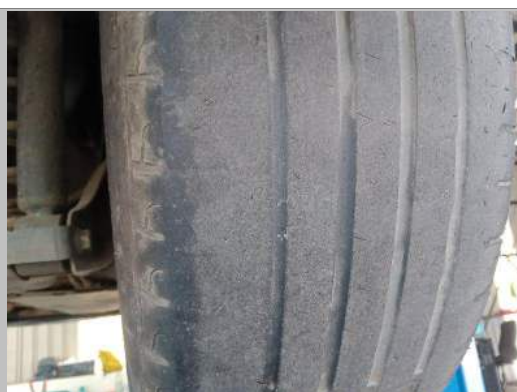
| Tyre Rear Right Smooth | Replace |

| | Size | Load/Speed Index | Manufacture | Model | Type* | Production Date | Tread Depth (mm) |
|---|---|---|---|---|---|---|---|
| Rear Right | 195/65R15 | 91V | Powertrac | Adams | V | 0125 | 0 mm |

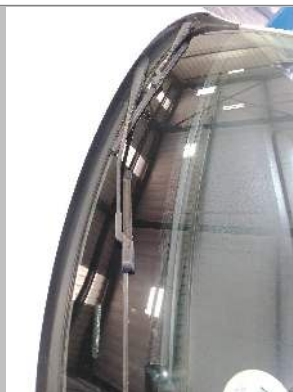
| Windscreen Wiper Damaged | Replace |

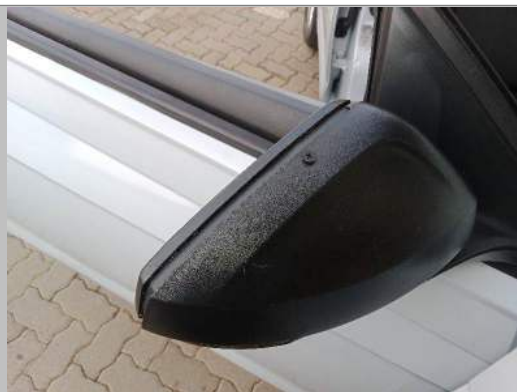
| Side Mirror Right Damaged | Repair |
