## CONDITION REPORT

Report No:  
2017298878  
DATE  
15/09/2026

| Manufacturer | CHEVROLET | Registration Number | BY72RVGP |
| Model | SPARK 1.2 LS 5-DR [2012-2013] | Register Number | |

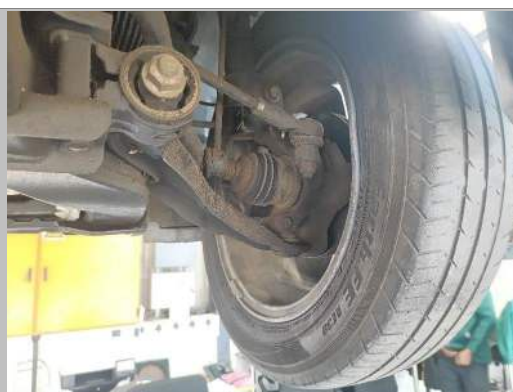
RF TYRE TREAD

| Damage | Repair Way |
|---|---|
| Front tyre size differs | Replace |

| | Size | Load/Speed Index | Manufacture | Model | Type* | Production Date | Tread Depth (mm) |
|---|---|---|---|---|---|---|---|
| Front Right | 175/60R15 | 81H | Yokohama | Bluearth | V | 2623 | 1 mm |

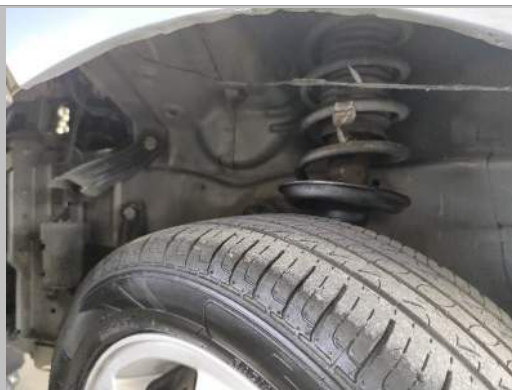
L/F fender liner missing

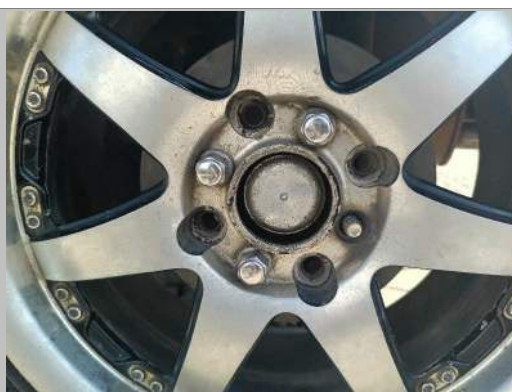
| Damage | Repair Way |
|---|---|
| Bolt(s) / Nut(s) Rear Wheel Left Missing | Replace |

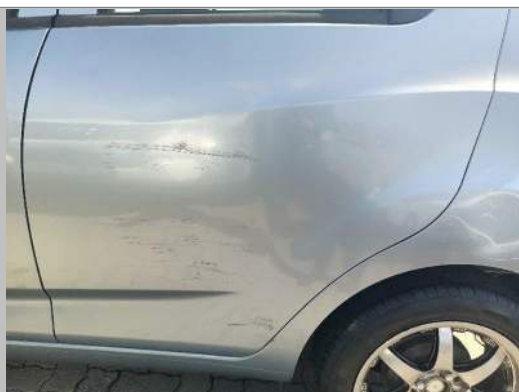
| Damage | Repair Way |
|---|---|
| Door Rear Left Paintwork • Scratched | Repair |

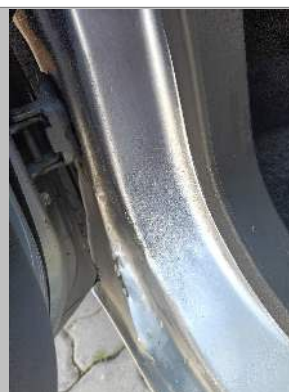
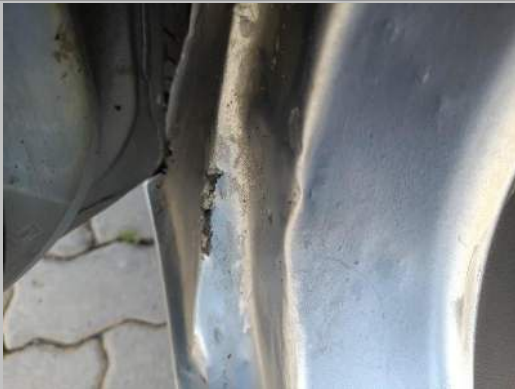
| Damage | Repair Way |
|---|---|
| A • Pillar Left Residual Traces of Repair | Repair |

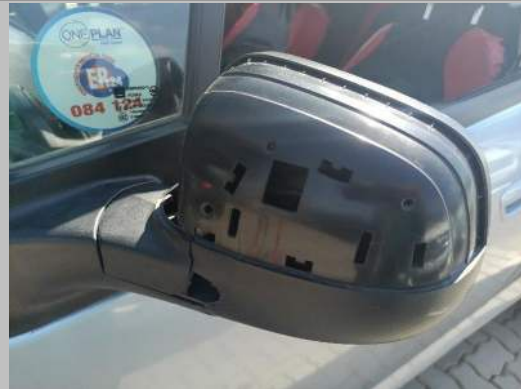
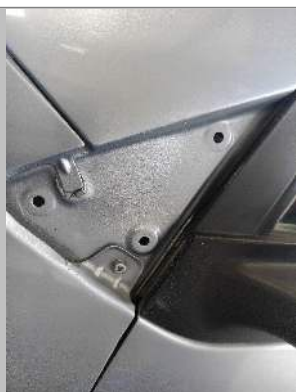
| Damage | Repair Way |
|---|---|
| Side Mirror Left Damaged | Replace |

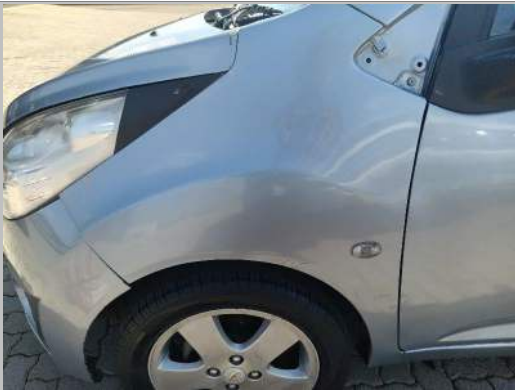
| Damage | Repair Way |
|---|---|
| Front Fender Left Residual Traces of Repair | Repair |

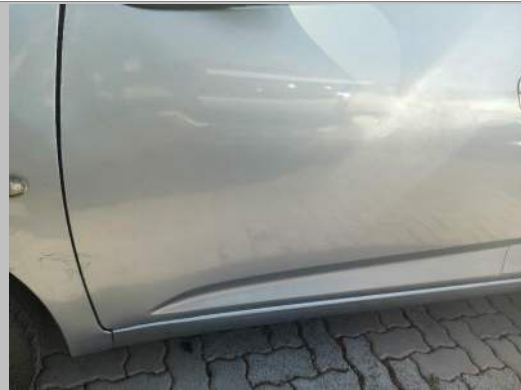
| Damage | Repair Way |
|---|---|
| Door Front Left Residual Traces of Repair | Repair |

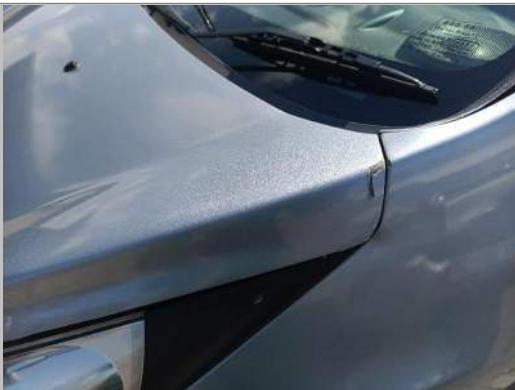
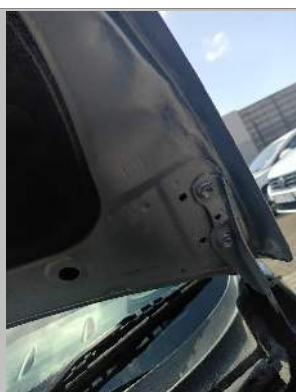
| Damage | Repair Way |
|---|---|
| Bonnet Residual Traces of Repair | Repair |

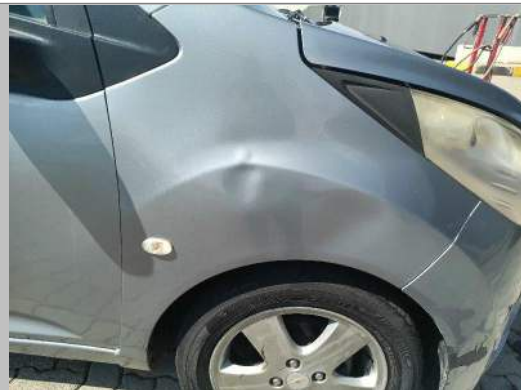
| Damage | Repair Way |
|---|---|
| Front Fender Right Dented | Repair |

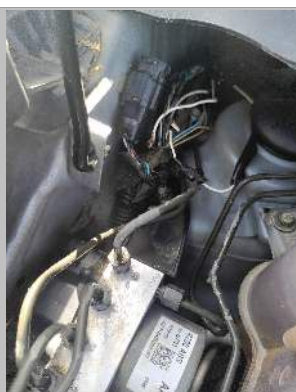
| Damage | Repair Way |
|---|---|
| Engine Wiring Defective | Repair |

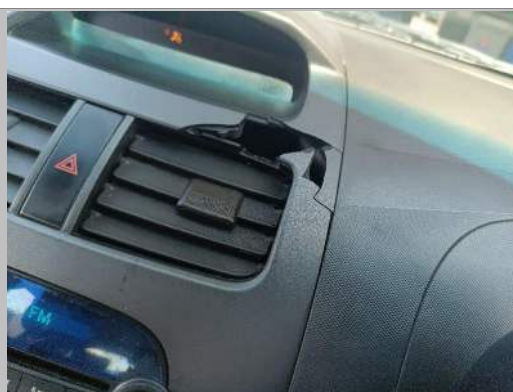
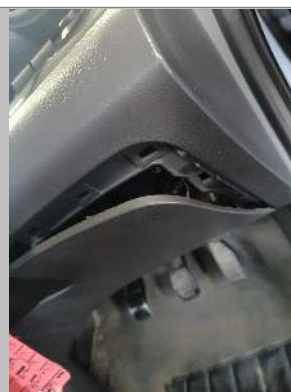
| Damage | Repair Way |
|---|---|
| Dash Padding Damaged | Repair |

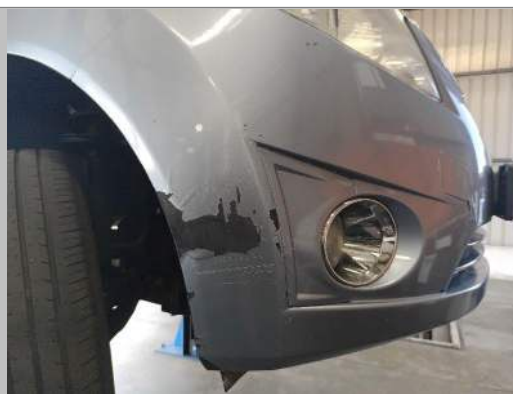
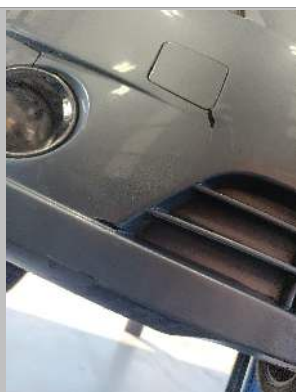
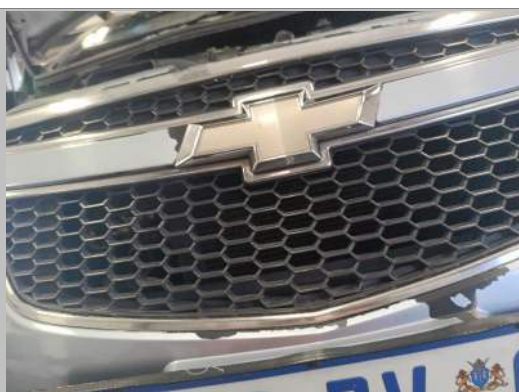
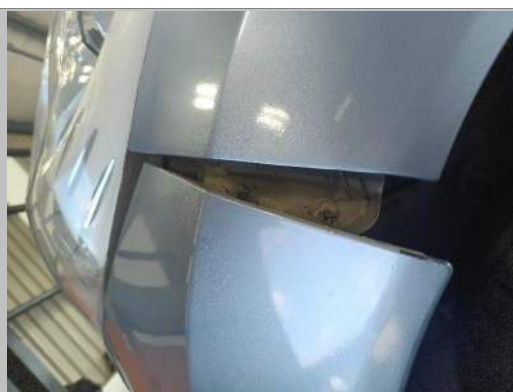
| Damage | Repair Way |
|---|---|
| Front Bumper Paintwork • Flaking | Repair |

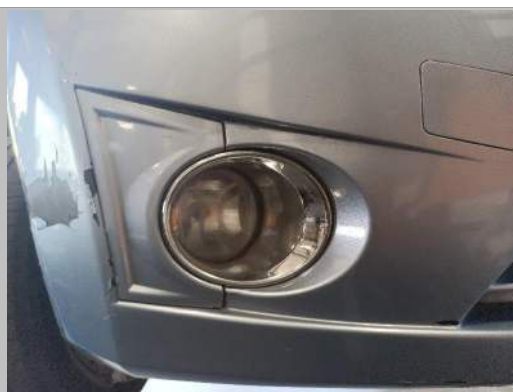
| Damage | Repair Way |
|---|---|
| Fog Light Front Right Defective | Repair |

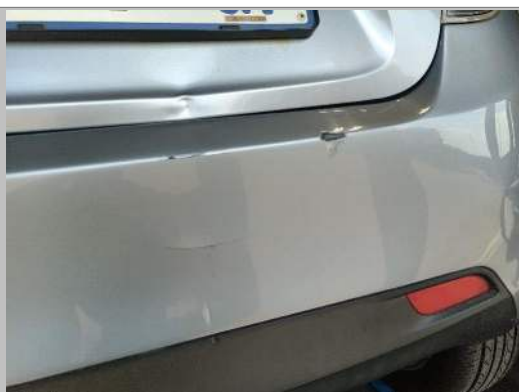
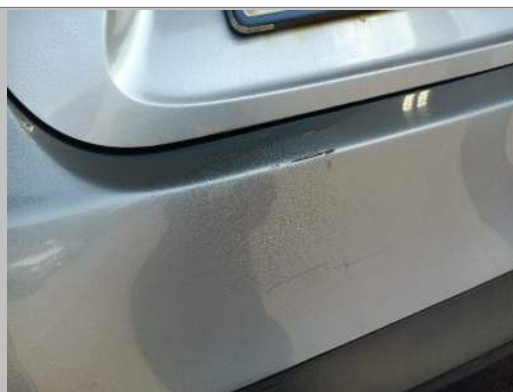
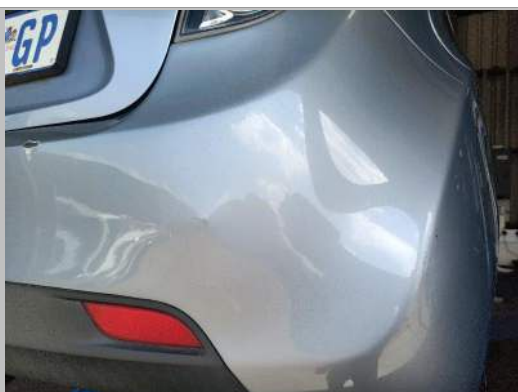
| Damage | Repair Way |
|---|---|
| Rear bumper Damaged | Repair |

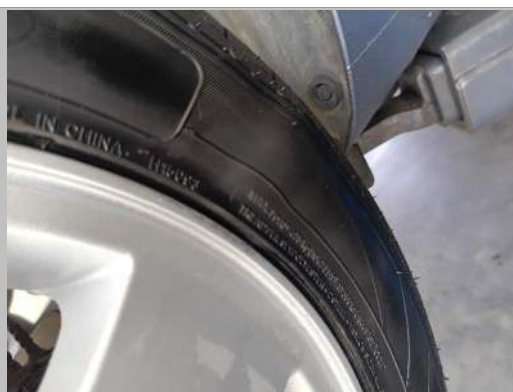
| Damage | Repair Way |
|---|---|
| Tyre Rear Right Damaged | Replace |

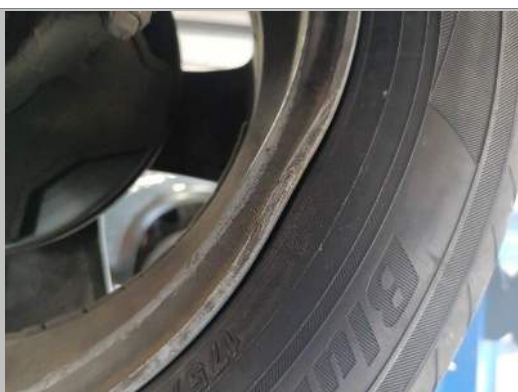
| Damage | Repair Way |
|---|---|
| Rim Front Right Deformed | Replace |

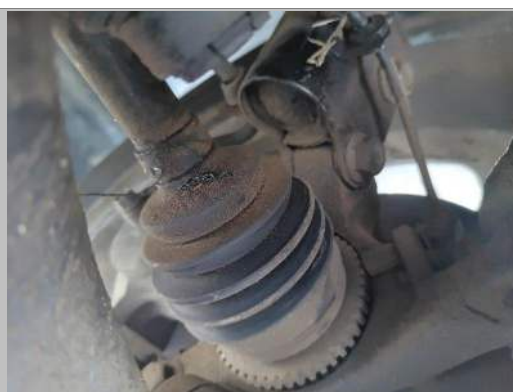
| Damage | Repair Way |
|---|---|
| CV Joint(s) Boot(s) Front Right (inner/outer) Damaged | Replace |

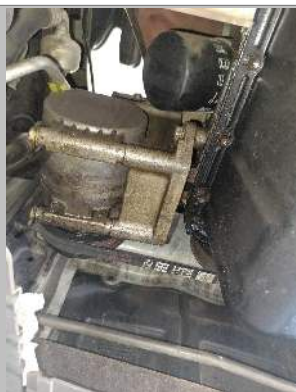
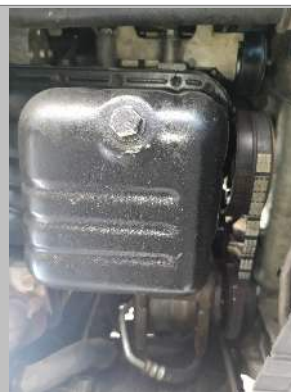
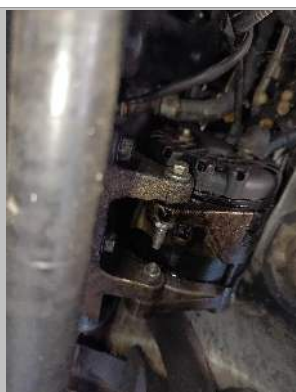
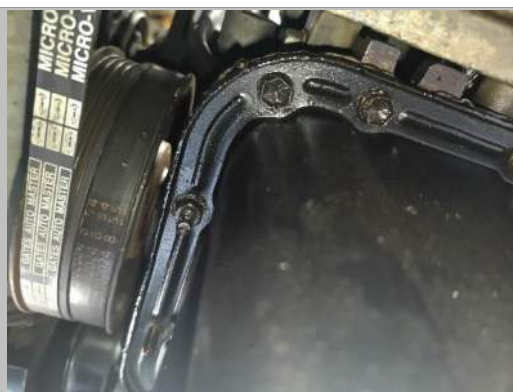
| Damage | Repair Way |
|---|---|
| Engine Oil Leak | Repair |

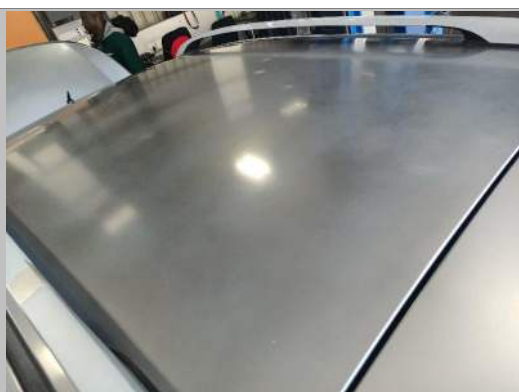
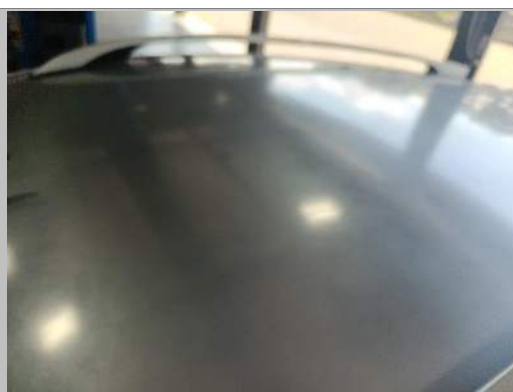
| Damage | Repair Way |
|---|---|
| Roof Paintwork • Dull | Repair |
