## CONDITION REPORT

Report No:  
2017283750  
DATE  
13/08/2026

MFC Auction House  
M57 Pretoria Rd, Glenmarais, KEMPTON PARK  
Gauteng

| Manufacturer | ISUZU | Registration Number | KKE635MP |

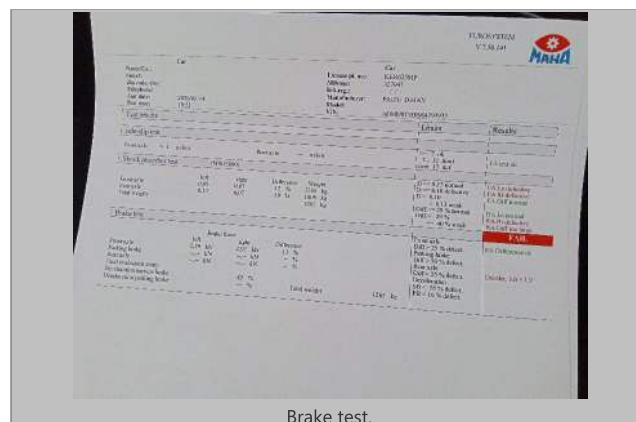
Brake test.

| | Left | Right | | |
|---|---|---|---|---|
| Rear | 0.0 | 0.0 | - | |
| Emergency / Parking | 0 | 0 | - | |

Brakes: vehicle has no handbrake and rear brakes. vehicle is unsafe to drive

| Brakes Insufficient | Repair |

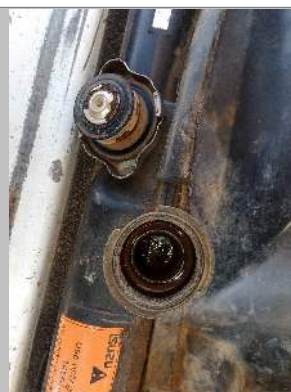
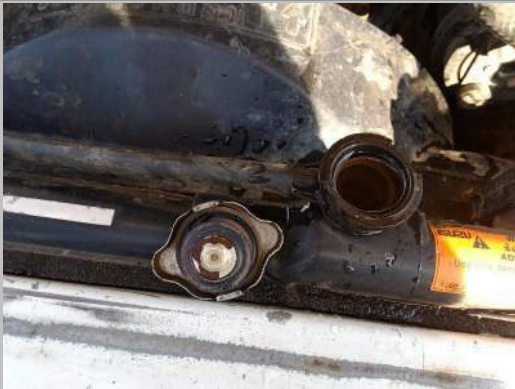
| Water level Insufficient | Repair |

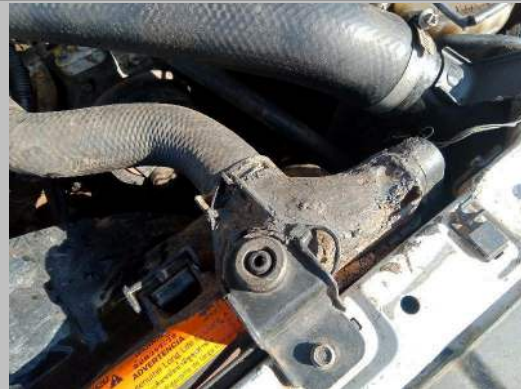
| Radiator Damaged | Replace |

General Comments: ACCORDING TO THE AGE AND MILEAGE OF THE VEHICLE, NORMAL WEAR AND TEAR MARKS ARE VISIBLE ON THE INTERIOR, EXTERIOR, ELECTRICAL AND MECHANICAL PARTS. Engine Compartment: incorrect battery fitted to vehicle. signs of rodent inside engine bay. vehicle struggles to start. excessive water leak from engine. excessive oil leak from engine.

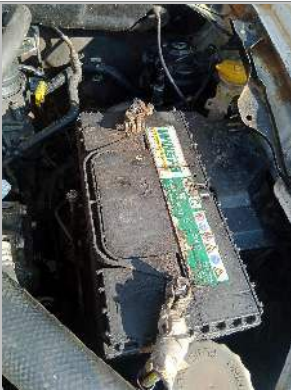
| Battery clamps Damaged | Repair |

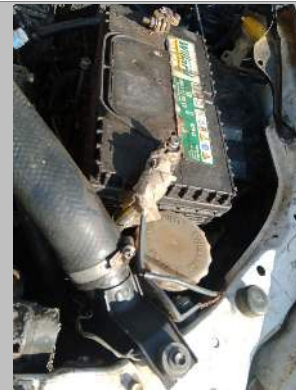
| Engine Wiring Damaged | Replace |

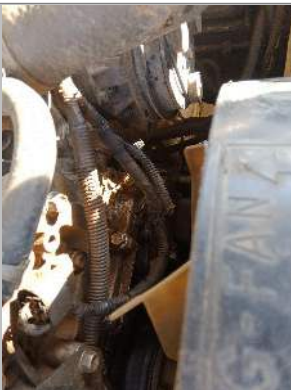
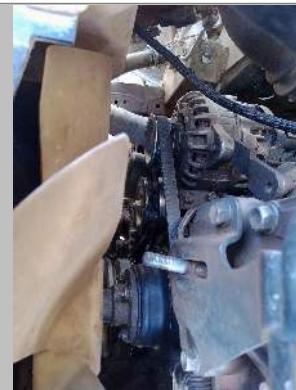
| Fan Belt Damaged | Replace |

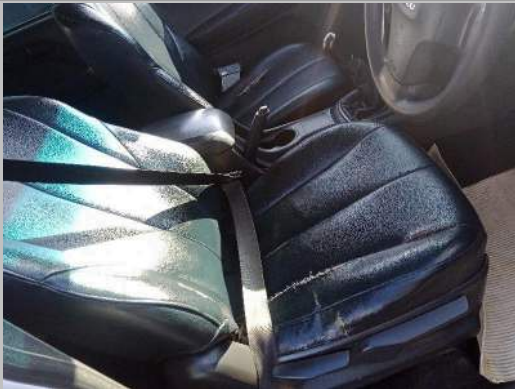
| Seat Front Right Damaged | Repair |

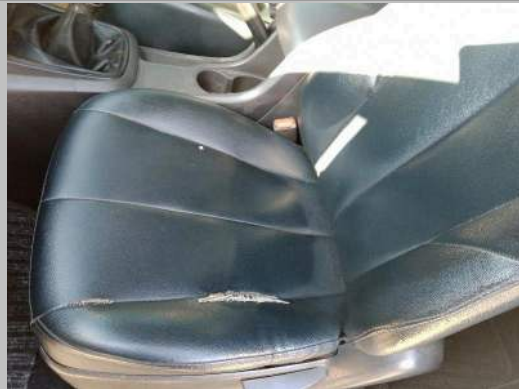
| Seat Front Left Damaged | Repair |

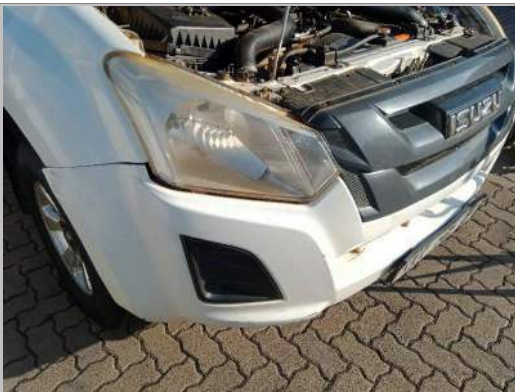
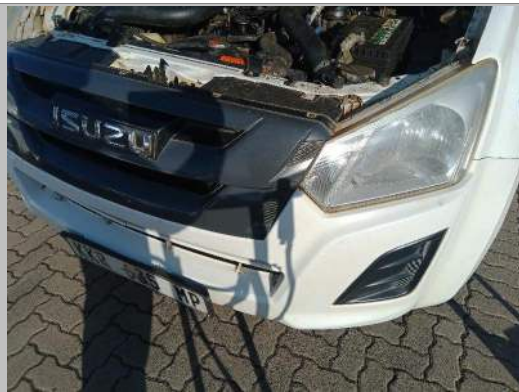
| Front Bumper Damaged | Repair |

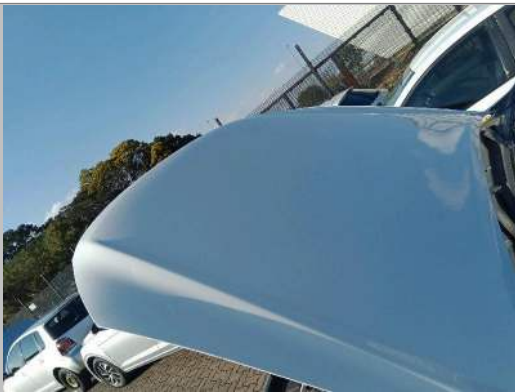
| Bonnet Damaged | Repair |

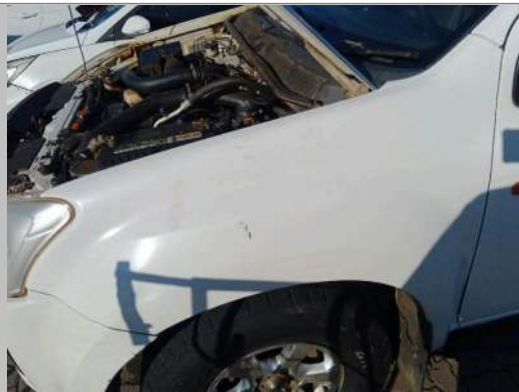
| Front Fender Left Damaged | Repair |

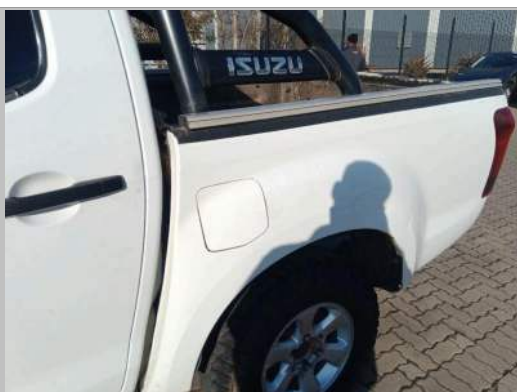
| Rear Fender Left Damaged | Repair |

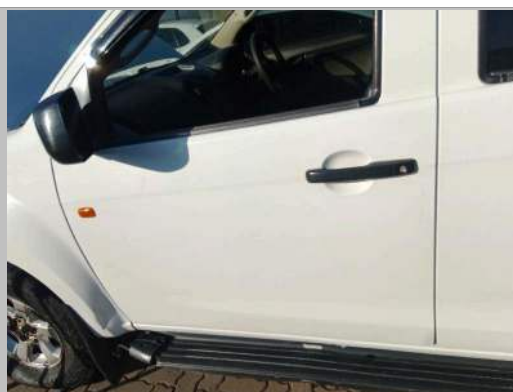
| Door Front Left Damaged | Repair |

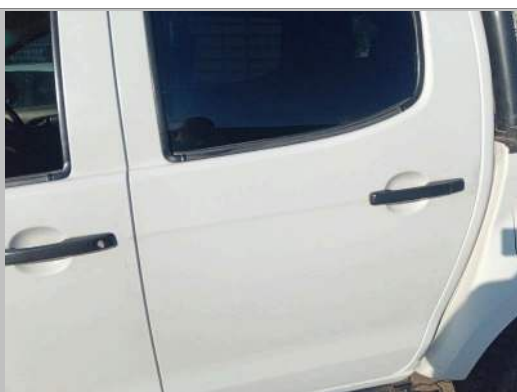
| Door Rear Left Damaged | Repair |

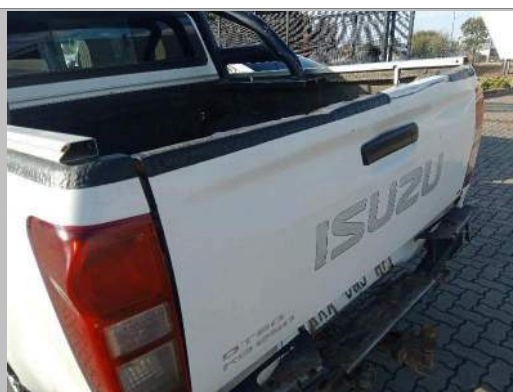
| Tailgate Damaged | Repair |

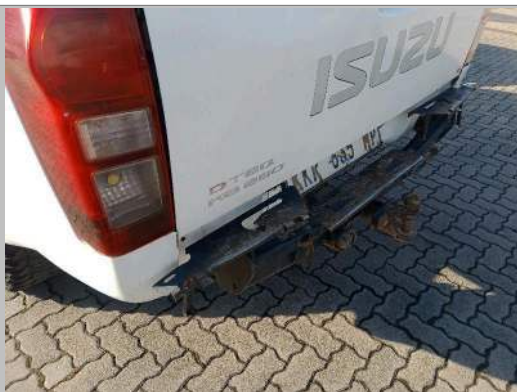
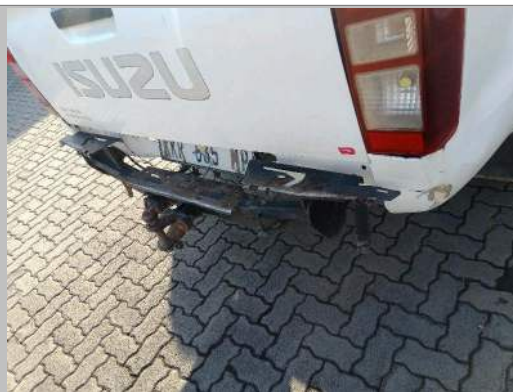
| Rear bumper Damaged | Replace |

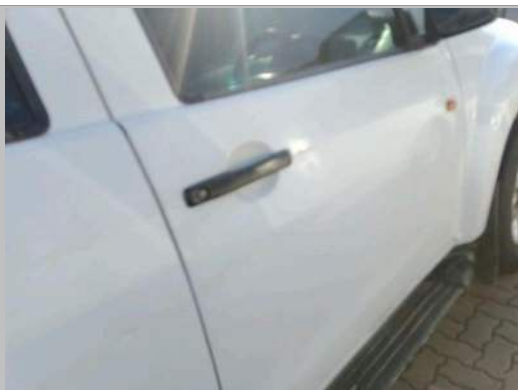
| Door Front Right Damaged | Repair |

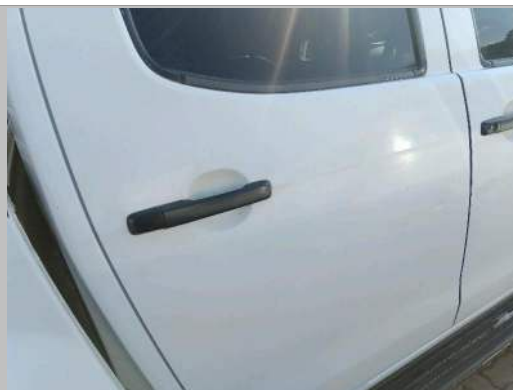
| Door Rear Right Damaged | Repair |

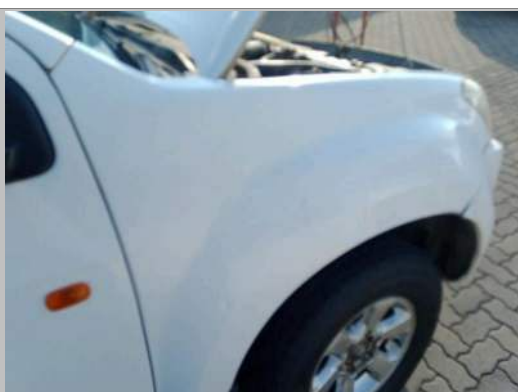
| Front Fender Right Damaged | Repair |

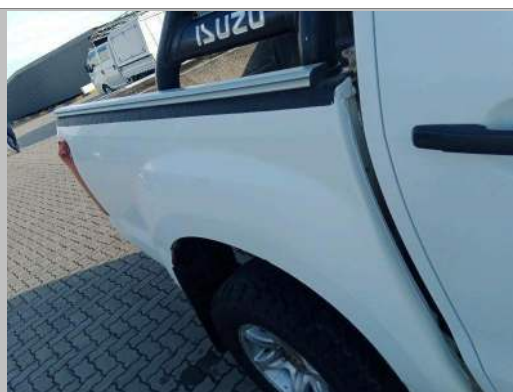
| Rear Fender Right Damaged | Repair |

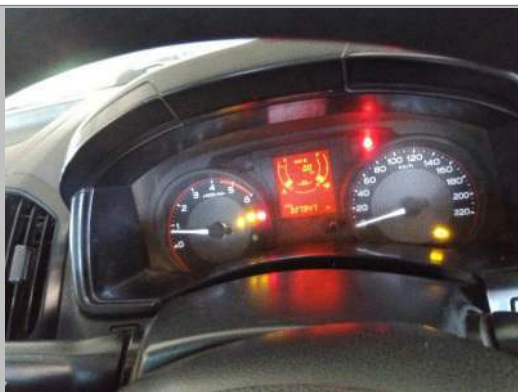
| Engine Management Lights Set | Repair |

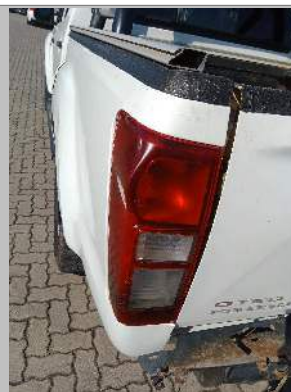
| Tail Light Left Damaged | Replace |

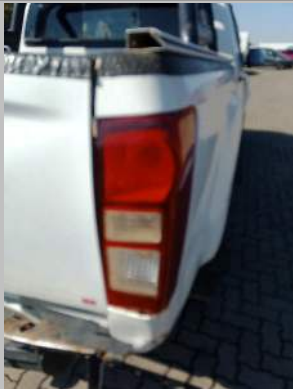
| Tail Light Right Damaged | Replace |

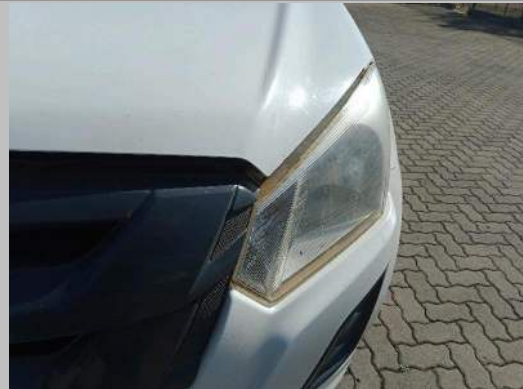
| Headlight Left Scratched | Repair |

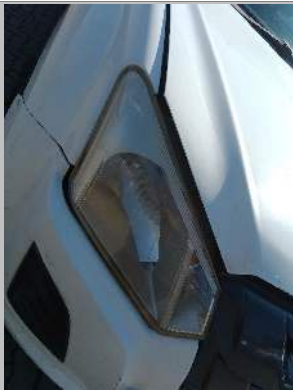
| Headlight Right Scratched | Repair |

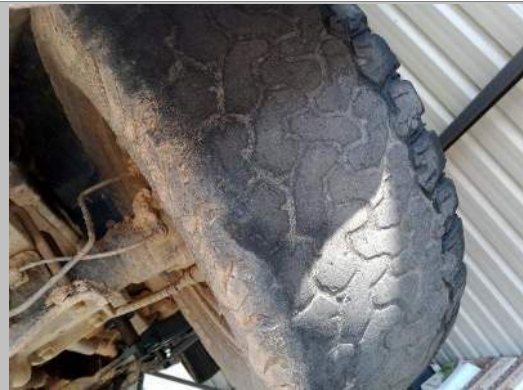
| Tyre Rear Right Worn | Replace |

| | Size | Load/Speed Index | Manufacture | Model | Type* | Production Date | Tread Depth (mm) |
|---|---|---|---|---|---|---|---|
| Rear Right | 255/70R16 | 117S | BFGoodrich | Radial | V | 0417 | 0 mm |

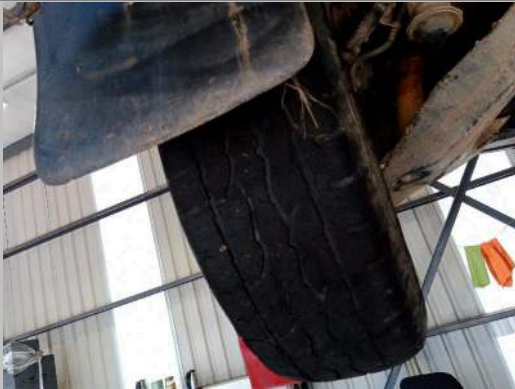
| Tyre Front Left Worn | Replace |

| | Size | Load/Speed Index | Manufacture | Model | Type* | Production Date | Tread Depth (mm) |
|---|---|---|---|---|---|---|---|
| Front Left | 265/70R16 | 112T | Dunlop | Grandtrek | V | 1021 | 0 mm |

Tyres and Rims: rear tire sizes do not match. front tire sizes do not match.

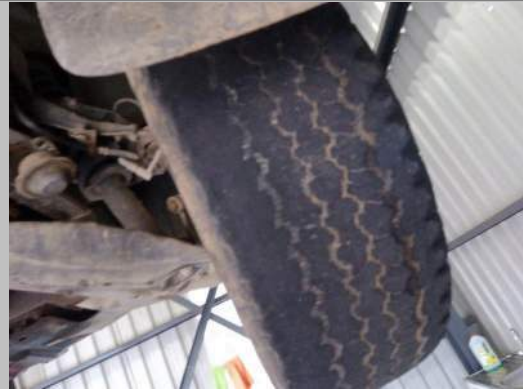
| Tyre Front Right Worn | Replace |

| | Size | Load/Speed Index | Manufacture | Model | Type* | Production Date | Tread Depth (mm) |
|---|---|---|---|---|---|---|---|
| Front Right | 245/70R16 | 109T | Goodyear | Wrangler | V | 3723 | 0 mm |

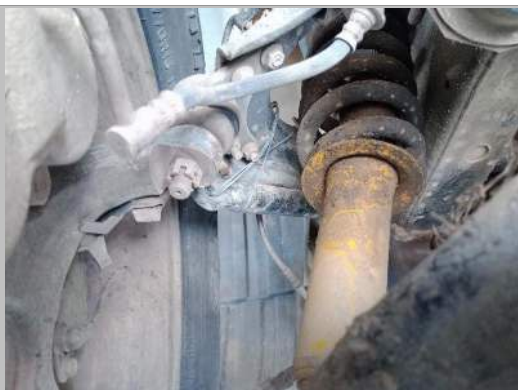
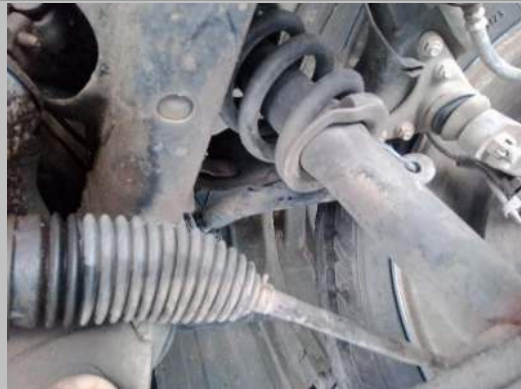
| Stabilizer Front Damaged | Replace |

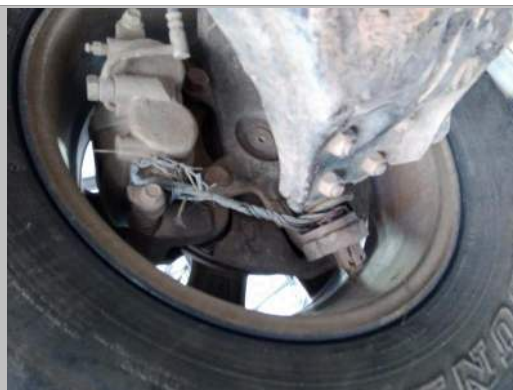
| Ball Joint(s) Front Axle Left Damaged | Replace |

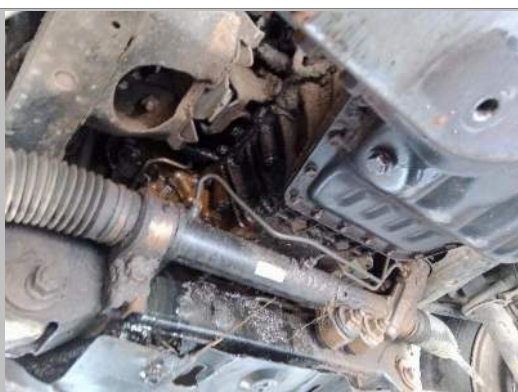
| Engine Oil Leak | Repair |

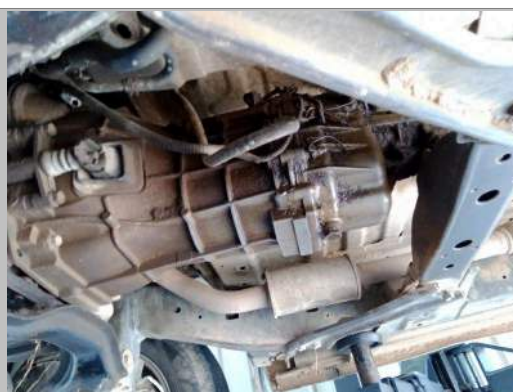
| Gearbox Oil Leak | Replace |

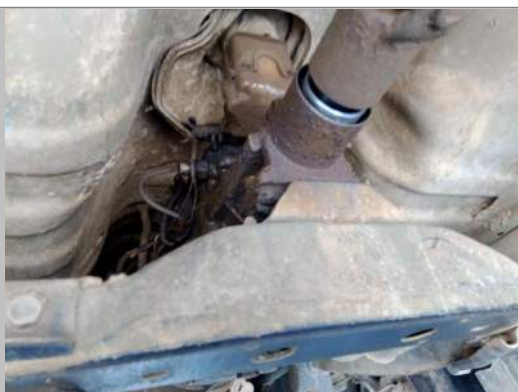
| Gearbox Mountings Damaged | Replace |

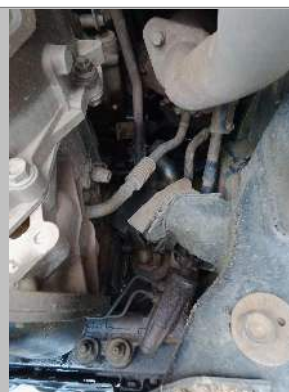
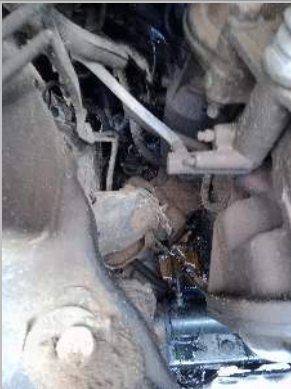
| Engine mountings Damaged | Replace |

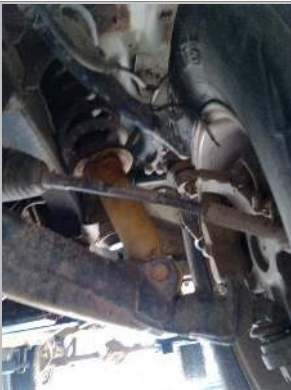
| Stabilizer Mounting Front Left Damaged | Replace |

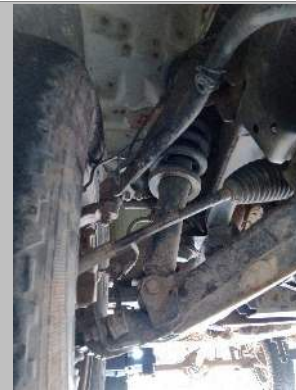
| Stabilizer Mounting Front Right Damaged | Replace |

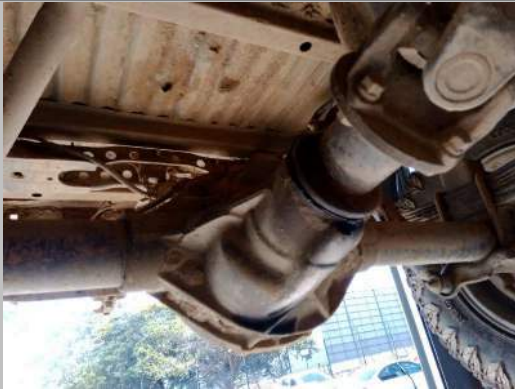
| Differential Oil Leak | Repair |
