## CONDITION REPORT

Report No:  
2017298445  
DATE  
14/09/2026

MFC Auction House  
M57 Pretoria Rd, Glenmarais, KEMPTON PARK  
Gauteng

| Manufacturer | OPEL | Registration Number | BP20XPGP |

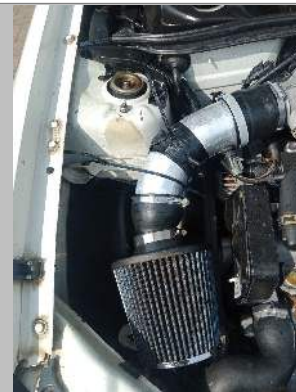
| Air cleaner Defective | Repair |

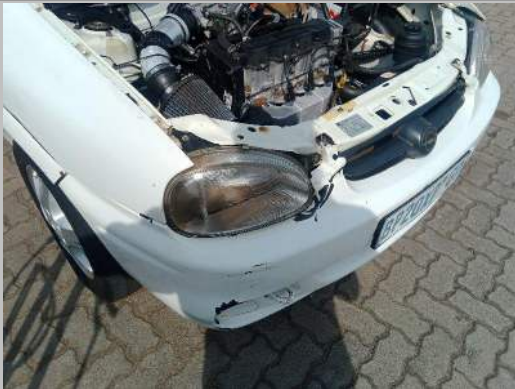
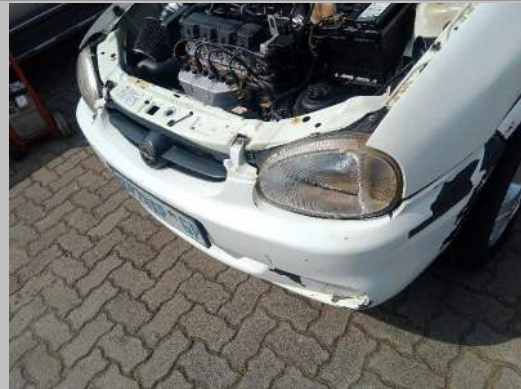
| Front Bumper Damaged | Repair |

Body • Exterior: Minor dents and scratches and stone chips to body panels. Signs of repair work done to body panels. Poor alignment to somebody panels.

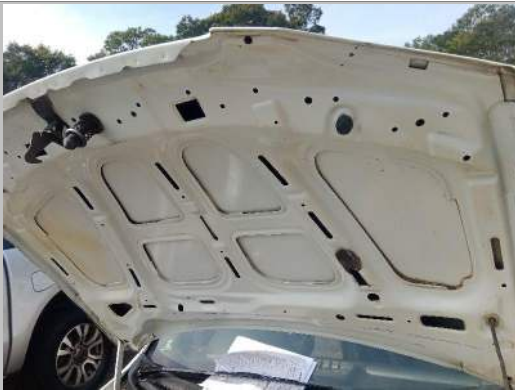
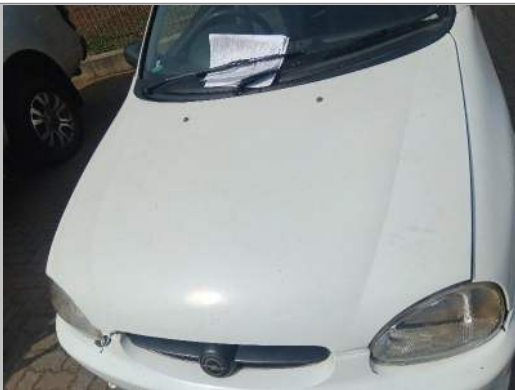
| Bonnet Damaged | Repair |

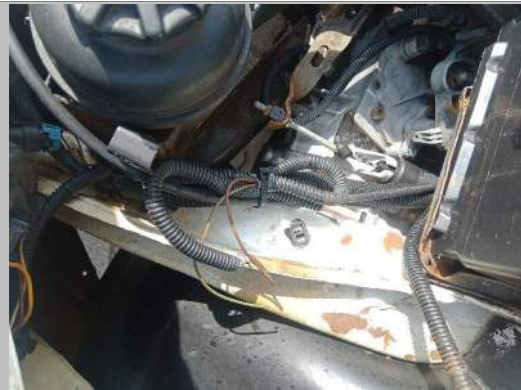
| Engine Wiring Damaged | Replace |

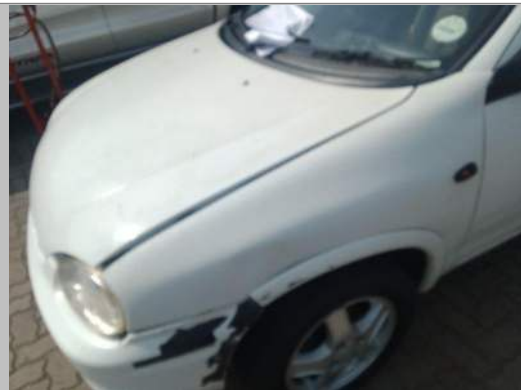
| Front Fender Left Damaged | Repair |

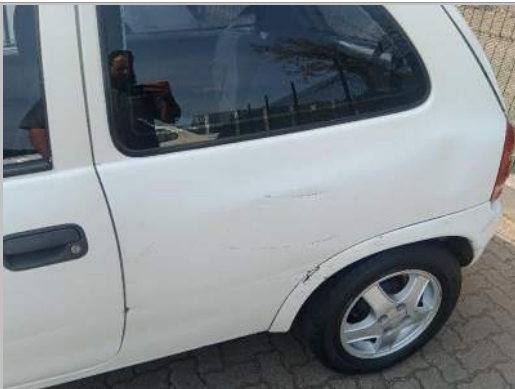
| Rear Fender Left Damaged | Repair |

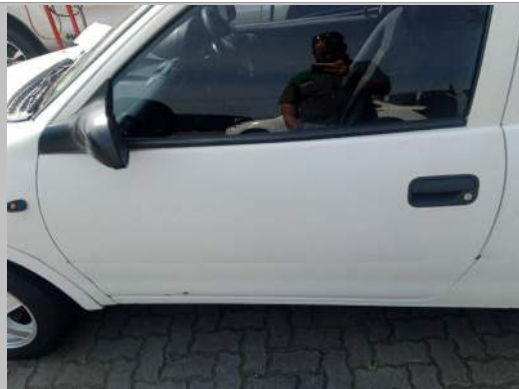
| Door Front Left Damaged | Repair |

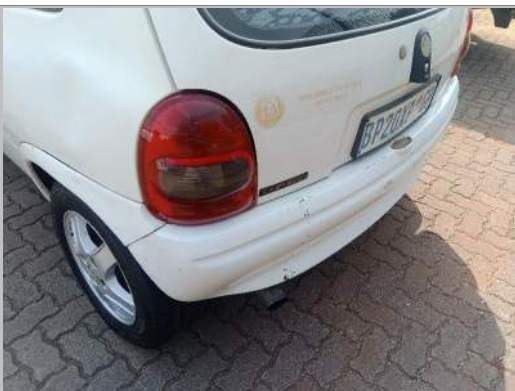
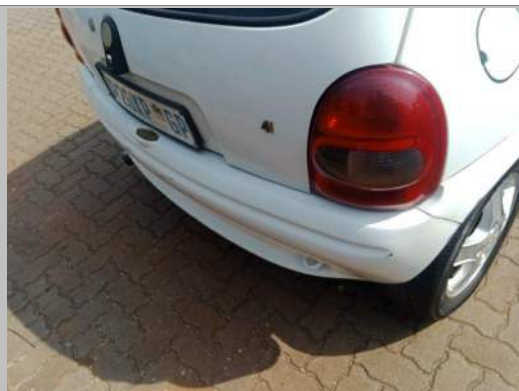
| Rear bumper Damaged | Repair |

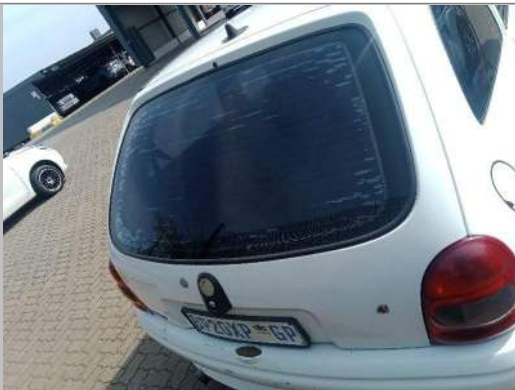
| Boot Lid / Hatch door Damaged | Repair |

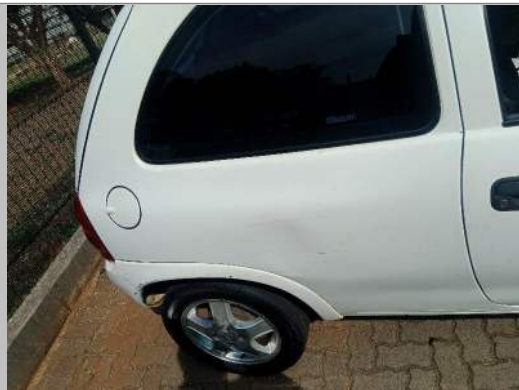
| Rear Fender Right Damaged | Repair |

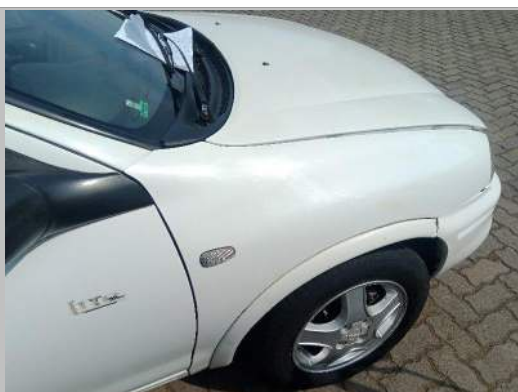
| Front Fender Right Damaged | Repair |

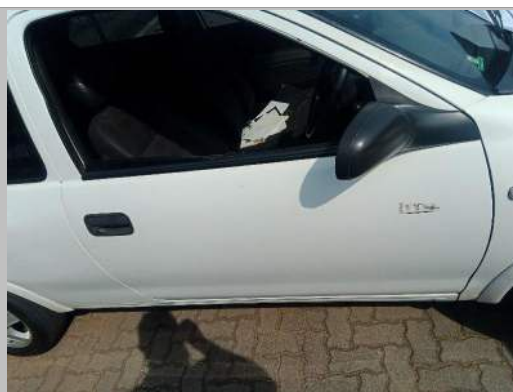
| Door Front Right Damaged | Repair |

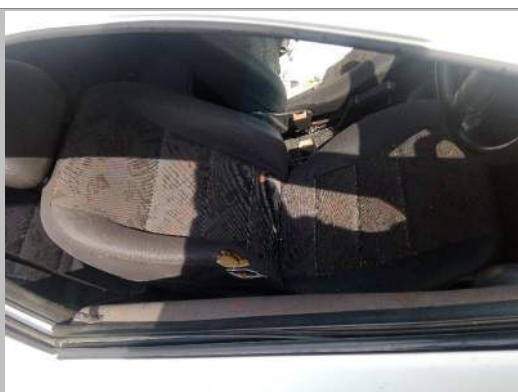
| Seat Front Right Damaged | Repair |

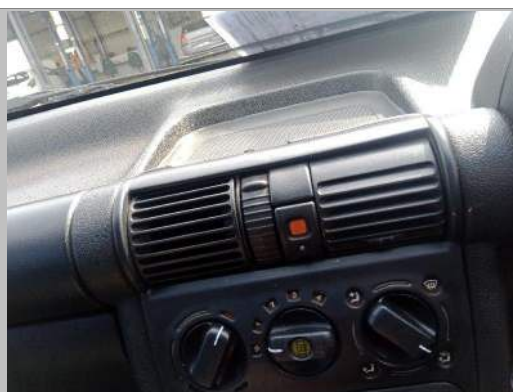
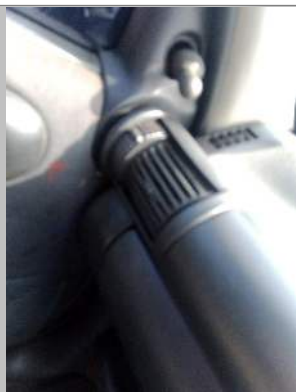
| Central Air Vent Damaged | Replace |

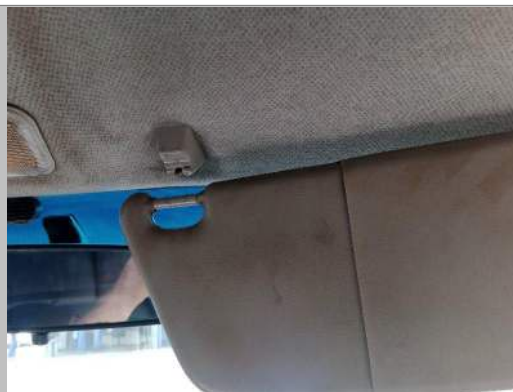
| Sun Visor Right Damaged | Repair |

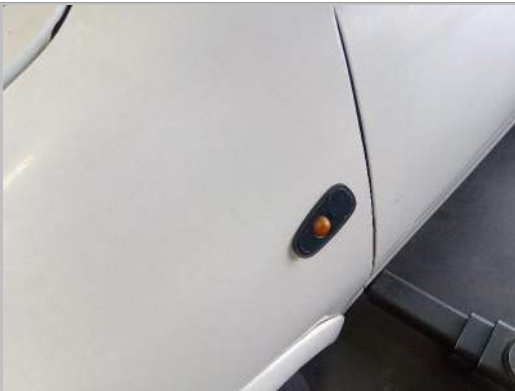
| Indicator Light Front Left Damaged | Replace |

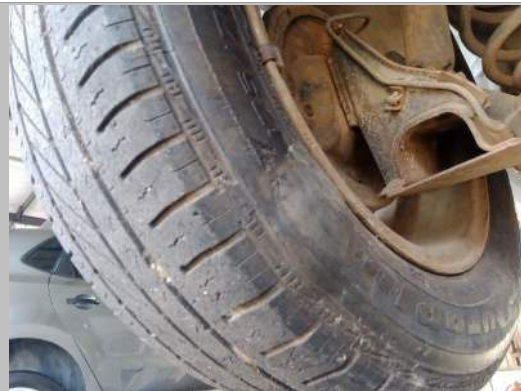
| Tyre Rear Left Damaged | Replace |

| | Size | Load/Speed Index | Manufacture | Model | Type* | Production Date | Tread Depth (mm) |
|---|---|---|---|---|---|---|---|
| Rear Left | 175/70R14 | 84T | Goodyear | Duraplus | V | 2421 | 1 mm |

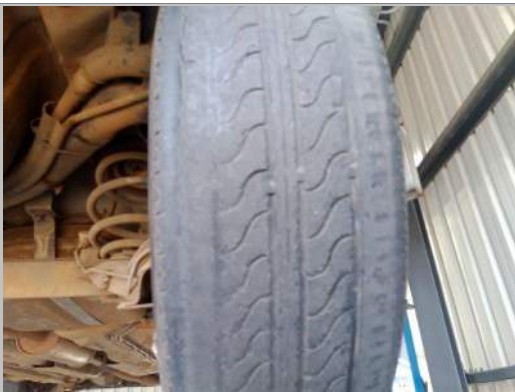
| Tyre Rear Right Worn | Replace |

| | Size | Load/Speed Index | Manufacture | Model | Type* | Production Date | Tread Depth (mm) |
|---|---|---|---|---|---|---|---|
| Rear Right | 185/60R14 | 82H | Timax | Radial | V | 4521 | 0 mm |

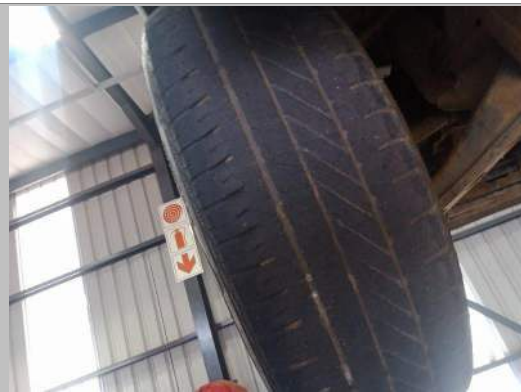
| Tyre Front Left Worn | Replace |

| | Size | Load/Speed Index | Manufacture | Model | Type* | Production Date | Tread Depth (mm) |
|---|---|---|---|---|---|---|---|
| Front Left | 175/70R14 | 84T | Goodyear | Duraplus | V | 2421 | 0 mm |

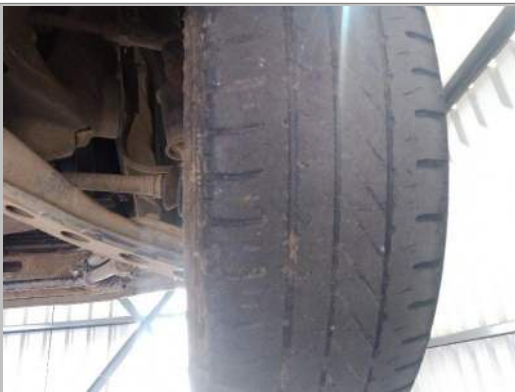
| Tyre Front Right Worn | Replace |

| | Size | Load/Speed Index | Manufacture | Model | Type* | Production Date | Tread Depth (mm) |
|---|---|---|---|---|---|---|---|
| Front Right | 175/70R14 | 84T | Goodyear | Duraplus | V | 2421 | 0 mm |

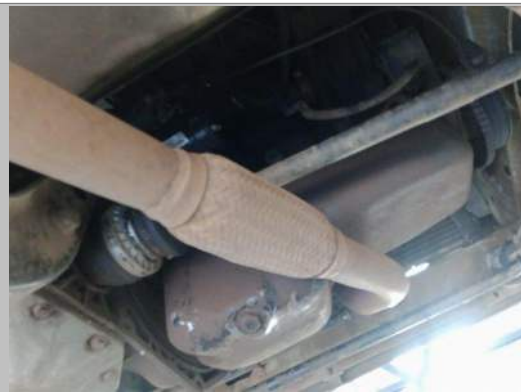
| Engine Oil Leak | Repair |

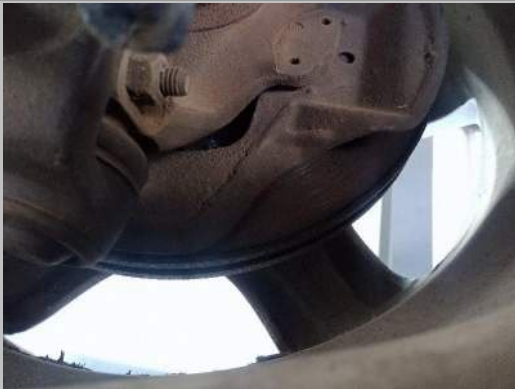
| Brake disc 1. Axle right Worn | Replace |

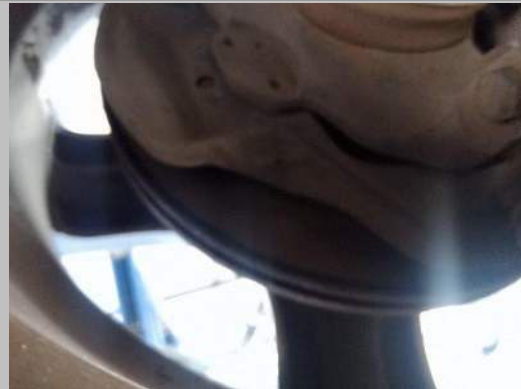
| Brake disc 2. Axle left Worn | Replace |

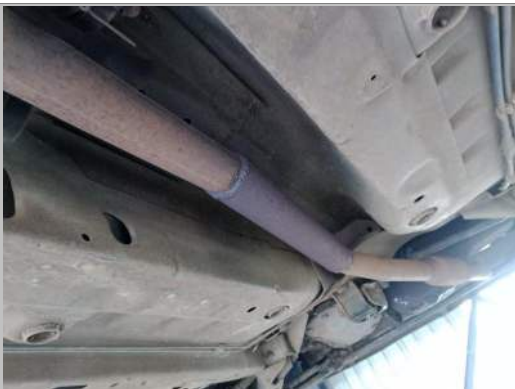
| Engine to silencer pipe Welded | Replace |

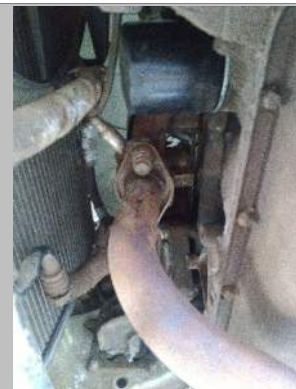
| Catalytic converter Missing | Replace |

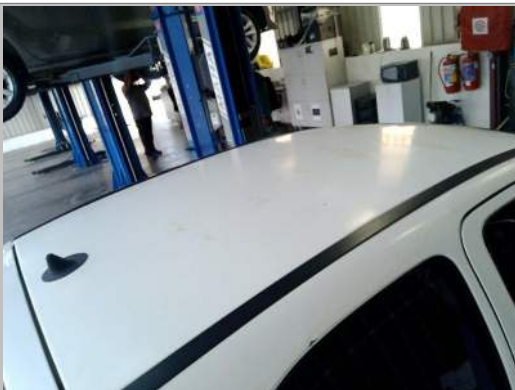
| Roof Damaged | Repair |

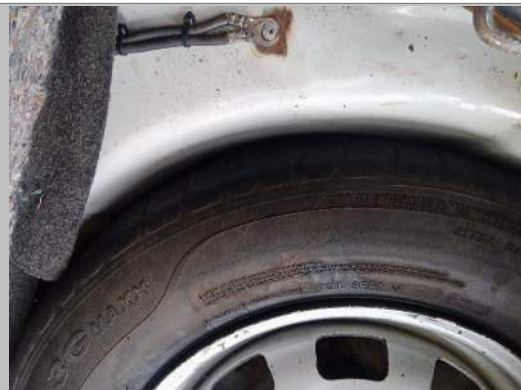
| Spare Tyre Worn | Replace |

| | Size | Load/Speed Index | Manufacture | Model | Type* | Production Date | Tread Depth (mm) |
|---|---|---|---|---|---|---|---|
| Spare | 165/80R14 | 85T | Apollo | Radial | V | 0619 | 0 mm |

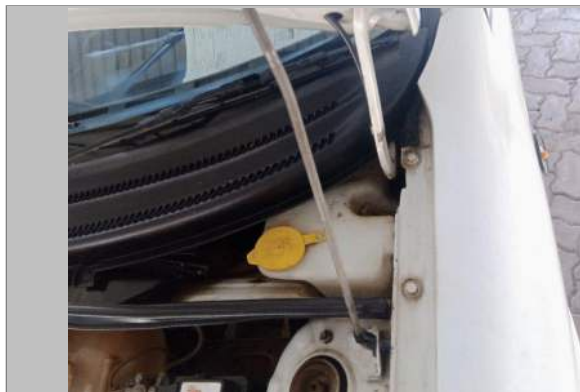
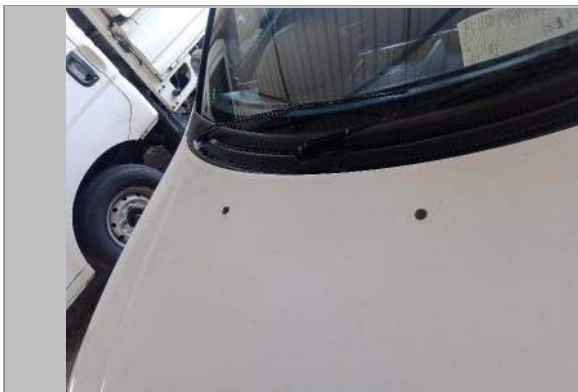
| Windscreen Washer Defective | Repair |
