CONDITION REPORT

Report No: 2016239725

MFC Auction House
M57 Pretoria Rd, Glenmarais, KEMPTON PARK
Gauteng

Vehicle Type	LIGHT LOAD VEHICLE	Registered Owner	MFC AUCTION HOUSE
Manufacturer	NISSAN	Registration Number	JG71SSGP
Model	NP200	Register Number	
VIN	ADNUSN1D5U0170273	Date Of First Licensing	
Engine Number		Last COR	
Doors	2	License Expiry Date	30/06/2024
Color	WHITE	Power / Displacement	
Year Model		Paint Finish	C - COMMON
Km Reading	162,480 KM	Fuel	PETROL
Cab / Body Type	SINGLE CAB	Transmission	MANUAL

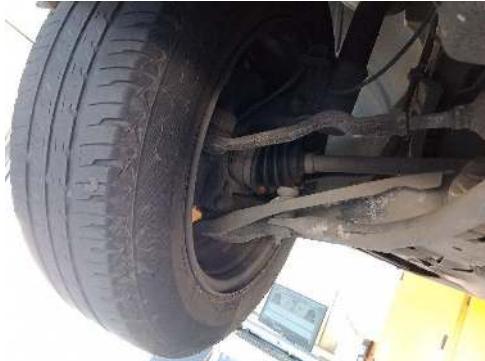
LF TYRE TREAD

Size	Load/Speed Index	Manufacture	Model	Type*	Production Date	Tread Depth (mm)
Front Left	185/65R15	88H	Firestone	Touring		4121	1 mm
Front Right	185/65R15	88T	Continental	Contact	V	2222	2 mm
Rear Left	185/65R15	92H	Blackhwak	Street	V	1821	3 mm
Rear Right	185/65R15	92T	Barum	Brilliantis	V	0423	5 mm
Spare	185/65R15	92H	Sumitomo	HTR	V	//////	3 mm

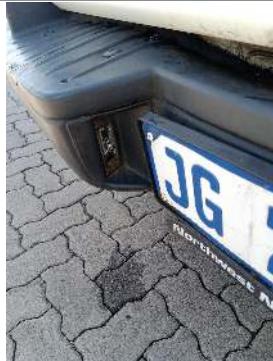
Damage	Repair Way
Engine Oil Leak	Repair
Engine Wiring Defective	Repair
Battery clamps Defective	Repair
Dim Light Left Defective	Repair
Number Plate Light Left Defective	Repair
Seat Front Left Torn / Cut	Repair
Seat Front Right Torn / Cut	Repair
Window Winder front right Defective	Repair
Front Bumper Damaged	Repair
Rear bumper Damaged	Repair
Shock Absorber Rear Right Leak	Replace
Spare Tyre Torn / Cut	Replace
Rim Rear Right Dented	Repair
Gearbox Oil Leak	Repair

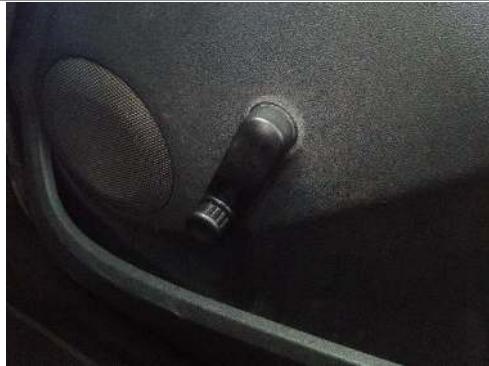
Window Winder front right

General Comments: ACCORDING TO THE AGE AND MILEAGE OF THE VEHICLE, NORMAL WEAR AND TEAR MARKS ARE VISIBLE ON THE INTERIOR, EXTERIOR, ELECTRICAL AND MECHANICAL PARTS. Interior: Driver window malfunction.
Body • Exterior: Minor dents scratches and stone chips on som
