MFC Auction House  
M57 Pretoria Rd, Glenmarais, KEMPTON PARK  
Gauteng

Vehicle Type	LIGHT LOAD VEHICLE	Registered Owner	
Manufacturer	FORD	Registration Number	CP28BWGP
Model	RANGER SUPER CAB 2.2TD HI-POWER XL HI-RIDER DSL PU [2011-2016]	Register Number	
VIN	AFAGXXMJ2GDP08894	Date Of First Licensing	
Engine Number		Last COR	
Doors	2	License Expiry Date	
Color	WHITE	Power / Displacement	
Year Model	2013	Paint Finish	C - COMMON
Km Reading	280,335 KM	Fuel	DIESEL
Cab / Body Type	SUPER CAB	Transmission	MANUAL

**VEHICLE INSPECTION**

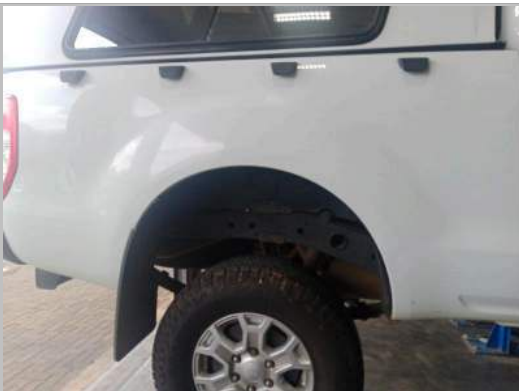
Damage	Repair Way
Front Bumper Discoloured	Repair
Bonnet Paintwork • Chipmarks	Repair
Front Fender Left Paintwork • Scratched	Repair
Front Fender Right Dented	Repair
Rear Fender Left Paintwork • Scratched	Repair
Rear Fender Right Paintwork • Scratched	Repair
Door Front Left Paintwork • Scratched	Repair
Door Front Right Dented	Repair
Door Rear Left Paintwork • Scratched	Repair
Door Rear Right Paintwork • Scratched	Repair
Tailgate Paintwork • Scratched	Repair
Rear bumper Damaged	Repair
Windscreen Cracked	Repair
Service Brake Performance Rear Axle Left / Right	Repair
Difference out of legal range	
Parking Brake Performance Left / Right Difference out of legal range	Repair
Body exterior	Vehicle got minor scratches stone chips and dents
