MFC Auction House
M57 Pretoria Rd, Glenmarais, KEMPTON PARK
Gauteng

DEKRA MFC
M57 Pretoria Rd - 1619
KEMPTON PARK - GT
08610 33572

VEHICLE INSPECTION

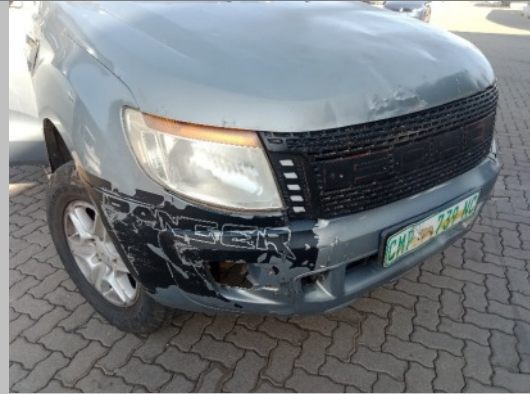
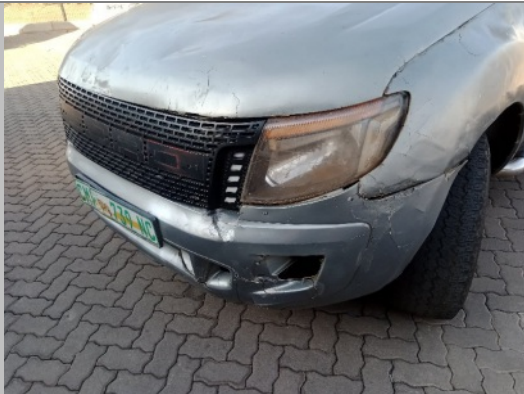
| | Damage | Repair Way |
|---|---|---|
| | Front Bumper Damaged | Repair |

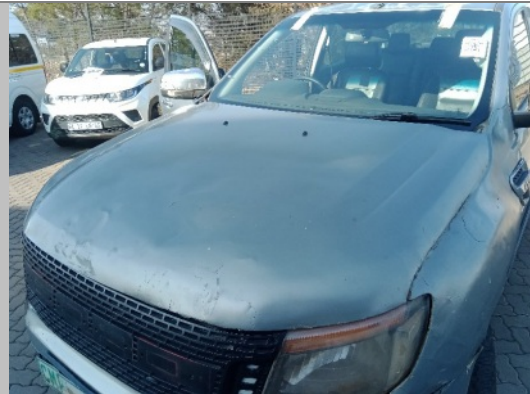
| | Damage | Repair Way |
|---|---|---|
| | Bonnet Damaged | Repair |

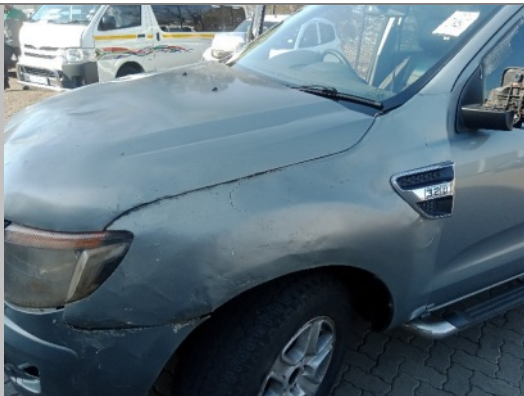
| | Damage | Repair Way |
|---|---|---|
| | Front Fender Left Damaged | Repair |

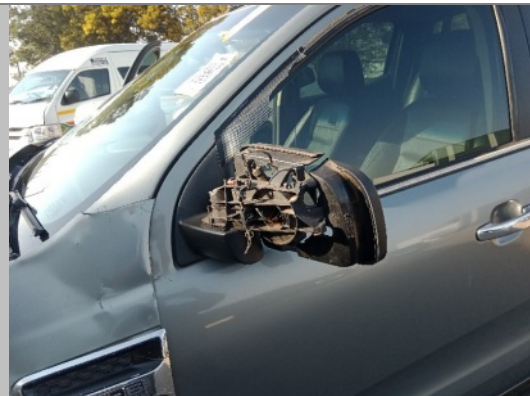
| | Damage | Repair Way |
|---|---|---|
| | Side Mirror Left Damaged | Repair |

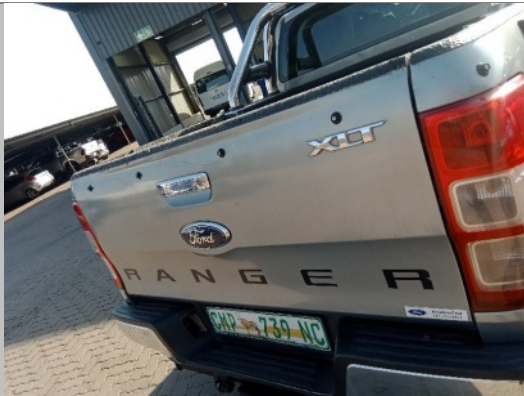
| Damage | Repair Way |
|--|---|
| Tailgate Damaged | Repair |

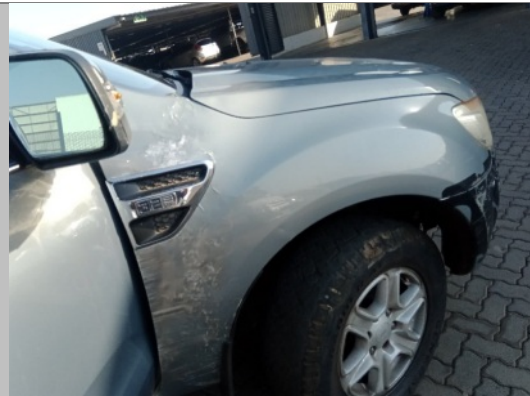
| | Damage | Repair Way |
|---|---|---|
| Front Fender Right Damaged | Repair | |

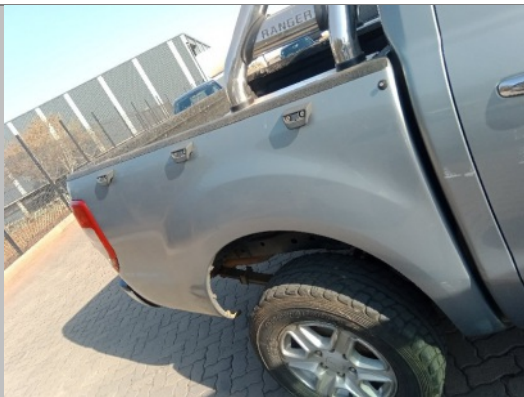
| | Damage | Repair Way |
|---|---|---|
| Rear Fender Right Damaged | Repair | |

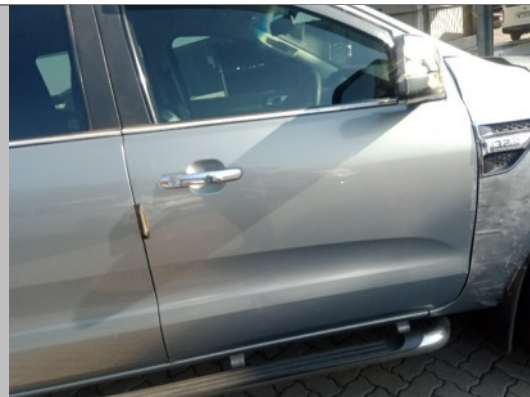
| | Damage | Repair Way |
|---|---|---|
| Door Front Right Defective | Repair | |

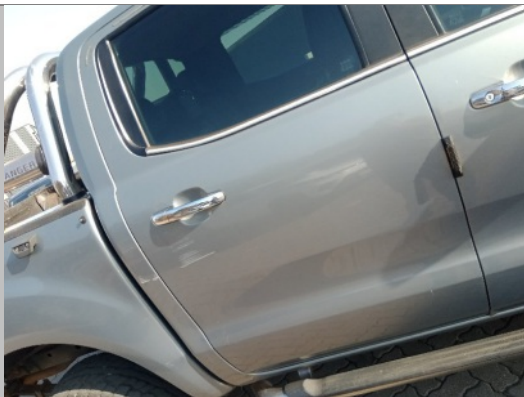
| Damage | Repair Way |
|--|---|
| Door Rear Right Damaged | Repair |

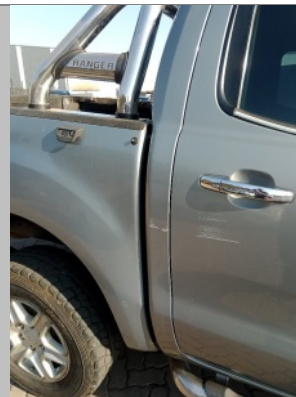
| | Damage | Repair Way |
|---|---|---|
| | C • Pillar Right Damaged | Replace |

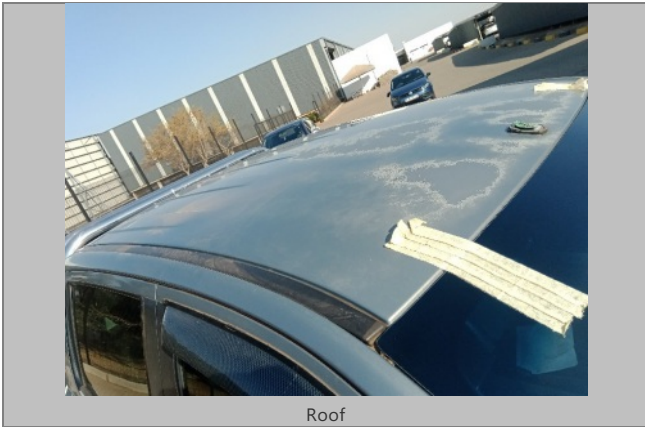
| Damage | Repair Way |
|--|---|
| Roof Damaged | Repair |

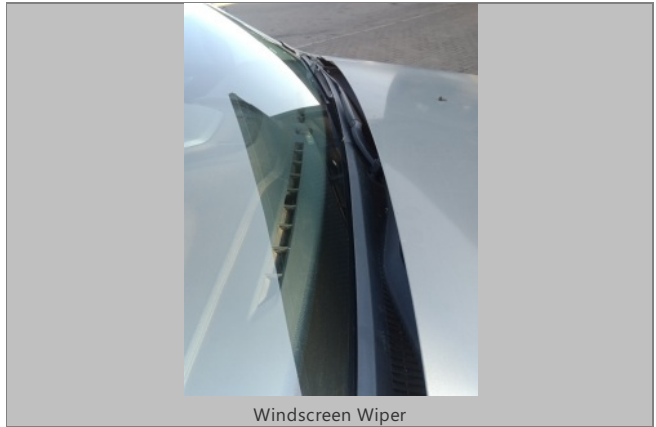
| | Damage | Repair Way |
|---|---|---|
| | Windscreen Wiper Damaged | Replace |

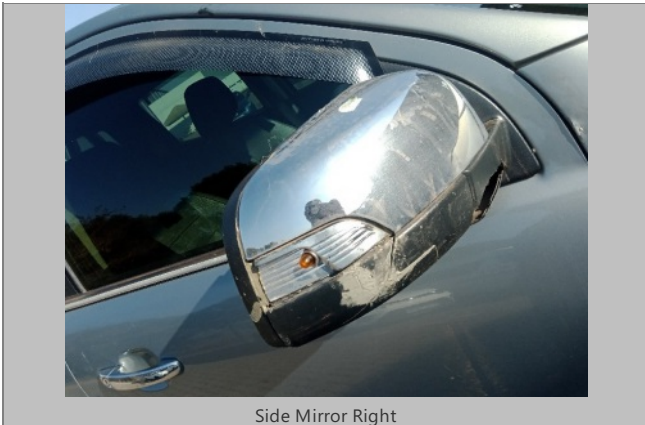
| | Damage | Repair Way |
|---|---|---|
| | Side Mirror Right Damaged | Replace |

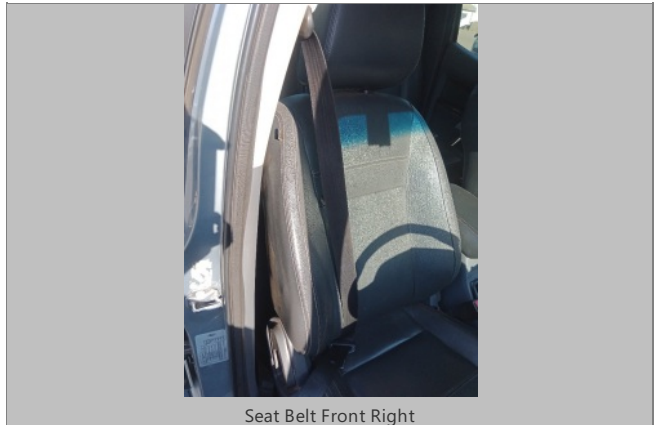
| | Damage | Repair Way |
|---|---|---|
| | Seat Belt Front Right Damaged | Replace |

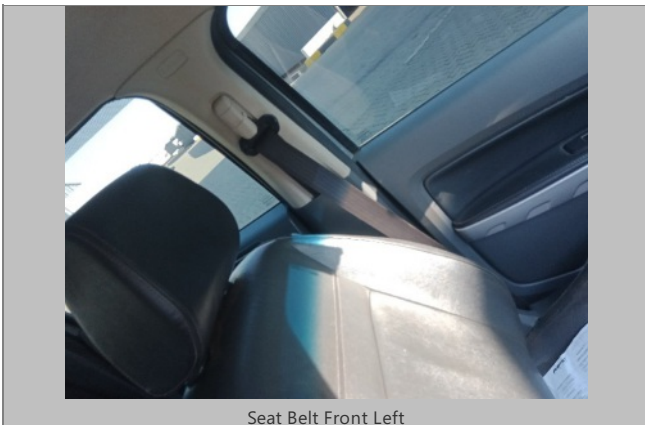
| | Damage | Repair Way |
|---|---|---|
| | Seat Belt Front Left Damaged | Replace |

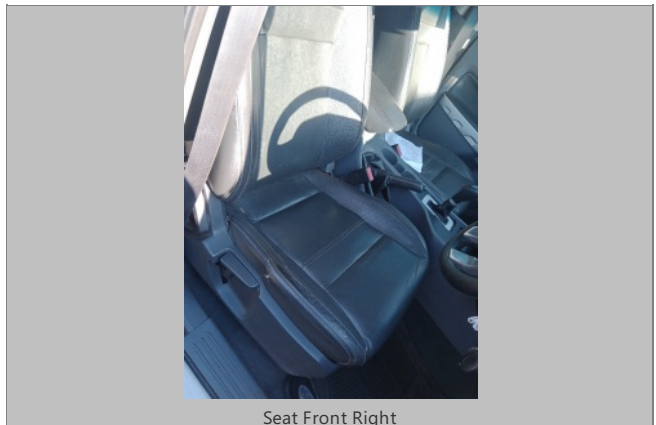
| | Damage | Repair Way |
|---|---|---|
| | Seat Front Right Damaged | Repair |

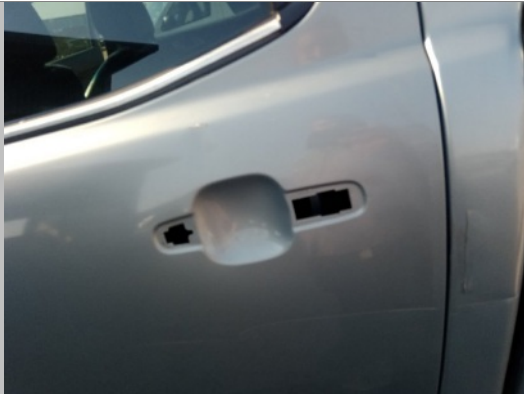
| | Damage | Repair Way |
|---|---|---|
| | Door Handle Rear Left Damaged | Replace |

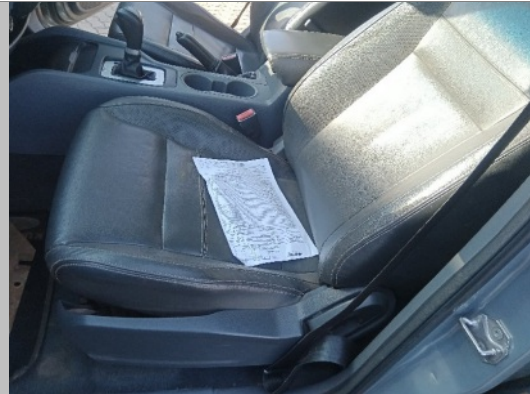
| | Damage | Repair Way |
|---|---|---|
| | Seat Front Left Damaged | Repair |

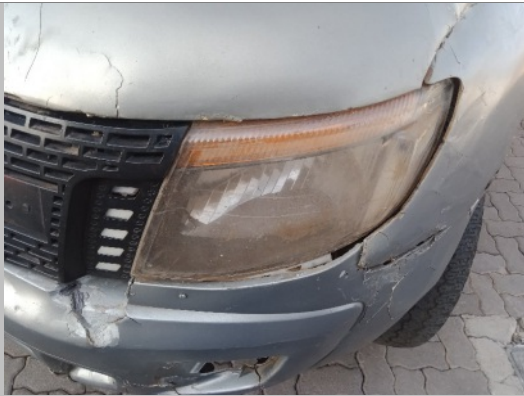
| | Damage | Repair Way |
|---|---|---|
| | Headlight Left Damaged | Replace |

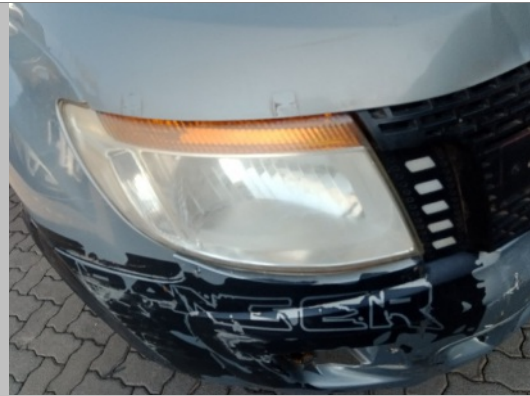
| | Damage | Repair Way |
|---|---|---|
| | Headlight Right Damaged | Replace |

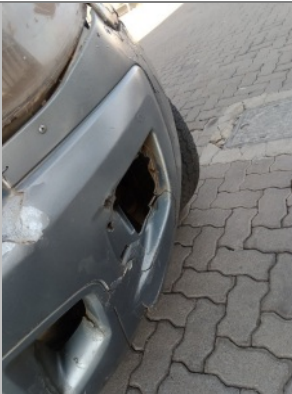
| | Damage | Repair Way |
|---|---|---|
| | Fog Light Front Left Damaged | Replace |

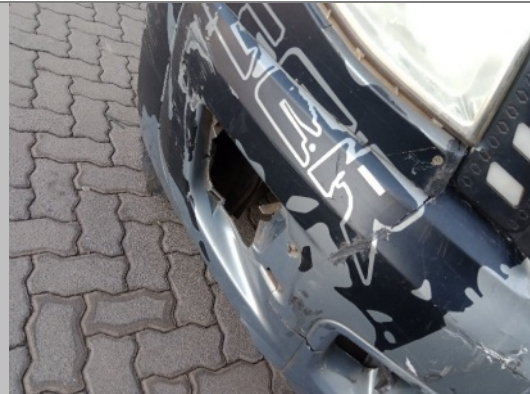
| | Damage | Repair Way |
|---|---|---|
| | Fog Light Front Right Damaged | Replace |

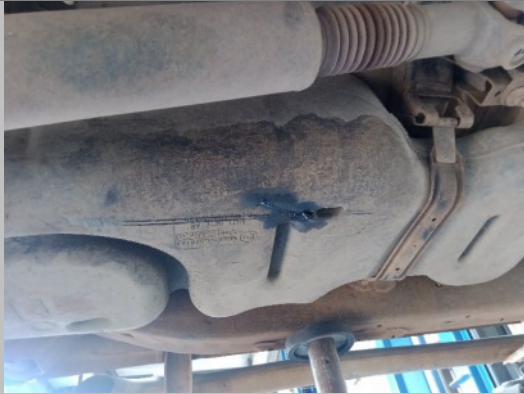
| Damage | Repair Way |
|--|---|
| Fuel Tank Damaged | Replace |

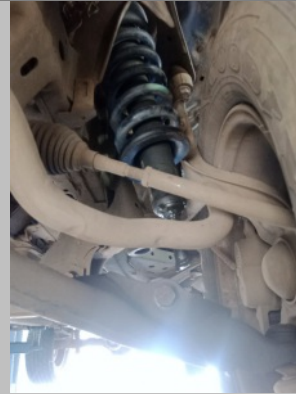
| Damage | Repair Way |
|--|---|
| Shock Absorber Front Left Damaged | Replace |

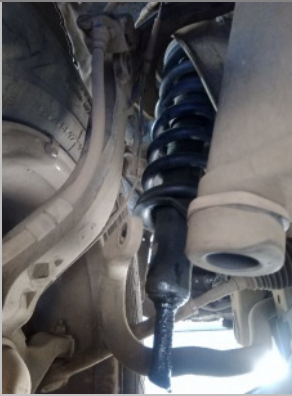
| Damage | Repair Way |
|--|---|
| Stabilizer Mounting Front Left Missing | Replace |

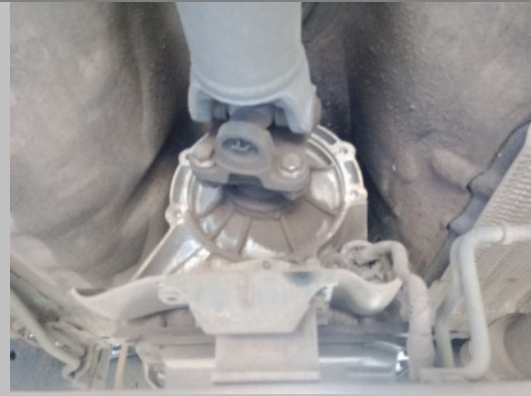
| Damage | Repair Way |
|--|---|
| Gearbox Oil Leak | Repair |

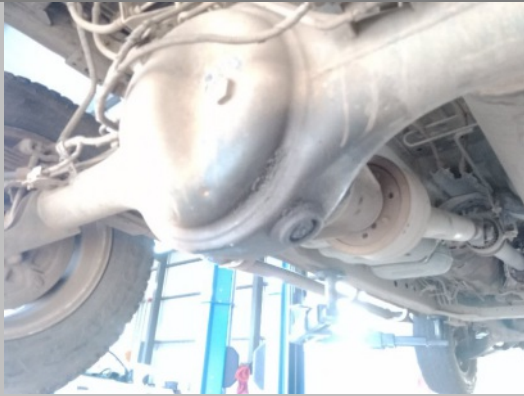
| Damage | Repair Way |
|--|---|
| Differential Oil Leak | Replace |

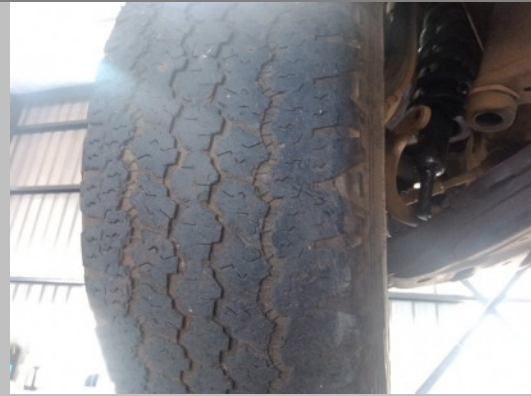
| Damage | Repair Way |
|--|---|
| Tyre Front Left Worn | Replace |

| | Size | Load/Speed Index | Manufacture | Model | Type* | Production Date | Tread Depth (mm) |
|---|---|---|---|---|---|---|---|
| Front Left | 265/65R17 | 112S | Goodyear | Wrangler | V | 1517 | 0 mm |

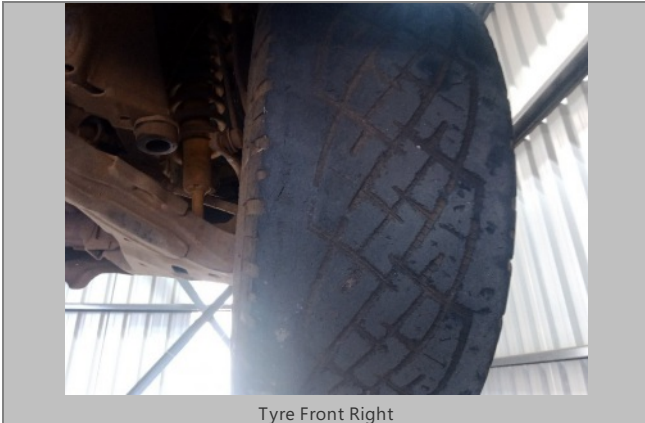
| Damage | Repair Way |
|--|---|
| Tyre Front Right Worn | Replace |

| | Size | Load/Speed Index | Manufacture | Model | Type* | Production Date | Tread Depth (mm) |
|---|---|---|---|---|---|---|---|
| Front Right | 265/65R17 | 112T | General | Radial | V | 4416 | 0 mm |

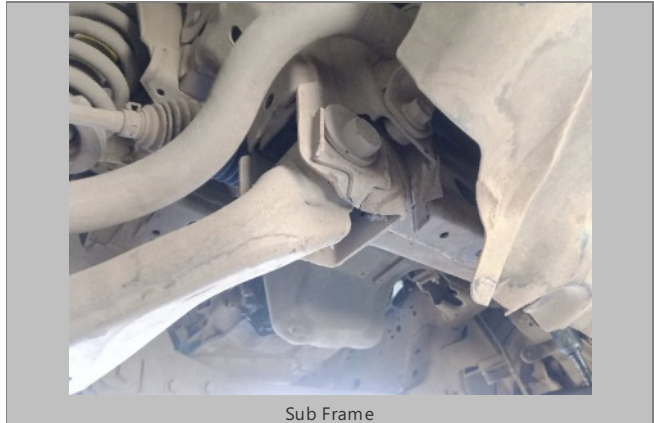
| Damage | Repair Way |
|--|---|
| Sub Frame Damaged | Replace |

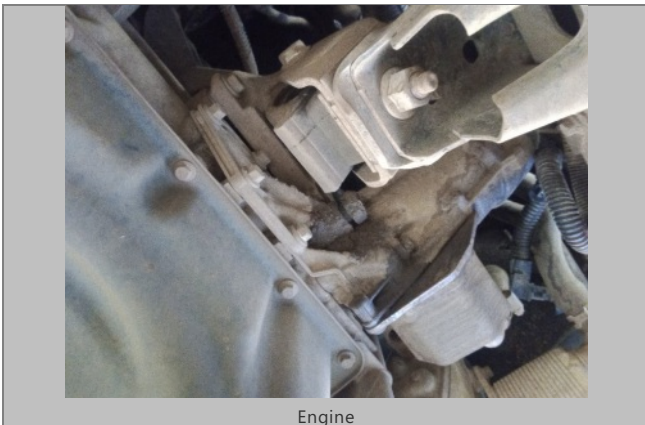
| | Damage | Repair Way |
|---|---|---|
| | Engine Oil Leak | Repair |

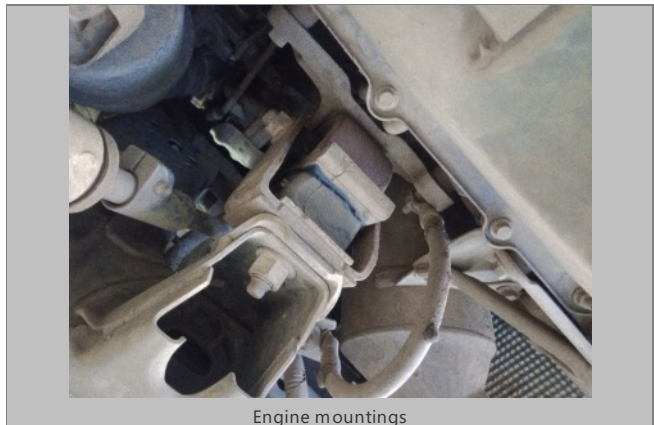
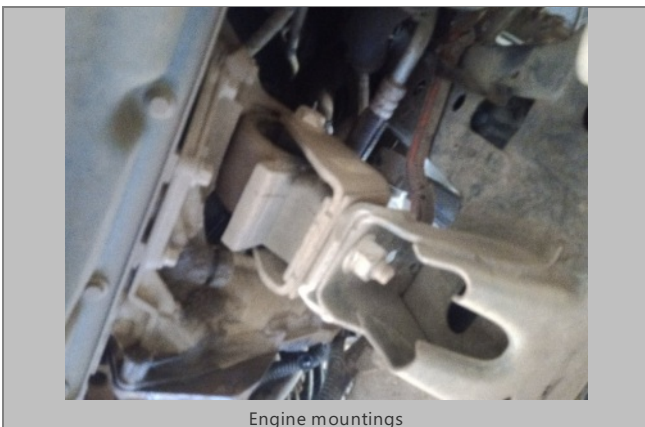
| Damage | Repair Way |
|--|---|
| Engine mountings Damaged | Replace |

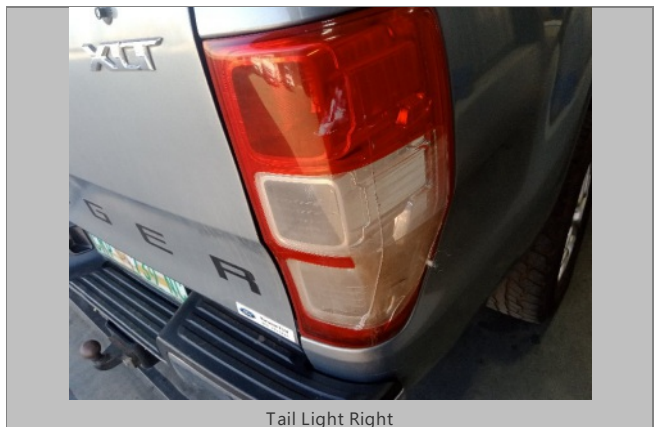
| | Damage | Repair Way |
|---|---|---|
| | Tail Light Right Damaged | Replace |

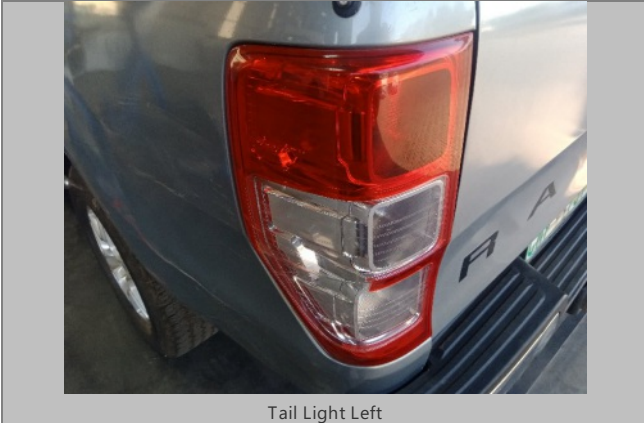
| | Damage | Repair Way |
|---|---|---|
| | Tail Light Left Damaged | Replace |
