## CONDITION REPORT

Report No: 2016202351

MFC Auction House  
M57 Pretoria Rd, Glenmarais, KEMPTON PARK  
Gauteng

| Manufacturer | FORD | Registration Number | NJ101361 |

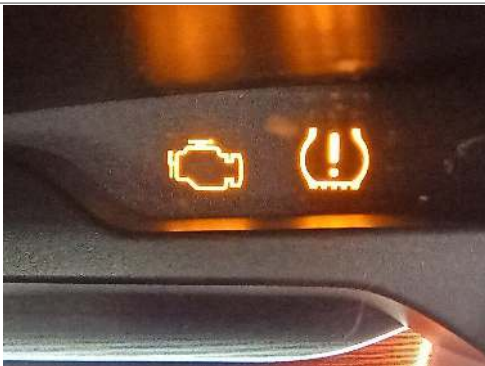
Warning light illuminated.

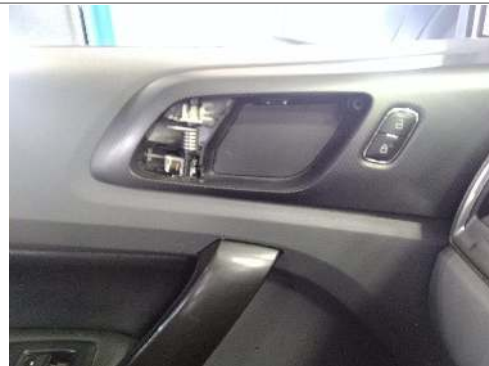
| Damage | Repair Way |
|---|---|
| Door Handle Front Left Missing | Replace |

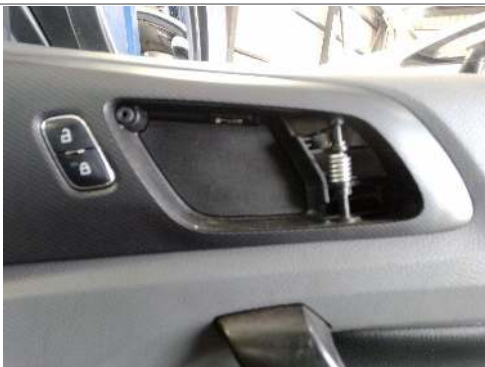
| Damage | Repair Way |
|---|---|
| Door Panel Rear Right Missing | Replace |

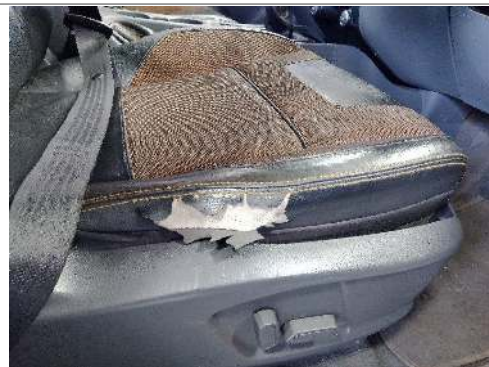
| Damage | Repair Way |
|---|---|
| Seat Front Right Torn / Cut | Repair |

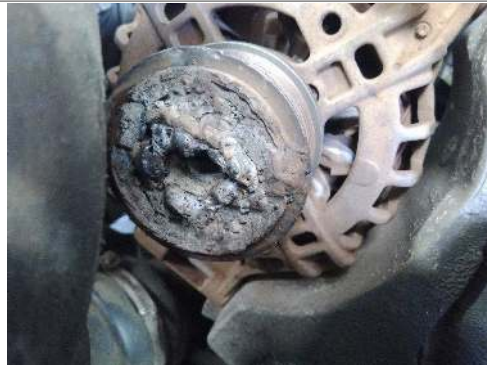
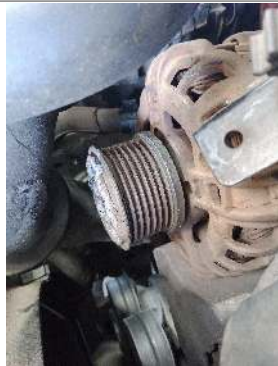
| Damage | Repair Way |
|---|---|
| Alternator Damaged | Replace |

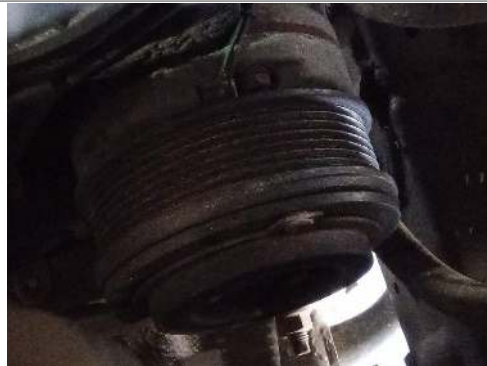
| Damage | Repair Way |
|---|---|
| Air conditioner pump Damaged | Replace |

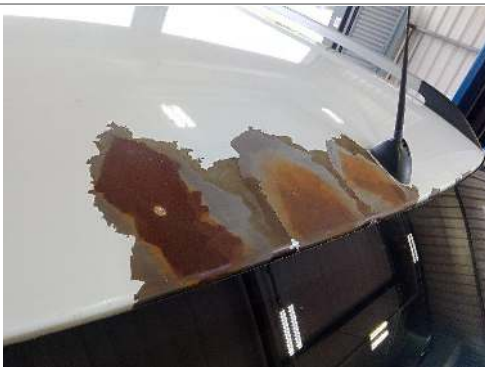
| Damage | Repair Way |
|---|---|
| Roof Paintwork • Flaking | Repair |

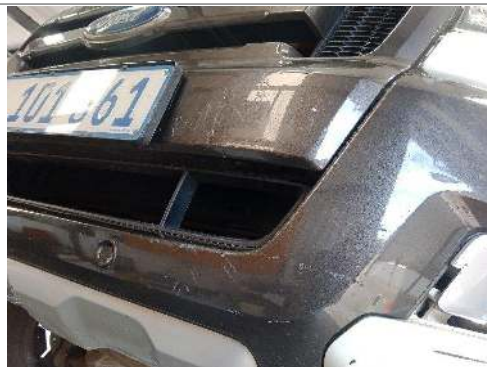
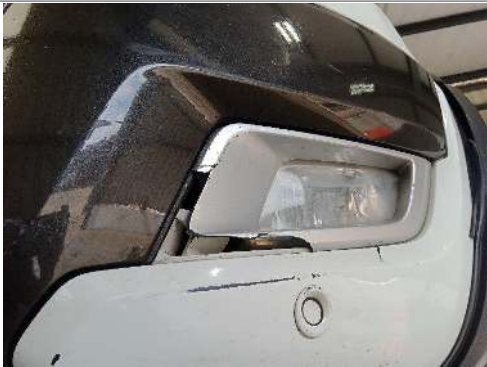
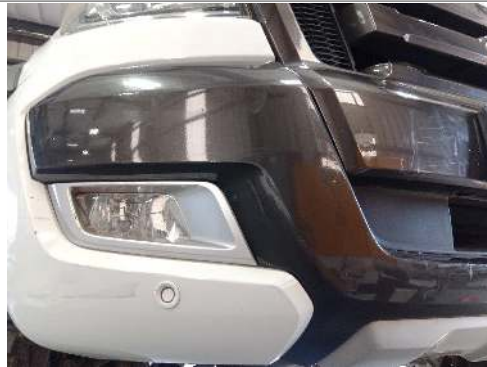
| Damage | Repair Way |
|---|---|
| Front Bumper Paintwork • Scratched | Repair |

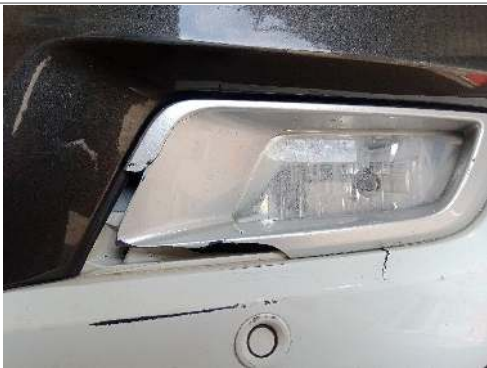
| Damage | Repair Way |
|---|---|
| Fog Light Front Left Damaged | Replace |

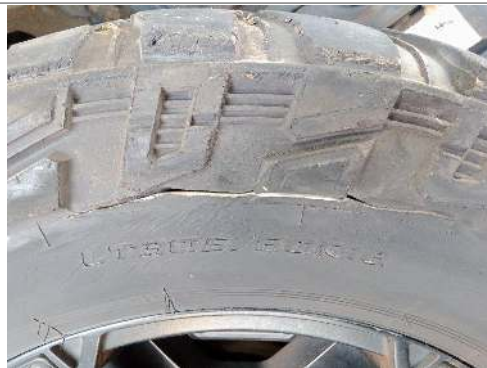
| Damage | Repair Way |
|---|---|
| Tyre Front Left Torn / Cut | Replace |

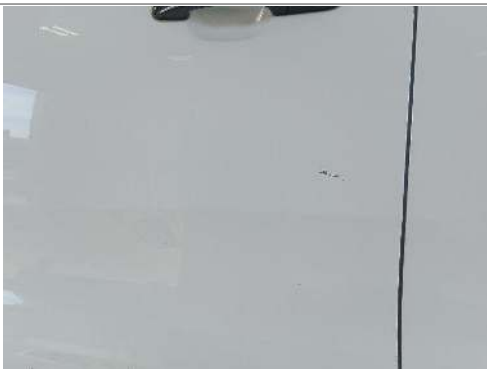
| Damage | Repair Way |
|---|---|
| Door Front Left Paintwork • Scratched | Repair |

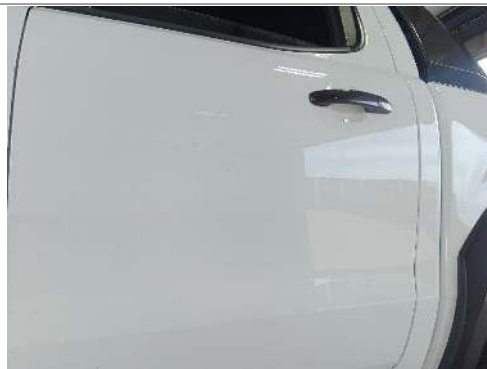
| Damage | Repair Way |
|---|---|
| Door Rear Left Paintwork • Scratched | Repair |

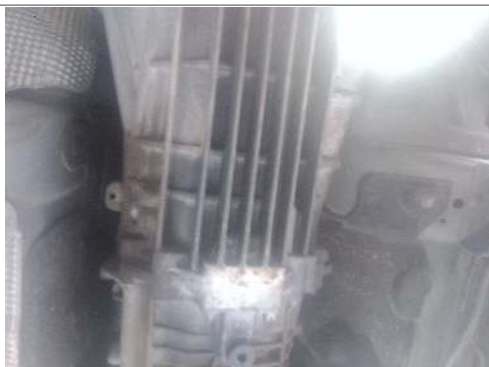
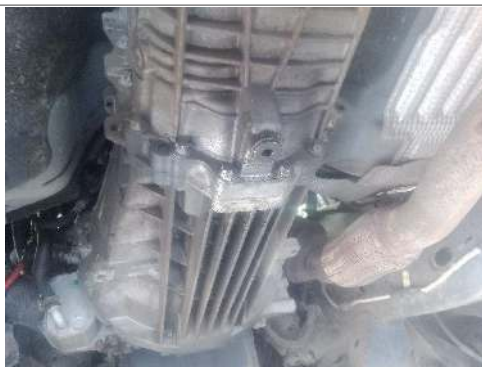
| Damage | Repair Way |
|---|---|
| Gearbox Oil Sweat | Repair |

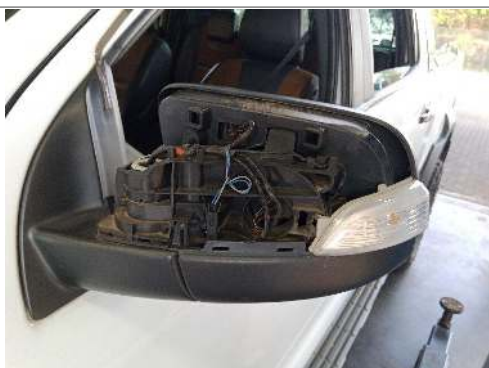
| Damage | Repair Way |
|---|---|
| Side Mirror Left Damaged | Replace |
