CONDITION REPORT

Report No:  
2017297912  
DATE  
11/09/2026

MFC Auction House  
M57 Pretoria Rd, Glenmarais, KEMPTON PARK  
Gauteng

| Manufacturer | TOYOTA | Registration Number | MD92JFGP |

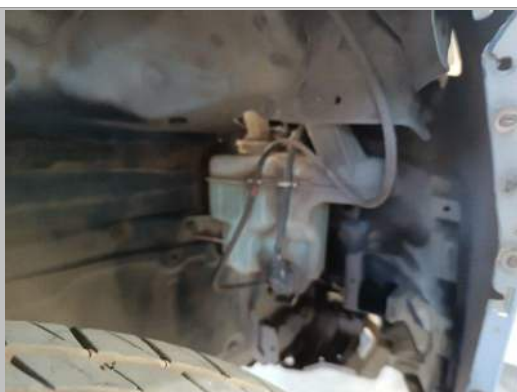
R/F fender liner missing

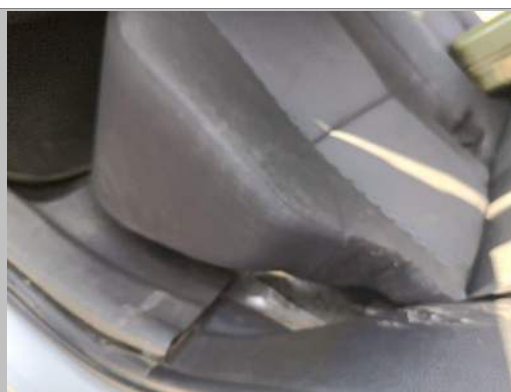
| Seat Rear Damaged | Repair |

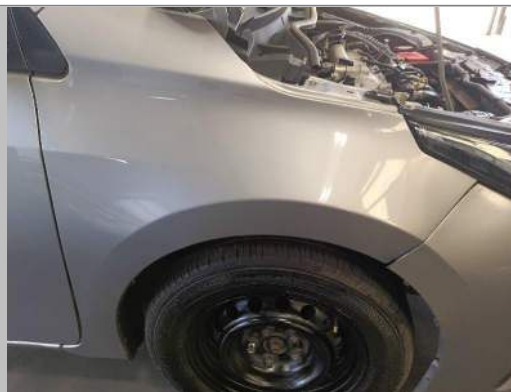
| Front Fender Right Residual Traces of Repair | Repair |

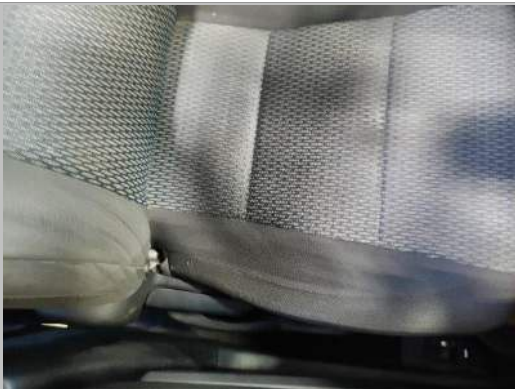
| Seat Front Right Torn / Cut | Repair |

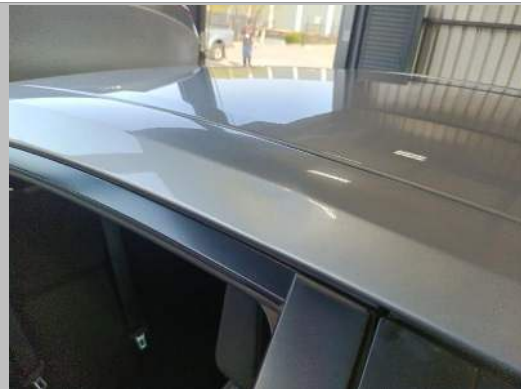
| A • Pillar Right Dented | Repair |

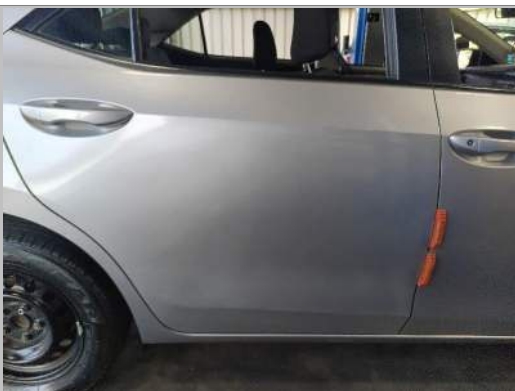
| Door Rear Right Residual Traces of Repair | Repair |

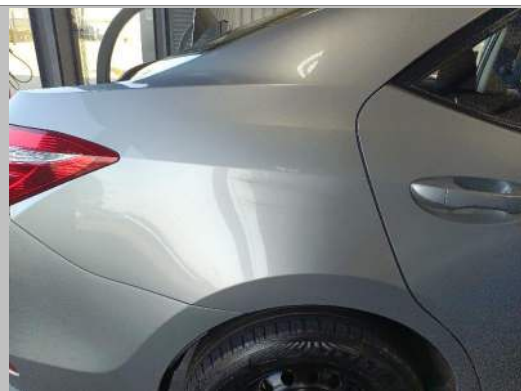
| Rear Fender Right Paintwork • Scratched | Repair |

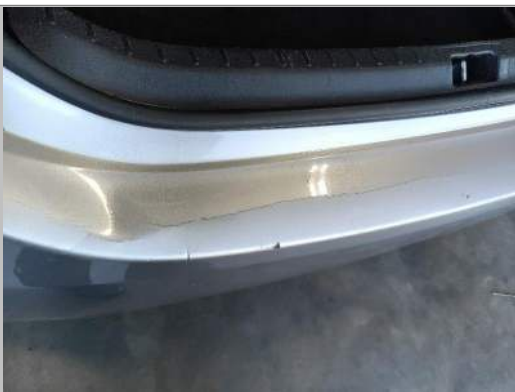
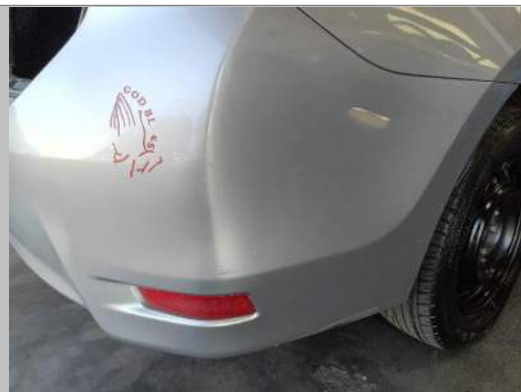
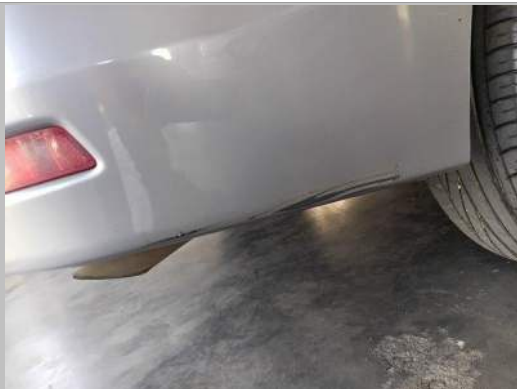
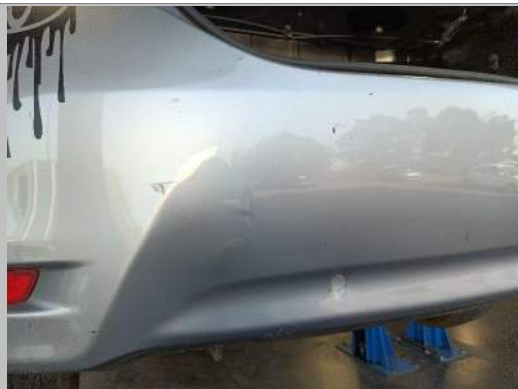
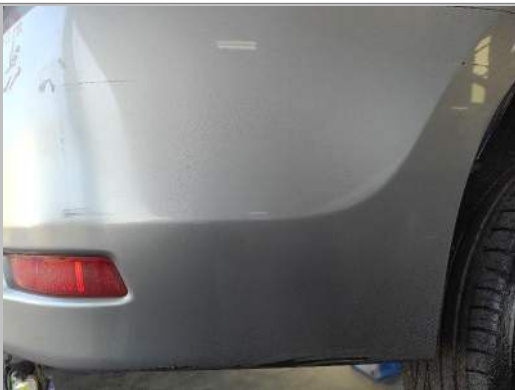
| Rear bumper Damaged | Repair |

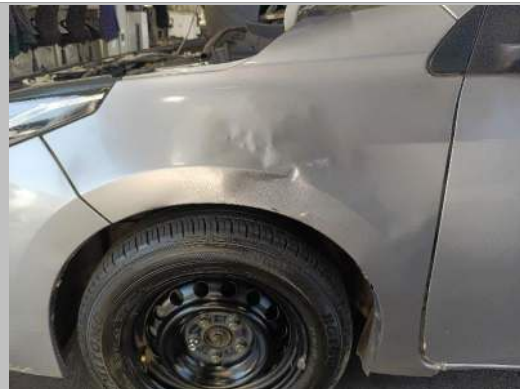
| Front Fender Left Damaged | Repair |

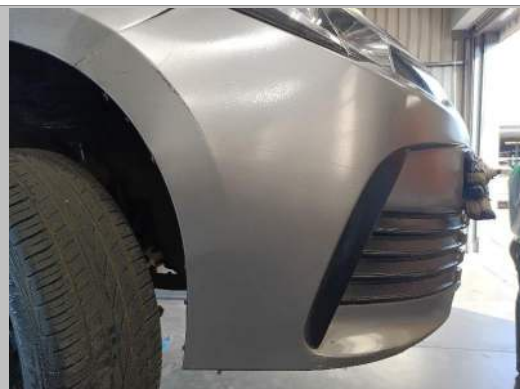
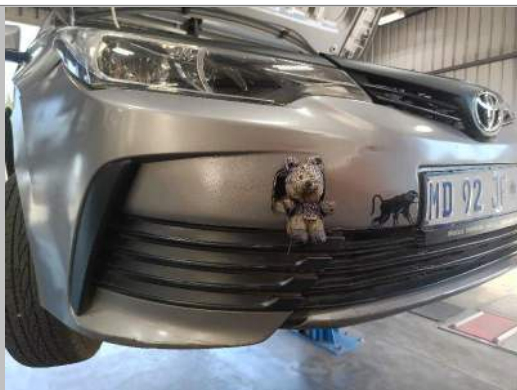
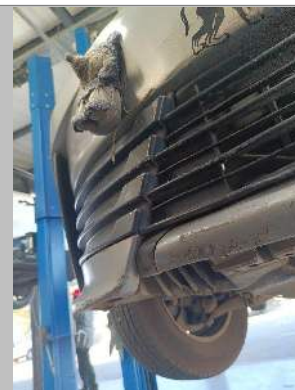
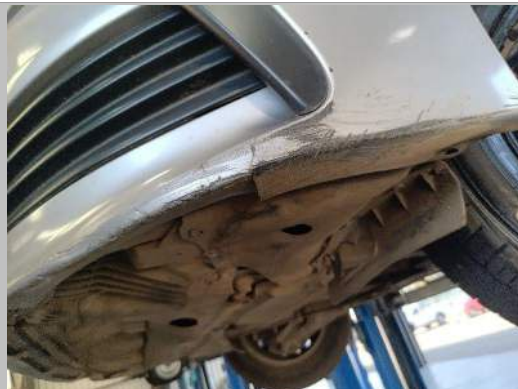
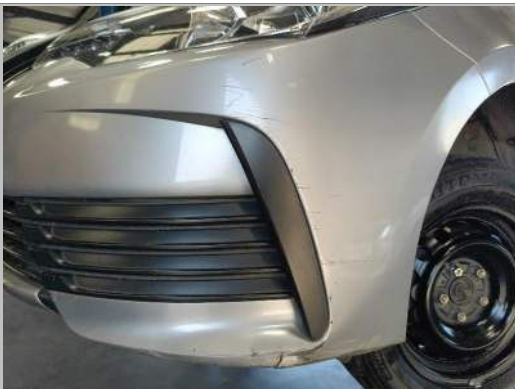
| Front Bumper Residual Traces of Repair | Repair |

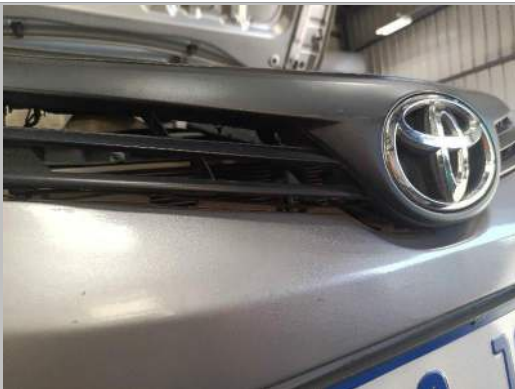
| Grill Damaged | Repair |

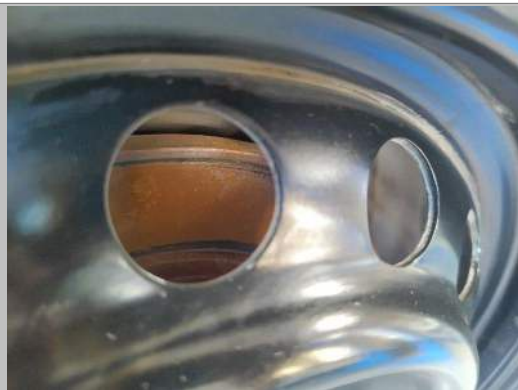
| Brake disc 2. Axle right Corrosion | Replace |

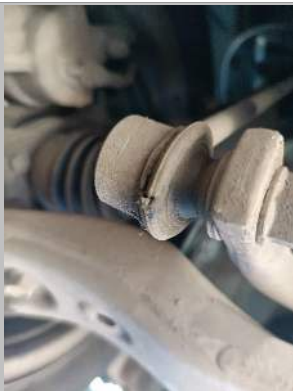
| Stabilizer Mounting Front Right Damaged | Replace |

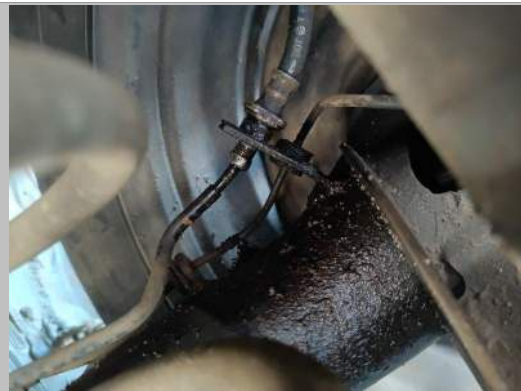
| Brake Piping Leak | Repair |

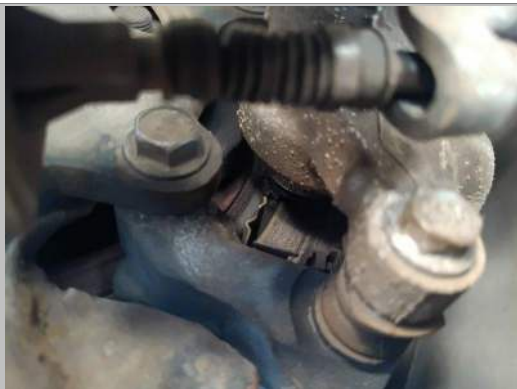
| Brake Pad/Shoe 2. Axle right Damaged | Replace |

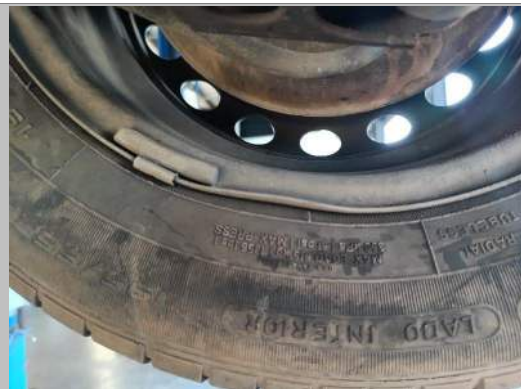
| Rim Rear Right Deformed | Repair |

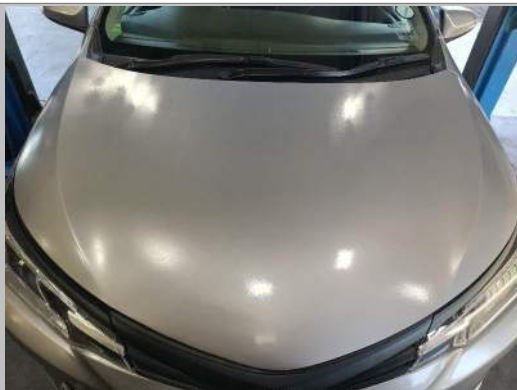
| Bonnet Residual Traces of Repair | Repair |
