CONDITION REPORT

Report No:  
2017296906  
DATE  
10/09/2026

| Manufacturer | TOYOTA | Registration Number | LDZ937NW |
| Model | COROLLA QUEST 1.8 PLUS [2022-2025] | Register Number | |

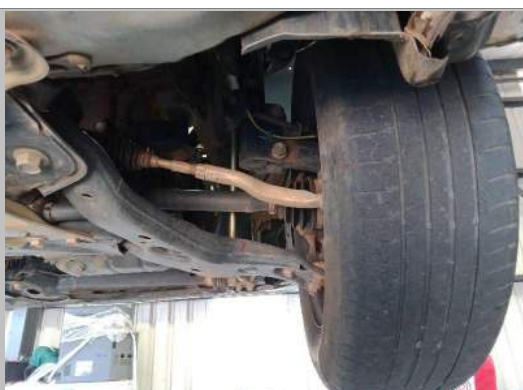
RF TYRE TREAD

| | Size | Load/Speed Index | Manufacture | Model | Type* | Production Date | Tread Depth (mm) |
|---|---|---|---|---|---|---|---|
| Front Right | 195/65R15 | 91V | Winrun | R330 | V | 1324 | 1 mm |

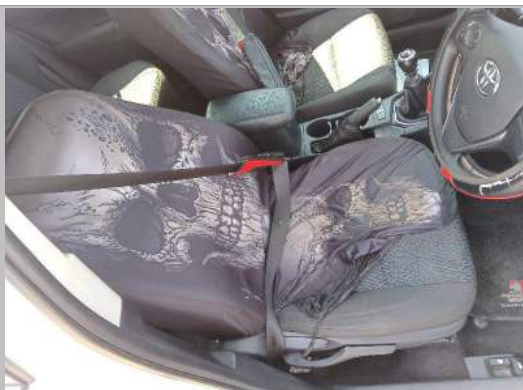
| Seat Front Right Dirty | Repair |

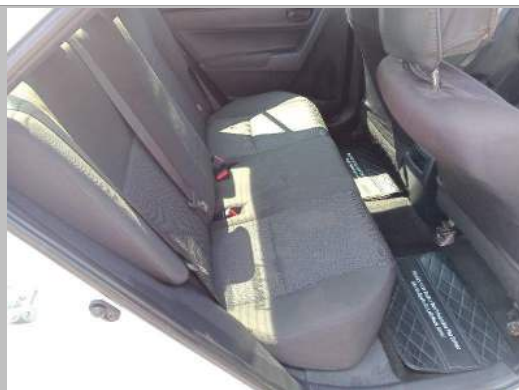
| Seat Rear Dirty | Repair |

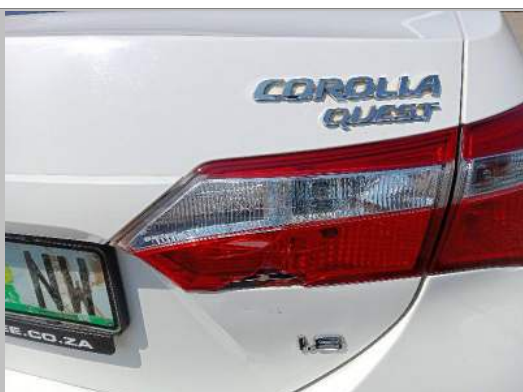
| Tail Light Right Damaged | Replace |

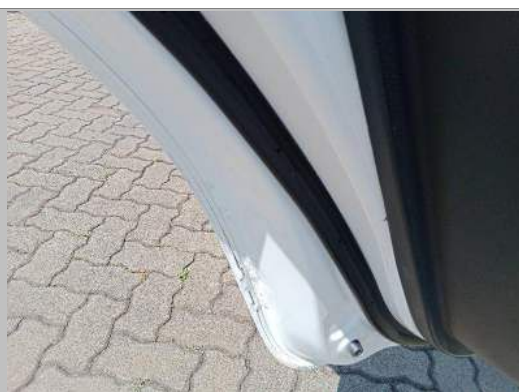
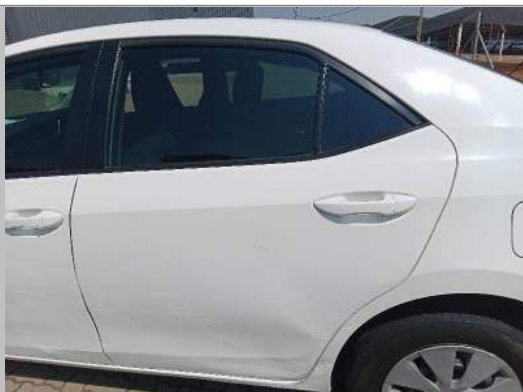
| Door Rear Left Damaged | Repair |

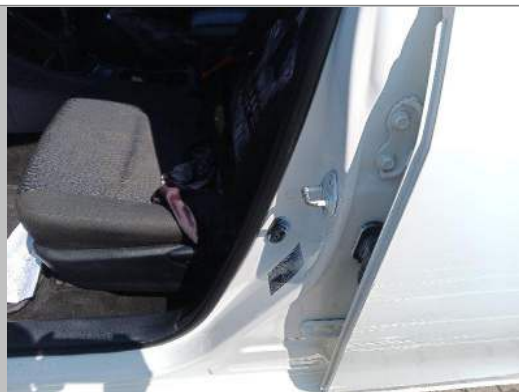
| B • Pillar Left Residual Traces of Repair | Repair |

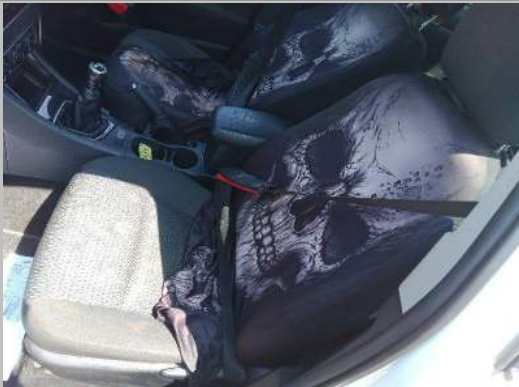
| Seat Front Left Dirty | Repair |

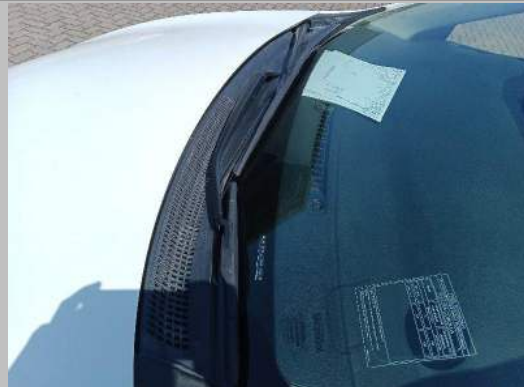
| Windscreen Wiper Damaged | Replace |

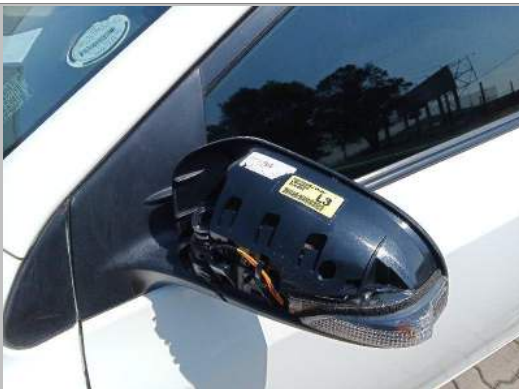
| Side Mirror Left Damaged | Replace |

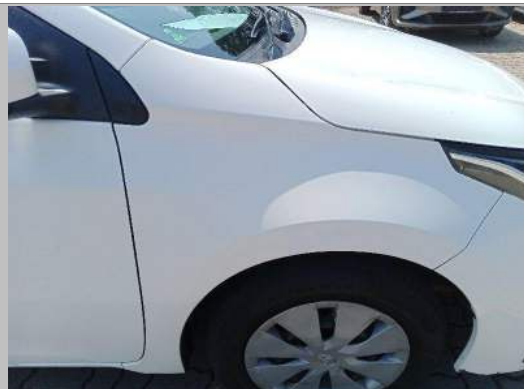
| Front Fender Right Residual Traces of Repair | Repair |

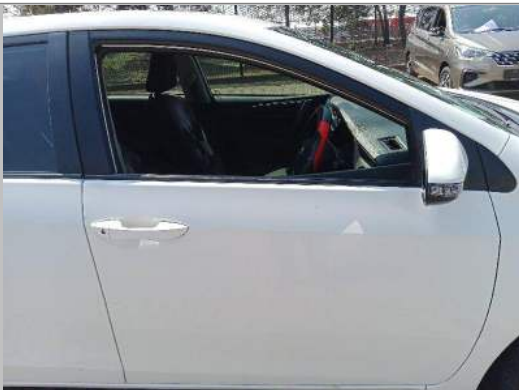
| Door Front Right Residual Traces of Repair | Repair |

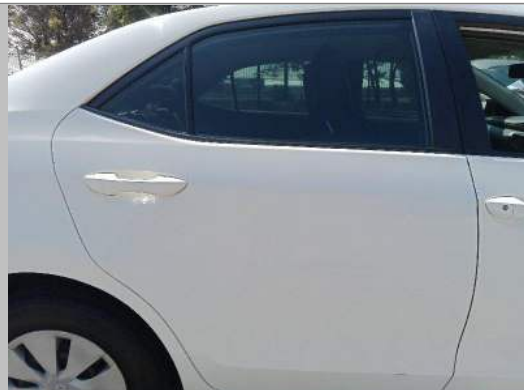
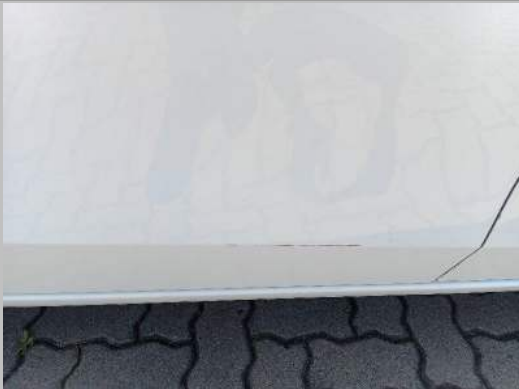
| Door Rear Right Paintwork • Scratched | Repair |

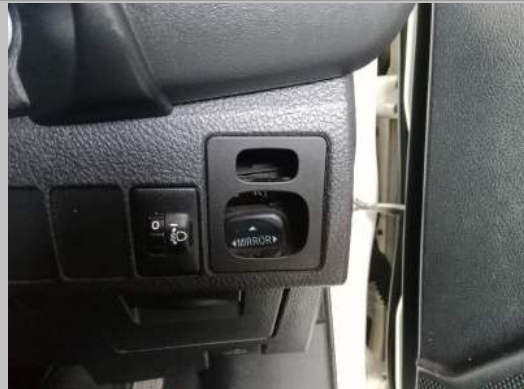
| Mirror Adjusters Damaged | Replace |

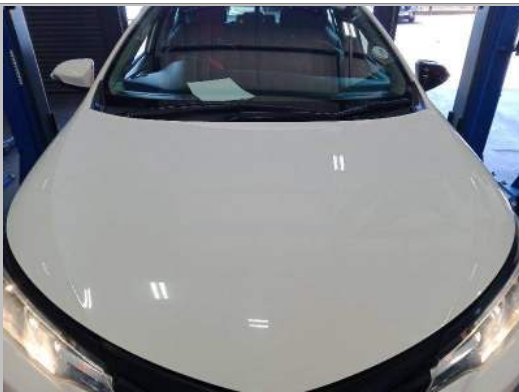
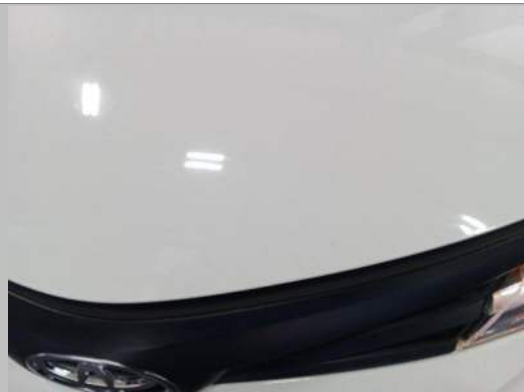
| Bonnet Paintwork • Chipmarks | Repair |

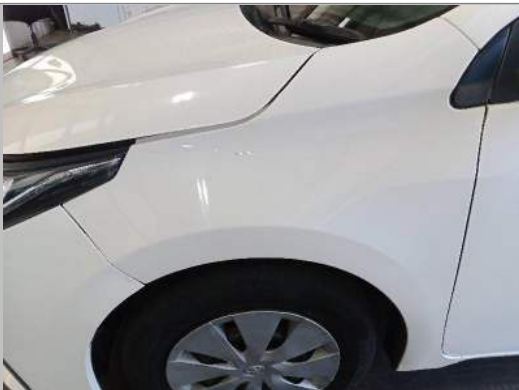
| Front Fender Left Residual Traces of Repair | Repair |

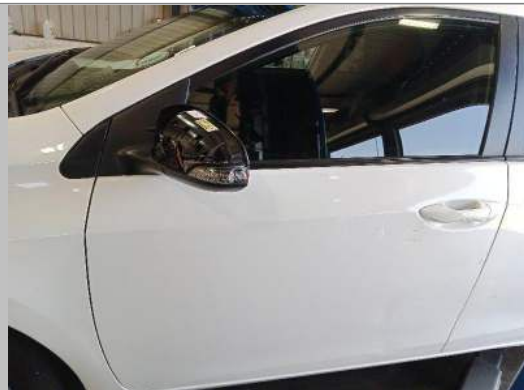
| Door Front Left Damaged | Repair |

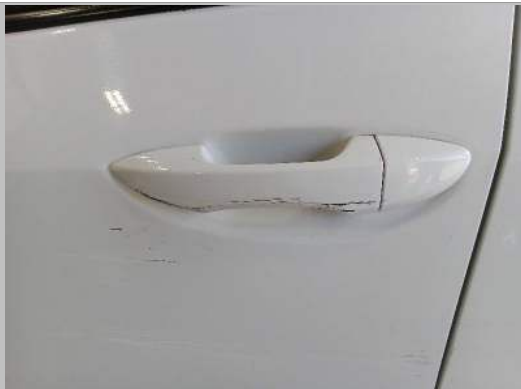
| Door Handle Front Left Damaged | Repair |

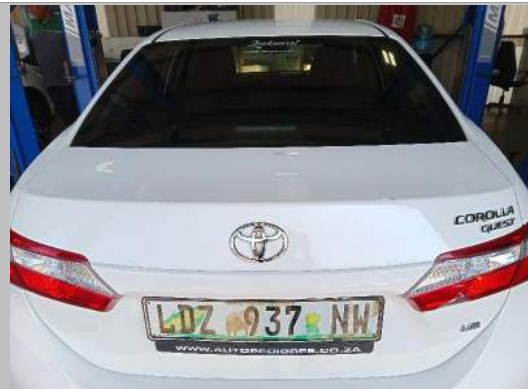
| Boot Lid / Hatch door Residual Traces of Repair | Repair |

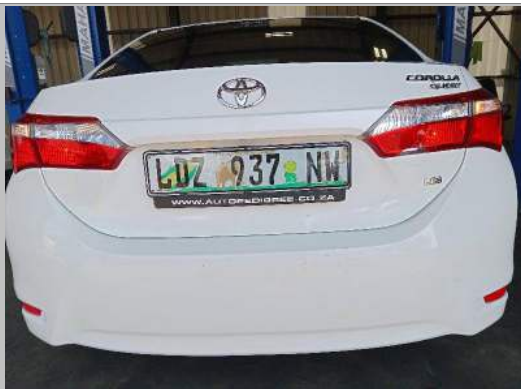
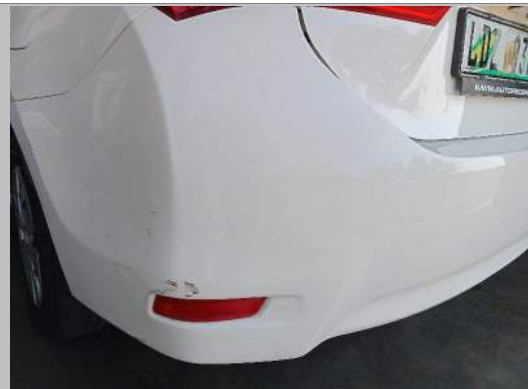
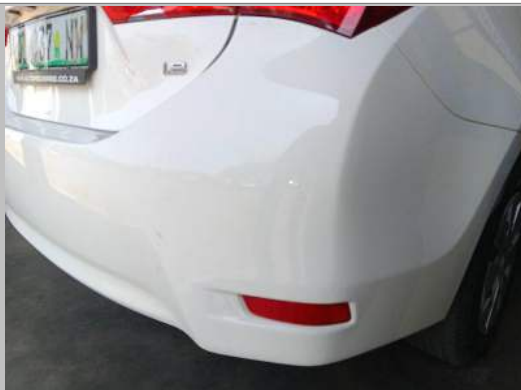
| Rear bumper Paintwork • Scratched | Repair |

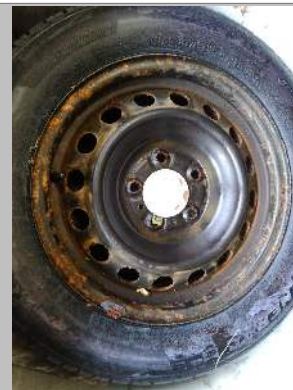
| Rim Spare Wheel Defective | Repair |

Tyres and Rims: Spare Wheel could not be checked properly due to lock down pin stuck.

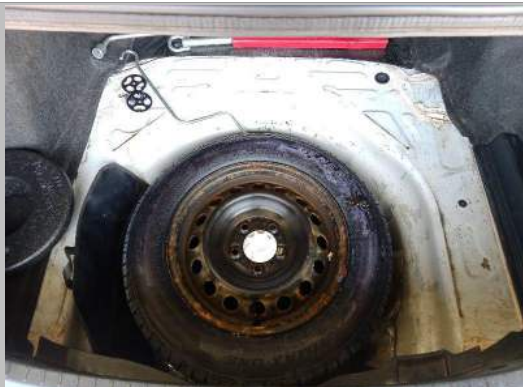
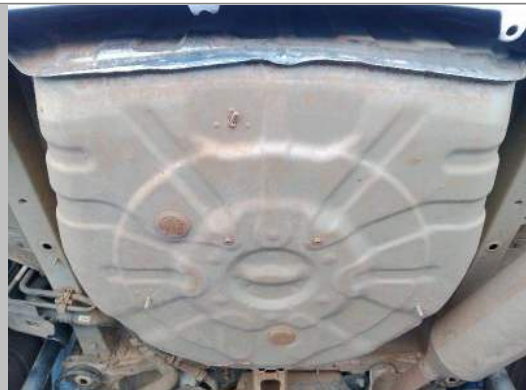
| Inner Boot Floor Pan and Spare Wheel Well Dented | Repair |

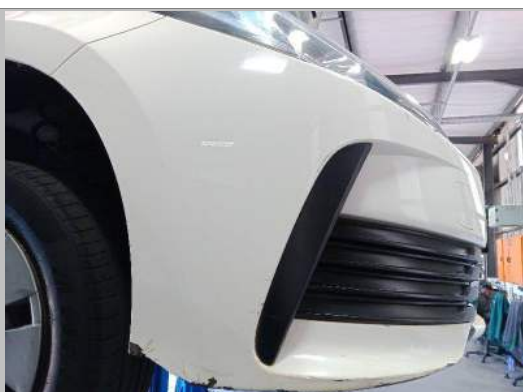
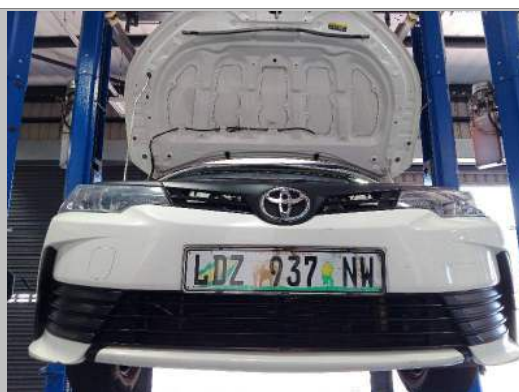
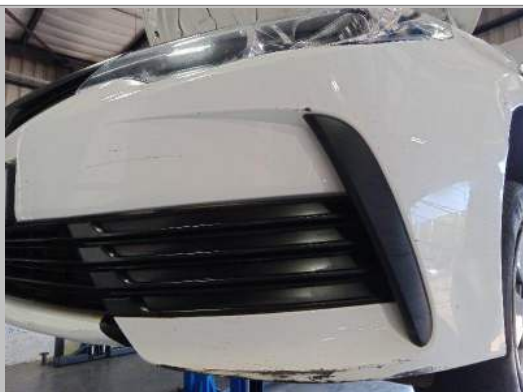
| Front Bumper Damaged | Repair |

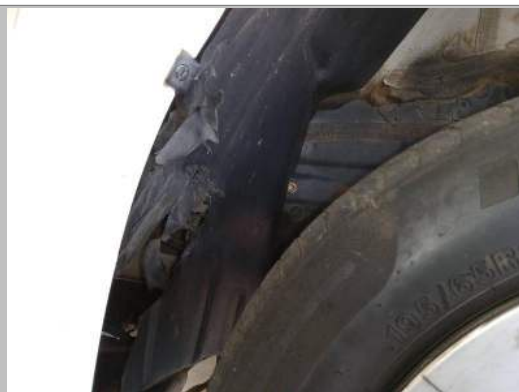
| Front Fender Left / Inner Tray Damaged | Replace |

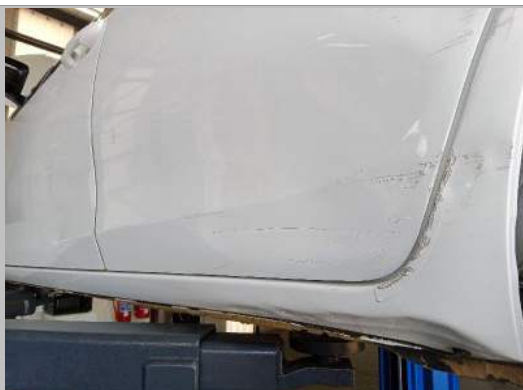
| Sill Panel Left Damaged | Repair |

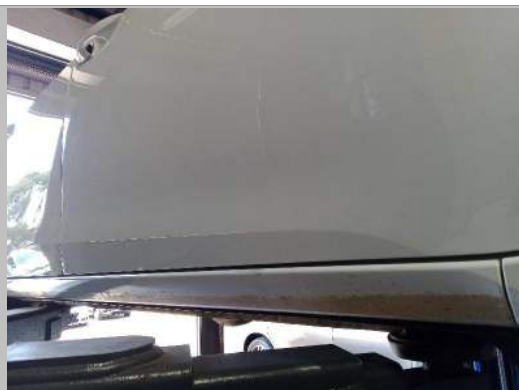
| Sill Panel Right Paintwork • Flaking | Repair |

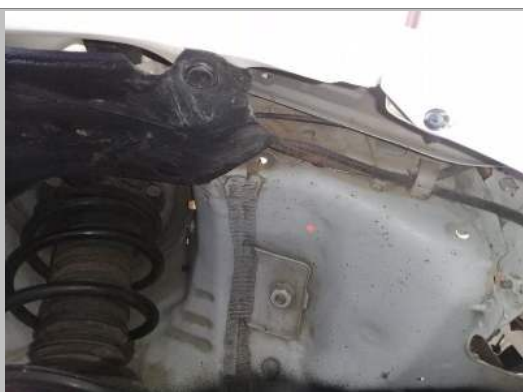
| Front Fender Right / Inner Tray Damaged | Replace |

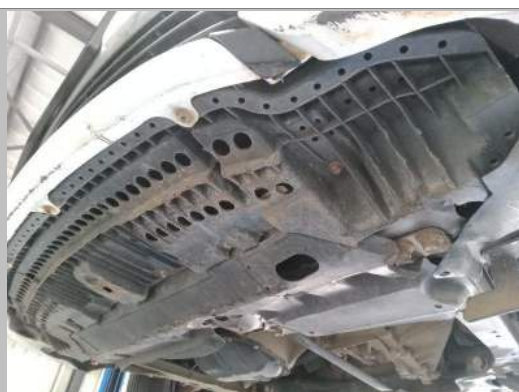
| Belly plates Damaged | Replace |

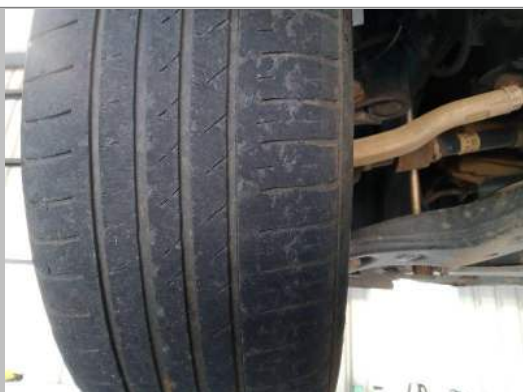
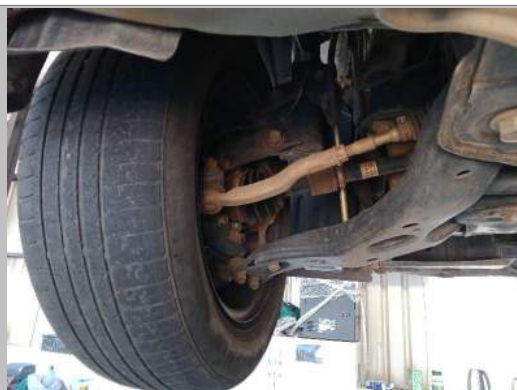
| Tyre Front Left Worn | Replace |

| | Size | Load/Speed Index | Manufacture | Model | Type* | Production Date | Tread Depth (mm) |
|---|---|---|---|---|---|---|---|
| Front Left | 195/65R15 | 91V | Winrun | R330 | V | 1324 | 0 mm |

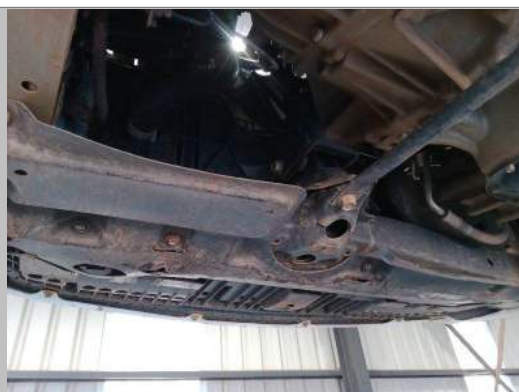
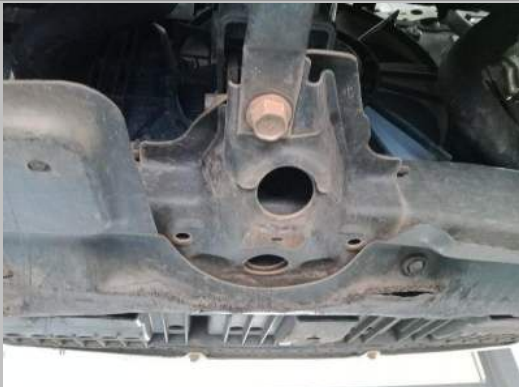
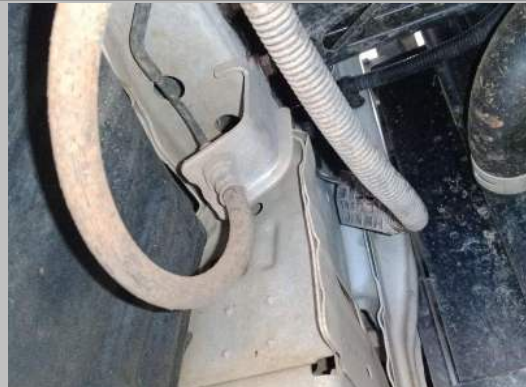
| Radiator Cradle Damaged | Repair |

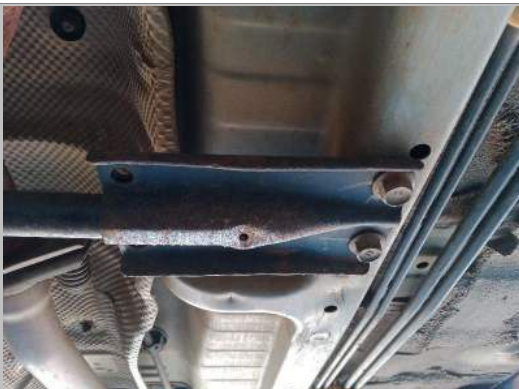
| Cross Member Rear Left Damaged | Repair |

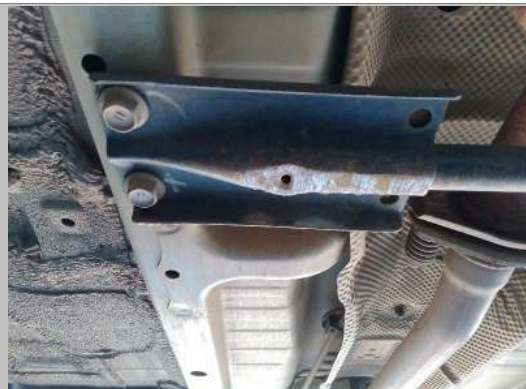
| Cross Member Rear Right Damaged | Repair |

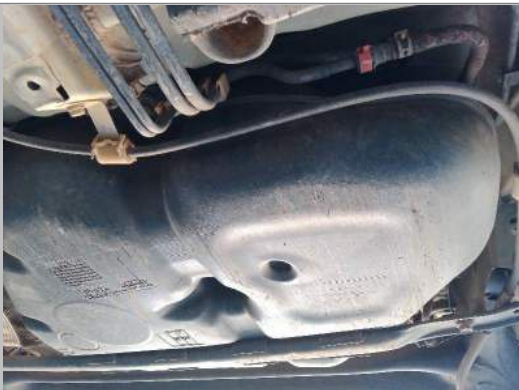
| Fuel Tank Damaged | Repair |

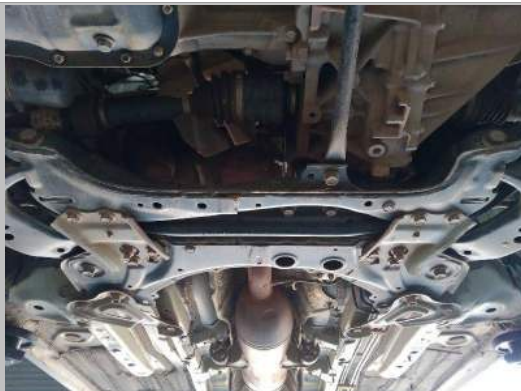
| Sub Frame Scratched | Repair |

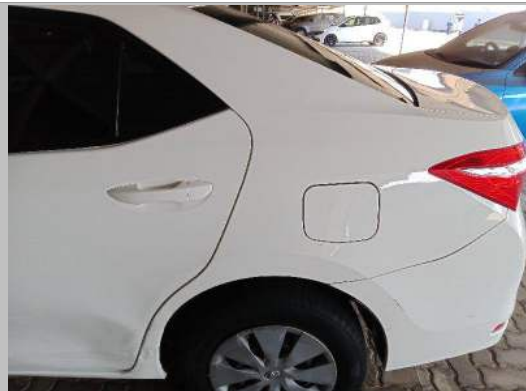
| Rear Fender Left Damaged | Smart Repair |

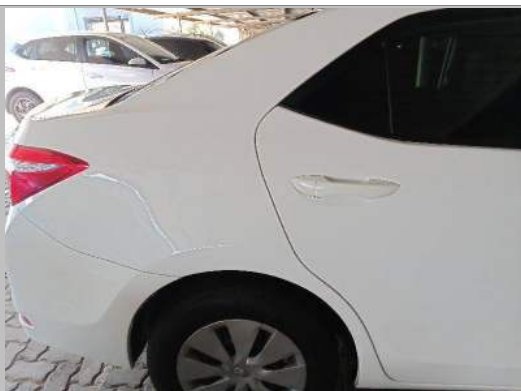
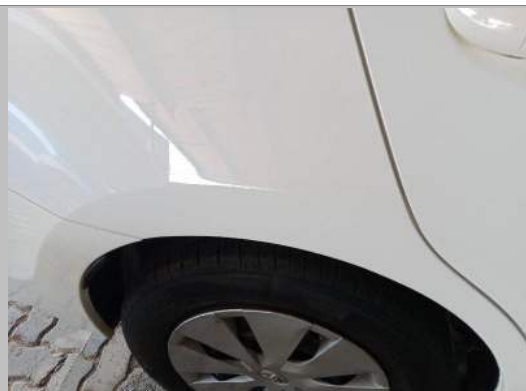
| Rear Fender Right Paintwork • Scratched | Repair |
