MFC Auction House  
M57 Pretoria Rd, Glenmarais, KEMPTON PARK  
Gauteng

**Assignment**

**Vehicle Data**

**VEHICLE INSPECTION**

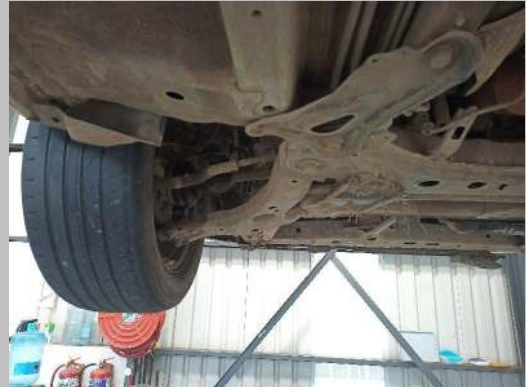
LF TYRE TREAD

Size	Load/Speed Index	Manufacture	Model	Type*	Production Date	Tread Depth (mm)
Front Left	225/50R16	92V	Continental	Contipremium	V	4513	0 mm
Front Right	205/55R16	91V	Bridgestone	Radial	V	2115	0 mm
Rear Left	195/55R16	91V	Royalblack	Radial	V	1022	2 mm
Rear Right	225/55R16	99W	Falken	Radial	V	2916	0 mm

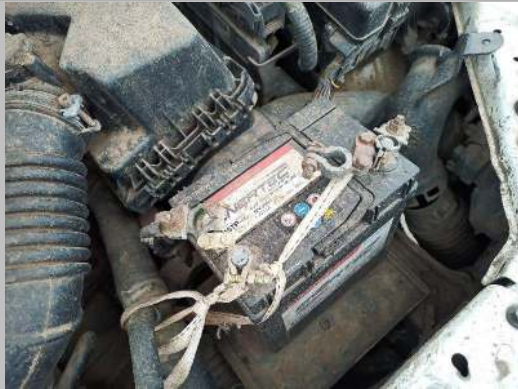
Damage	Repair Way
Engine Oil Leak	Repair
Battery clamps Defective	Replace
Central Air Vent	
Seat Front Left Damaged	Repair
Seat Front Right Damaged	Repair
Seat Rear Damaged	Repair
Front Bumper Damaged	Repair
Bonnet Damaged	Repair
Front Fender Left Damaged	Repair
Front Fender Right Damaged	Repair
Rear Fender Left Damaged	Repair
Rear Fender Right Damaged	Repair
Door Front Left Damaged	Repair
Door Front Right Damaged	Repair
Door Rear Left Damaged	Repair
Door Rear Right Damaged	Repair
Boot Lid / Hatch door Damaged	Repair
Rear bumper Damaged	Repair
Sill Panel Left Damaged	Repair
Roof Damaged	Repair
Windscreen Damaged	Replace
Parking Brake Performance Left / Right Difference out of legal range	Repair
Tyre Front Left Worn	Replace
Tyre Front Right Worn	Replace
Tyre Rear Right Worn	Replace
Bolt(s) / Nut(s) Rear Wheel Left Damaged	Replace
Gearbox Oil Leak	Repair
Radiator Cradle Damaged	Repair

Engine Compartment: Incorrect battery fitted to vehicle.

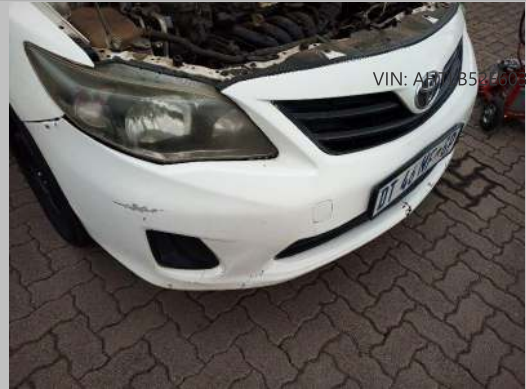
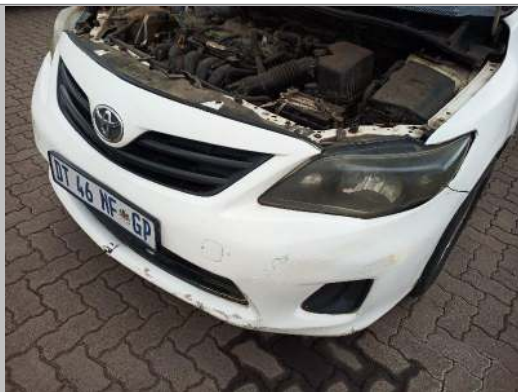
Front Bumper

Body • Exterior: Minor dents and scratches and stone chips to some body panels. Signs of repair work done to some body panels. Signs of impact damage to front of vehicle. Poor alignment to some body panels. Vehicle body in poor condition. Repair work done to vehicle below-standard.

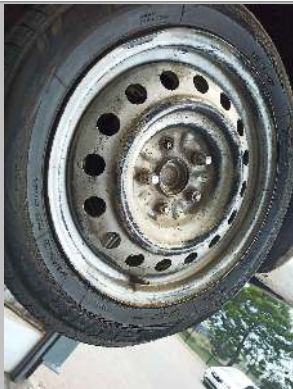
Bolt(s) / Nut(s) Rear Wheel Left

Tyres and Rims: Left rear wheel does not hold pressure.
