## CONDITION REPORT

Report No:  
2017288390  
DATE  
24/08/2026

| Manufacturer | TOYOTA | Registration Number | LW04FCGP |
| Model | HI-ACE 2.5 SESFIKILE 16-S DSL MINIBUS<br>[2021-2024] | Register Number | |

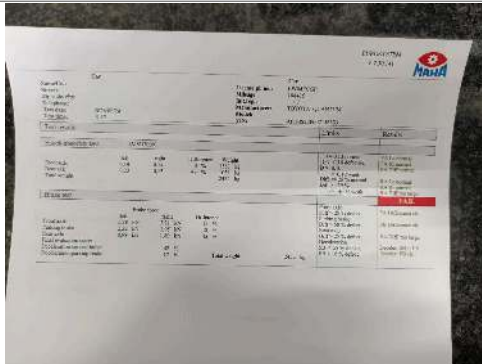
Shock and brake report

| Service Brake Performance Rear Axle Left / Right | Repair |
| Difference out of legal range | Repair |

| Shock absorber test (MAN/0000) | | | | |
|---|---|---|---|---|
| Rear axle | 0,23 | 0,13 | 43 % | 1051 kg |

| Brake test | | | |
|---|---|---|---|
| Rear axle | 0,99 kN | 1,80 kN | 45 % |

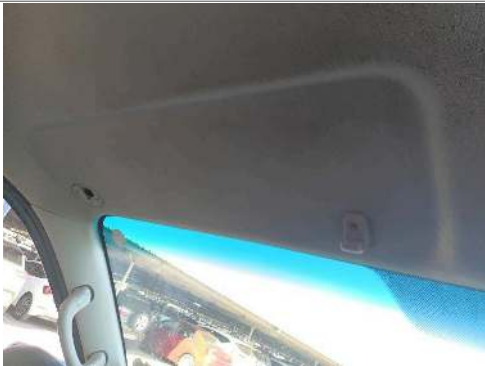
| Sun Visor Left Missing | Replace |

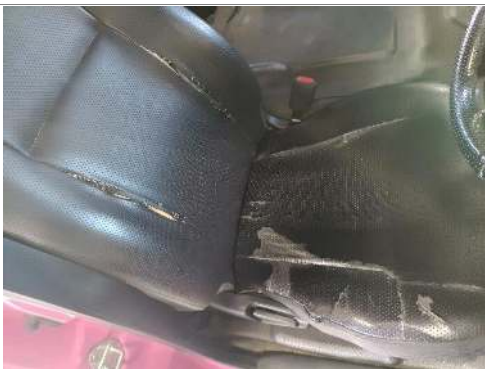
| Seat Front Right Torn / Cut | Repair |

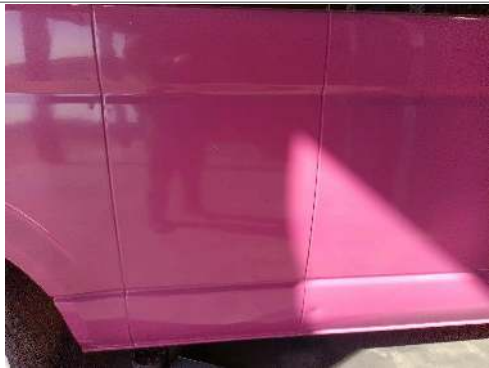
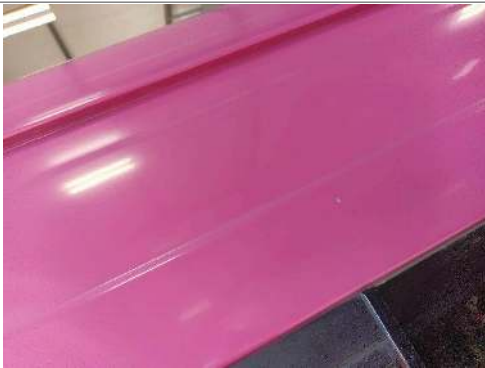
| Rear Fender Right Paintwork • Scratched | Repair |

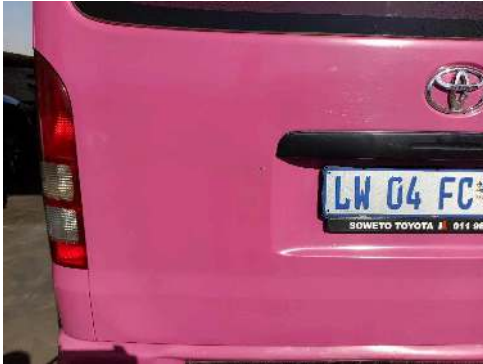
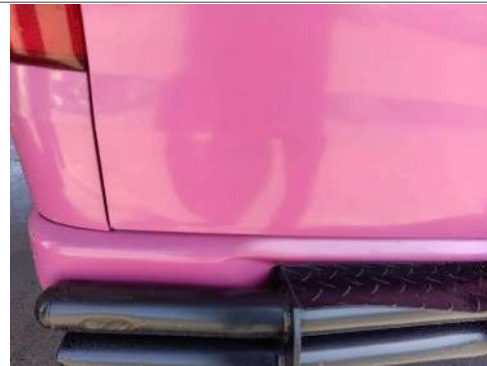
| Boot Lid / Hatch door Paintwork • Scratched | Repair |

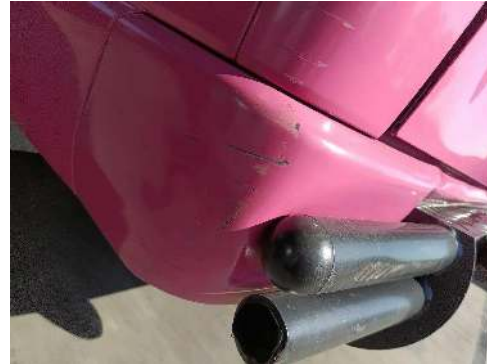
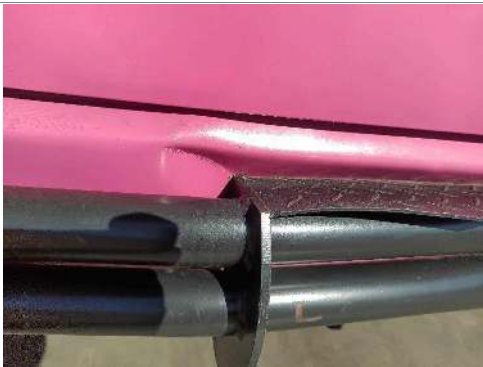
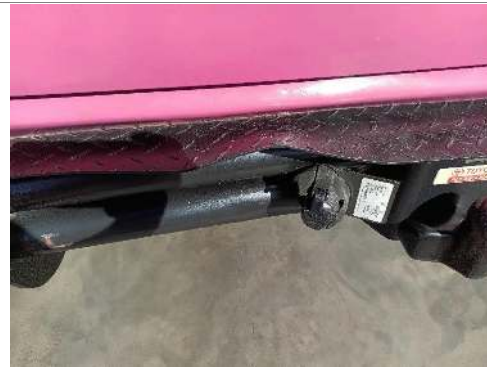
| Rear bumper Dented | Repair |

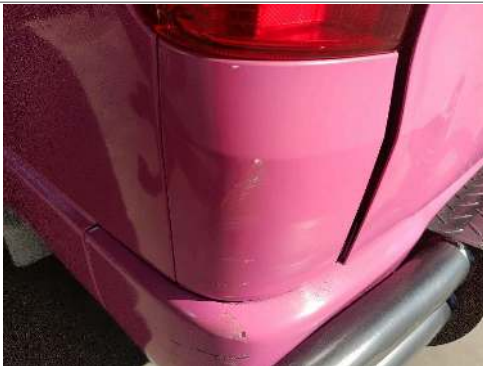
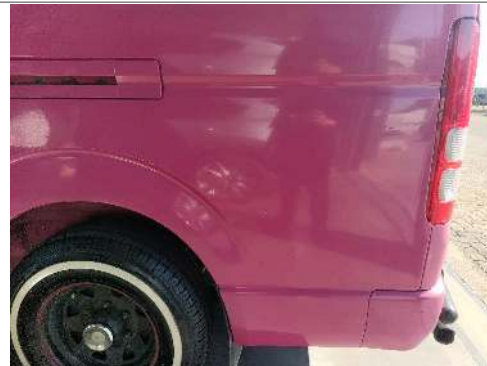
| Rear Fender Left Paintwork • Scratched | Repair |

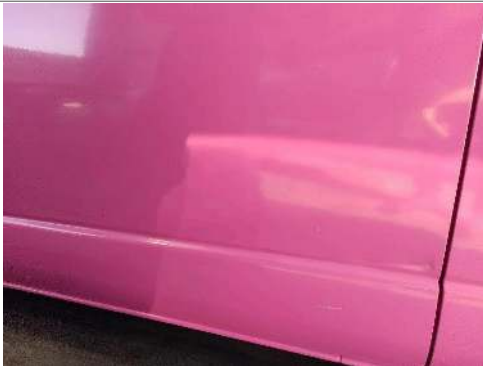
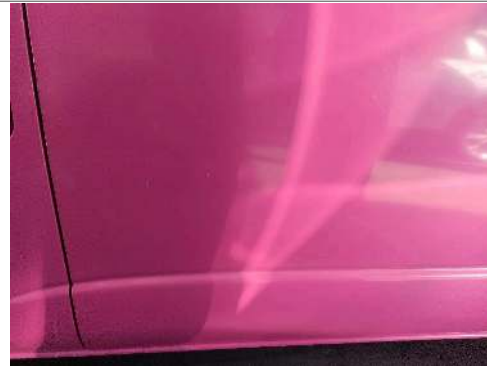
| Sliding Door Paintwork • Scratched | Repair |

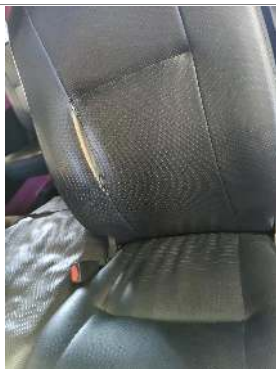
| Seat Front Left Torn / Cut | Repair |

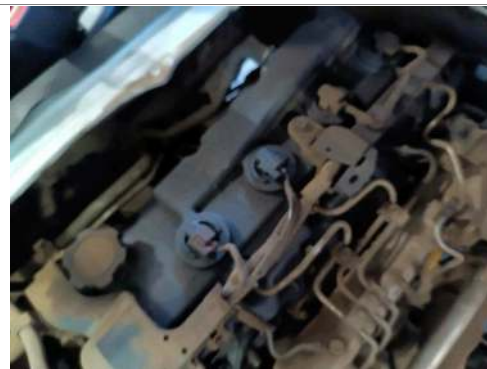
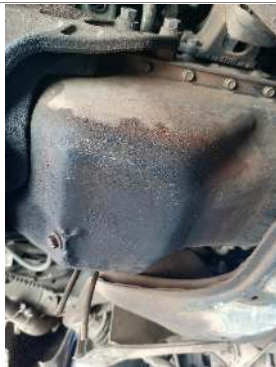
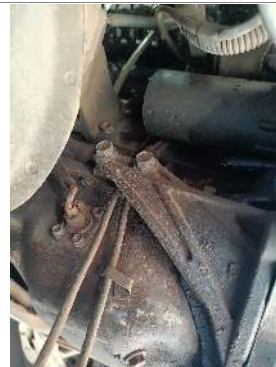
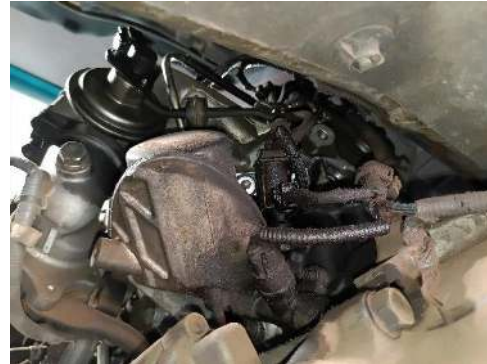
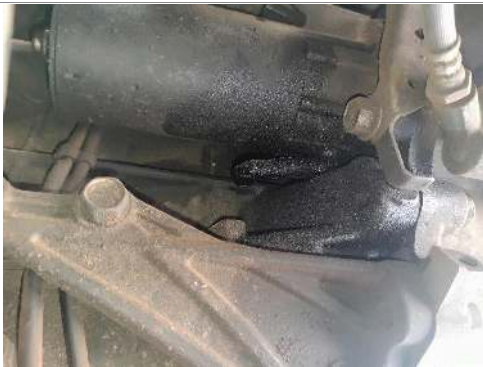
| Engine Oil Leak | Repair |

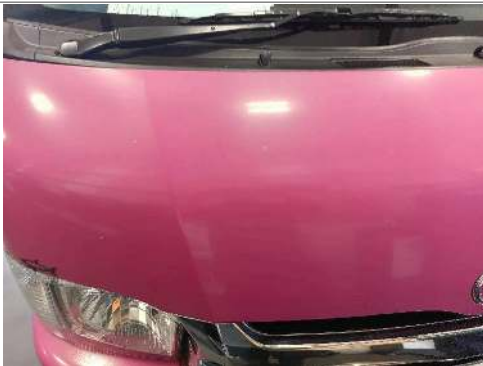
| Bonnet Paintwork • Scratched | Repair |

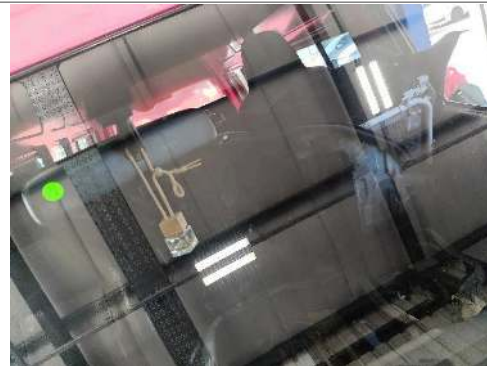
| Windscreen Chipped | Replace |

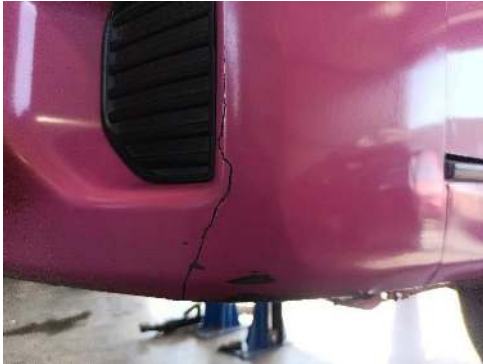
| Front Bumper Damaged | Repair |

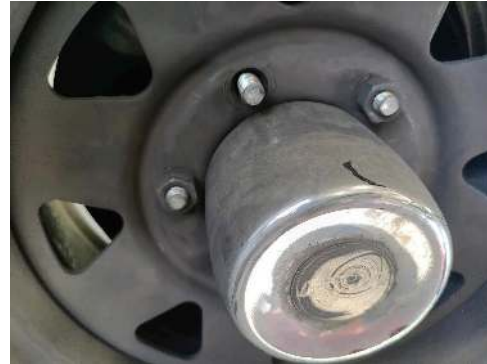
| Bolt(s) / Nut(s) Front Wheel Left Missing | Replace |

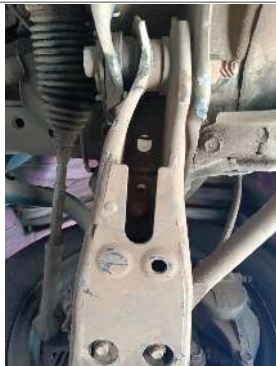
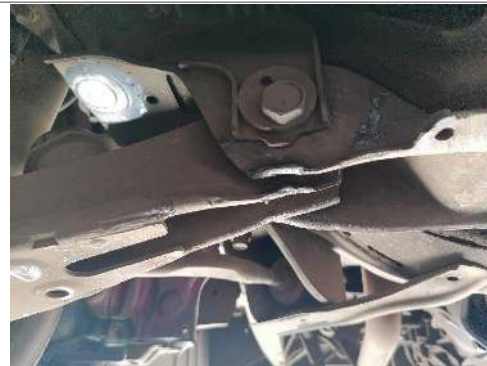
| Control Arm(s) Front Axle Right Deformed | Replace |

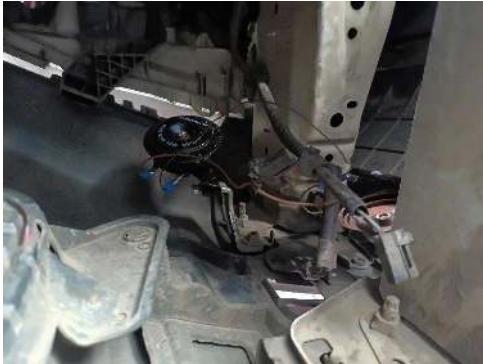
| Engine Wiring Defective | Repair |

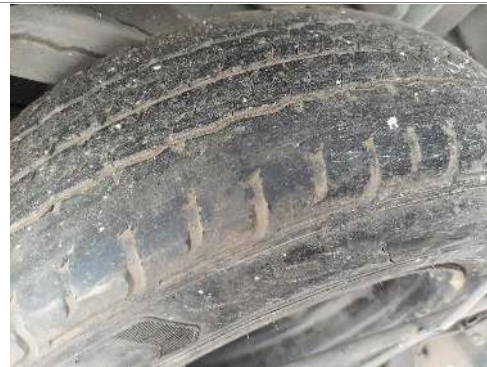
| Spare Tyre Smooth | Replace |

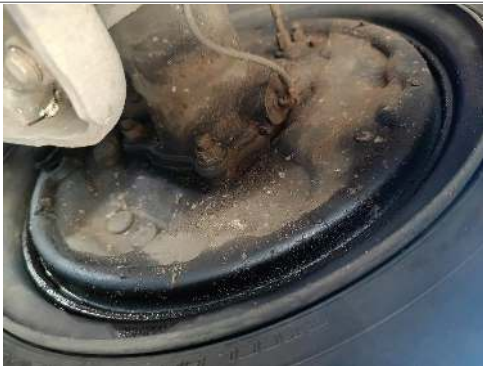
| Brake Drum 2. Axle right Defective | Repair |

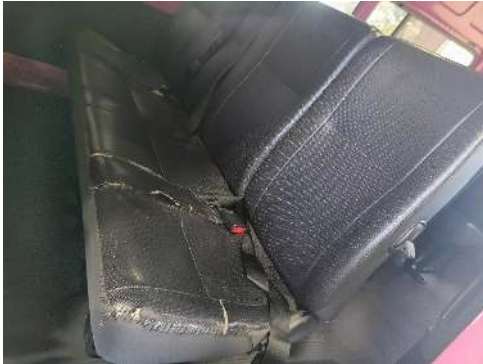
| Seat Rear Torn / Cut | Repair |
