CONDITION REPORT

Report No:  
2017296263  
DATE  
09/09/2026

| Manufacturer | TOYOTA | Registration Number | HFG367L |
| Model | HI-ACE 2.5 SESFIKILE 16-S DSL MINIBUS [2021-2024] | Register Number | |

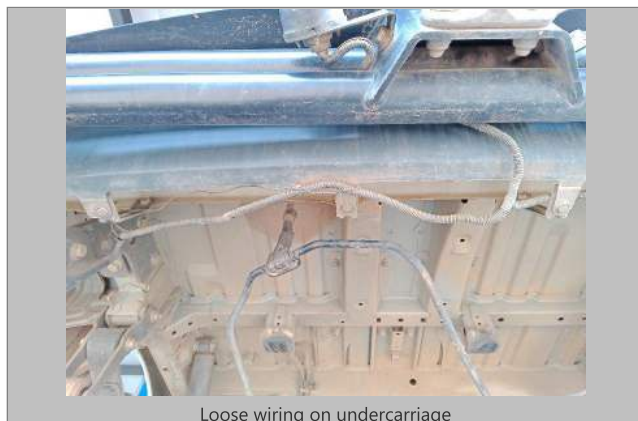
| Damage | Repair Way |
|---|---|
| Loose wiring on undercarriage | Repair |

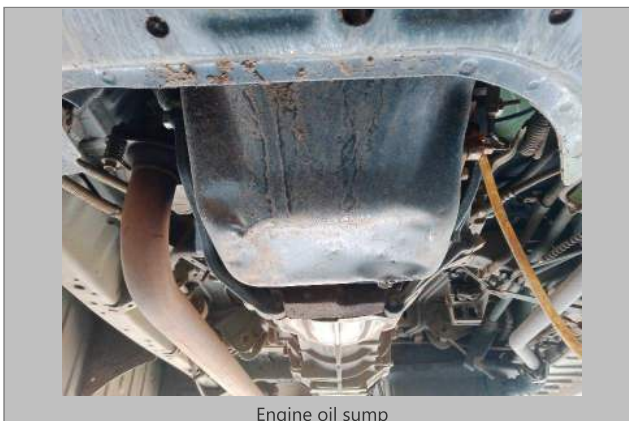
| Damage | Repair Way |
|---|---|
| Engine oil sump damaged | Replace |

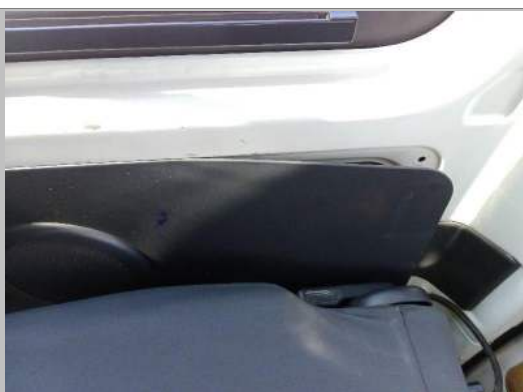
| Damage | Repair Way |
|---|---|
| Rear right interior panel damaged | Repair |

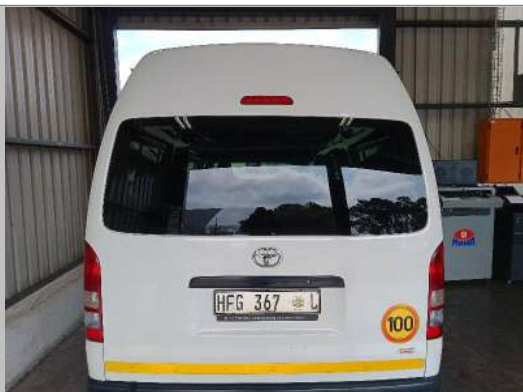
| Boot Lid / Hatch door Paintwork • Scratched | Repair |

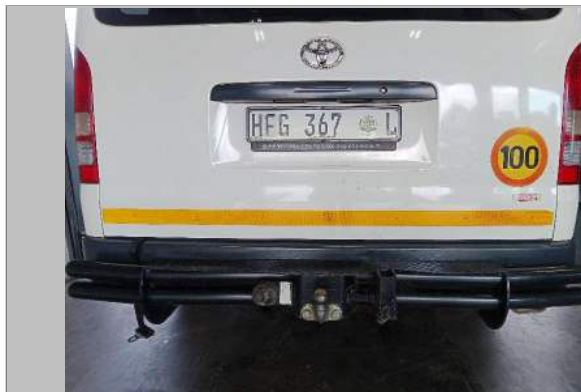
| Rear bumper Damaged | Repair |

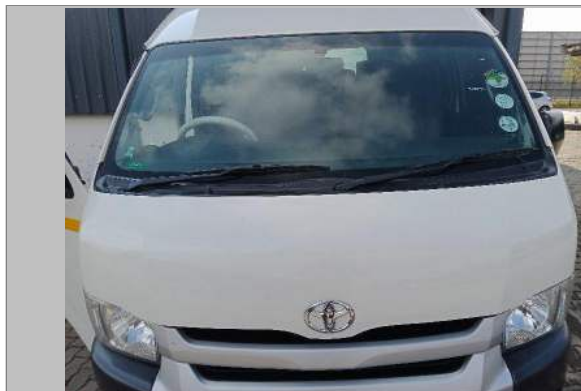
| Bonnet Paintwork • Chipmarks | Repair |

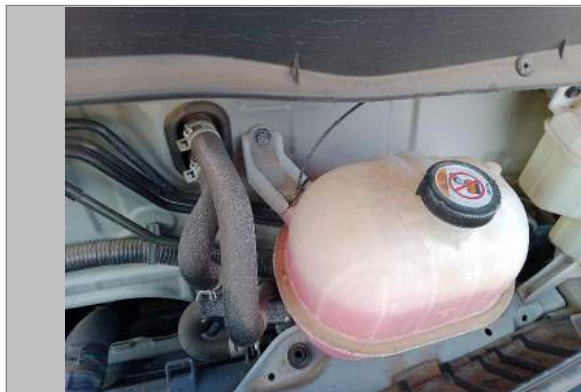
| Expansion Bottle Damaged | Replace |

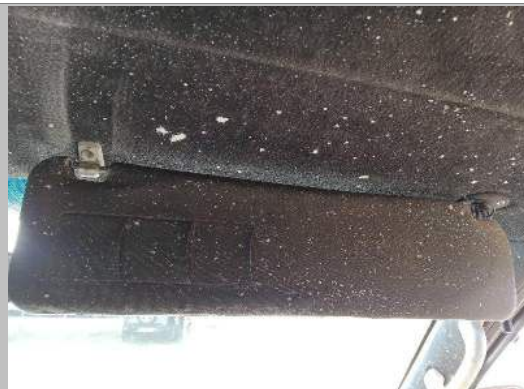
| Sun Visor Right Damaged | Replace |

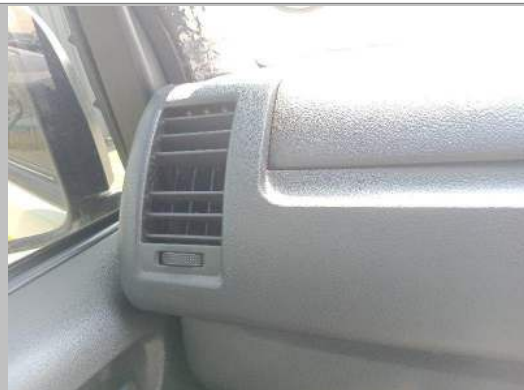
| Central Air Vent Damaged | Replace |

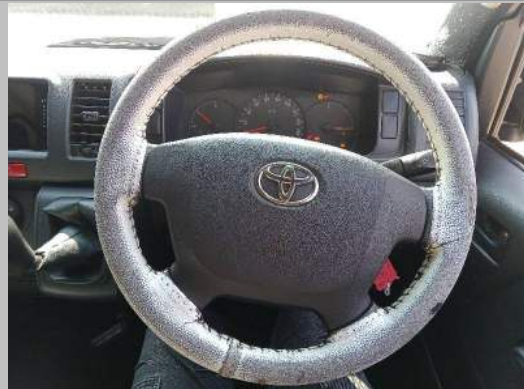
| Steering Wheel Trim Defective | Repair |

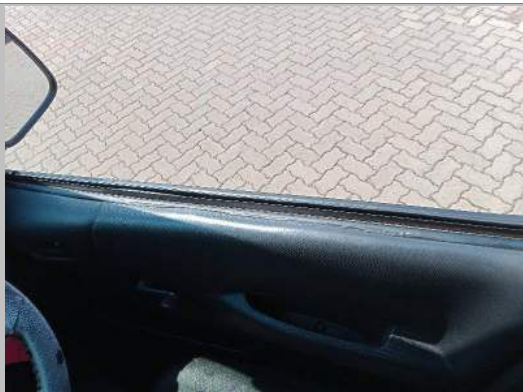
| Weather Strip Door Front Right Damaged | Replace |

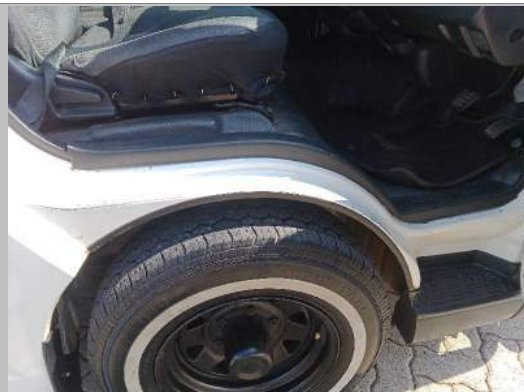
| Front Fender Right / Inner Tray Damaged | Repair |

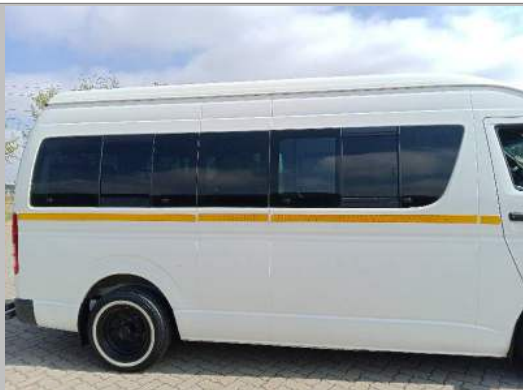
| Rear Fender Right Damaged | Repair |

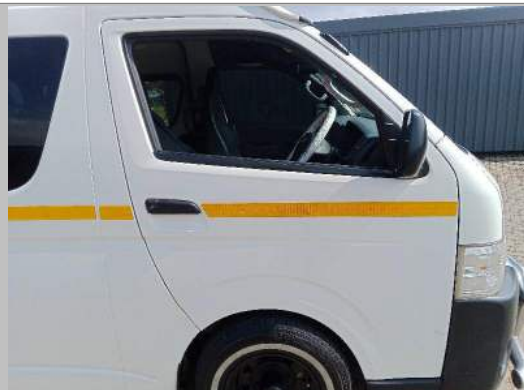
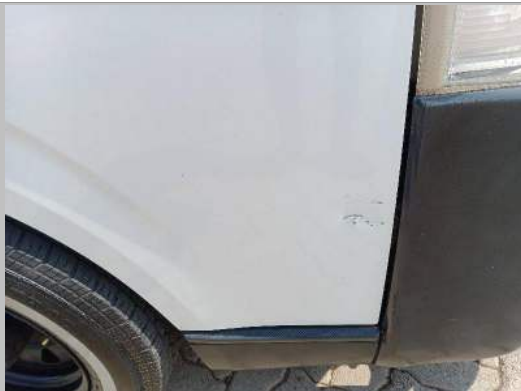
| Door Front Right Damaged | Repair |

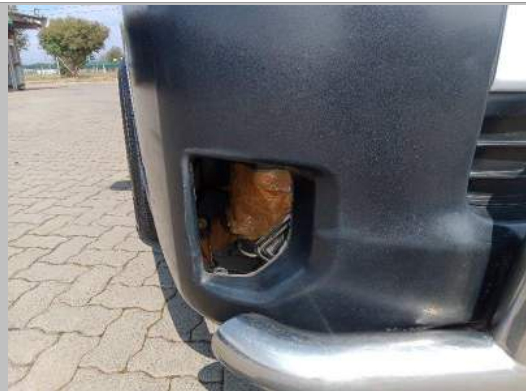
| Fog Light Front Right Missing | Replace |

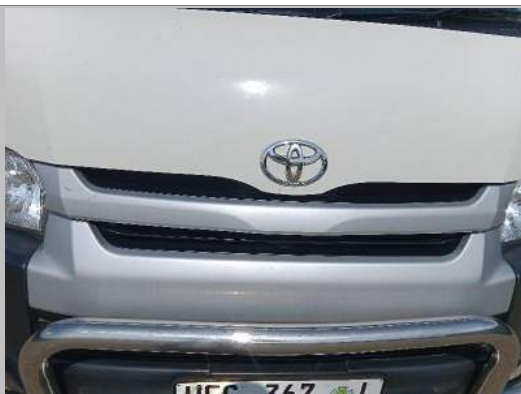
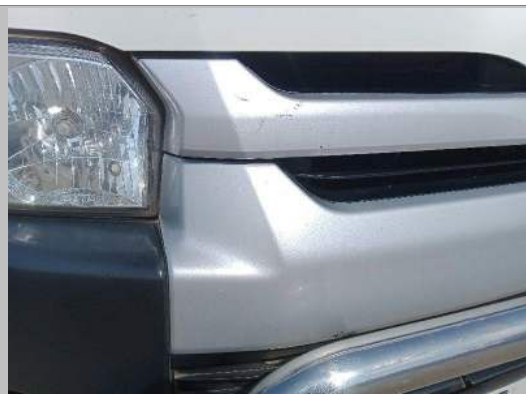
| Grill Paintwork • Scratched | Repair |

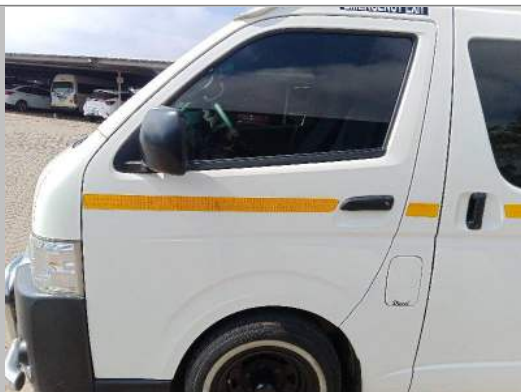
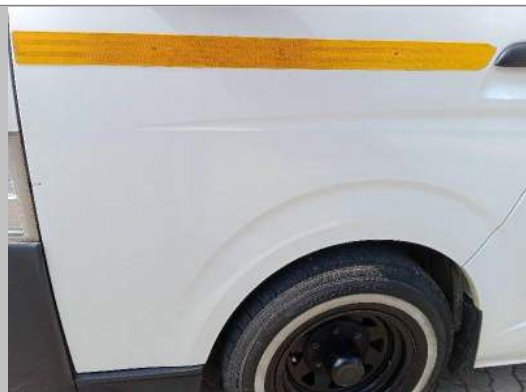
| Door Front Left Paintwork • Scratched | Repair |

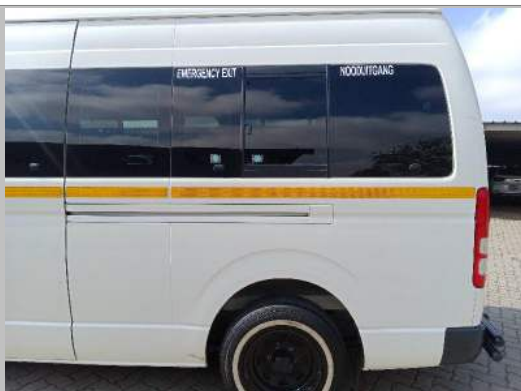
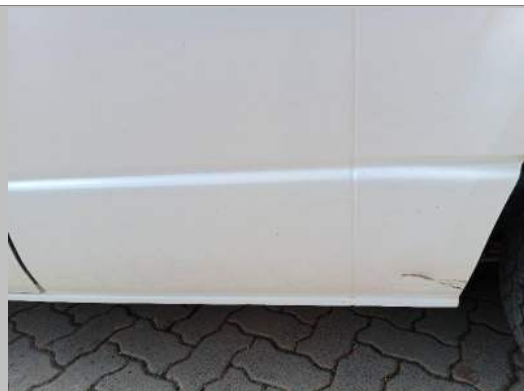
| Rear Fender Left Damaged | Repair |

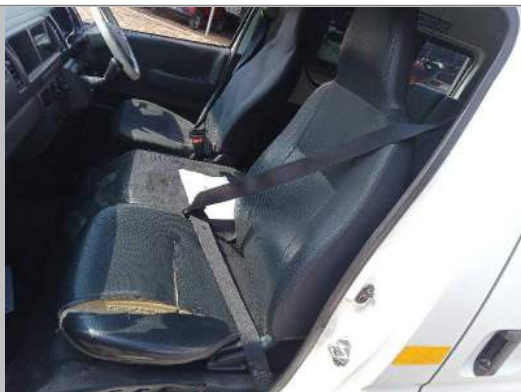
| Seat Front Left Damaged | Repair |

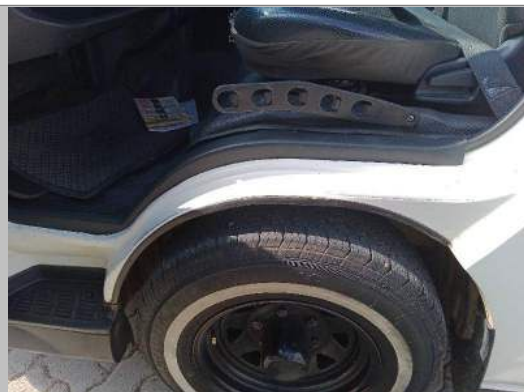
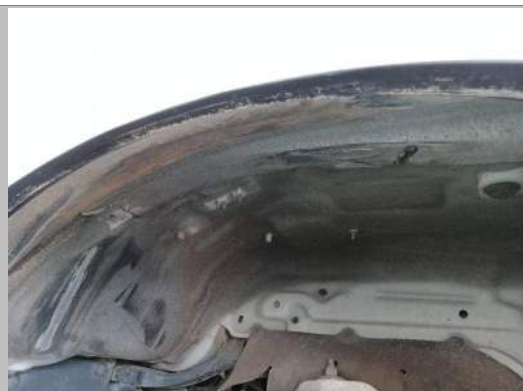
| Front Fender Left / Inner Tray Damaged | Repair |

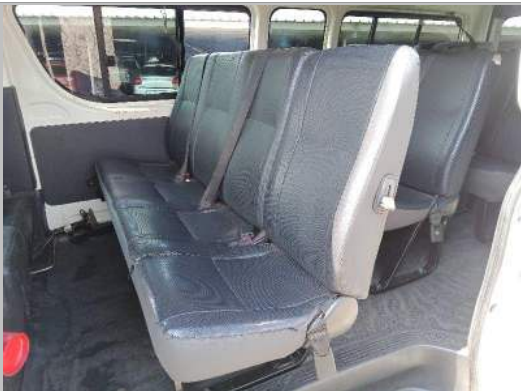
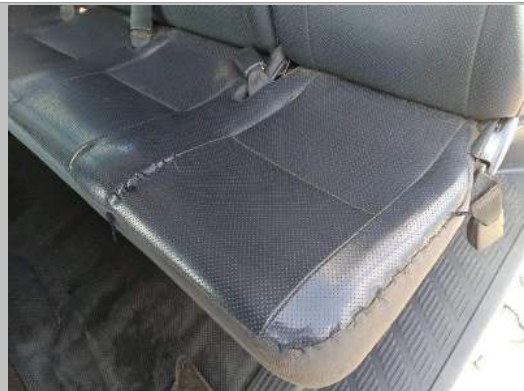
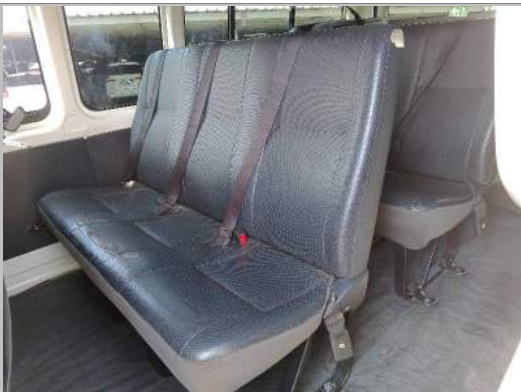
| Seat Rear Damaged | Repair |

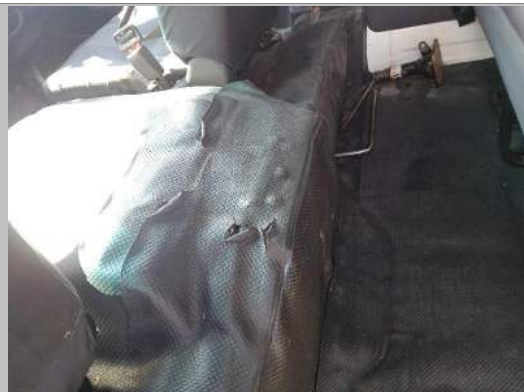
| Carpet Rear Damaged | Repair |

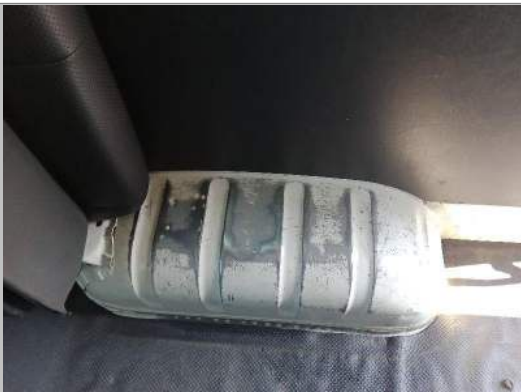
| Rear Fender Left / Inner Tray Damaged | Repair |

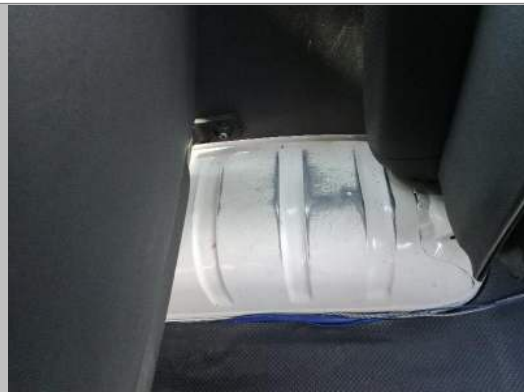
| Rear Fender Right / Inner Tray Paintwork • Scratched | Repair |

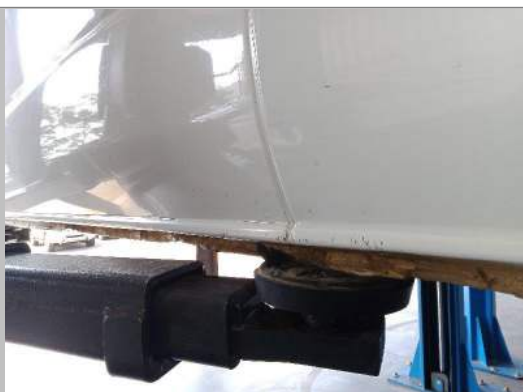
| Sill Panel Right Damaged | Repair |

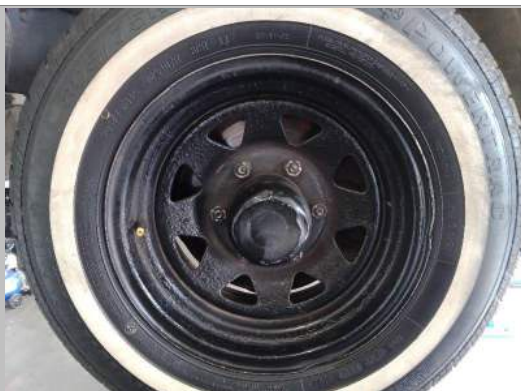
| Rim Front Left Damaged | Repair |

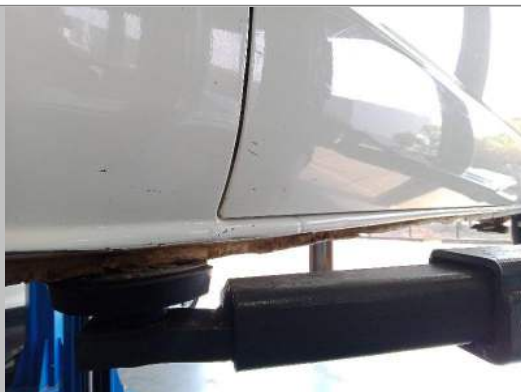
| Sill Panel Left Damaged | Repair |

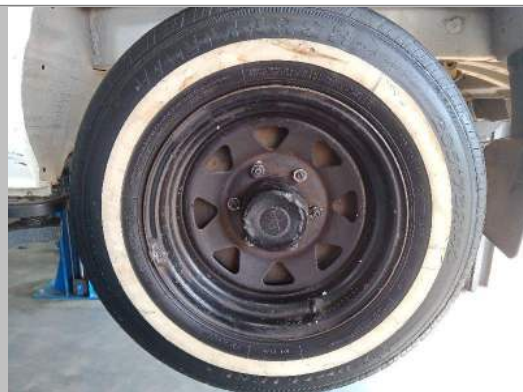
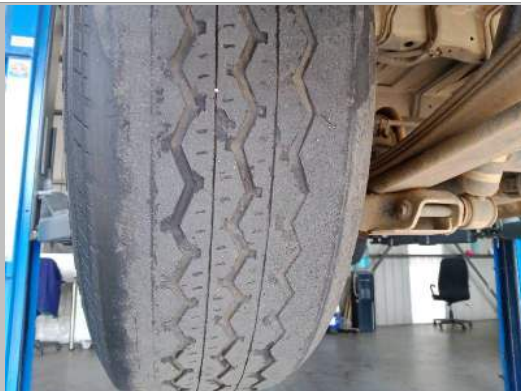
| Tyre Rear Left Damaged | Replace |

| | Size | Load/Speed Index | Manufacture | Model | Type* | Production Date | Tread Depth (mm) |
|---|---|---|---|---|---|---|---|
| Rear Left | 205/75R14C | 109R | Powertrac | VanMarch | V | 3024 | 0 mm |

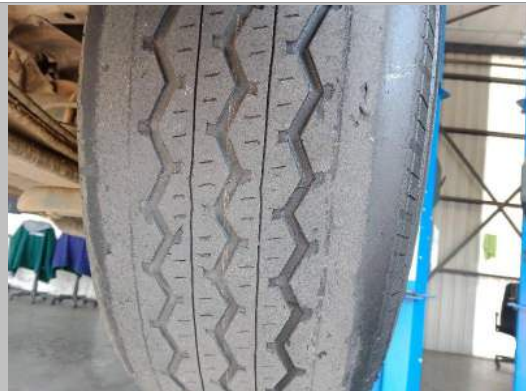
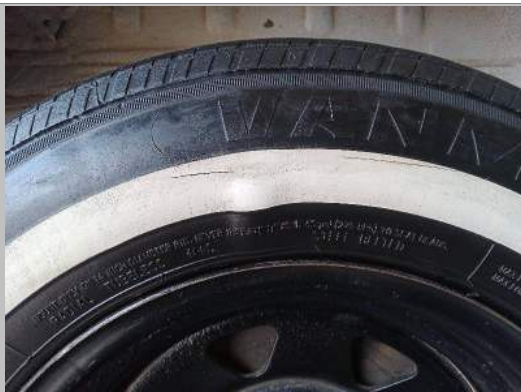
| Tyre Rear Right Damaged | Replace |

| | Size | Load/Speed Index | Manufacture | Model | Type* | Production Date | Tread Depth (mm) |
|---|---|---|---|---|---|---|---|
| Rear Right | 205/75R14C | 109R | Powertrac | VanMarch | V | 3525 | 0 mm |

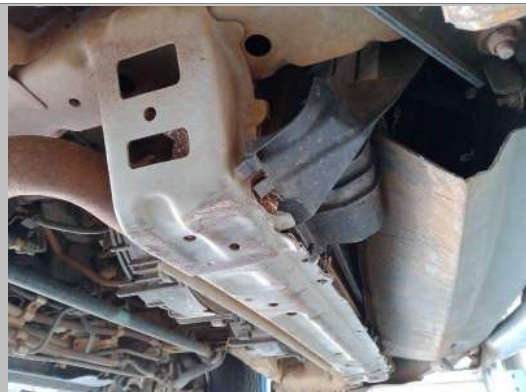
| Radiator Cradle Damaged | Replace |

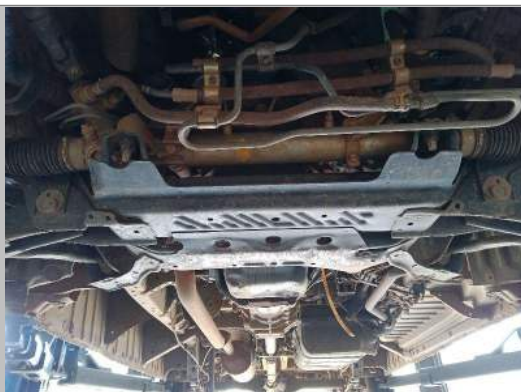
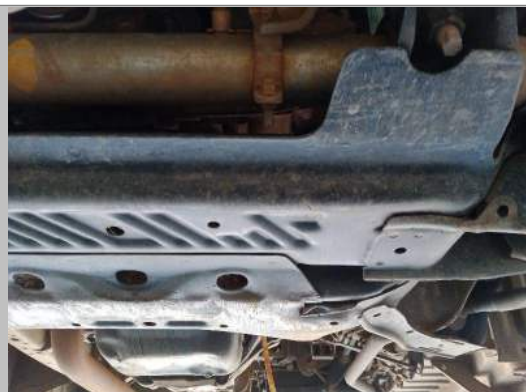
| Sub Frame Damaged | Replace |

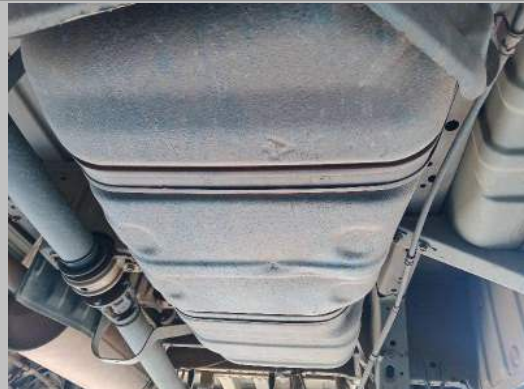
| Fuel Tank Dented | Repair |

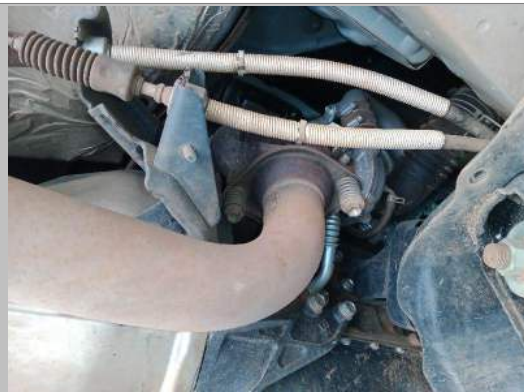
| Catalytic converter Missing | Replace |

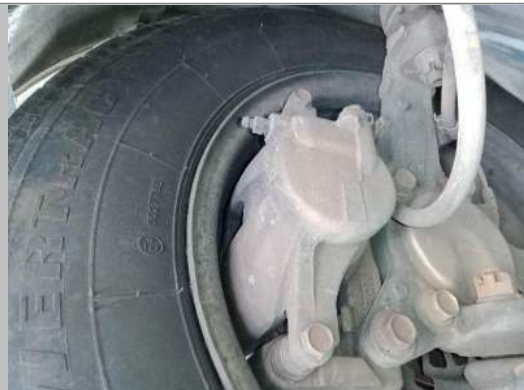
| Caliper 1. Axle left Damaged | Replace |

Interior: Vehicle interior dirty and panels scratched. Interior A pillar plastic trims defective. Aftermarket sound fitted to vehicle.  
Body • Exterior: Dents and scratches on body panels. Nudge bar dented.  
Brakes: Front left and right brake calipers grinded down to fit smaller rim. Rear left speed sensor damaged.

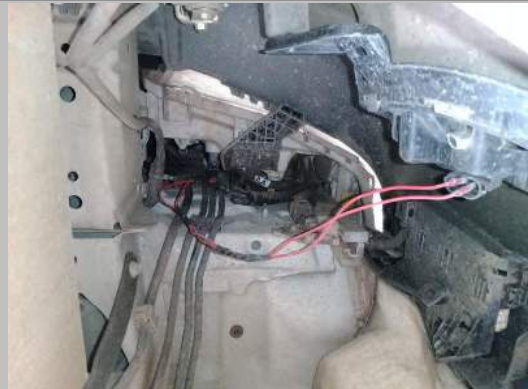
| Engine Wiring Defective | Repair |

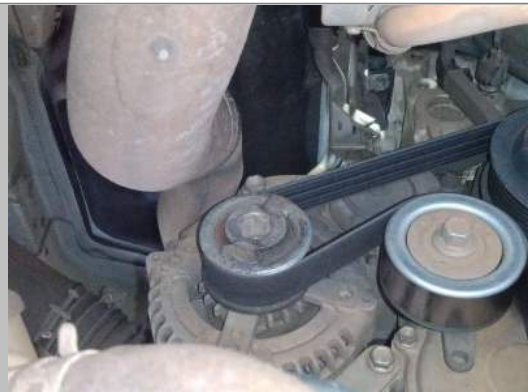
| Alternator Defective | Replace |

General Comments: ACCORDING TO THE AGE AND MILEAGE OF THE VEHICLE, NORMAL WEAR AND TEAR MARKS ARE VISIBLE ON THE INTERIOR, EXTERIOR, ELECTRICAL AND MECHANICAL PARTS. Engine Compartment: Alternator pulley welded.  
Electrical Components and Instruments: Radio not working.

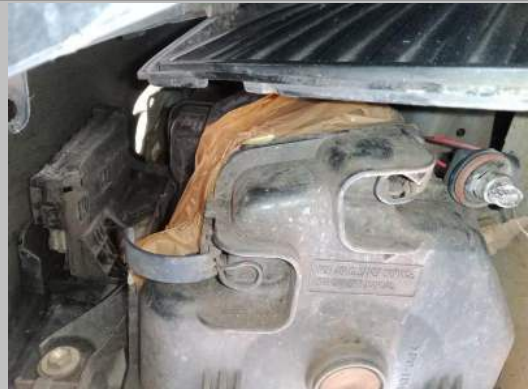
| Air cleaner Damaged | Replace |

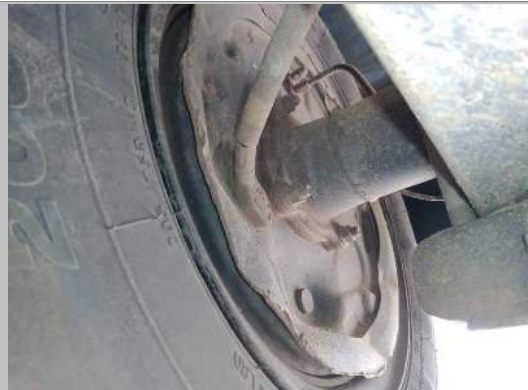
| Brake Drum 2. Axle right Damaged | Replace |

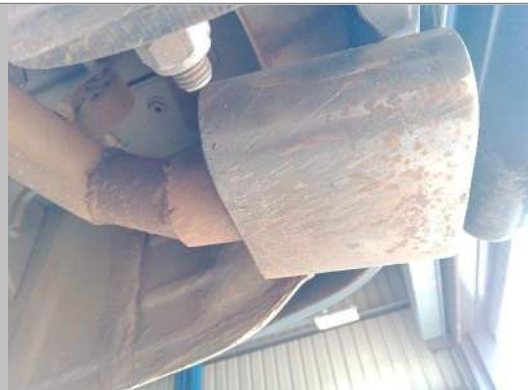
| Engine to silencer pipe Welded | Replace |

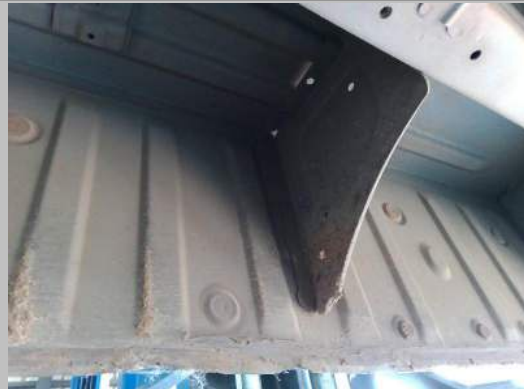
| Chassis Damaged | Repair |

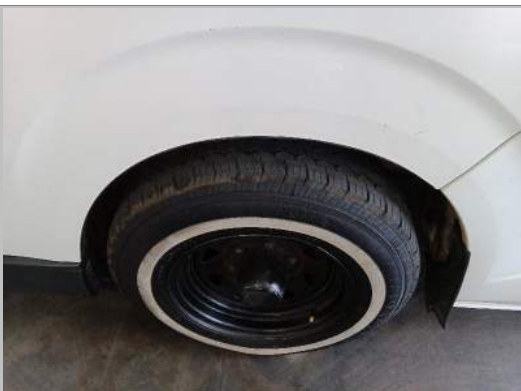
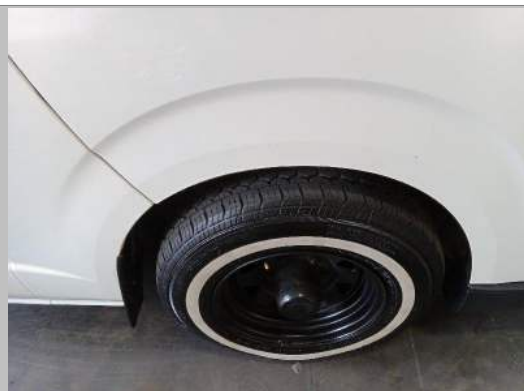
| Riding Height Front Incorrect | Repair |

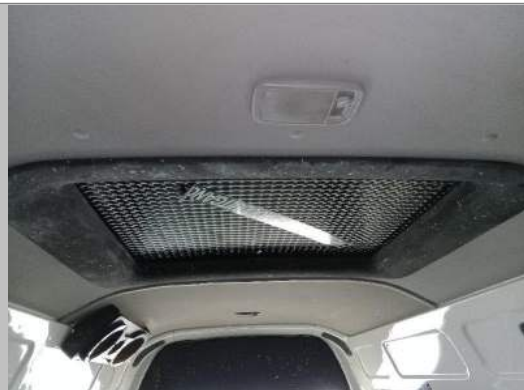
| Hood Lining Damaged | Repair |

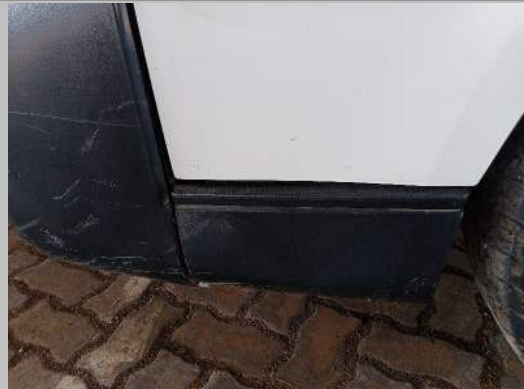
| Front Bumper Damaged | Repair |
