CONDITION REPORT

Report No:  
2017292773  
DATE  
01/09/2026

| Manufacturer | JETOUR | Registration Number | MB72SGGP |
| Model | X70 | Register Number | |

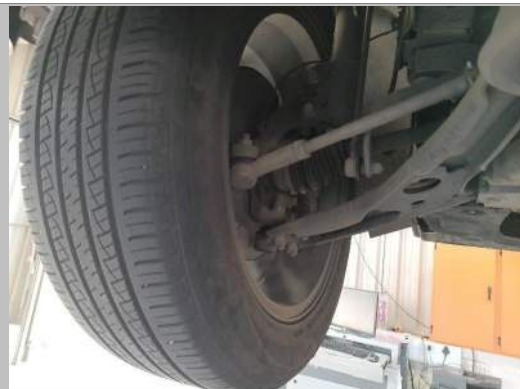
LF TYRE TREAD

| | Size | Load/Speed Index | Manufacture | Model | Type* | Production Date | Tread Depth (mm) |
|---|---|---|---|---|---|---|---|
| Front Left | 235/55R19 | 101V | Wanli | Flash | V | 3324 | 6 mm |

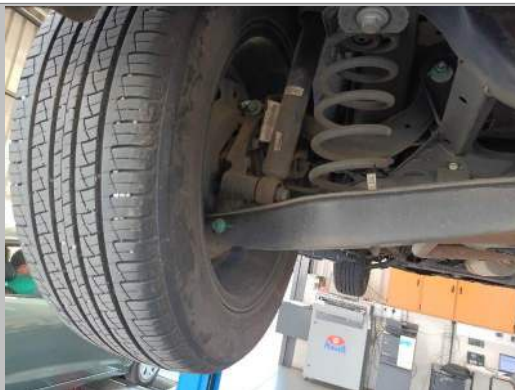
LR TYRE TREAD

| | Size | Load/Speed Index | Manufacture | Model | Type* | Production Date | Tread Depth (mm) |
|---|---|---|---|---|---|---|---|
| Rear Left | 235/55R19 | 101V | Wanli | Flash | V | 3324 | 6 mm |

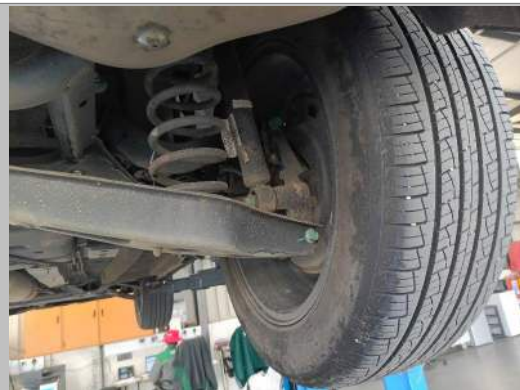
RR TYRE TREAD

| | Size | Load/Speed Index | Manufacture | Model | Type* | Production Date | Tread Depth (mm) |
|---|---|---|---|---|---|---|---|
| Rear Right | 235/55R19 | 101V | Wanli | Flash | V | 3324 | 6 mm |

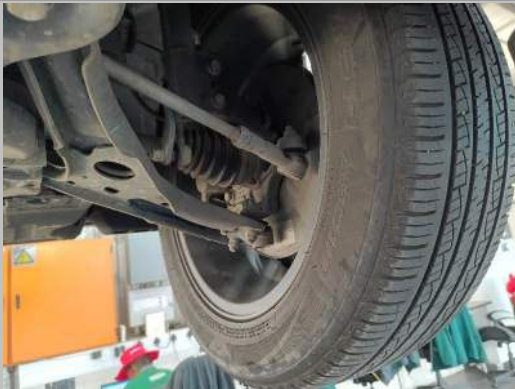
RF TYRE TREAD

| | Size | Load/Speed Index | Manufacture | Model | Type* | Production Date | Tread Depth (mm) |
|---|---|---|---|---|---|---|---|
| Front Right | 235/55R19 | 101V | Wanli | Flash | V | 3324 | 5 mm |

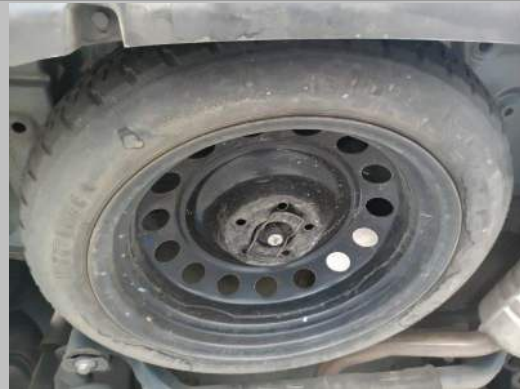
Sparewheel

| | Size | Load/Speed Index | Manufacture | Model | Type* | Production Date | Tread Depth (mm) |
|---|---|---|---|---|---|---|---|
| Spare | T125/80D17 | 99M | Westlake | Temporary | V | 0000 | 5 mm |

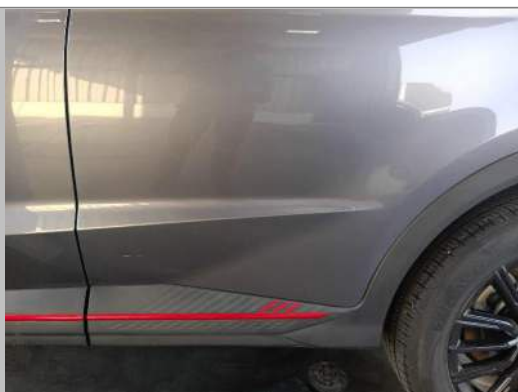
| Damage | Repair Way |
|---|---|
| Door Rear Left Paintwork • Scratched | Repair |

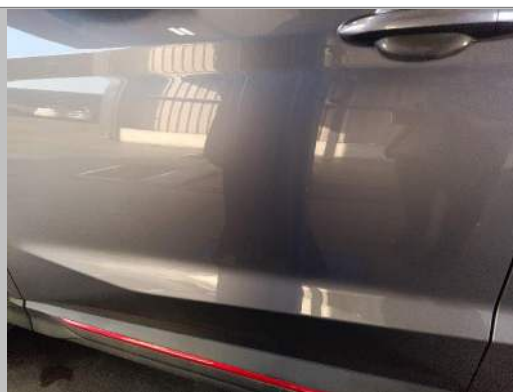
| Damage | Repair Way |
|---|---|
| Door Front Left Paintwork • Scratched | Repair |

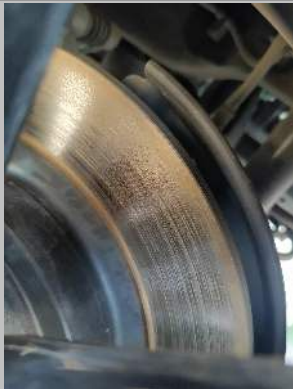
| Damage | Repair Way |
|---|---|
| Brake disc 2. Axle left Corrosion | Replace |

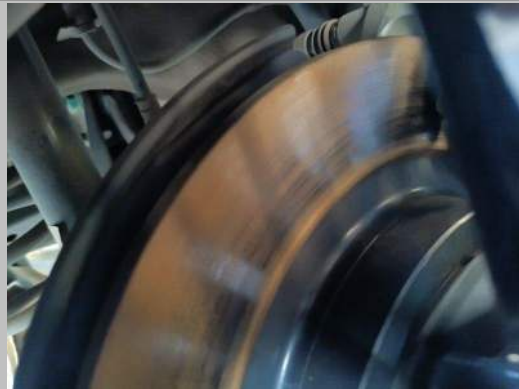
| Damage | Repair Way |
|---|---|
| Brake disc 2. Axle right Corrosion | Replace |

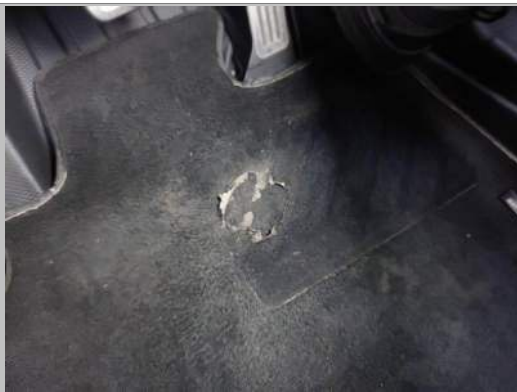
| Damage | Repair Way |
|---|---|
| Carpet Front Torn / Cut | Repair |

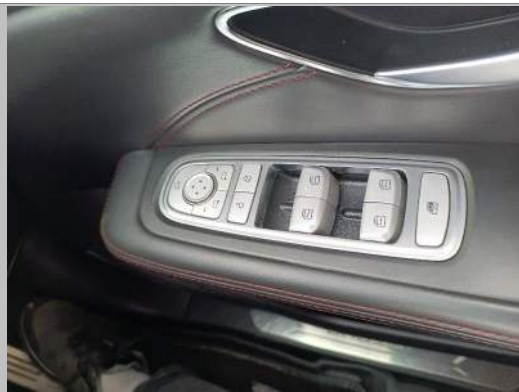
| Damage | Repair Way |
|---|---|
| Switch Electrical Window Winder front right Defective | Repair |
