CONDITION REPORT

Report No:  
2017297260  
DATE  
10/09/2026

| Manufacturer | MAZDA | Registration Number | ML26GCGP |
| Model | CX-5 2.0L DYNAMIC AT [2022-2024] | Register Number | |

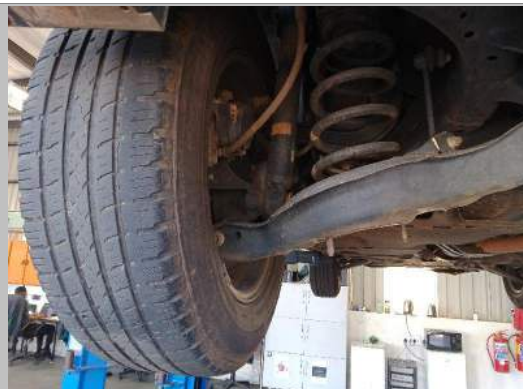
LR TYRE TREAD

| Rear left and right tyre sizes different | Replace |

| | Size | Load/Speed Index | Manufacture | Model | Type* | Production Date | Tread Depth (mm) |
|---|---|---|---|---|---|---|---|
| Rear Left | 225/65 R17 | 102H | Hify | Vigorous | V | 1617 | 1 mm |

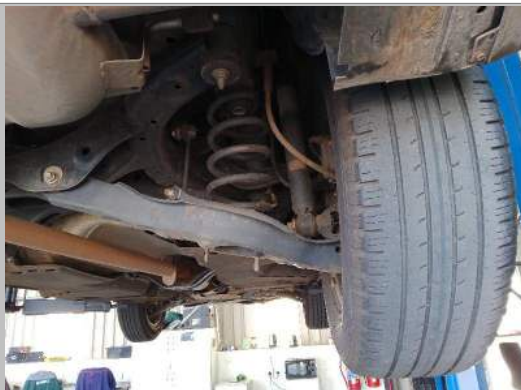
RR TYRE TREAD

| | Size | Load/Speed Index | Manufacture | Model | Type* | Production Date | Tread Depth (mm) |
|---|---|---|---|---|---|---|---|
| Rear Right | 235/65 R17 | 108V | Goodyear | Efficient | V | 0320 | 3 mm |

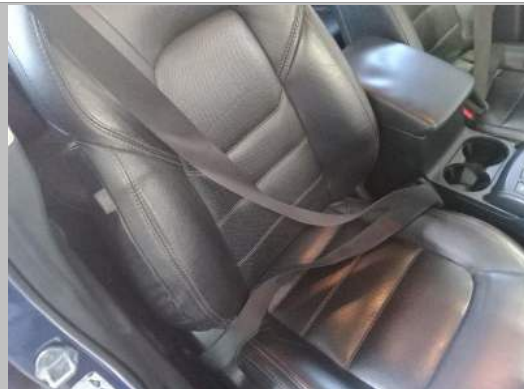
| Seat Belt Front Right Damaged | Replace |

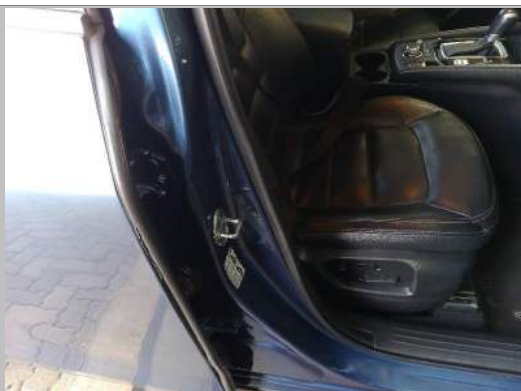
| B • Pillar Right Damaged | Repair |

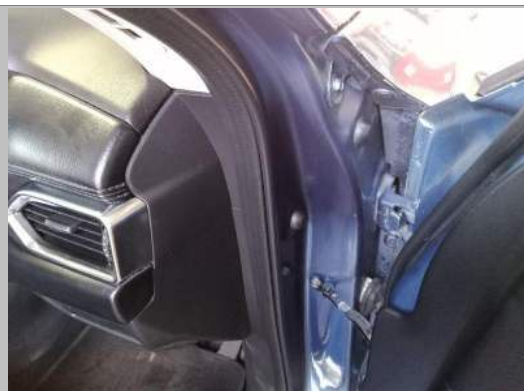
| A • Pillar Right Residual Traces of Repair | Repair |

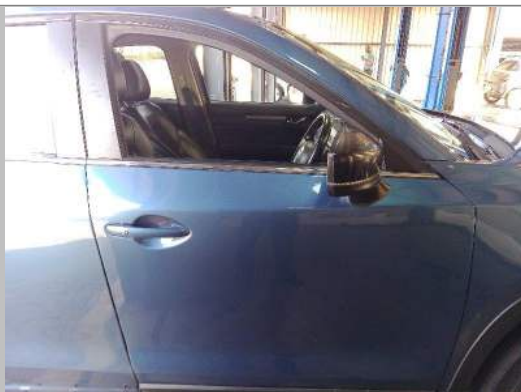
| Door Front Right Residual Traces of Repair | Repair |

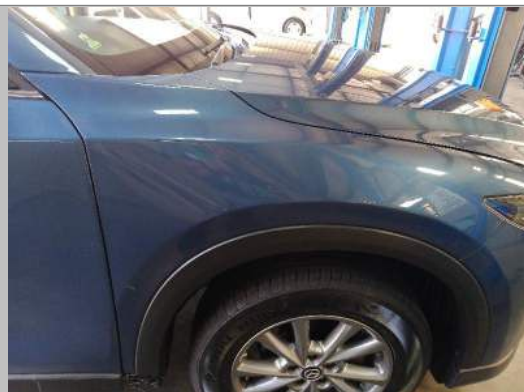
| Front Fender Right Residual Traces of Repair | Repair |

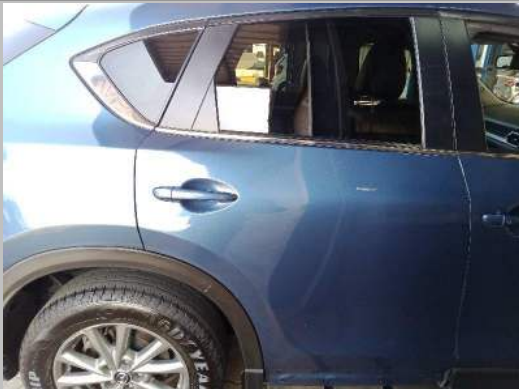
| Door Rear Right Residual Traces of Repair | Repair |

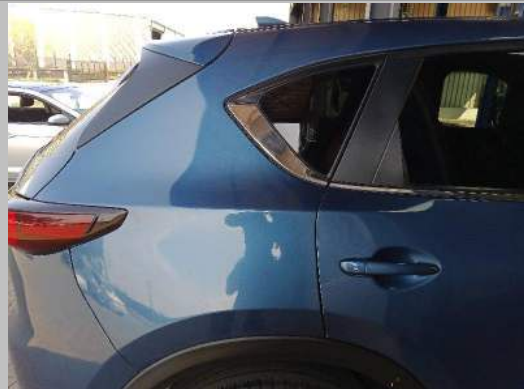
| Rear Fender Right Residual Traces of Repair | Repair |

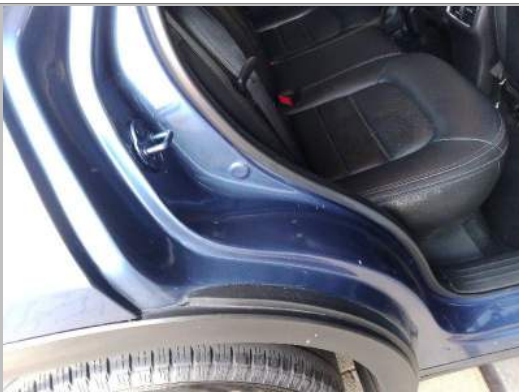
| C • Pillar Right Residual Traces of Repair | Repair |

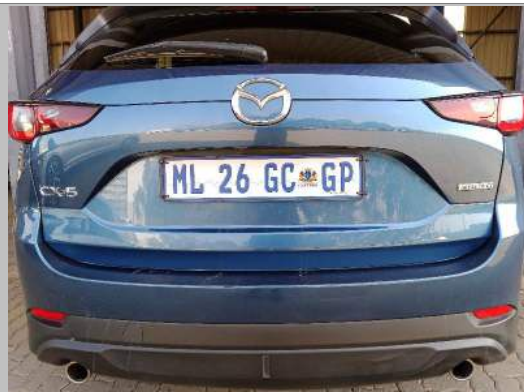
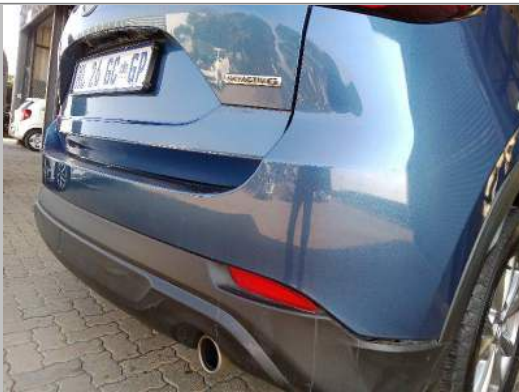
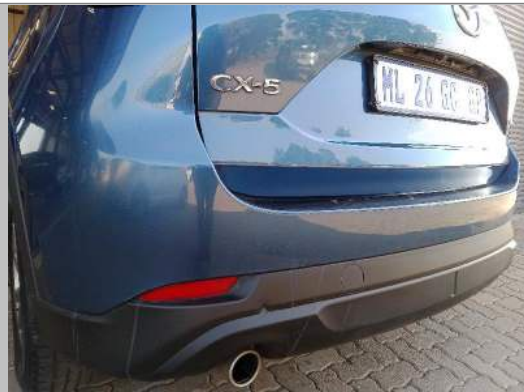
| Rear bumper Damaged | Repair |

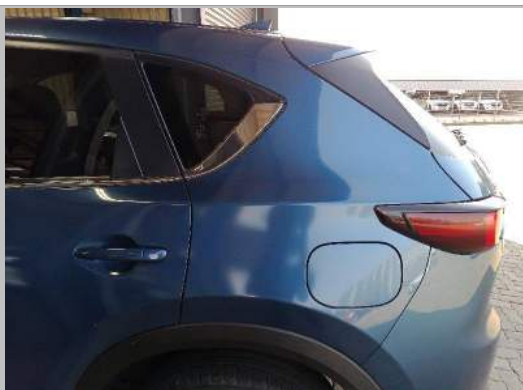
| Rear Fender Left Residual Traces of Repair | Repair |

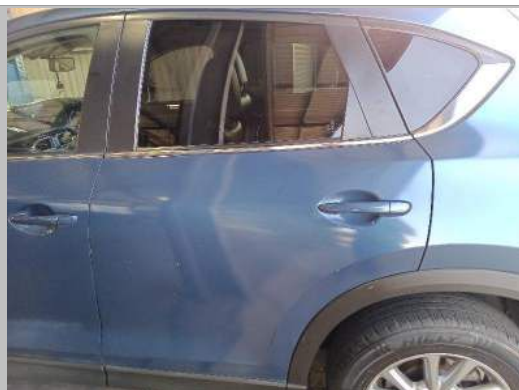
| Door Rear Left Residual Traces of Repair | Repair |

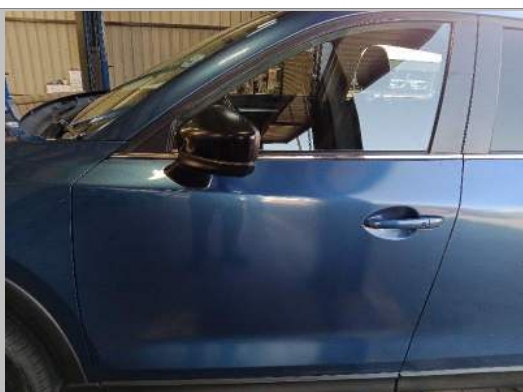
| Door Front Left Residual Traces of Repair | Repair |

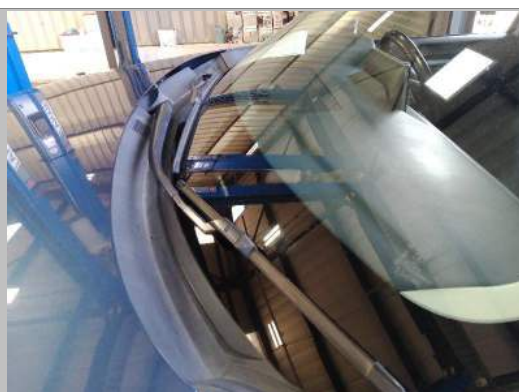
| Windscreen Wiper Damaged | Replace |

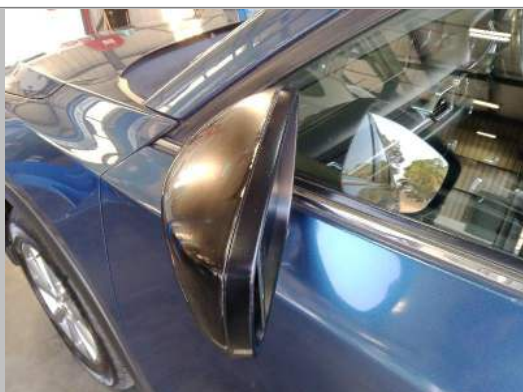
| Side Mirror Left Paintwork • Scratched | Repair |

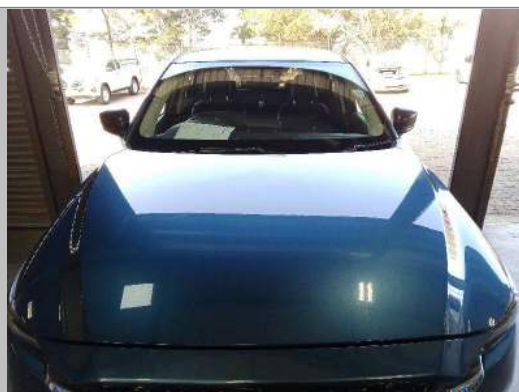
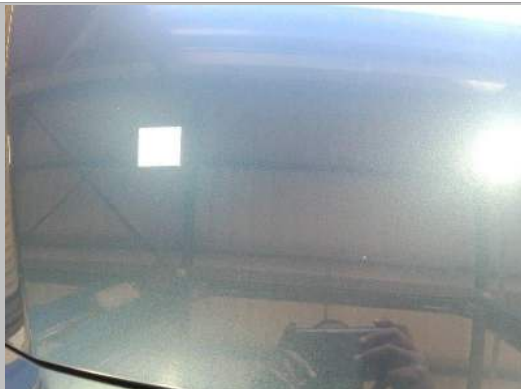
| Bonnet Paintwork • Chipmarks | Repair |

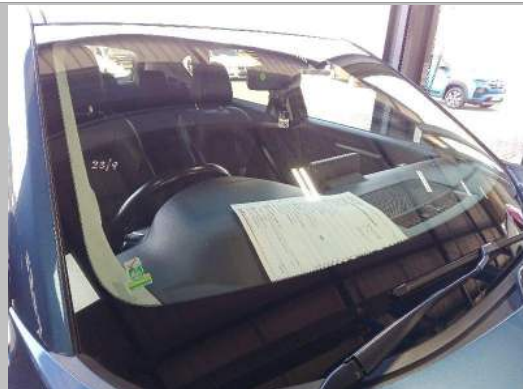
| Windscreen Chipped | Repair |

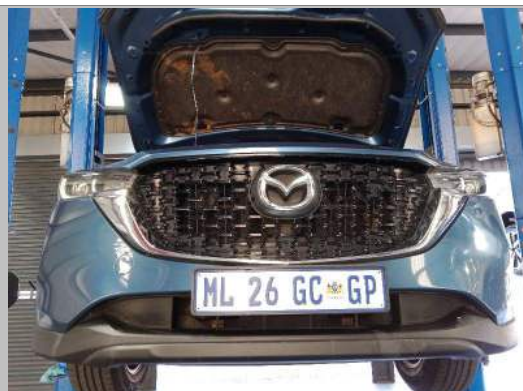
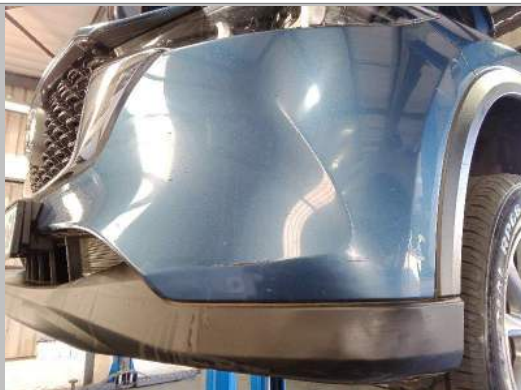
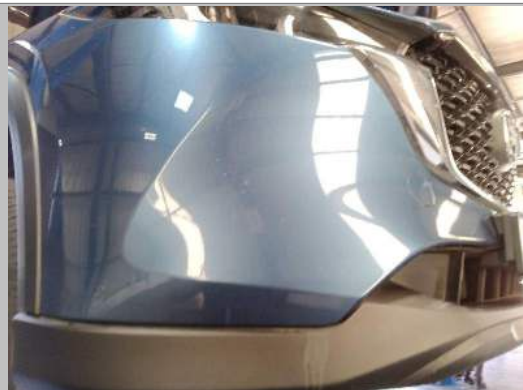
| Front Bumper Damaged | Repair |

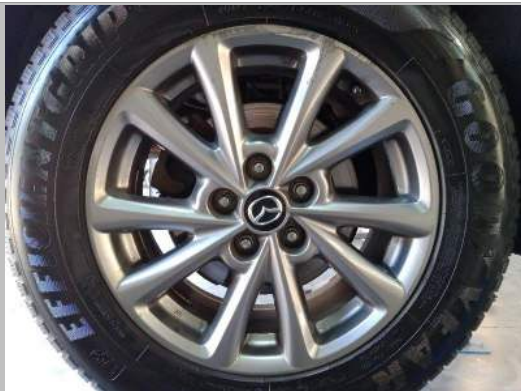
| Rim Front Right Scratched | Repair |

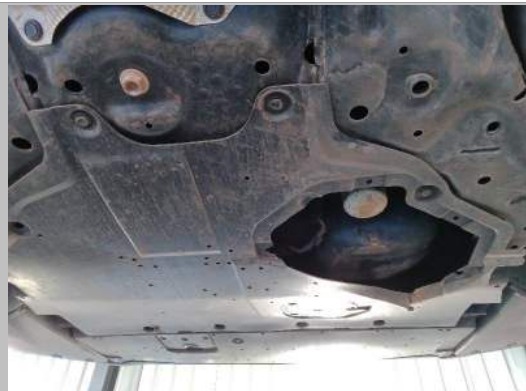
| Belly plates Damaged | Replace |

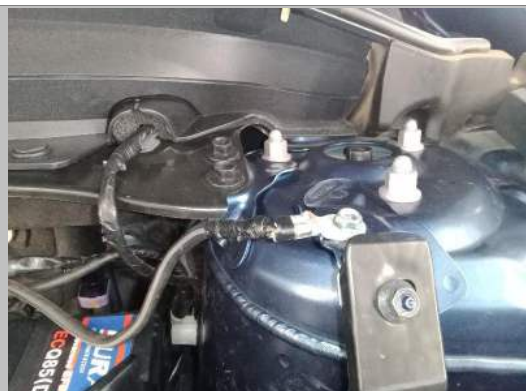
| Engine Wiring Defective | Repair |

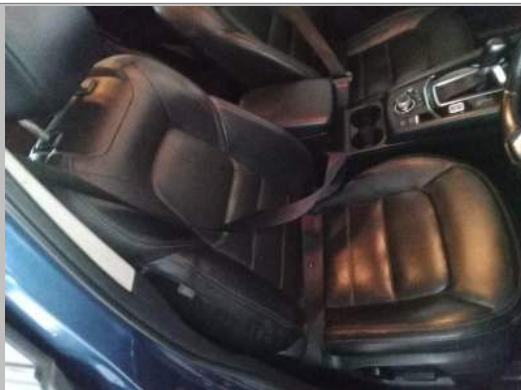
| Seat Front Right Damaged | Repair |
