CONDITION REPORT

Report No: 2016201689

MFC Auction House
M57 Pretoria Rd, Glenmarais, KEMPTON PARK
Gauteng

Vehicle Type	PASSENGER VEHICLE	Registered Owner	MFC
Manufacturer	TOYOTA	Registration Number	FXH701L
Model	STARLET	Register Number	
VIN	JTDGWC52S00669303	Date Of First Licensing	
Engine Number		Last COR	
Doors	5	License Expiry Date	30/11/2023
Color	GREY	Power / Displacement	
Year Model		Paint Finish	TWO COAT METALLIC
Km Reading	36,047 KM	Fuel	PETROL
Cab / Body Type	HATCHBACK	Transmission	AUTOMATIC

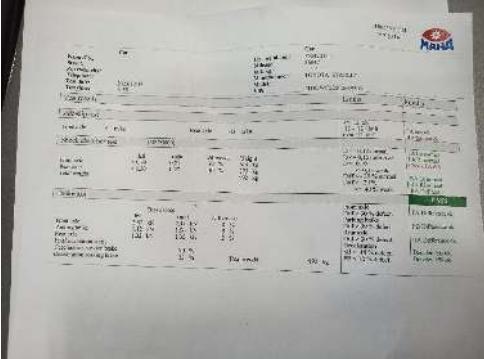
Brake and shock test

Left	Right	Axle Weight [KG]	Deceleration [m/s ²]
	Braking Force [kN]	Braking Force [kN]		
Front	2.62	2.41	-	
Rear	1.32	1.35	-	
Emergency / Parking	1.12	1.06	-

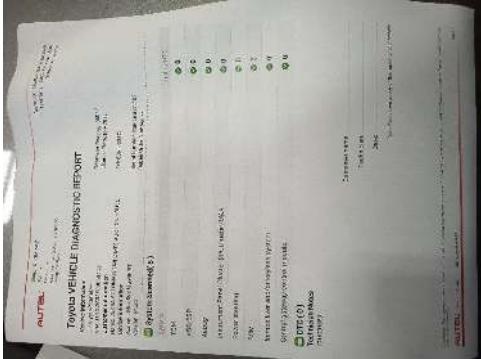
Diagnostic report

During the diagnostic no active error messages were detected. (See also attached Diagnostic Report. For more information regarding the Fault Codes (DTC) and the recommended rectifications please contact the workshops of the vehicle manufacture).

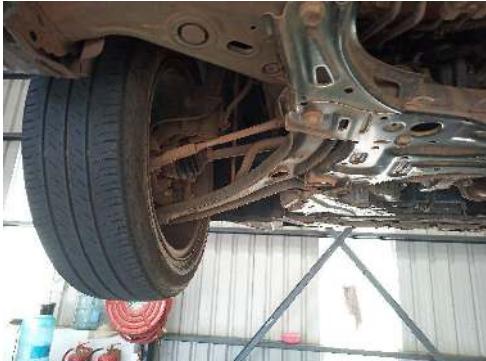
LF TYRE TREAD

Size	Load/Speed Index	Manufacture	Model	Type*	Production Date	Tread Depth (mm)
Front Left	185/55R16	83V	Bridgestone	Radial	V	0521	2 mm
Front Right	185/55R16	83V	Bridgestone	Radial	V	0521	2 mm
Rear Left	185/55R16	83V	Bridgestone	Radial	V	0421	2 mm
Rear Right	185/55R16	83V	Bridgestone	Radial	V	0421	2 mm

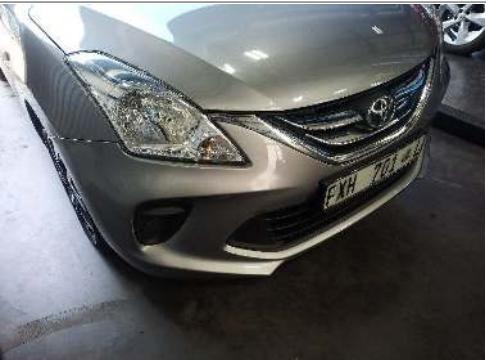
Damage	Repair Way
Front Bumper Damaged	Repair
Bonnet Damaged	Repair
Door Front Left Damaged	Repair
Door Front Right Damaged	Repair
Door Rear Left Damaged	Repair
Door Rear Right Damaged	Repair
Rear bumper Damaged	Repair
