## CONDITION REPORT

Report No:  
2017298906  
DATE  
15/09/2026

| Manufacturer | HYUNDAI | Registration Number | JD29CMGP |
| Model | ELANTRA MD 1.6 PREMIUM [2011-2015] | Register Number | |

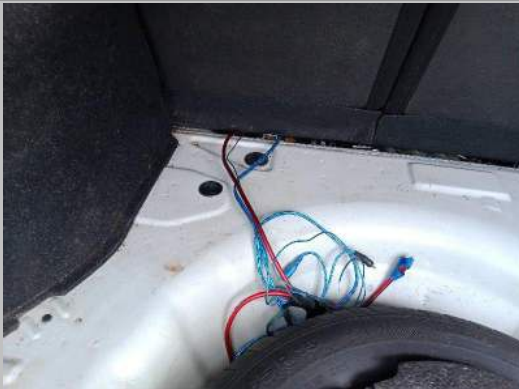
| Loose sound wiring inside boot of vehicle | Replace |

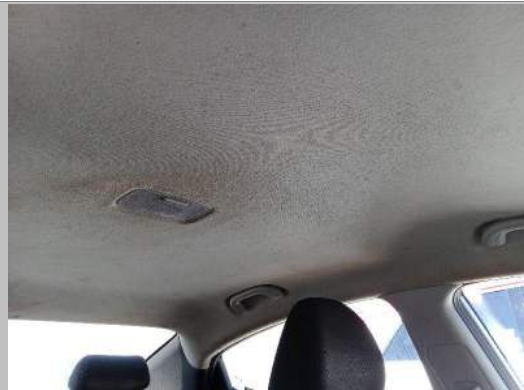
| Hood Lining Dirty | Repair |

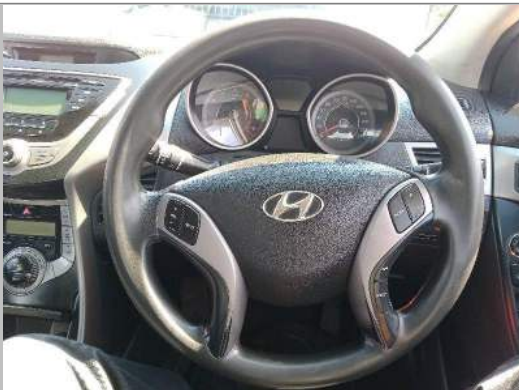
| Steering Wheel Trim Excessive Wear & Tear | Repair |

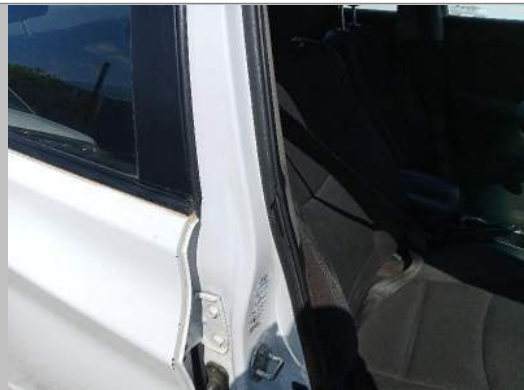
| Door Sealing Rubber Front Right Damaged | Replace |

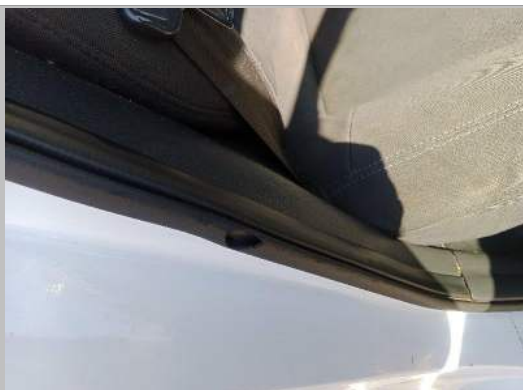
| Door Sealing Rubber Rear Right Damaged | Replace |

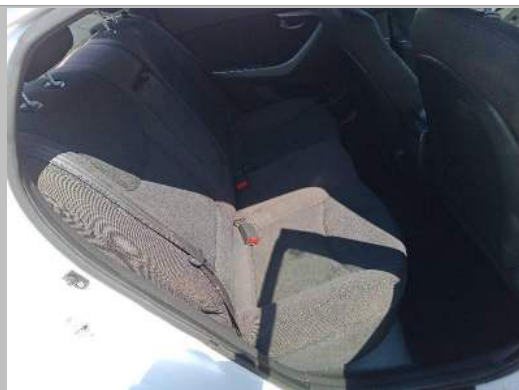
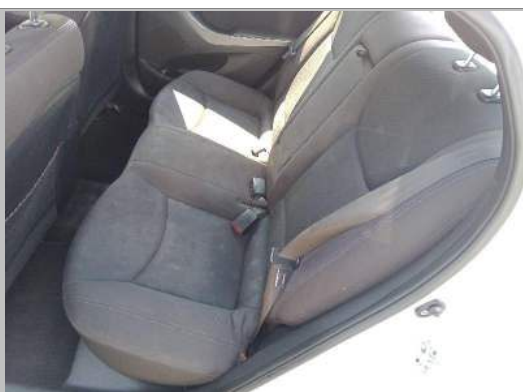
| Seat Rear Dirty | Repair |

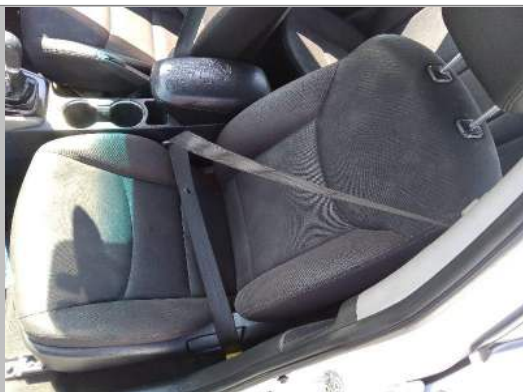
| Seat Front Left Dirty | Repair |

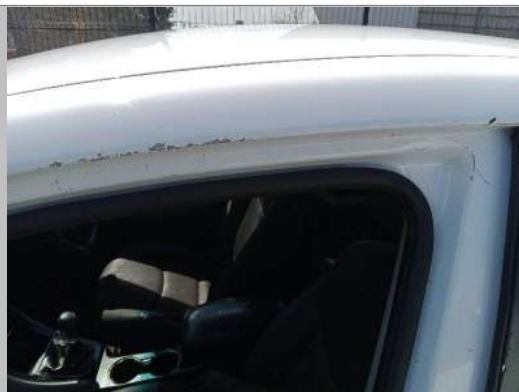
| B • Pillar Left Paintwork • Scratched | Repair |

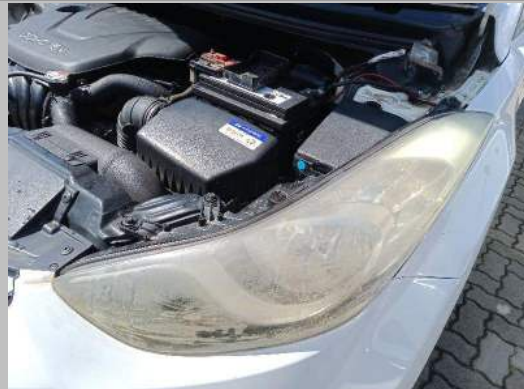
| Headlight Left Damaged | Replace |

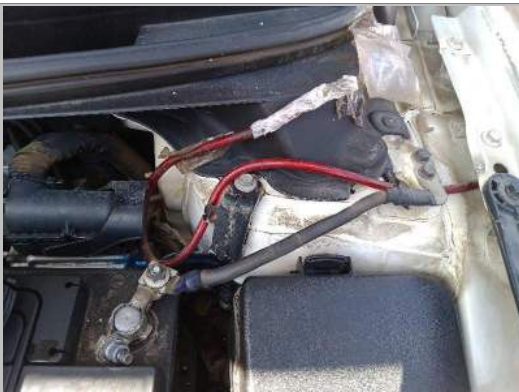
| Engine Wiring Damaged | Replace |

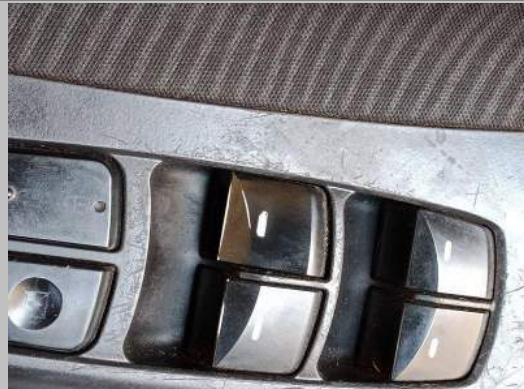
| Switch Electrical Window Winder front right Damaged | Replace |

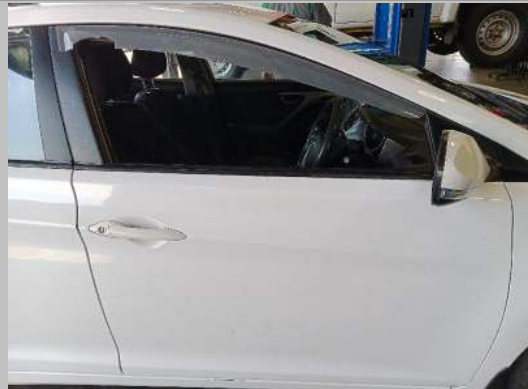
| Door Front Right Damaged | Repair |

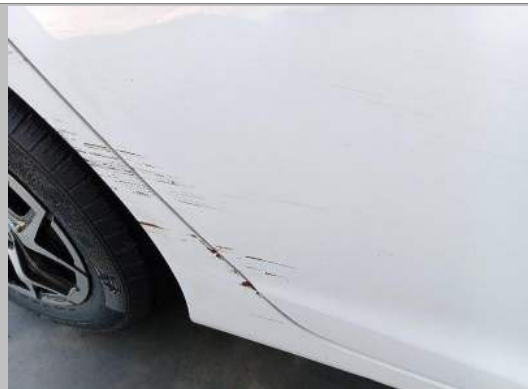
| Door Rear Right Paintwork • Scratched | Repair |

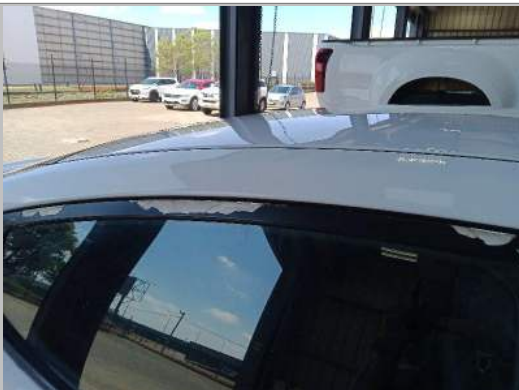
| Weather Strip Door Rear Right Defective | Repair |

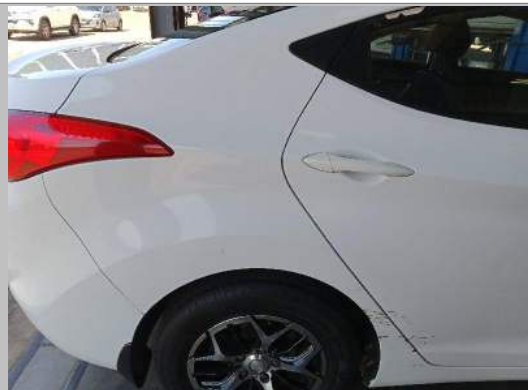
| Rear Fender Right Damaged | Repair |

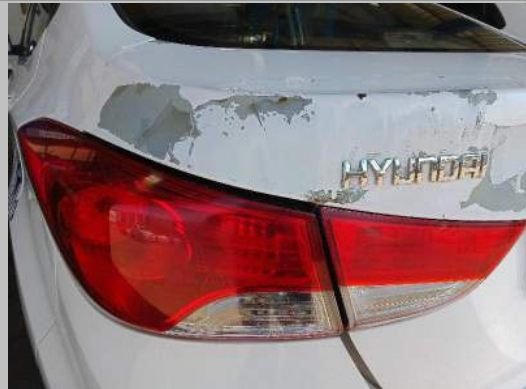
| Tail Light Left Cracked | Replace |

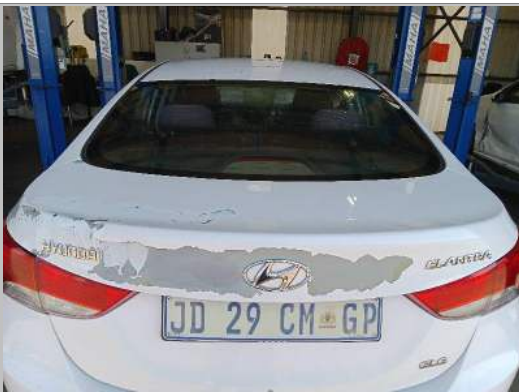
| Boot Lid / Hatch door Damaged | Repair |

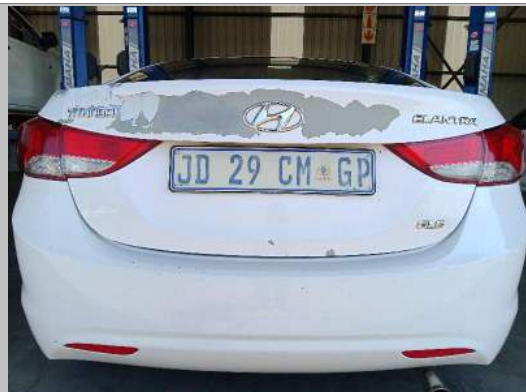
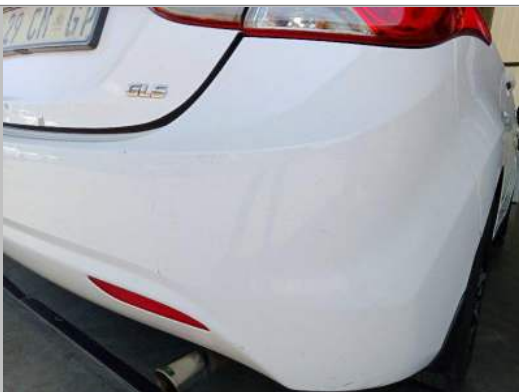
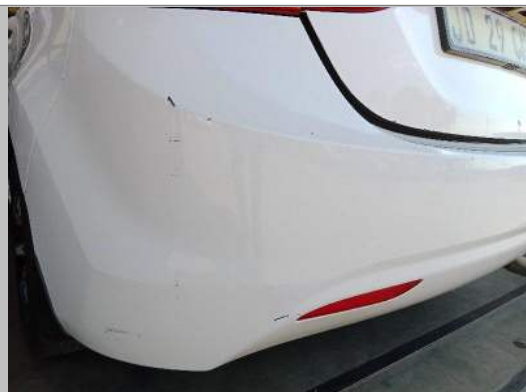
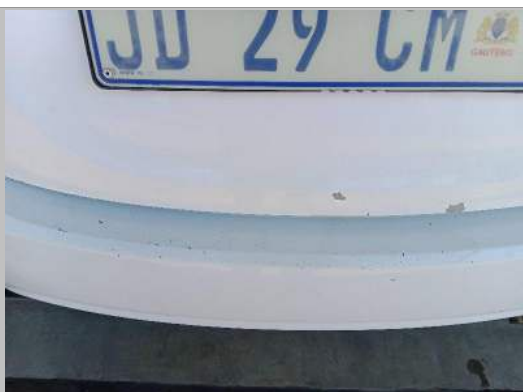
| Rear bumper Paintwork • Scratched | Repair |

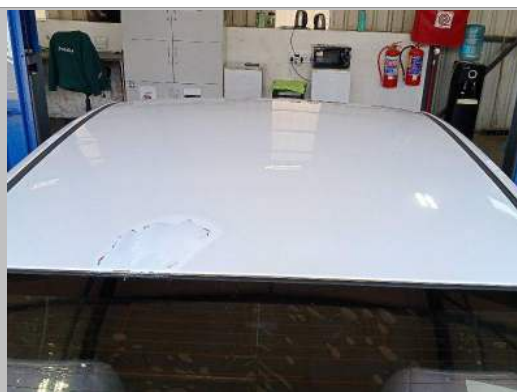
| Roof Damaged | Repair |

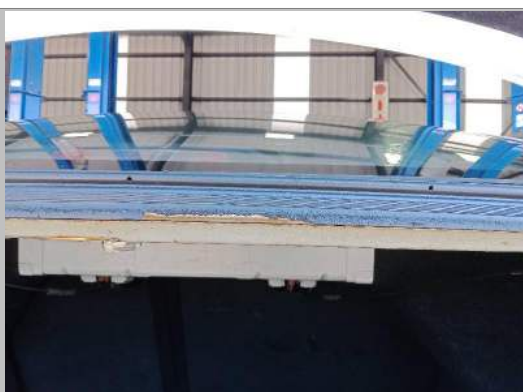
| Boot Lid / Hatch Door Rubbers Damaged | Replace |

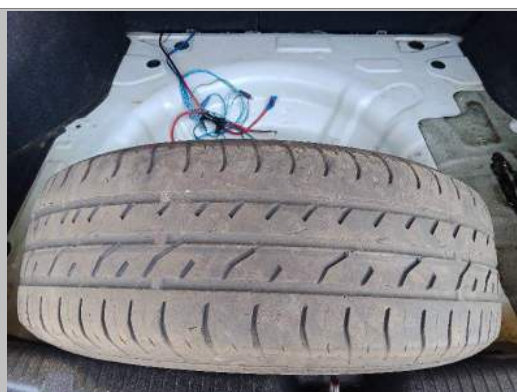
| Spare Tyre Damaged | Replace |
| Spare Wheel regrooved | Replace |

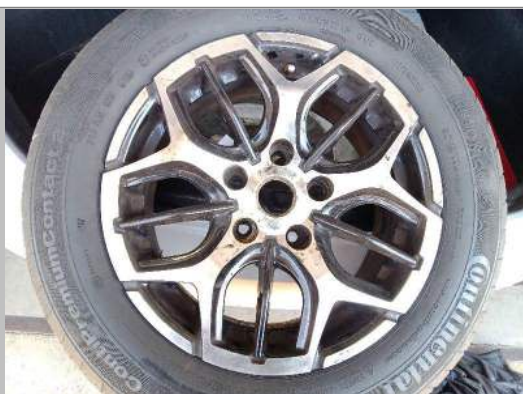
| Rim Spare Wheel Scratched | Repair |

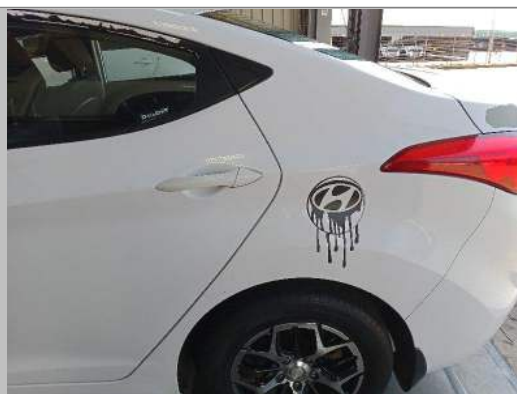
| Rear Fender Left Paintwork • Scratched | Repair |

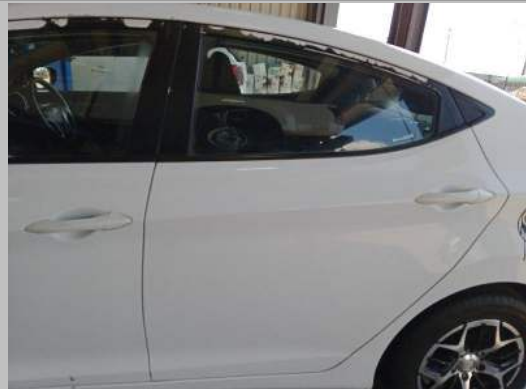
| Door Rear Left Residual Traces of Repair | Repair |

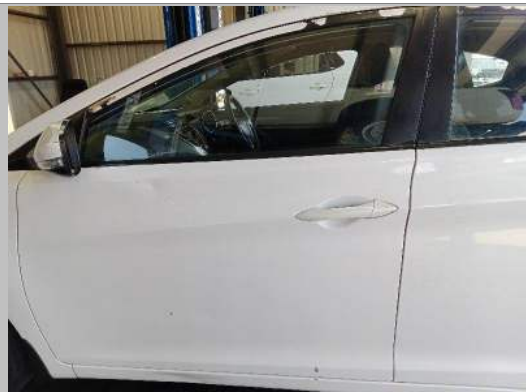
| Door Front Left Damaged | Repair |

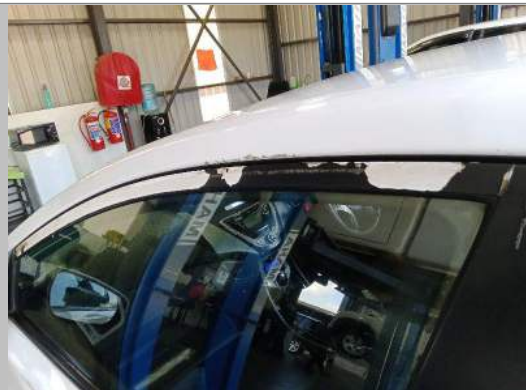
| Weather Strip Door Front Left Defective | Repair |

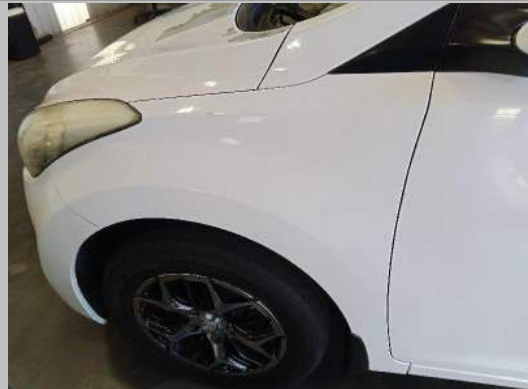
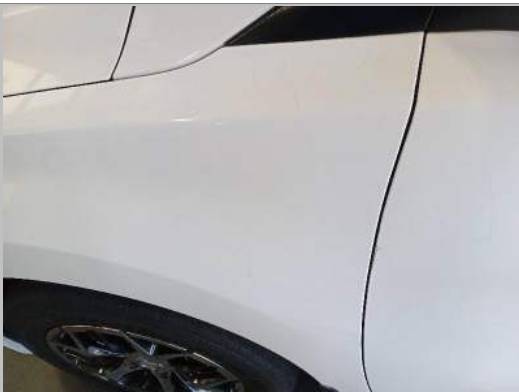
| Front Fender Left Paintwork • Scratched | Repair |

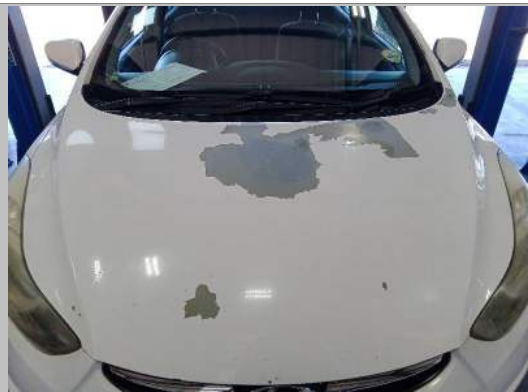
| Bonnet Damaged | Repair |

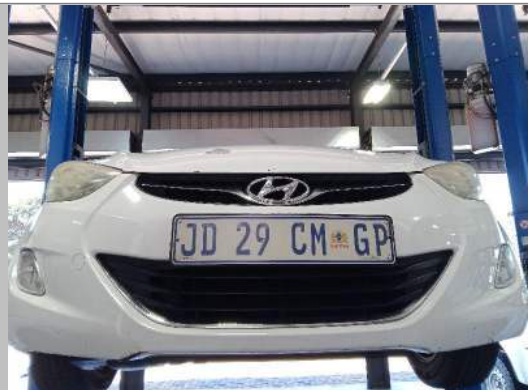
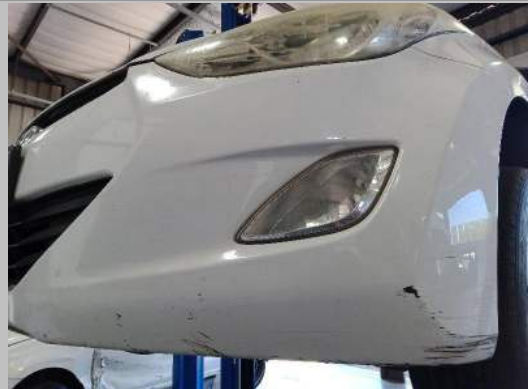
| Front Bumper Paintwork • Scratched | Repair |

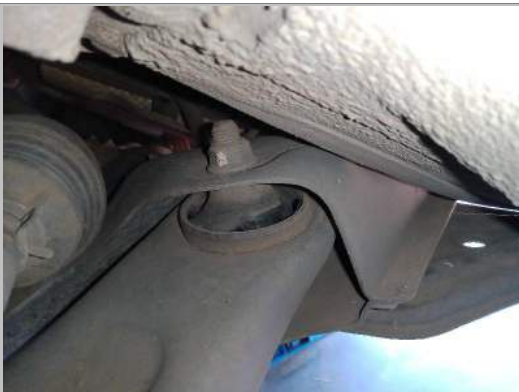
| Control Arm Bush(es) Front Axle Left Cracked | Replace |

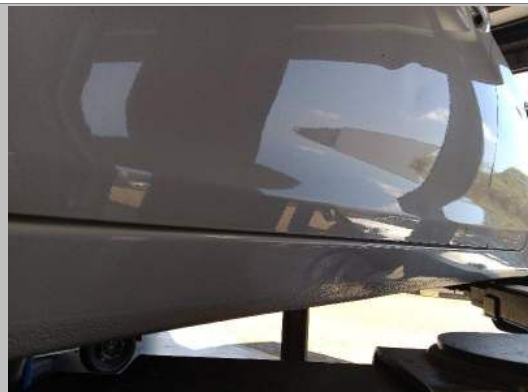
| Sill Panel Left Dented | Repair |

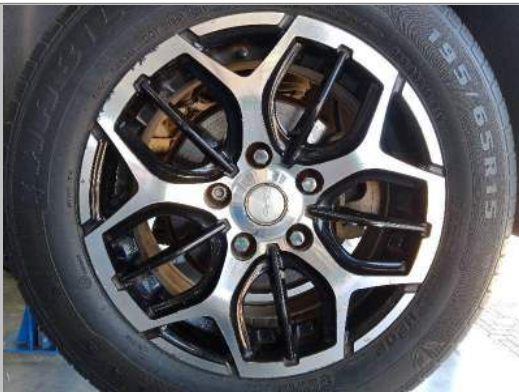
| Rim Rear Left Scratched | Repair |

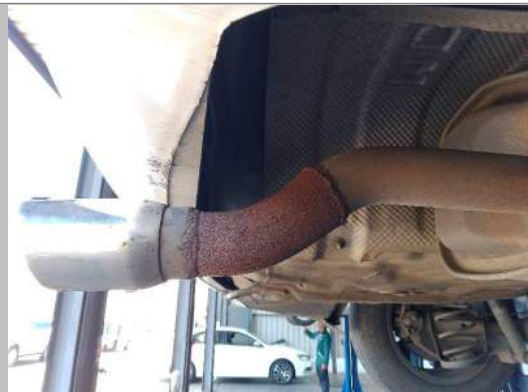
| Engine to silencer pipe Welded | Repair |

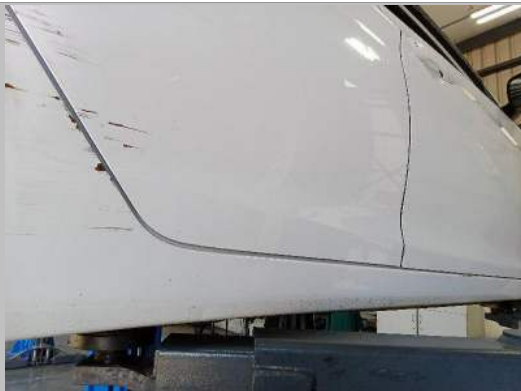
| Sill Panel Right Damaged | Repair |

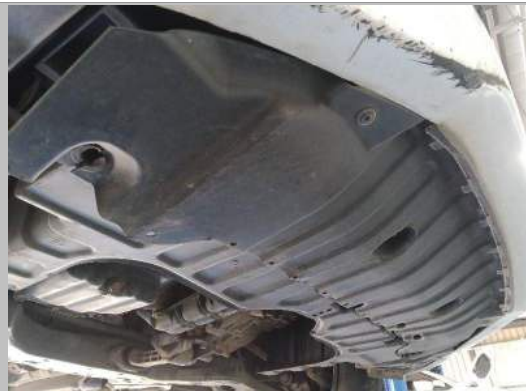
| Belly plates Damaged | Repair |

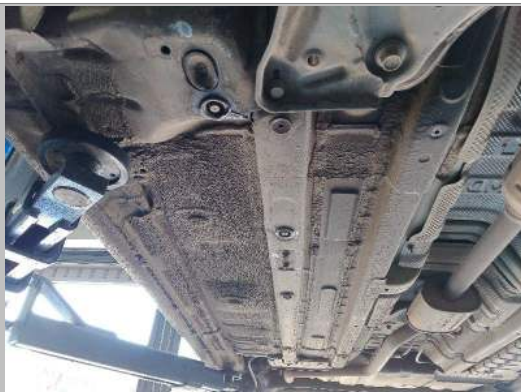
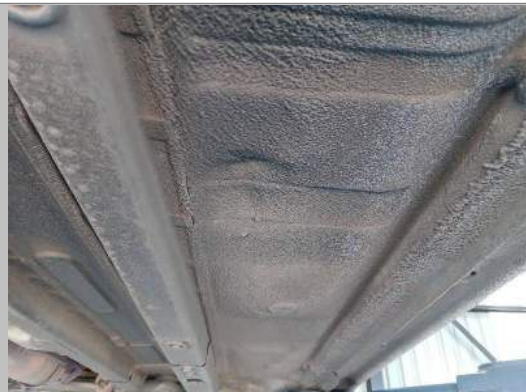
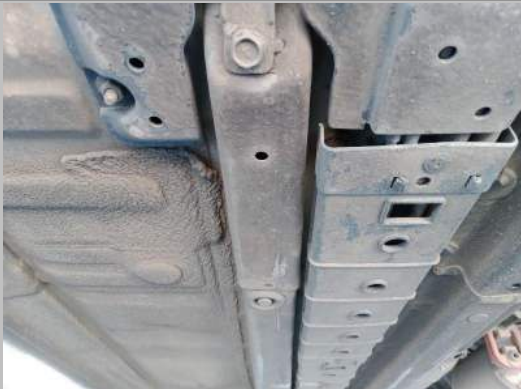
| Chassis Dented | Repair |

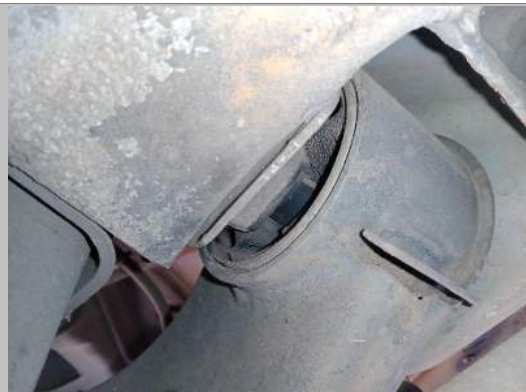
| Mounting Rubber(s) Rear Axle Right Cracked | Replace |

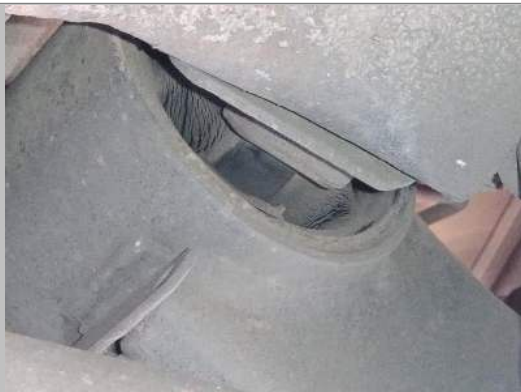
| Mounting Rubber(s) Rear Axle Left Cracked | Replace |

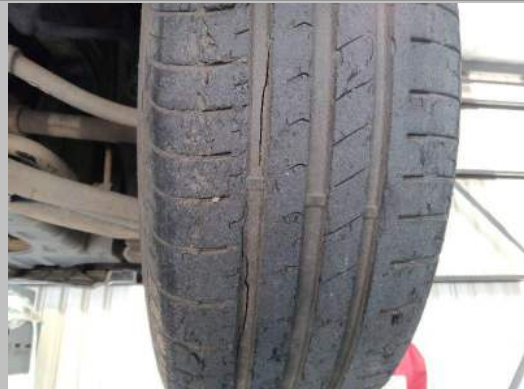
| Tyre Front Right Damaged | Replace |

| | Size | Load/Speed Index | Manufacture | Model | Type* | Production Date | Tread Depth (mm) |
|---|---|---|---|---|---|---|---|
| Front Right | 195/65 R15 | 91H | Hankook | Kinergy | V | 2013 | 0 mm |

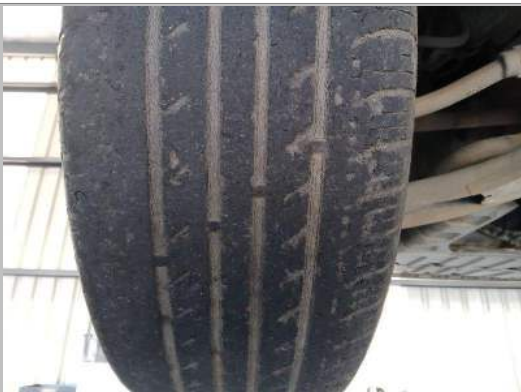
| Tyre Front Left Worn | Replace |

| | Size | Load/Speed Index | Manufacture | Model | Type* | Production Date | Tread Depth (mm) |
|---|---|---|---|---|---|---|---|
| Front Left | 195/65 R15 | 91V | Habilead | Comfort | V | 4718 | 0 mm |

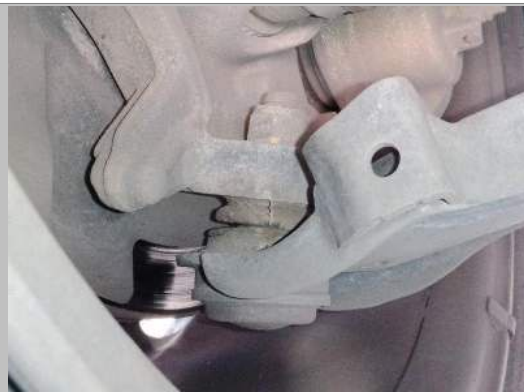
| Ball Joint(s) Front Axle Left Damaged | Replace |

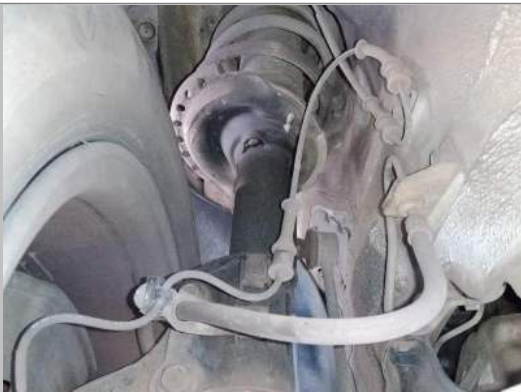
| Shock Absorber Front Left Sweat | Replace |

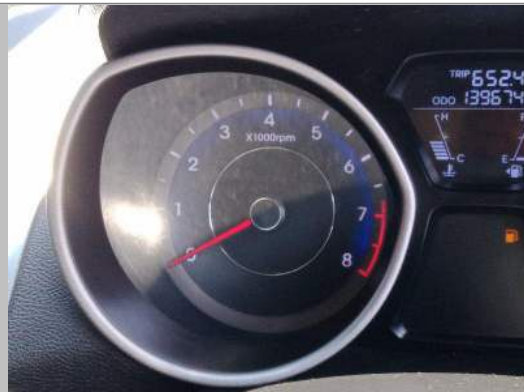
| Ref Counter Defective | Repair |

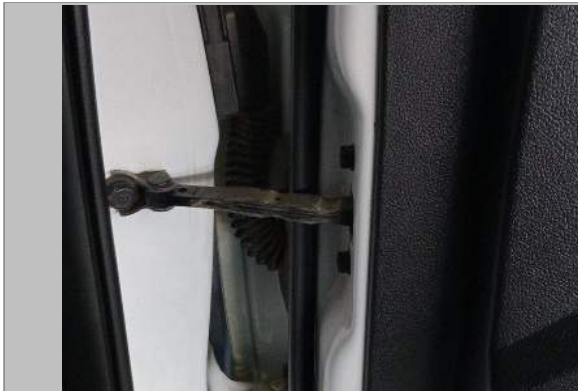
| Doorstopper Front Right Excessive Wear & Tear | Replace |
