## CONDITION REPORT

Report No:  
2017300801  
DATE  
18/09/2026

MFC Auction House  
M57 Pretoria Rd, Glenmarais, KEMPTON PARK  
Gauteng

| Manufacturer | KIA | Registration Number | HC37GHGP |

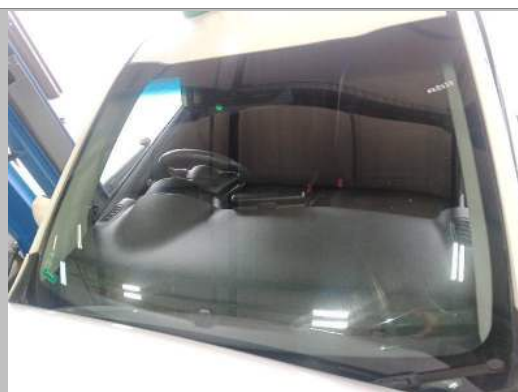
| Damage | Repair Way |
|---|---|
| No license disc | Replace |

No license disc

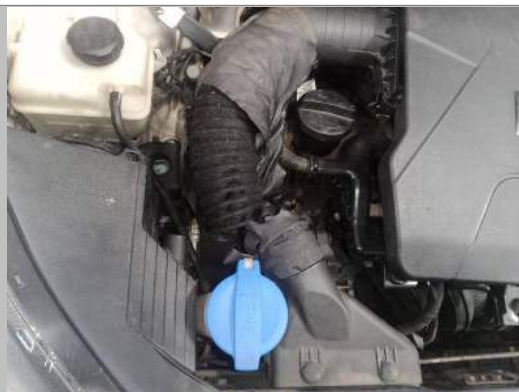
| Damage | Repair Way |
|---|---|
| Air cleaner Damaged | Repair |

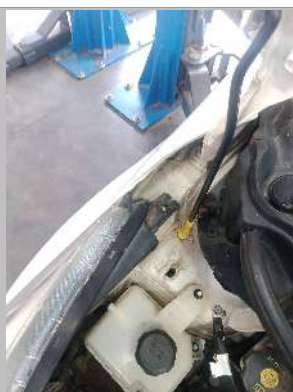
| Damage | Repair Way |
|---|---|
| Headlight Right Defective | Repair |

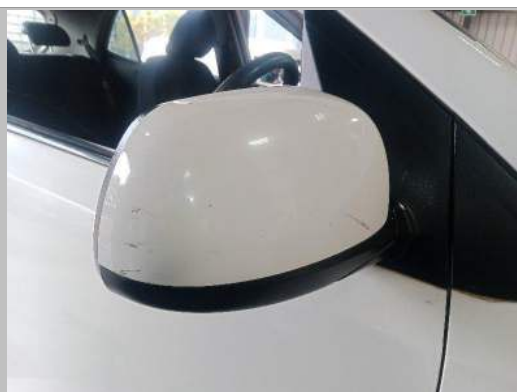
| Damage | Repair Way |
|---|---|
| Side Mirror Right Paintwork • Scratched | Repair |

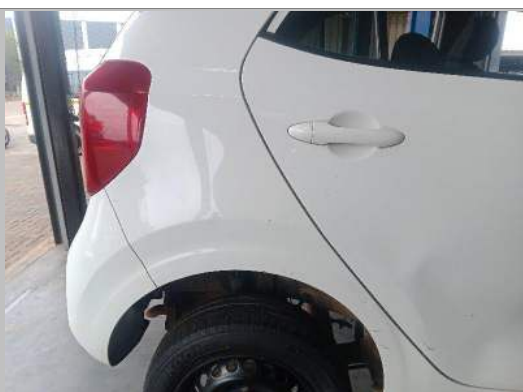
| Damage | Repair Way |
|---|---|
| Rear Fender Right Dented | Repair |

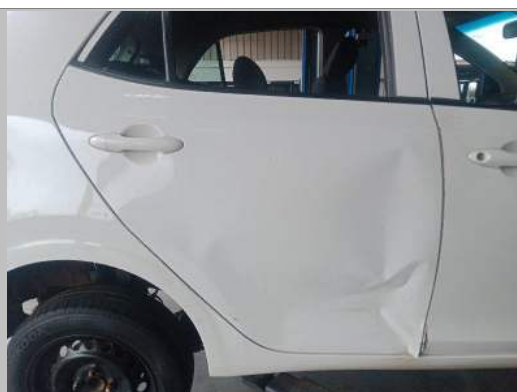
| Damage | Repair Way |
|---|---|
| Door Rear Right Dented | Repair |

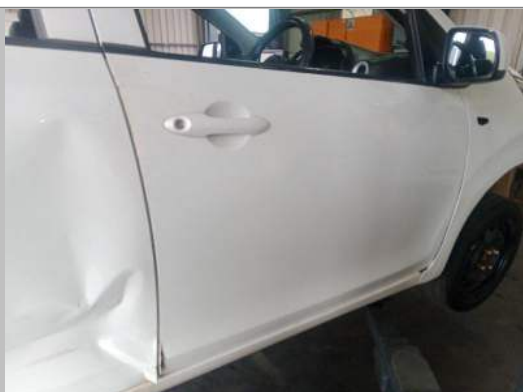
| Damage | Repair Way |
|---|---|
| Door Front Right Paintwork • Discoloured | Repair |

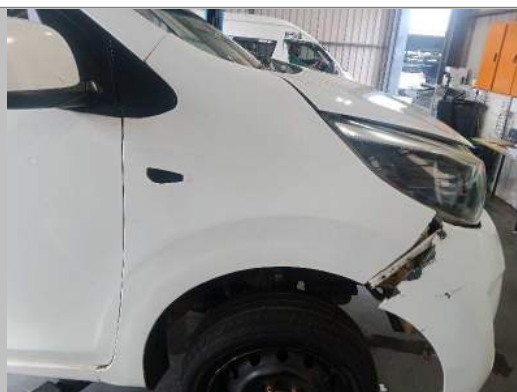
| Damage | Repair Way |
|---|---|
| Front Fender Right Paintwork • Discoloured | Repair |

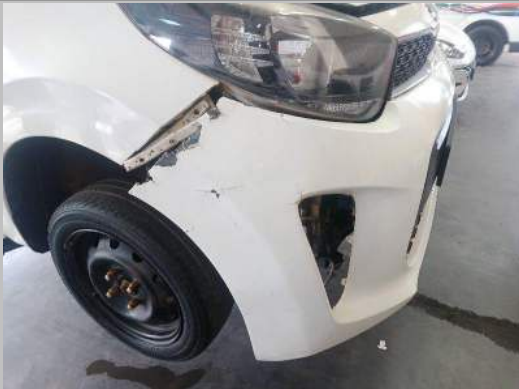
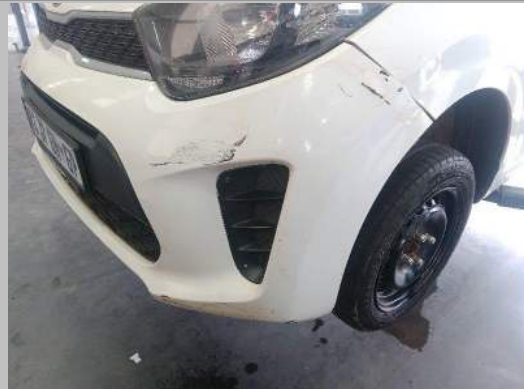
| Damage | Repair Way |
|---|---|
| Front Bumper Damaged | Repair |

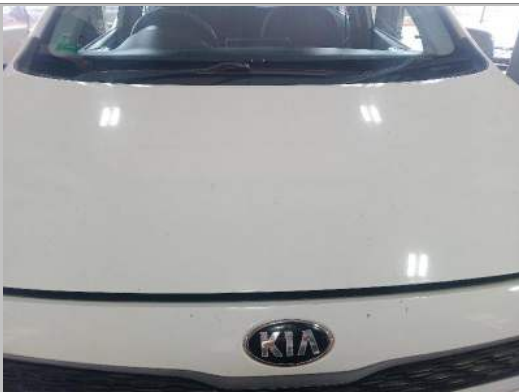
| Damage | Repair Way |
|---|---|
| Bonnet Paintwork • Scratched | Repair |

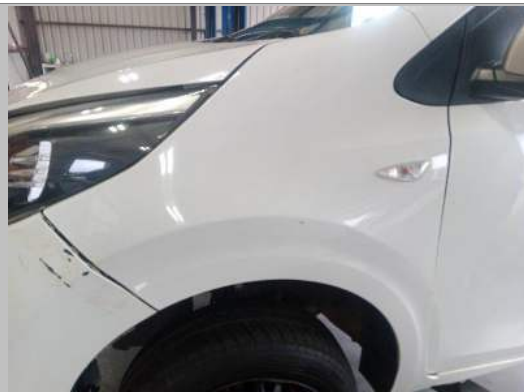
| Damage | Repair Way |
|---|---|
| Front Fender Left Paintwork • Scratched | Repair |

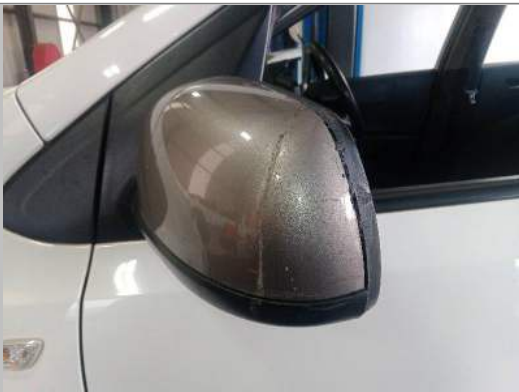
| Damage | Repair Way |
|---|---|
| Side Mirror Left Damaged | Repair |

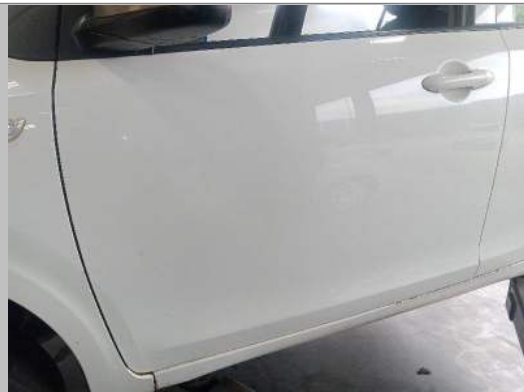
| Damage | Repair Way |
|---|---|
| Door Front Left Dented | Repair |

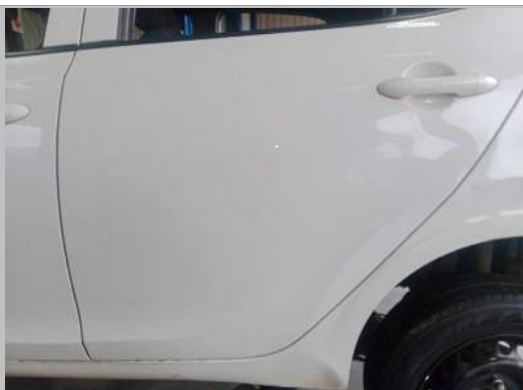
| Damage | Repair Way |
|---|---|
| Door Rear Left Paintwork • Scratched | Repair |

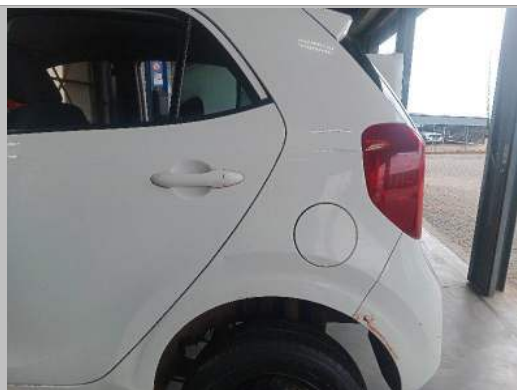
| Damage | Repair Way |
|---|---|
| Rear Fender Left Dented | Repair |

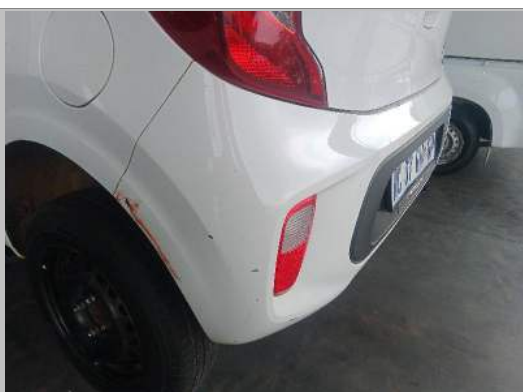
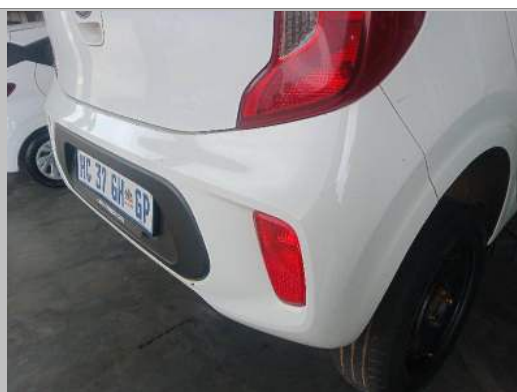
| Damage | Repair Way |
|---|---|
| Rear bumper Paintwork • Scratched | Repair |

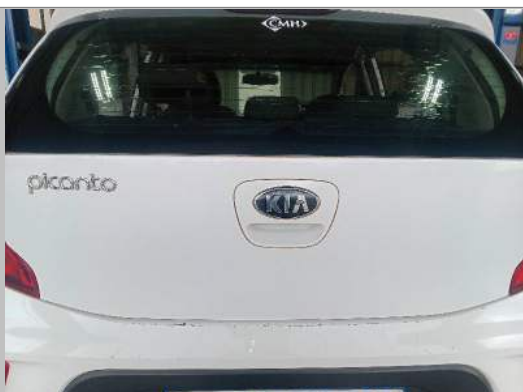
| Damage | Repair Way |
|---|---|
| Boot Lid / Hatch door Paintwork • Scratched | Repair |

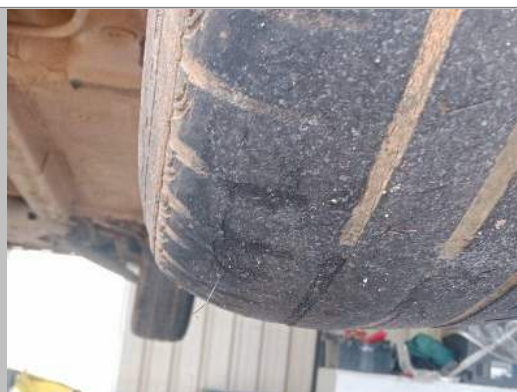
| Damage | Repair Way |
|---|---|
| Tyre Rear Right Damaged | Replace |

| | Size | Load/Speed Index | Manufacture | Model | Type* | Production Date | Tread Depth (mm) |
|---|---|---|---|---|---|---|---|
| Rear Right | 175/65R14 | 82T | Hankook | Optimo | V | 1519 | 0 mm |

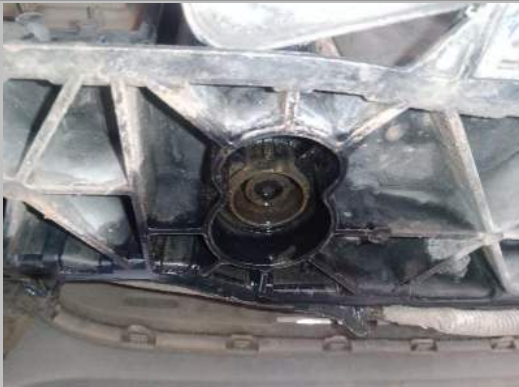
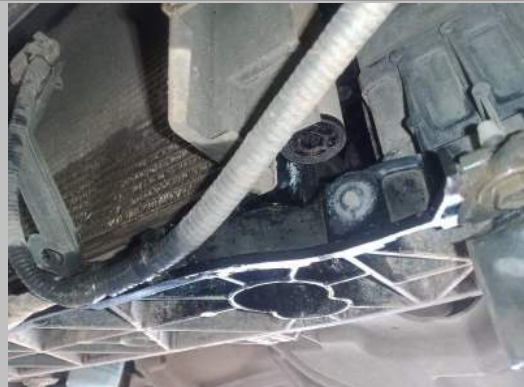
| Damage | Repair Way |
|---|---|
| Radiator Water Leak | Repair |

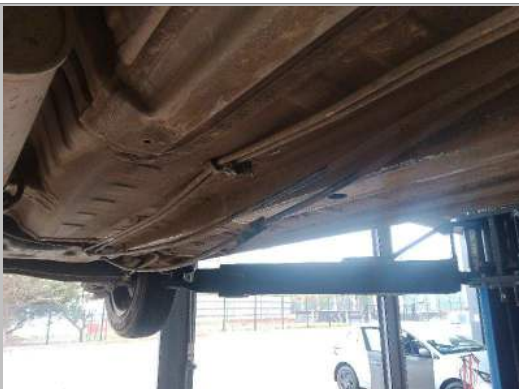
| Damage | Repair Way |
|---|---|
| Brake Piping Defective | Repair |

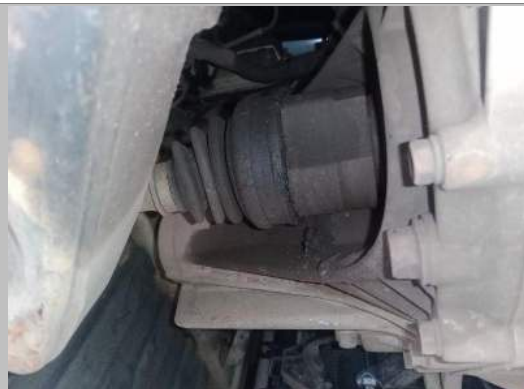
| Damage | Repair Way |
|---|---|
| CV Joint(s) Boot(s) Front Left (inner/outer) Defective | Repair |

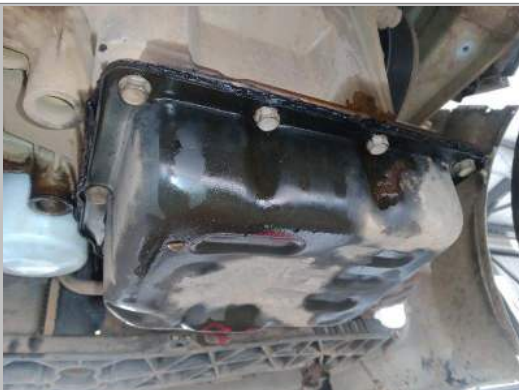
| Damage | Repair Way |
|---|---|
| Engine Oil Leak | Repair |

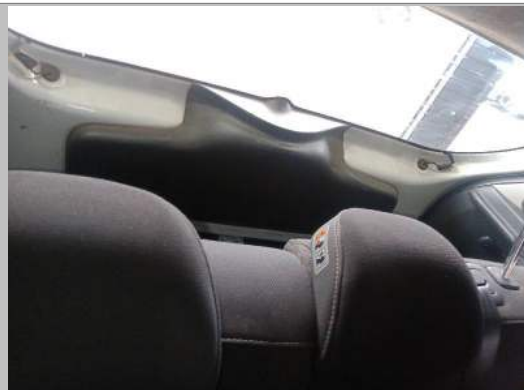
| Damage | Repair Way |
|---|---|
| Parcel Tray Missing | Replace |

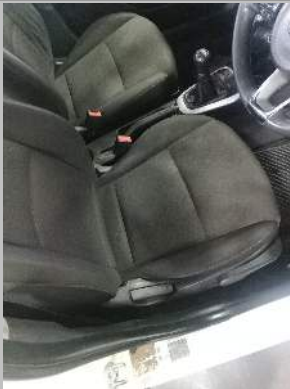
| Damage | Repair Way |
|---|---|
| Seat Front Right Loose / Excessive Play | Repair |

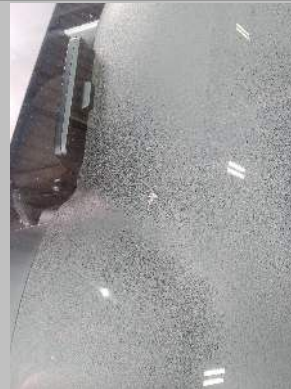
| Damage | Repair Way |
|---|---|
| Windscreen Chipped | Repair |

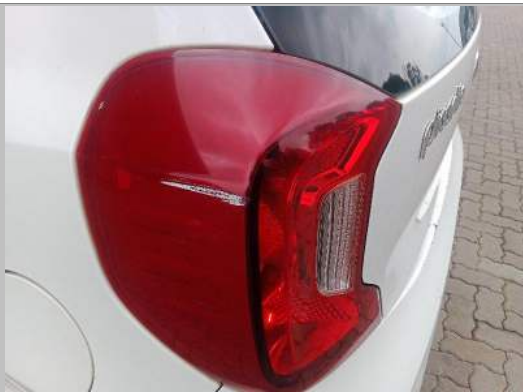
| Damage | Repair Way |
|---|---|
| Tail Light Left Scratched | Repair |

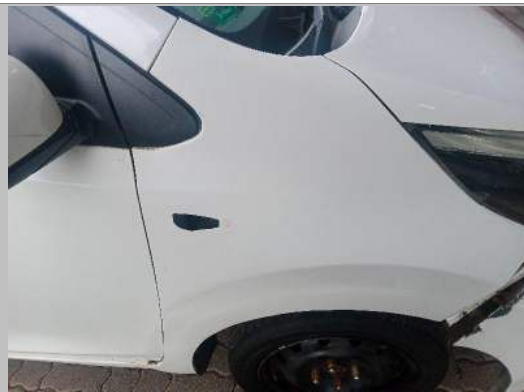
| Damage | Repair Way |
|---|---|
| Indicator Light Front Right Missing | Replace |
