CONDITION REPORT

Report No: 2016209948

MFC Auction House  
M57 Pretoria Rd, Glenmarais, KEMPTON PARK  
Gauteng

| Manufacturer | KIA | Registration Number | KN02HNGP |

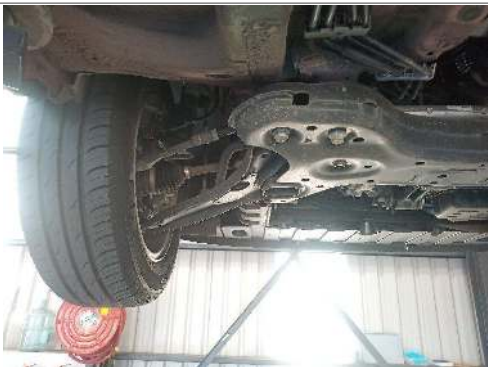
LF TYRE TREAD

| | Size | Load/Speed Index | Manufacture | Model | Type* | Production Date | Tread Depth (mm) |
|---|---|---|---|---|---|---|---|
| Front Left | 175/65R14 | 86T | Nexen | Radial | V | 4521 | 2 mm |

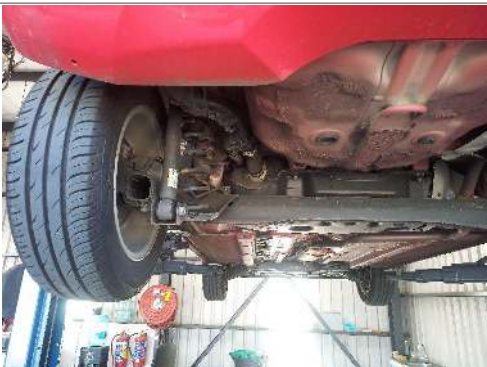
LR TYRE TREAD

| | Size | Load/Speed Index | Manufacture | Model | Type* | Production Date | Tread Depth (mm) |
|---|---|---|---|---|---|---|---|
| Rear Left | 175/65R14 | 86T | Nexen | Radial | V | 4521 | 2 mm |

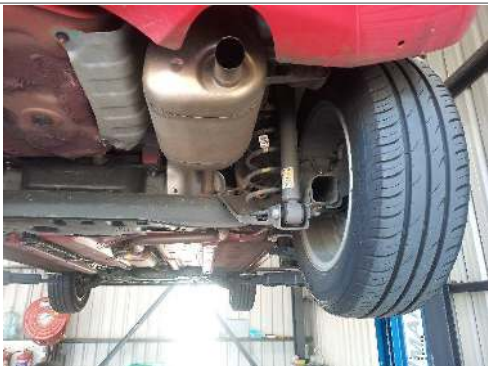
RR TYRE TREAD

| | Size | Load/Speed Index | Manufacture | Model | Type* | Production Date | Tread Depth (mm) |
|---|---|---|---|---|---|---|---|
| Rear Right | 175/65R14 | 86T | Nexen | Radial | V | 4721 | 2 mm |

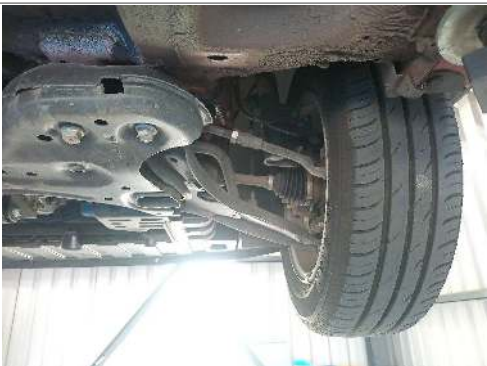
RF TYRE TREAD

| | Size | Load/Speed Index | Manufacture | Model | Type* | Production Date | Tread Depth (mm) |
|---|---|---|---|---|---|---|---|
| Front Right | 175/65R14 | 86T | Nexen | Radial | V | 4721 | 2 mm |

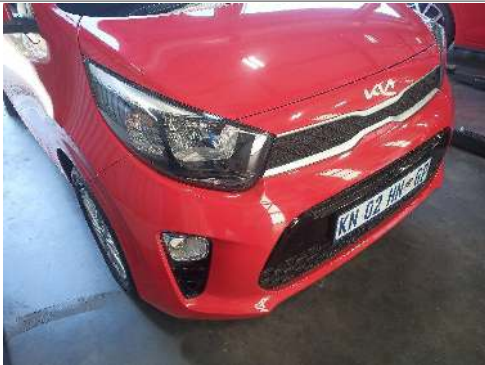
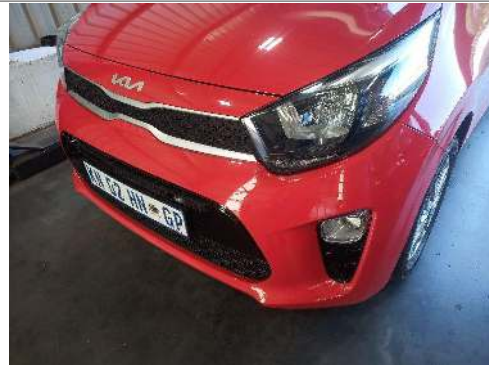
| Damage | Repair Way |
|---|---|
| Front Bumper Damaged | Repair |

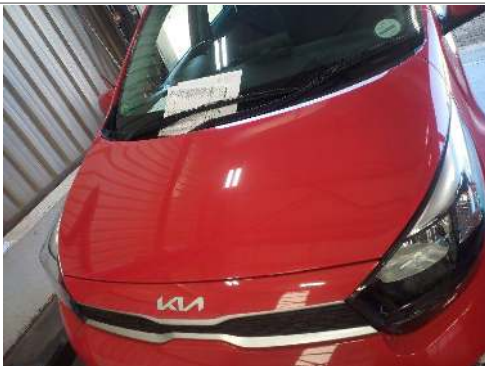
| Damage | Repair Way |
|---|---|
| Bonnet Damaged | Repair |

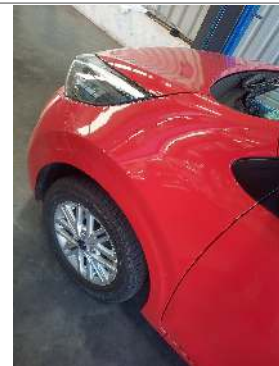
| Damage | Repair Way |
|---|---|
| Front Fender Left Damaged | Repair |

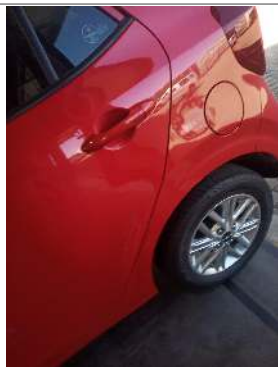
| Damage | Repair Way |
|---|---|
| Rear Fender Left Damaged | Repair |

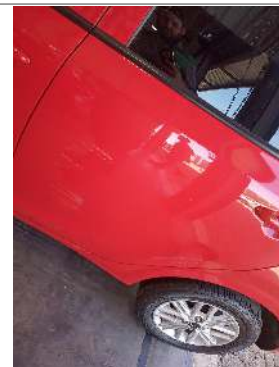
| Damage | Repair Way |
|---|---|
| Door Rear Left Damaged | Repair |

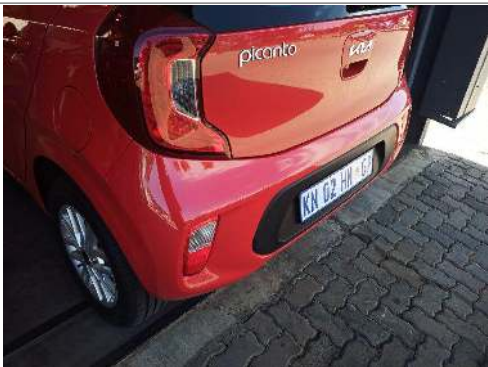
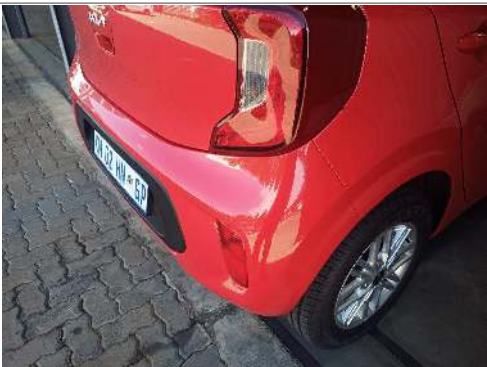
| Damage | Repair Way |
|---|---|
| Rear bumper Damaged | Repair |
