## CONDITION REPORT

2017296801

MFC Auction House  
M57 Pretoria Rd, Glenmarais, KEMPTON PARK  
Gauteng

| Model | RIO 1.4 TEC 5-DR [2015-2018] | Register Number | |

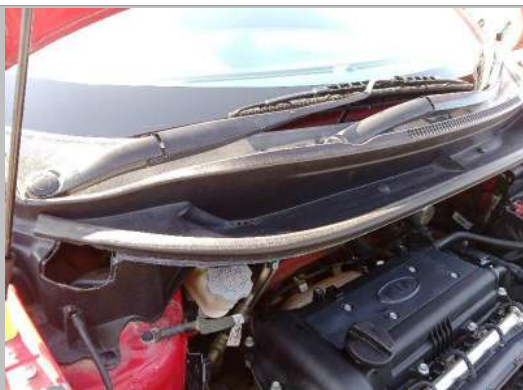
| Wiper valance damaged | Replace |

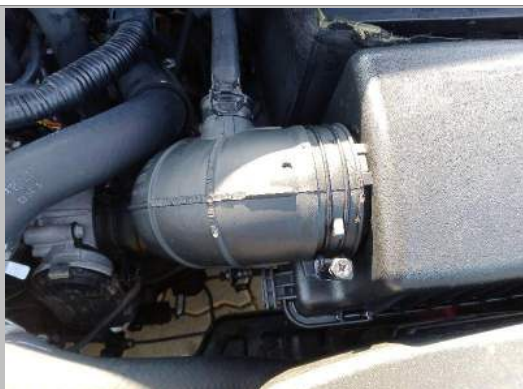
| Air cleaner Damaged | Replace |

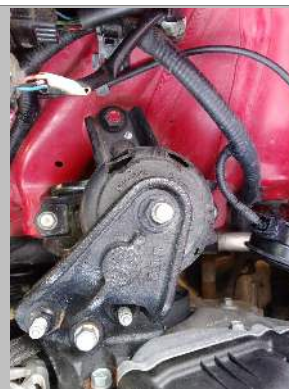
| Engine mountings Damaged | Replace |

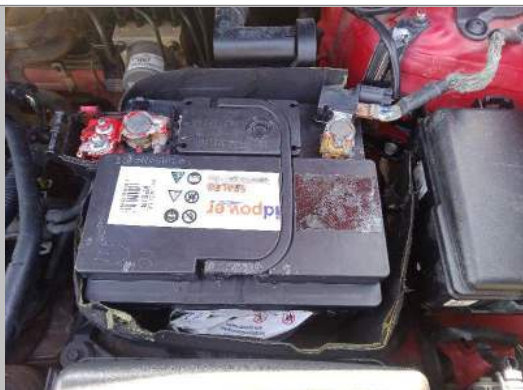
| Battery box Damaged | Replace |

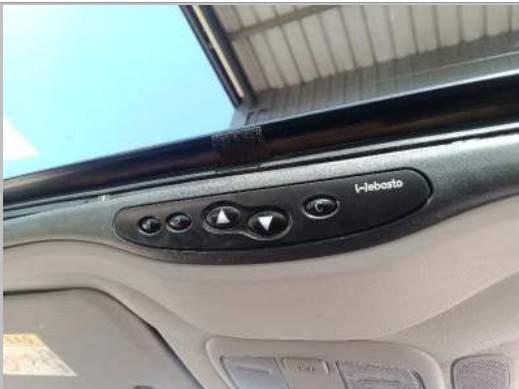
| Sun Roof Switch Malfunction | Replace |

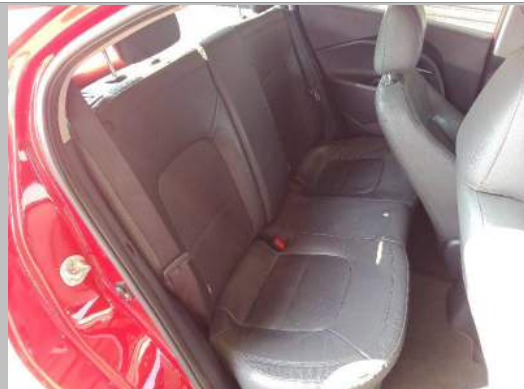
| Seat Rear Loose / Excessive Play | Repair |

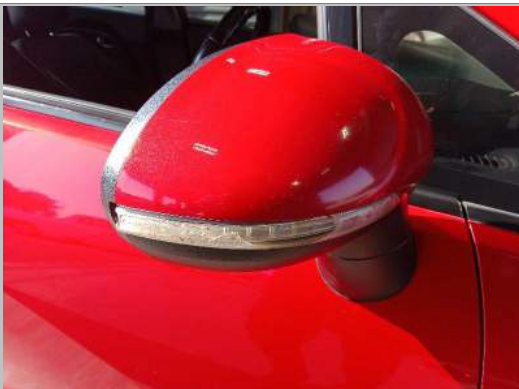
| Indicator Light Front Right Damaged | Replace |

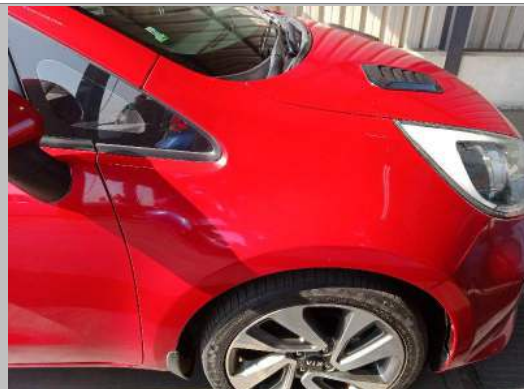
| Front Fender Right Residual Traces of Repair | Repair |

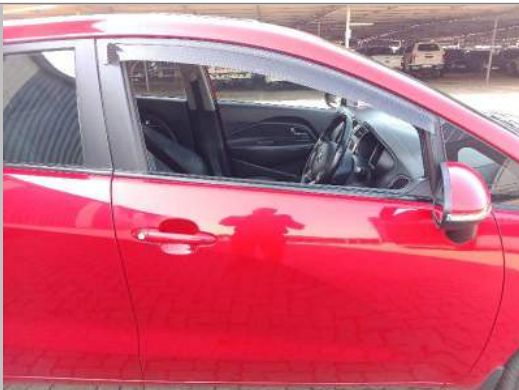
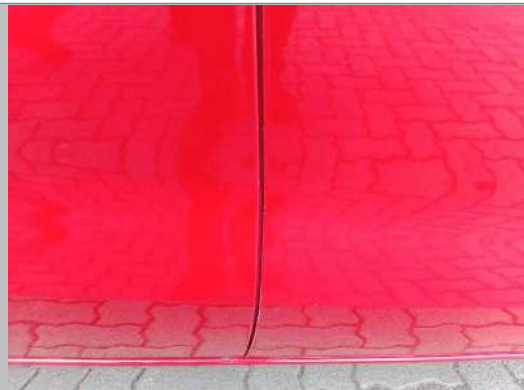
| Door Front Right Paintwork • Scratched | Repair |

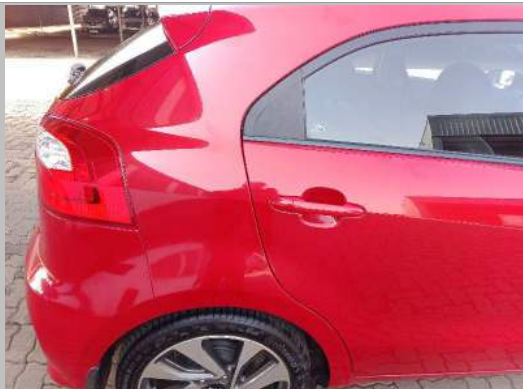
| Rear Fender Right Residual Traces of Repair | Repair |

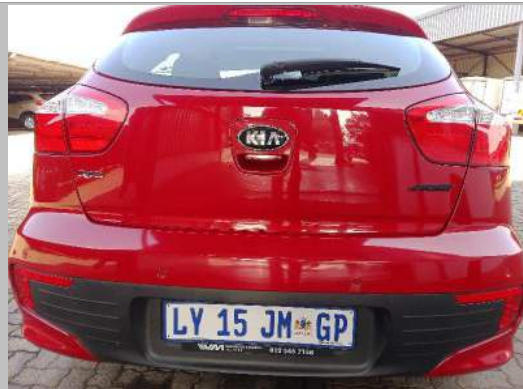
| Rear bumper Residual Traces of Repair | Repair |

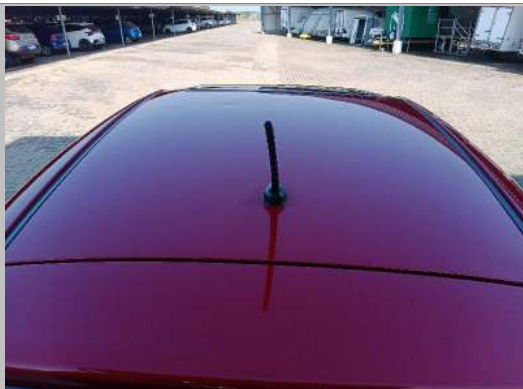
| Roof Dented | Repair |

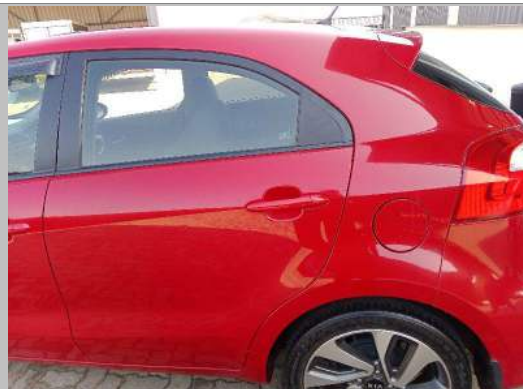
| Rear Fender Left Dented | Repair |

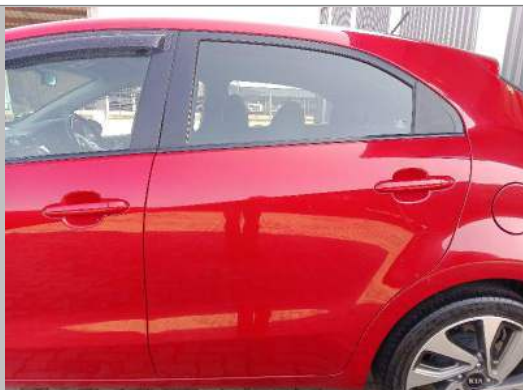
| Door Rear Left Dented | Repair |

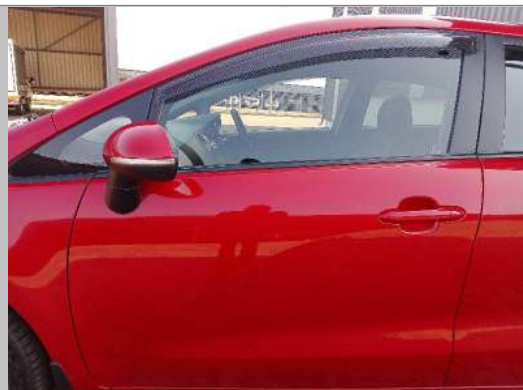
| Door Front Left Dented | Repair |

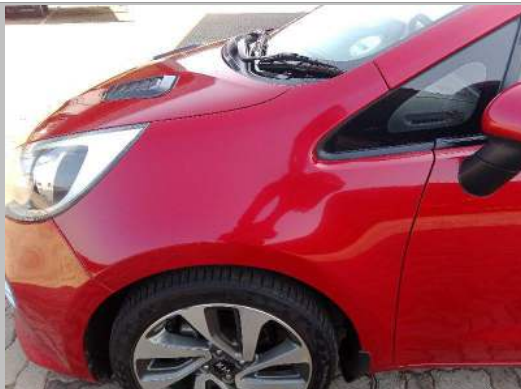
| Front Fender Left Residual Traces of Repair | Repair |

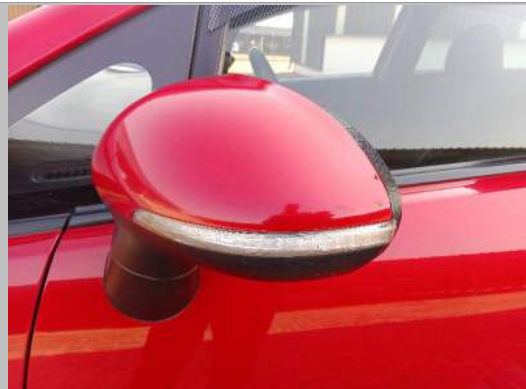
| Indicator Light Front Left Damaged | Replace |

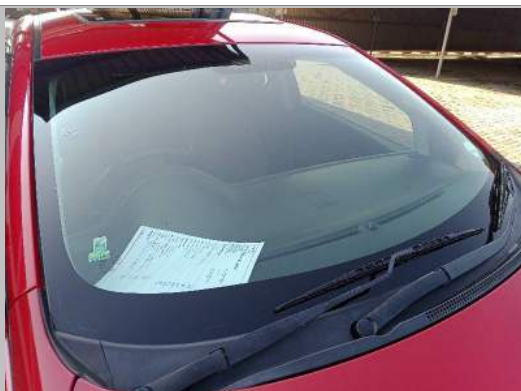
| Windscreen Chipped | Repair |

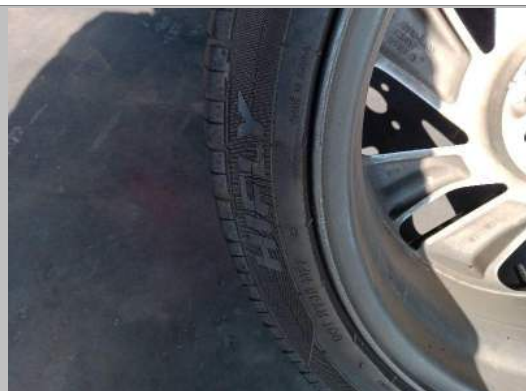
| Spare Tyre Damaged | Replace |

| | Size | Load/Speed Index | Manufacture | Model | Type* | Production Date | Tread Depth (mm) |
|---|---|---|---|---|---|---|---|
| Spare | 205/45 R17 | 88W | Hify | HF805 | V | 0817 | 1 mm |

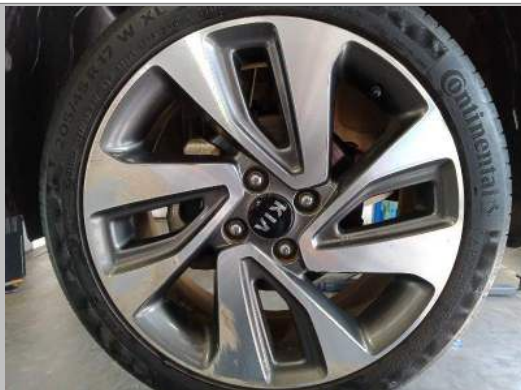
| Rim Front Left Scratched | Repair |

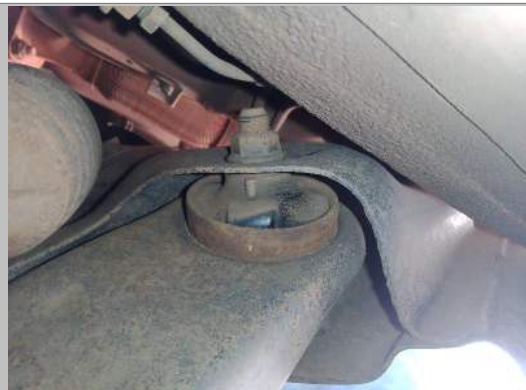
| Control Arm Bush(es) Front Axle Left Cracked | Replace |

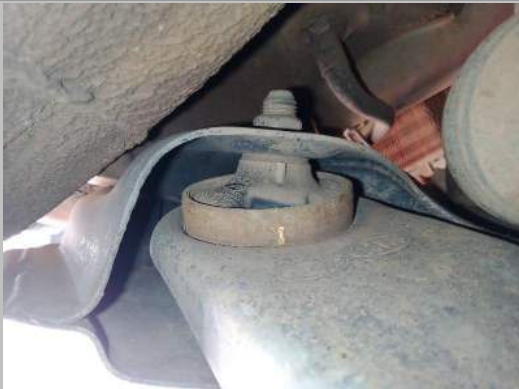
| Control Arm Bush(es) Front Axle Right Cracked | Replace |

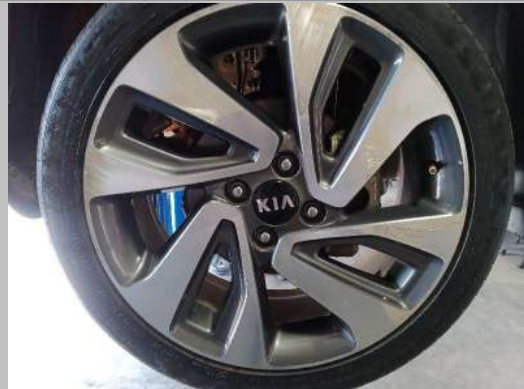
| Rim Front Right Scratched | Repair |

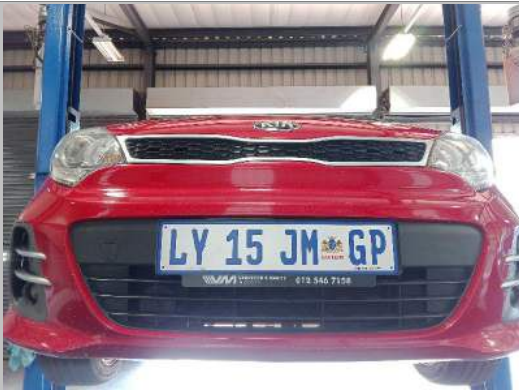
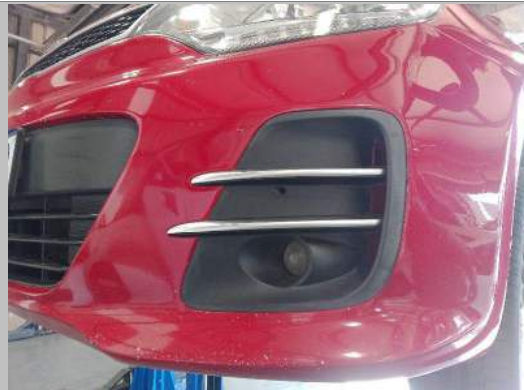
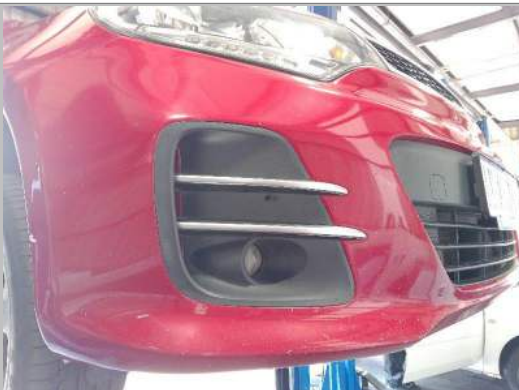
| Front Bumper Paintwork • Chipmarks | Repair |

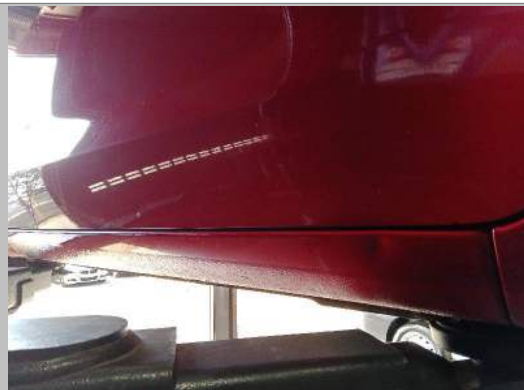
| Sill Panel Right Dented | Repair |

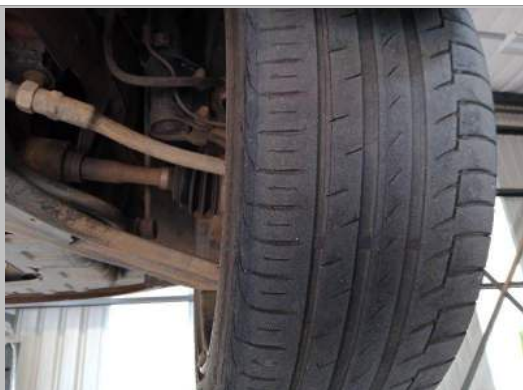
| Tyre Front Right Worn | Replace |

| | Size | Load/Speed Index | Manufacture | Model | Type* | Production Date | Tread Depth (mm) |
|---|---|---|---|---|---|---|---|
| Front Right | 205/45 R17 | 88W | Continental | Premium | V | 3319 | 0 mm |

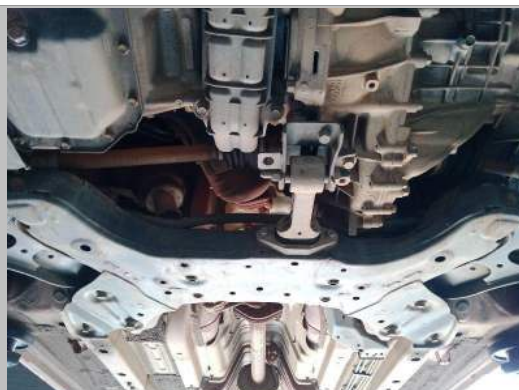
| Sub Frame Dented | Repair |

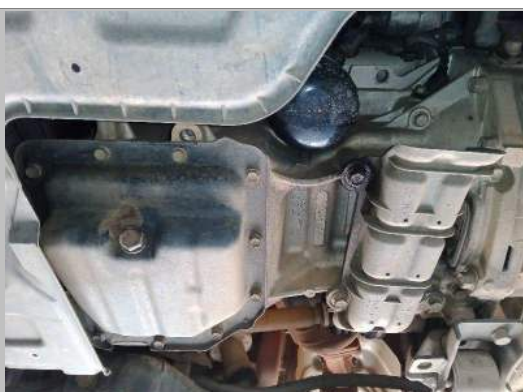
| Engine Oil Sweat | Repair |

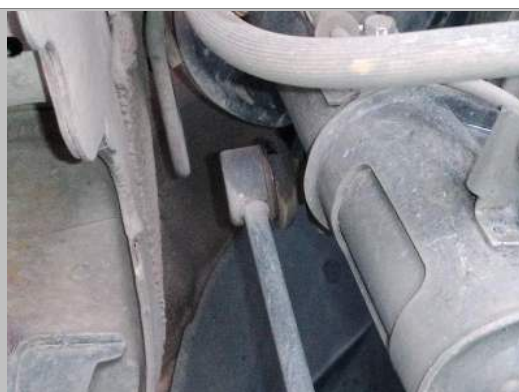
| Stabilizer Mounting Front Right Damaged | Replace |

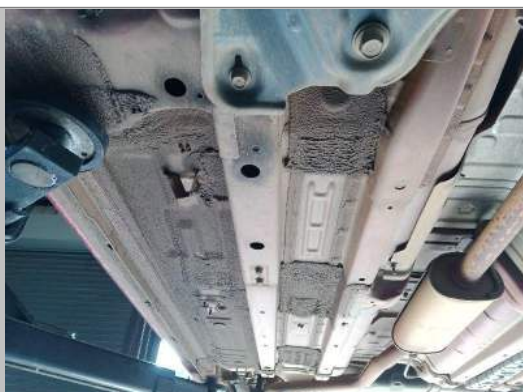
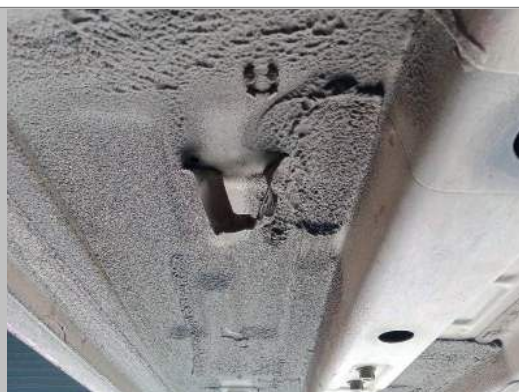
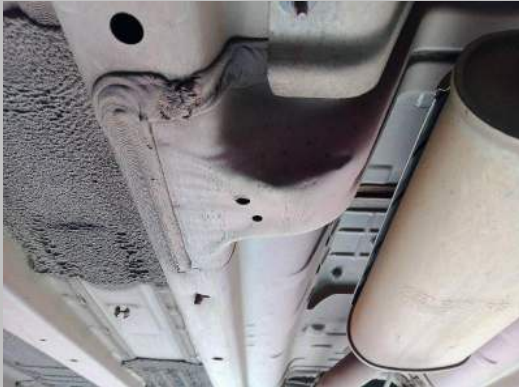
| Chassis Damaged | Repair |

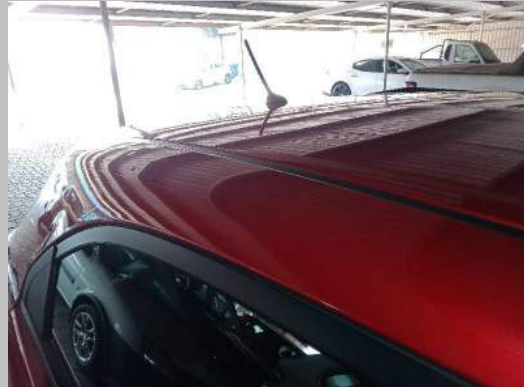
| C • Pillar Right Dented | Repair |
