CONDITION REPORT

Report No: 2016202101

MFC Auction House
M57 Pretoria Rd, Glenmarais, KEMPTON PARK
Gauteng

Vehicle Type	PASSENGER VEHICLE	Registered Owner	MFC
Manufacturer	KIA	Registration Number	DT97FYGP
Model	RIO	Register Number	
VIN	KNADN512LF6560805	Date Of First Licensing	
Engine Number		Last COR	
Doors	5	License Expiry Date	30/11/2022
Color	SILVER	Power / Displacement	
Year Model		Paint Finish	M - METALLIC
Km Reading	168,237 KM	Fuel	PETROL
Cab / Body Type	HATCHBACK	Transmission	MANUAL

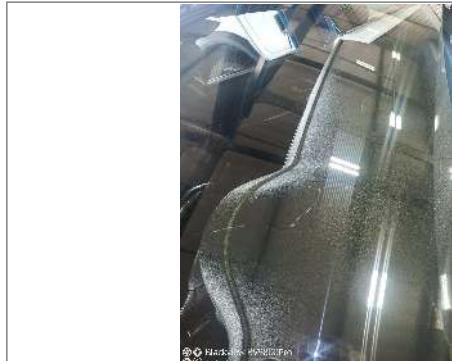
Damage	Repair Way
Engine Oil Leak	Repair
Tail Light Right Damaged	Replace
Dim Light Left Malfunction	Repair
Dim Light Right Malfunction	Repair
Fog Light Front Left Missing	Replace
Fog Light Front Right Defective	Repair
Seat Front Right Damaged	Repair
Gear Lever Dust Boot Damaged	Repair
Side Mirror Right Paintwork • Scratched	Repair
Front Bumper Paintwork • Scratched	Repair
Front Fender Left Dented	Repair
Front Fender Right Paintwork • Scratched	Repair
Rear Fender Left Dented	Repair
Rear Fender Right Dented	Repair
Door Front Left Paintwork • Scratched	Repair
Door Front Right Paintwork • Scratched	Repair
Door Rear Left Paintwork • Scratched	Repair
Door Rear Right Paintwork • Scratched	Repair
Sealing / Rubber Rear Door Left Missing	Replace
Sealing / Rubber Rear Door Right Damaged	Replace
Rear bumper Paintwork • Scratched	Repair
Sill Panel Left Dented	Repair
Sill Panel Right Dented	Repair
Windscreen Cracked	Replace
Tyre Front Left Torn / Cut	Replace
