CONDITION REPORT

Report No: 2016218798

MFC Auction House  
M57 Pretoria Rd, Glenmarais, KEMPTON PARK  
Gauteng

| Manufacturer | HAVAL | Registration Number | KW26LWGP |

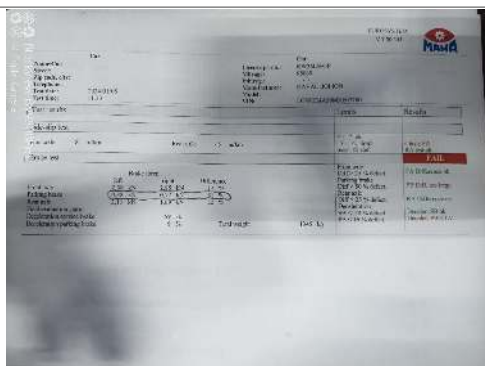
## Brake report

| Damage | Repair Way |
|---|---|
| Parking Brake Performance Left / Right Difference out of legal range | Repair |

| Parking brake | 0,38 kN | 0,77 kN | 51 % |

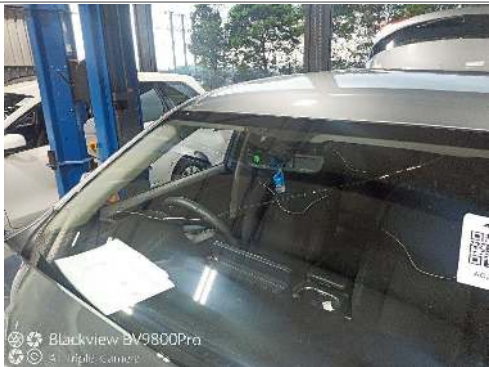
| Damage | Repair Way |
|---|---|
| Windscreen Cracked | Replace |

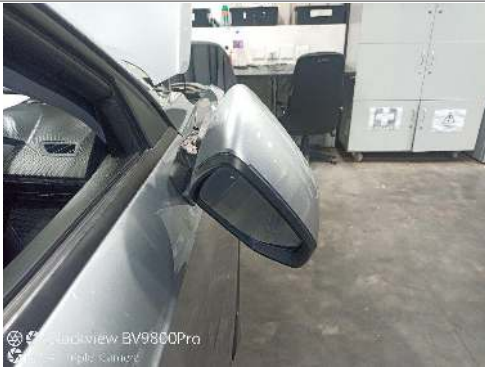
| Damage | Repair Way |
|---|---|
| Side Mirror Right Damaged | Repair |

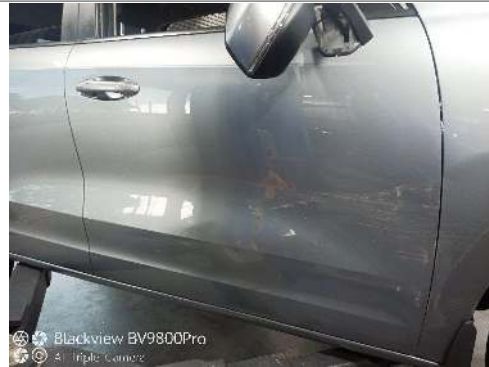
| Damage | Repair Way |
|---|---|
| Door Front Right Dented | Repair |

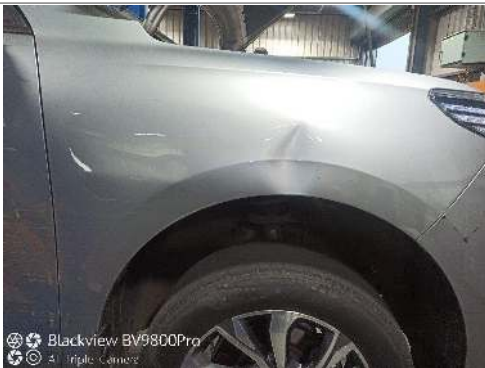
| Damage | Repair Way |
|---|---|
| Front Fender Right Dented | Repair |

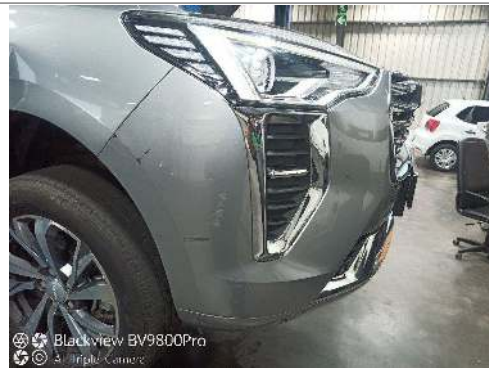
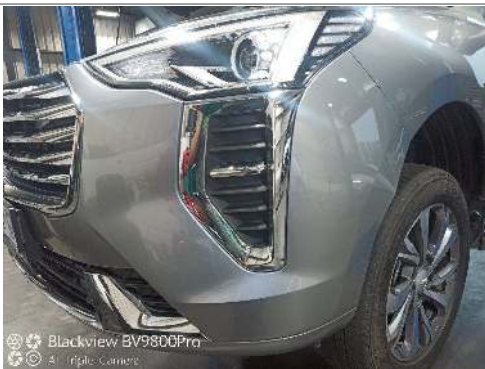
| Damage | Repair Way |
|---|---|
| Front Bumper Paintwork • Scratched | Repair |

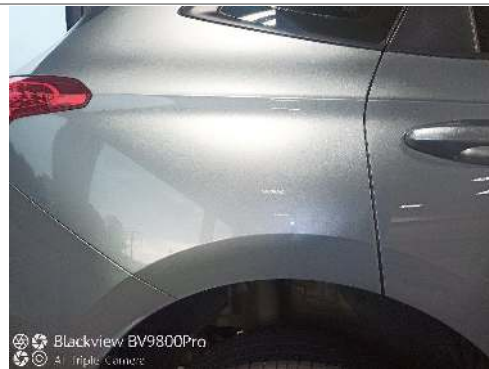
| Damage | Repair Way |
|---|---|
| Rear Fender Right Dented | Repair |

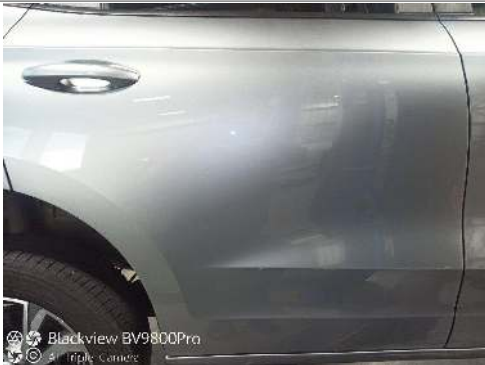
| Damage | Repair Way |
|---|---|
| Door Rear Right Paintwork • Scratched | Repair |

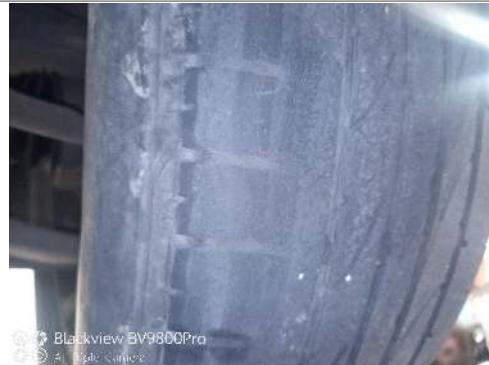
| Damage | Repair Way |
|---|---|
| Tyre Front Right Smooth | Replace |

| | Size | Load/Speed Index | Manufacture | Model | Type* | Production Date | Tread Depth (mm) |
|---|---|---|---|---|---|---|---|
| Front Right | 215/60R17 | 96H | Bridgestone | Alenza | V | 3418 | 0 mm |

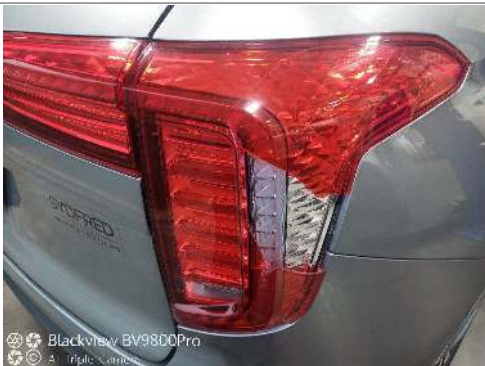
| Damage | Repair Way |
|---|---|
| Tail Light Right Damaged | Replace |
