MFC Auction House  
M57 Pretoria Rd, Glenmarais, KEMPTON PARK  
Gauteng

Vehicle Type	LIGHT LOAD VEHICLE	Registered Owner	
Manufacturer	CHANGAN	Registration Number	JW70FMGP
Model	STAR III SC 1.3 STD [2017-2021]	Register Number	
VIN	LSCAB13RXKG805521	Date Of First Licensing	
Engine Number		Last COR	
Doors	2	License Expiry Date	31/01/2022
Color	SILVER	Power / Displacement	
Year Model	2020	Paint Finish	M - METALLIC
Km Reading	81,002 KM	Fuel	PETROL
Cab / Body Type	SINGLE CAB	Transmission	MANUAL

## CONDITION REPORT

Report No: 2016606537

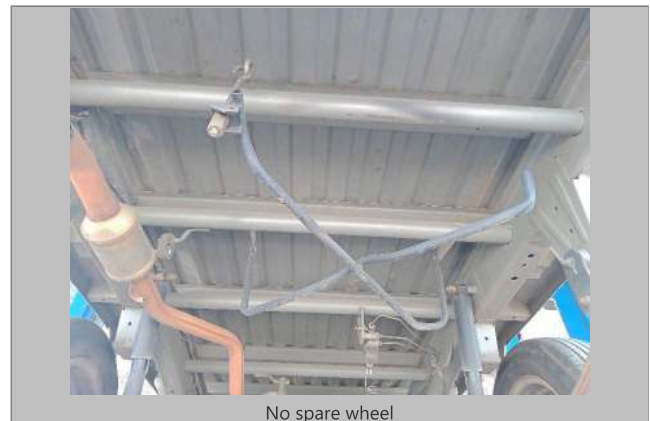
No spare wheel

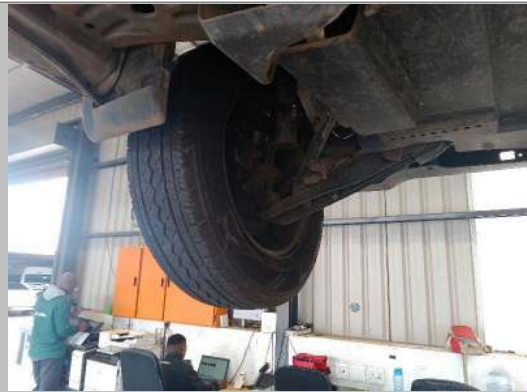
LF TYRE TREAD

Size	Load/Speed Index	Manufacture	Model	Type*	Production Date	Tread Depth (mm)
Front Left	175/70R14	99/97S	Haida	Strong HD517	V	1518	3 mm
Front Right	175/70R14	99/97S	Haida	Strong HD517	V	1518	1 mm
Rear Left	175/70R14	99/97S	Haida	Strong HD517	V	1518	1 mm
Rear Right	175/70R14	88T	Davanti	Dx390	V	3620	3 mm

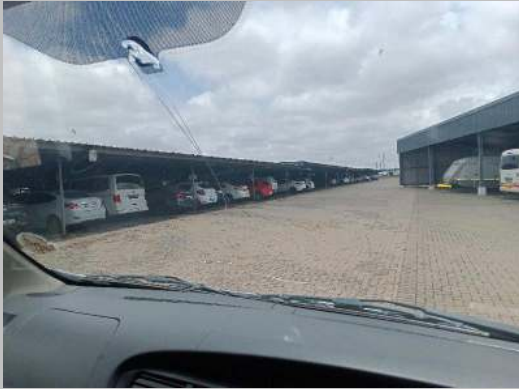
Damage	Repair Way
Interior Mirror Missing	Replace
Side Mirror Left Paintwork • Scratched	Repair
Side Mirror Right Paintwork • Scratched	Repair
Front Bumper Paintwork • Scratched	Repair
Bonnet Paintwork • Chipmarks	Repair
A • Pillar Right Dented	Repair
B • Pillar Left Paintwork • Scratched	Repair
Front Fender Left Paintwork • Scratched	Repair
Door Front Left Paintwork • Discoloured	Repair
Door Front Right Paintwork • Discoloured	Repair
Tailgate Paintwork • Scratched	Repair
Load Body Paintwork • Scratched	Repair
Windscreen Cracked	Replace
Parking Brake Performance Left / Right Difference out of legal range	Repair
Belly plates Damaged	Replace
Body exterior	Vehicle got minor scratches, stone chips and dents
Body exterior	Discoloring on some body panels
Windscreen washers not working	Repair
Body exterior	Signs of spray work done on some body panels
Canopy door missing	Replace
Body exterior	Signs of branding on some body panels
