## CONDITION REPORT

2017154923

| Manufacturer | VOLVO | Registration Number | MB33SKGP |
| Model | XC40 B4 2.0 MHEV PLUS DARK GEARTRONIC [2022-2023] | Register Number | |

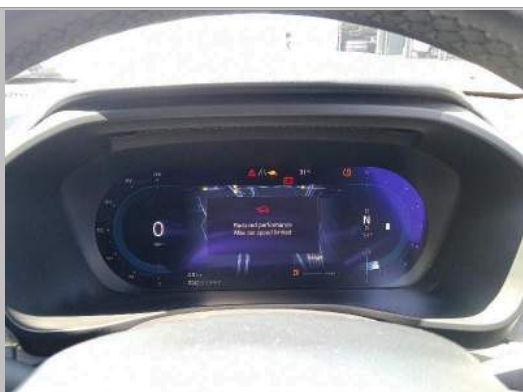
DASHBOARD (W/ ENGINE RUNNING)

| Damage | Repair Way |
|---|---|
| Warning lights illuminated on dashboard | Repair |

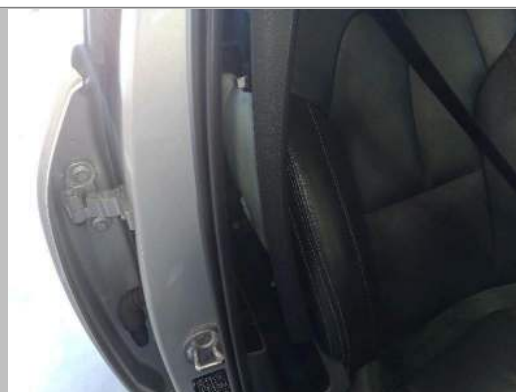
Driver interior B pillar plast

| Damage | Repair Way |
|---|---|
| Interior | Driver's interior B pillar plastic cover loose |

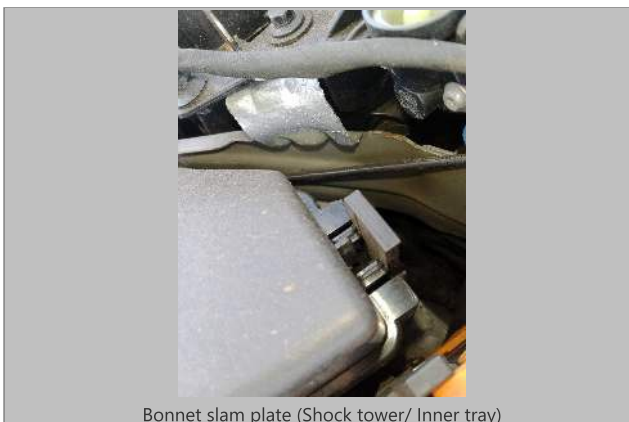
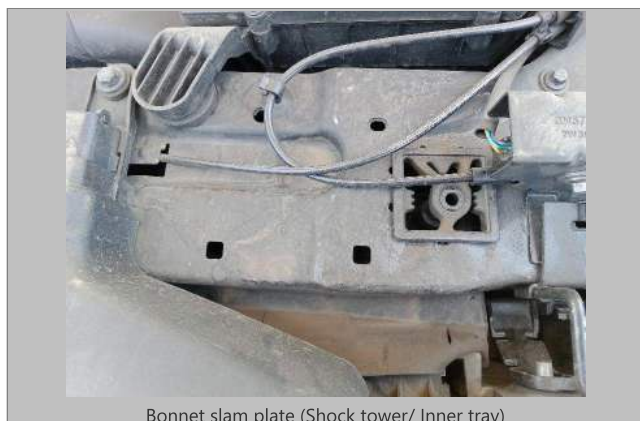
| Damage | Repair Way |
|---|---|
| Bonnet slam plate (Shock tower/ Inner tray) Damaged | Replace |

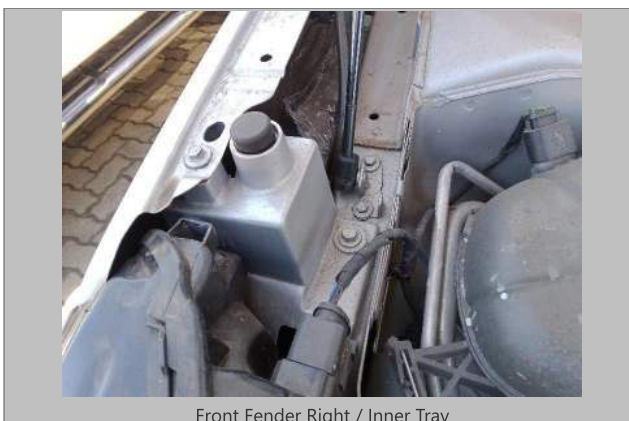
| Damage | Repair Way |
|---|---|
| Front Fender Right / Inner Tray Residual Traces of Repair | Repair |

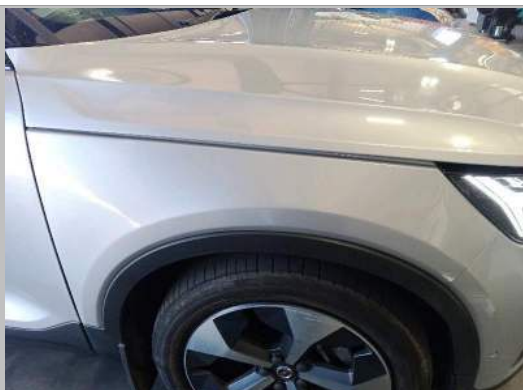
| Damage | Repair Way |
|---|---|
| Front Fender Right Residual Traces of Repair | Repair |

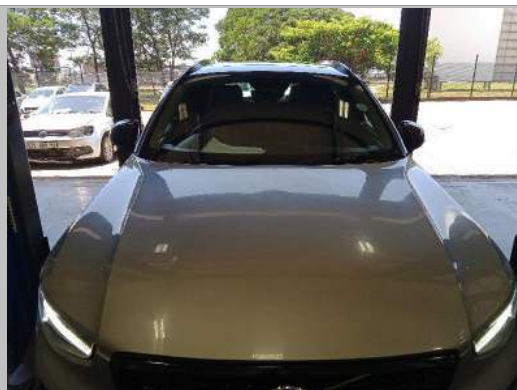
| Damage | Repair Way |
|---|---|
| Bonnet Residual Traces of Repair | Repair |

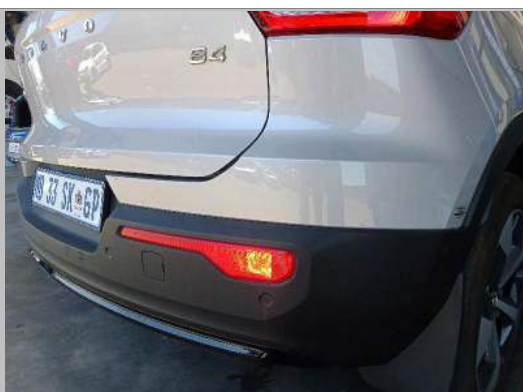
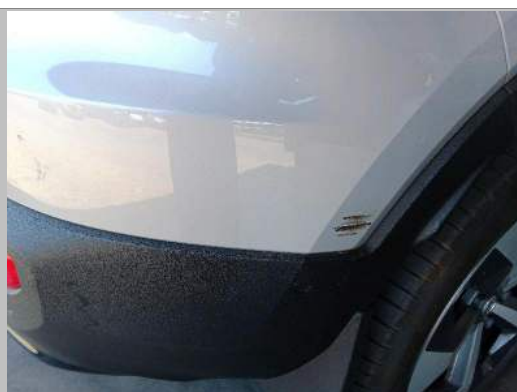
| Damage | Repair Way |
|---|---|
| Rear bumper Paintwork • Scratched | Repair |

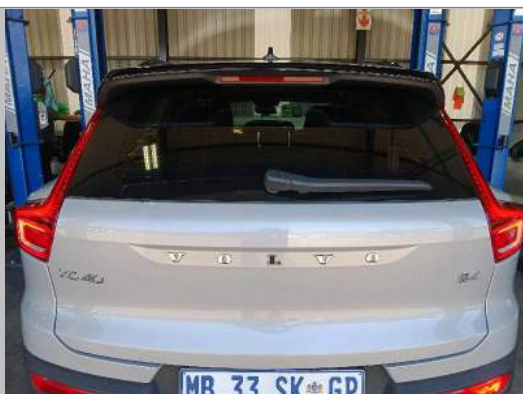
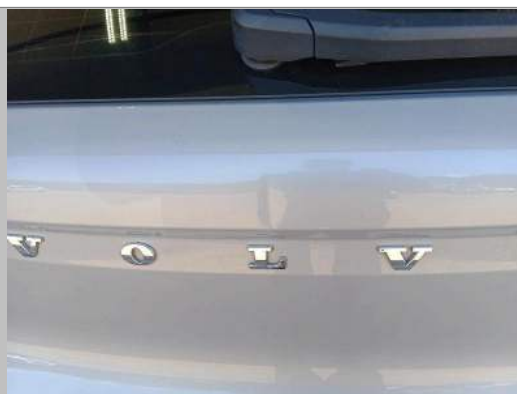
| Damage | Repair Way |
|---|---|
| Boot Lid / Hatch door Dented | Repair |

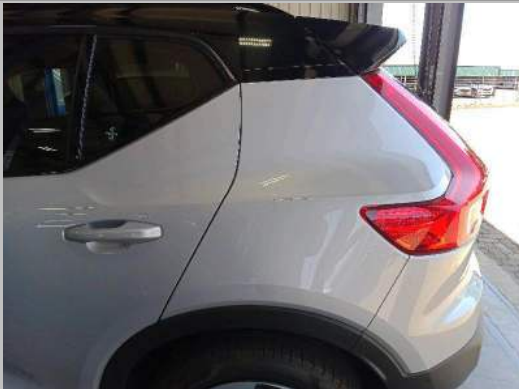
| Damage | Repair Way |
|---|---|
| Rear Fender Left Dented | Repair |

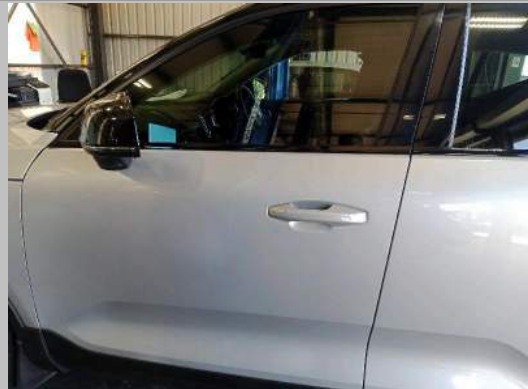
| Damage | Repair Way |
|---|---|
| Door Front Left Paintwork • Scratched | Repair |

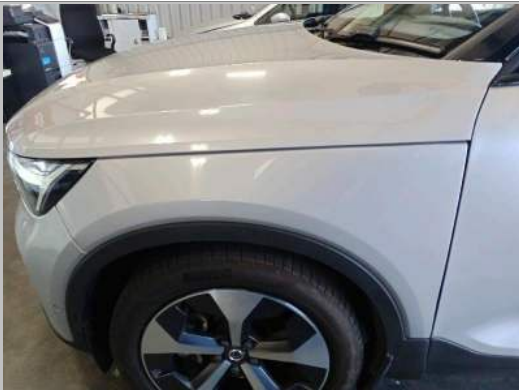
| Damage | Repair Way |
|---|---|
| Front Fender Left Residual Traces of Repair | Repair |

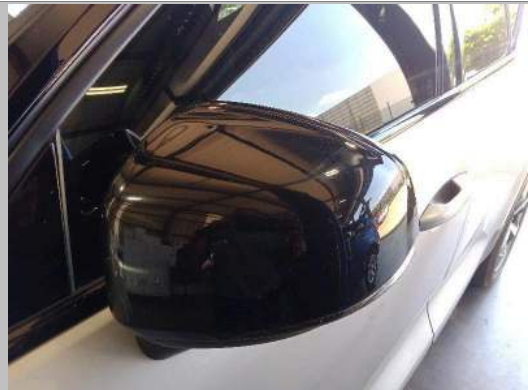
| Damage | Repair Way |
|---|---|
| Side Mirror Left Paintwork • Scratched | Repair |

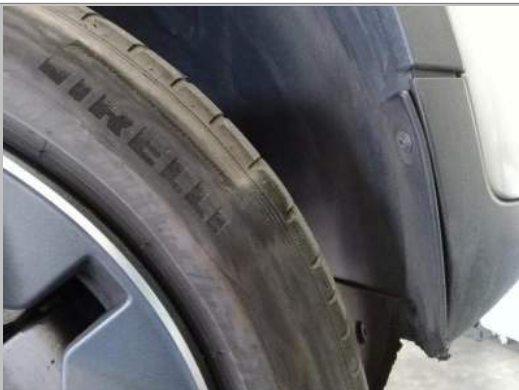
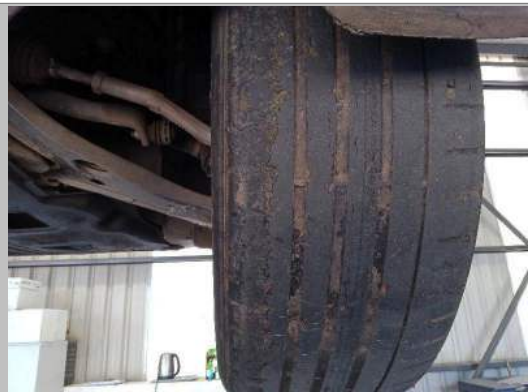
| Damage | Repair Way |
|---|---|
| Tyre Front Right Damaged | Replace |

| | Size | Load/Speed Index | Manufacture | Model | Type* | Production Date | Tread Depth (mm) |
|---|---|---|---|---|---|---|---|
| Front Right | 235/50 R19 | 99V | Pirelli | Pzero | V | 0422 | 0 mm |

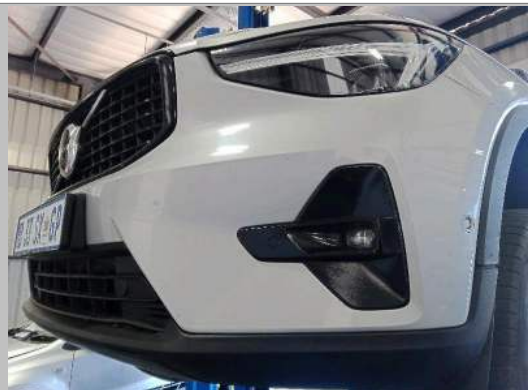
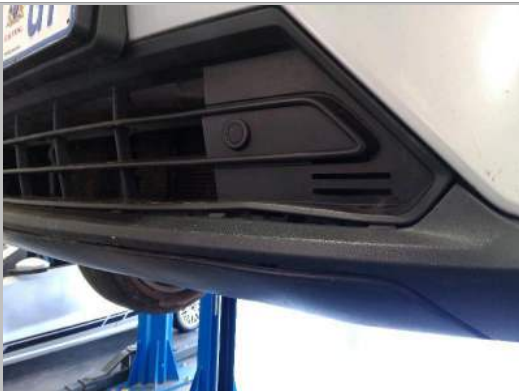
| Damage | Repair Way |
|---|---|
| Front Bumper Damaged | Repair |

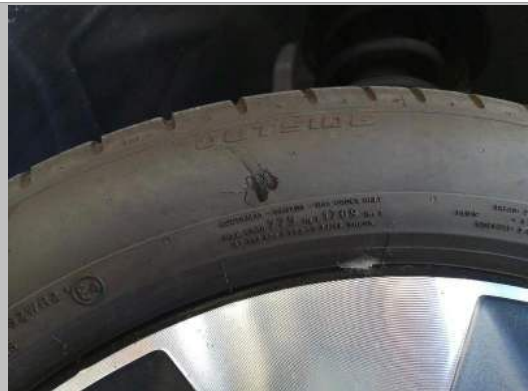
| Damage | Repair Way |
|---|---|
| Tyre Front Left Torn / Cut | Replace |

| | Size | Load/Speed Index | Manufacture | Model | Type* | Production Date | Tread Depth (mm) |
|---|---|---|---|---|---|---|---|
| Front Left | 235/50 R19 | 99V | Pirelli | Pzero | V | 0322 | 1 mm |

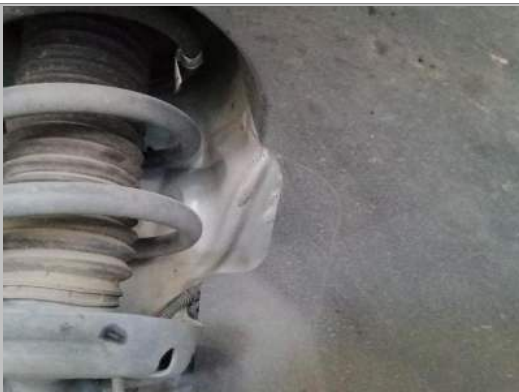
| Damage | Repair Way |
|---|---|
| Front Fender Left / Inner Tray Dented | Repair |

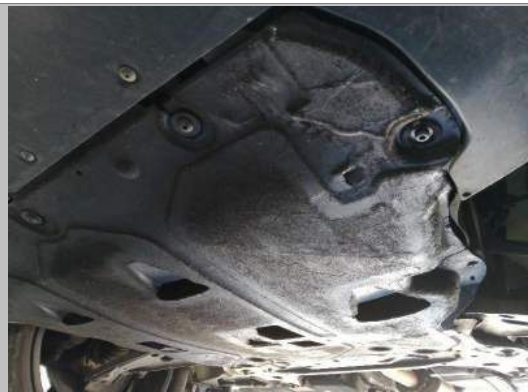
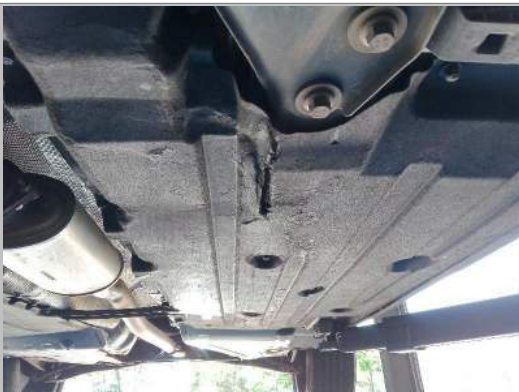
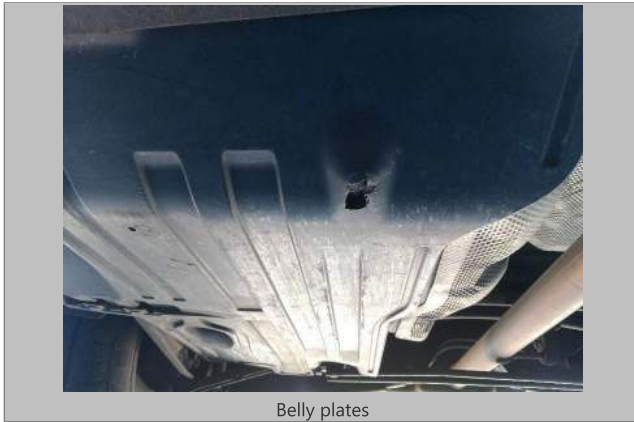
| Damage | Repair Way |
|---|---|
| Belly plates Damaged | Repair |
