CONDITION REPORT

Report No:  
2017299135  
DATE  
15/09/2026

| Manufacturer | SUZUKI | Registration Number | LHD680MP |
| Model | ERTIGA 1.5 GA MPV [2022-2025] | Register Number | |

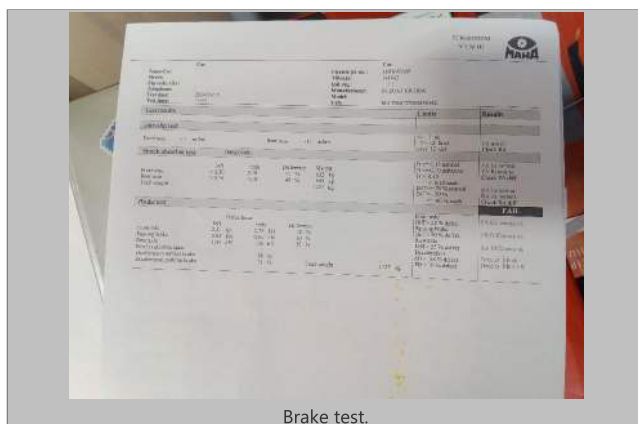
| | Left | Right | | |
|---|---|---|---|---|
| Front | 2.41 | 2.75 | - | |
| Rear | 1.41 | 1.66 | - | |
| Emergency / Parking | 0.85 | 0.94 | - | |

Brake test.

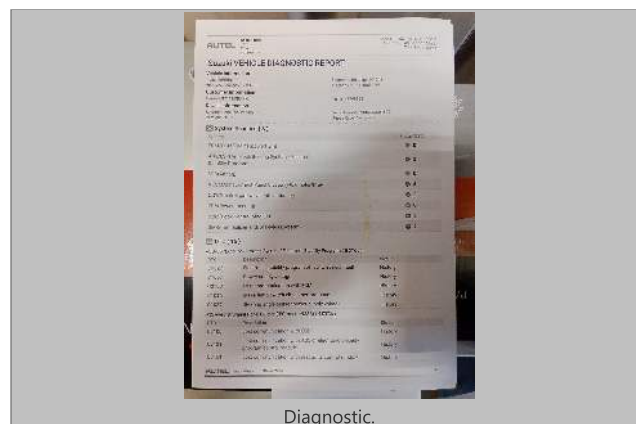
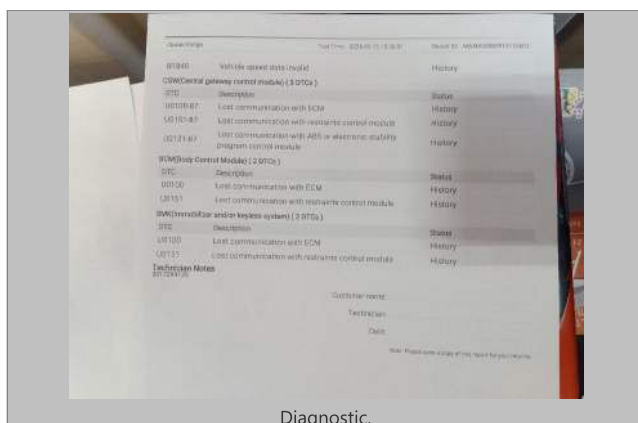
| No | System | Code | Description | Status |
|---|---|---|---|---|
| 1 | ABS/ESP | C1027 | ELECTRONICS STABILITY PROGRAM OFF SWITCH CIRCUIT F | |

Diagnostic.

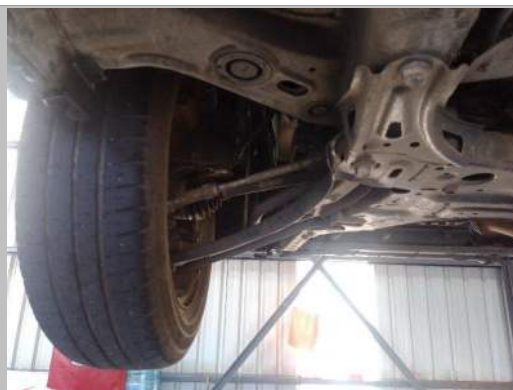
LF TYRE TREAD

| | Size | Load/Speed Index | Manufacture | Model | Type* | Production Date | Tread Depth (mm) |
|---|---|---|---|---|---|---|---|
| Front Left | 185/65R15 | 88H | Bridgestone | Radial | V | 1323 | 2 mm |

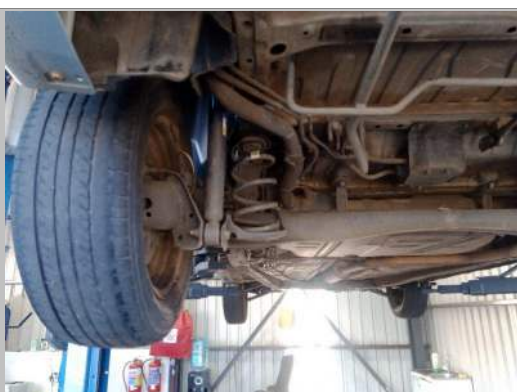
LR TYRE TREAD

| | Size | Load/Speed Index | Manufacture | Model | Type* | Production Date | Tread Depth (mm) |
|---|---|---|---|---|---|---|---|
| Rear Left | 185/60R14 | 82H | Rapid | Radial | V | 2719 | 1 mm |

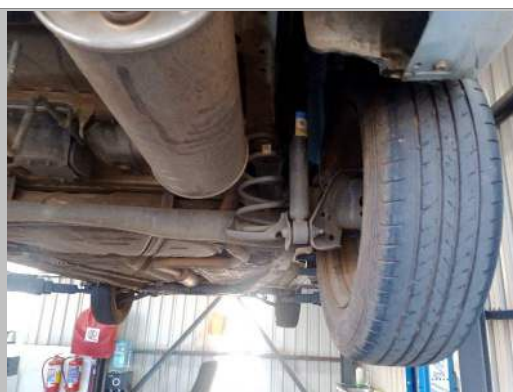
RR TYRE TREAD

| | Size | Load/Speed Index | Manufacture | Model | Type* | Production Date | Tread Depth (mm) |
|---|---|---|---|---|---|---|---|
| Rear Right | 185/65R15 | 88H | Symmetry | Radial | V | 5124 | 2 mm |

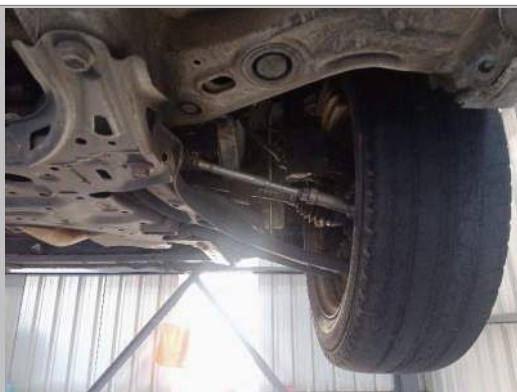
RF TYRE TREAD

| | Size | Load/Speed Index | Manufacture | Model | Type* | Production Date | Tread Depth (mm) |
|---|---|---|---|---|---|---|---|
| Front Right | 185/60R15 | 92T | Continental | Vancontact | V | 3812 | 0 mm |

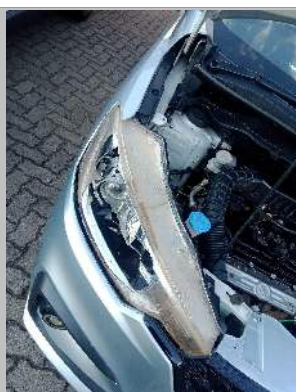
| Damage | Repair Way |
|---|---|
| Headlight Right Damaged | Replace |

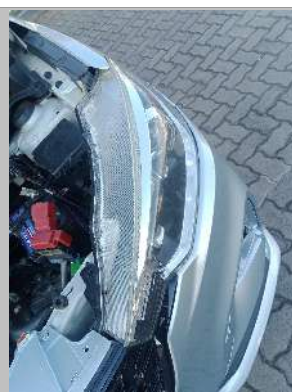
| Damage | Repair Way |
|---|---|
| Headlight Left Defective | Repair |

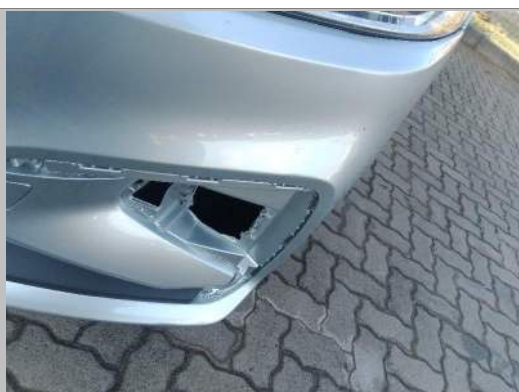
| Damage | Repair Way |
|---|---|
| Fog Light Front Left Damaged | Replace |

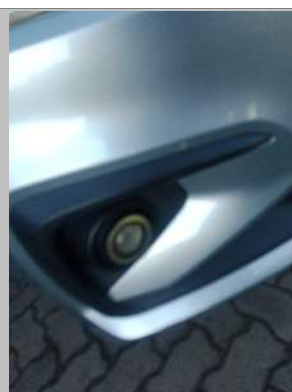
| Damage | Repair Way |
|---|---|
| Fog Light Front Right Damaged | Repair |

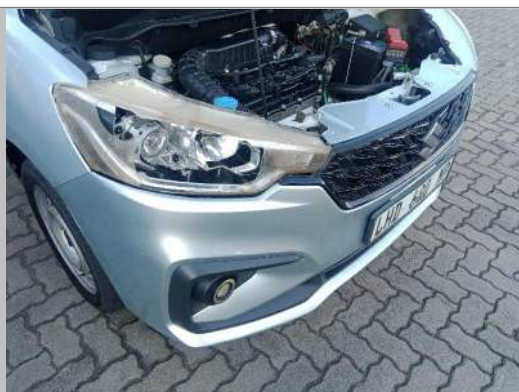
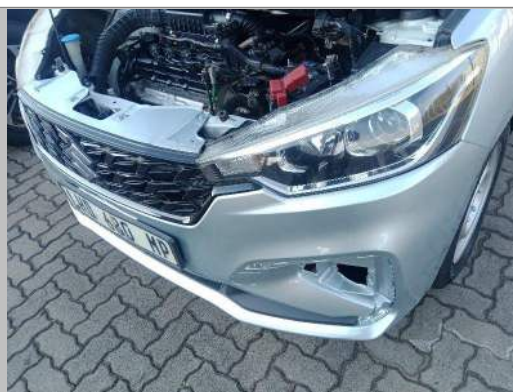
| Damage | Repair Way |
|---|---|
| Front Bumper Damaged | Repair |

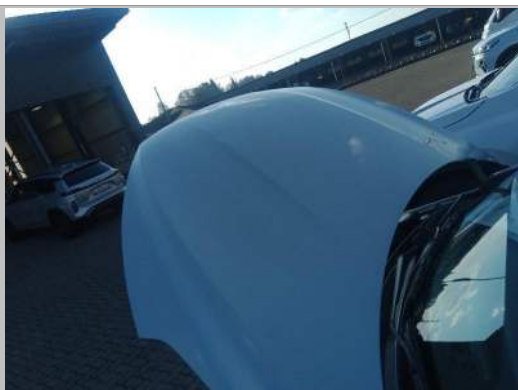
| Damage | Repair Way |
|---|---|
| Bonnet Damaged | Repair |

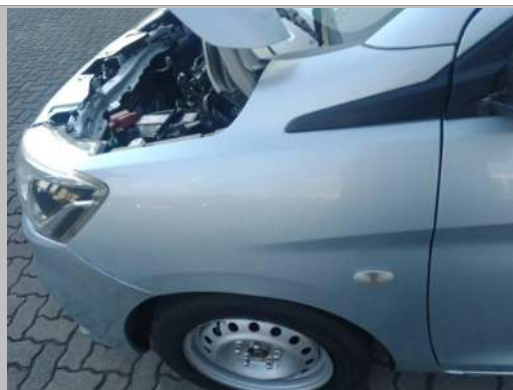
| Damage | Repair Way |
|---|---|
| Front Fender Left Damaged | Repair |

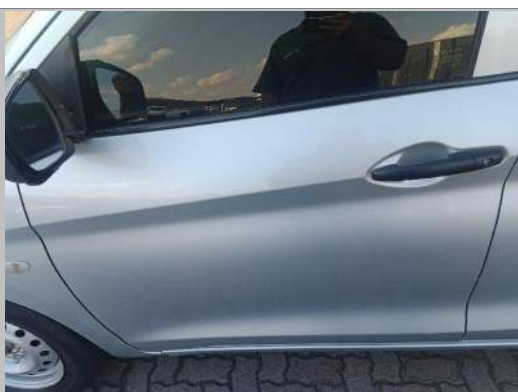
| Damage | Repair Way |
|---|---|
| Door Front Left Damaged | Repair |

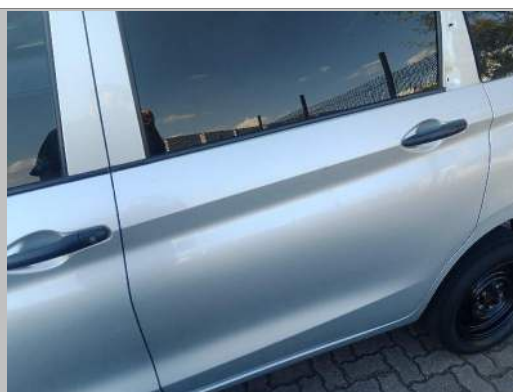
| Damage | Repair Way |
|---|---|
| Door Rear Left Damaged | Repair |

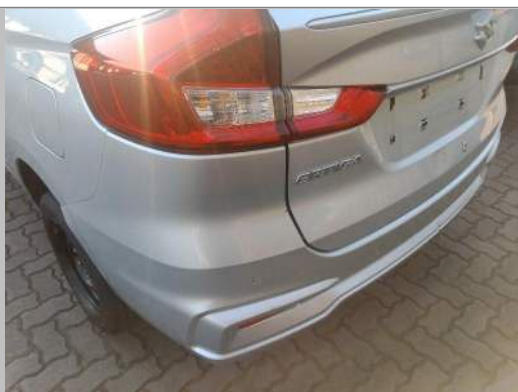
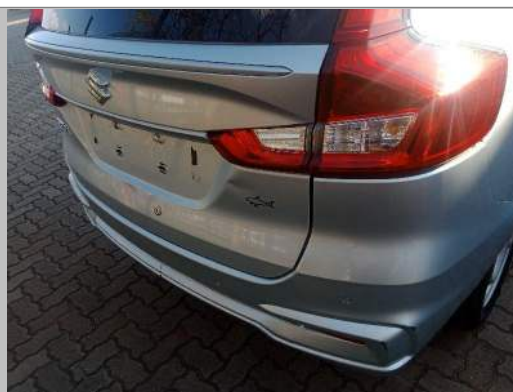
| Damage | Repair Way |
|---|---|
| Rear bumper Damaged | Repair |

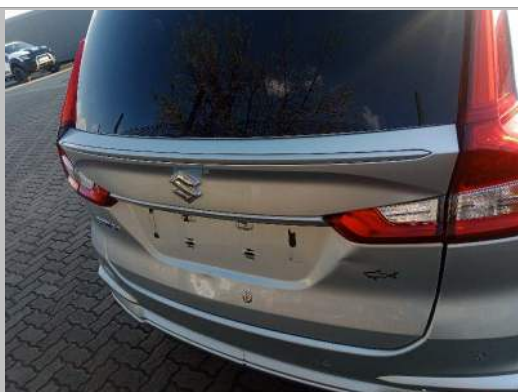
| Damage | Repair Way |
|---|---|
| Boot Lid / Hatch door Damaged | Repair |

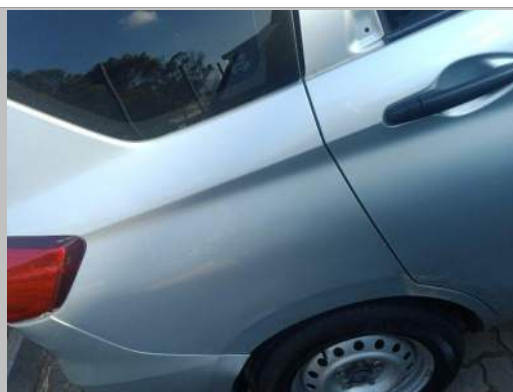
| Damage | Repair Way |
|---|---|
| Rear Fender Right Damaged | Repair |

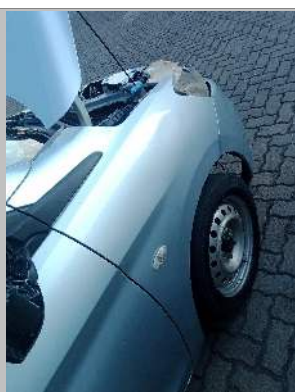
| Damage | Repair Way |
|---|---|
| Front Fender Right Damaged | Repair |

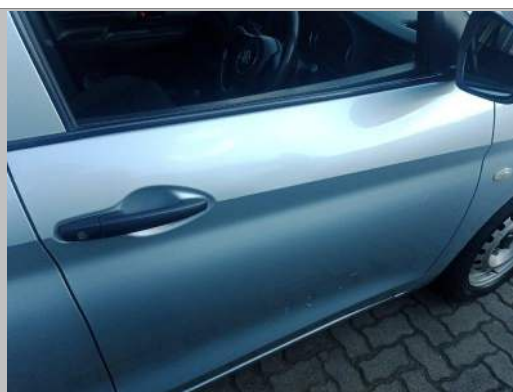
| Damage | Repair Way |
|---|---|
| Door Front Right Damaged | Repair |

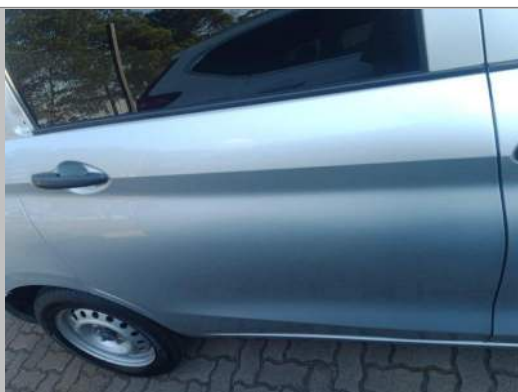
| Damage | Repair Way |
|---|---|
| Door Rear Right Damaged | Repair |

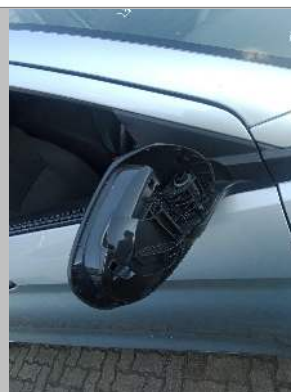
| Damage | Repair Way |
|---|---|
| Side Mirror Right Damaged | Replace |

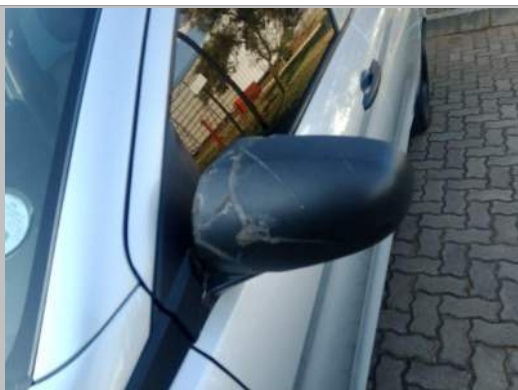
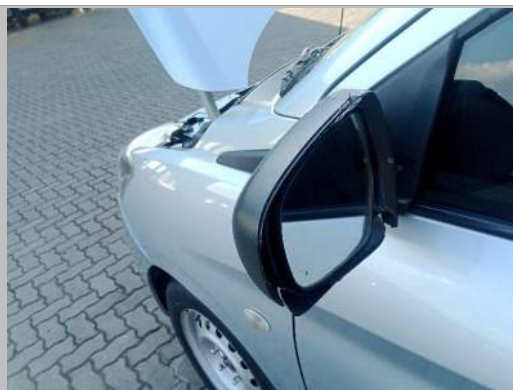
| Damage | Repair Way |
|---|---|
| Side Mirror Left Damaged | Replace |

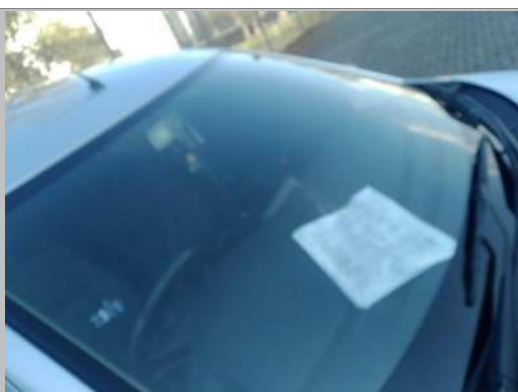
| Damage | Repair Way |
|---|---|
| Windscreen Damaged | Replace |

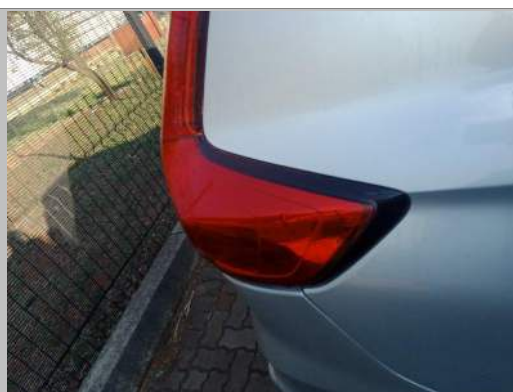
| Damage | Repair Way |
|---|---|
| Tail Light Right Damaged | Replace |

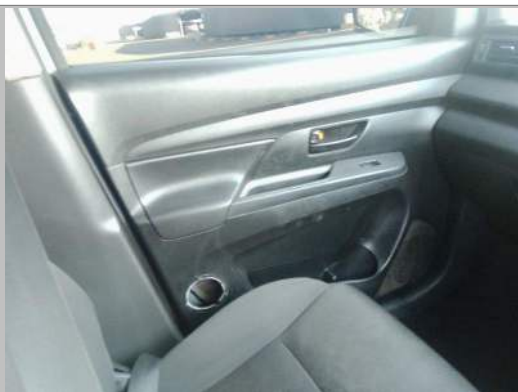
| Damage | Repair Way |
|---|---|
| Door Panel Front Left Damaged | Replace |

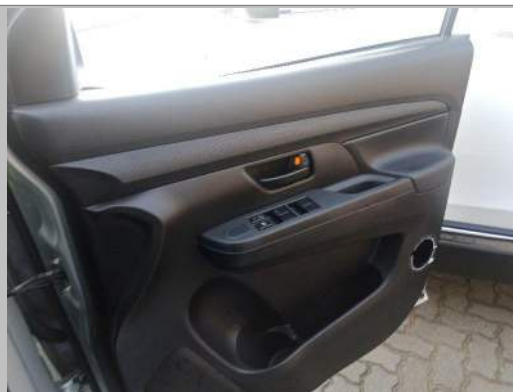
| Damage | Repair Way |
|---|---|
| Door Panel Front Right Damaged | Replace |

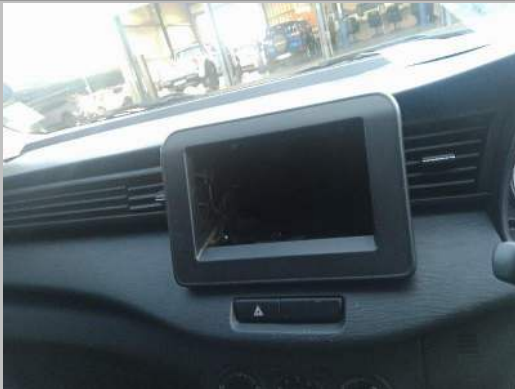
| Damage | Repair Way |
|---|---|
| Radio/CD/USB Missing | Replace |

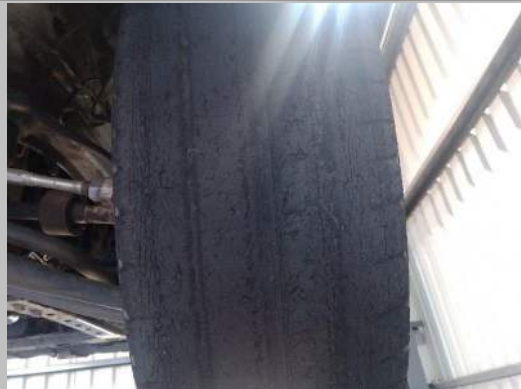
| Damage | Repair Way |
|---|---|
| Tyre Front Right Worn | Replace |

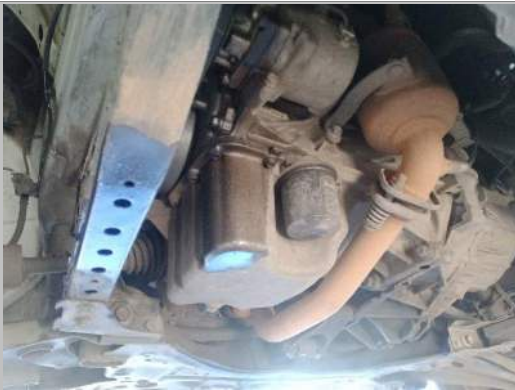
| Damage | Repair Way |
|---|---|
| Engine Oil Leak | Replace |

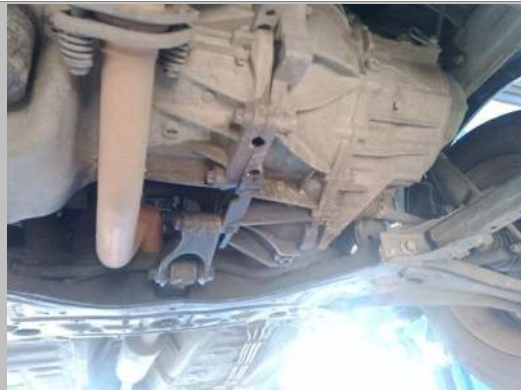
| Damage | Repair Way |
|---|---|
| Gearbox Oil Sweat | Repair |
