## CONDITION REPORT

Report No:  
2017296824  
DATE  
10/09/2026

| Manufacturer | SUZUKI | Registration Number | KD05VCGP |
| Model | CELERIO 1.0 GA 5-DR [2017-2022] | Register Number | |

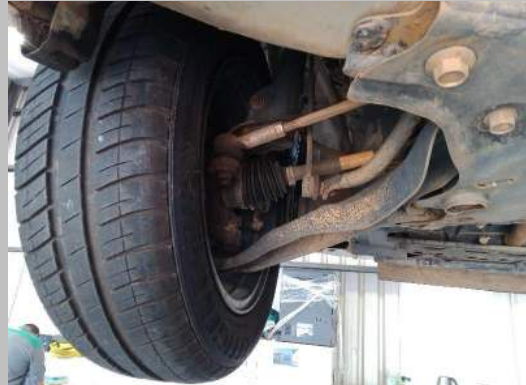
LF TYRE TREAD

| | Size | Load/Speed Index | Manufacture | Model | Type* | Production Date | Tread Depth (mm) |
|---|---|---|---|---|---|---|---|
| Front Left | 175/65R14 | 82H | Goodyear | Efficient | V | 4723 | 4 mm |

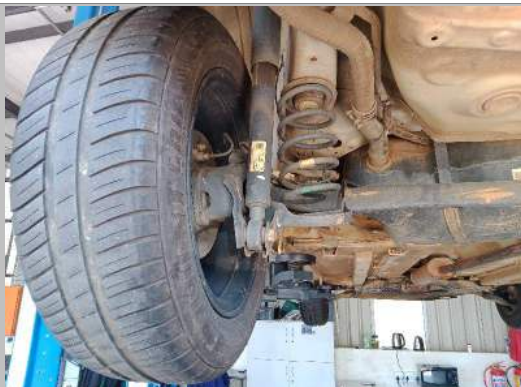
LR TYRE TREAD

| | Size | Load/Speed Index | Manufacture | Model | Type* | Production Date | Tread Depth (mm) |
|---|---|---|---|---|---|---|---|
| Rear Left | 175/65R14 | 82H | Goodyear | Efficient | V | 4422 | 3 mm |

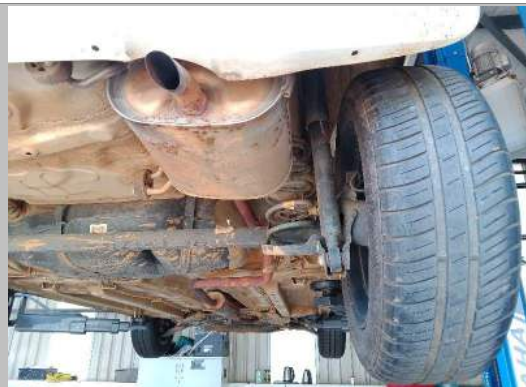
RR TYRE TREAD

| | Size | Load/Speed Index | Manufacture | Model | Type* | Production Date | Tread Depth (mm) |
|---|---|---|---|---|---|---|---|
| Rear Right | 175/65R14 | 82H | Goodyear | Efficient | V | 4422 | 3 mm |

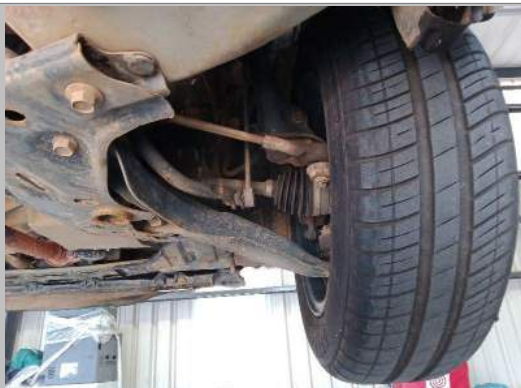
RF TYRE TREAD

| | Size | Load/Speed Index | Manufacture | Model | Type* | Production Date | Tread Depth (mm) |
|---|---|---|---|---|---|---|---|
| Front Right | 175/65R14 | 82H | Goodyear | Efficient | V | 0224 | 5 mm |

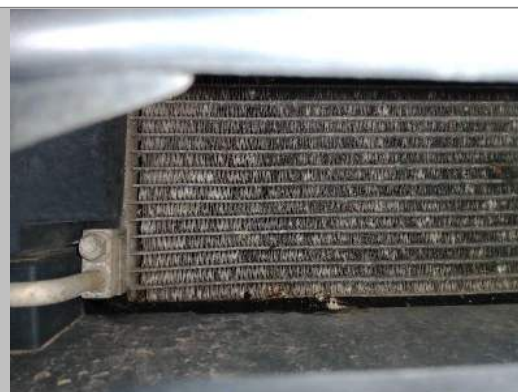
| Aircon condenser dented | Repair |

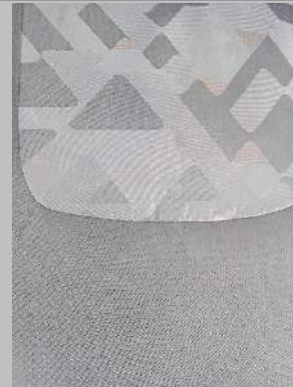
| Seat Front Right Damaged | Repair |

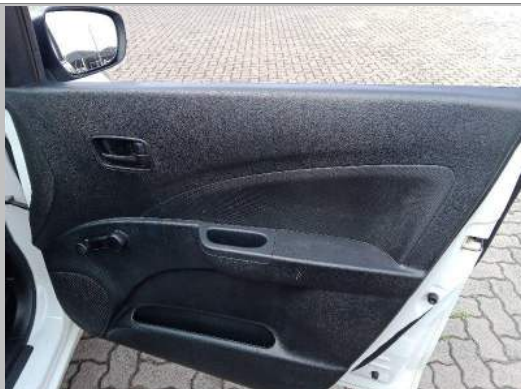
| Door Panel Front Right Defective | Repair |

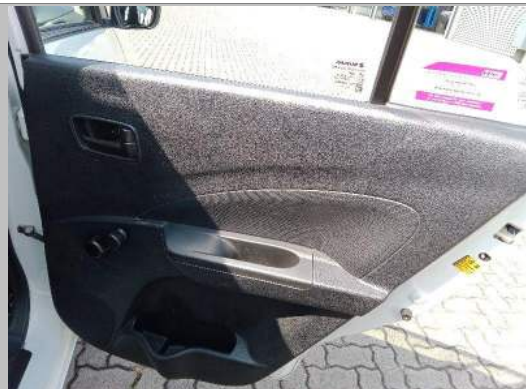
| Door Panel Rear Right Defective | Repair |

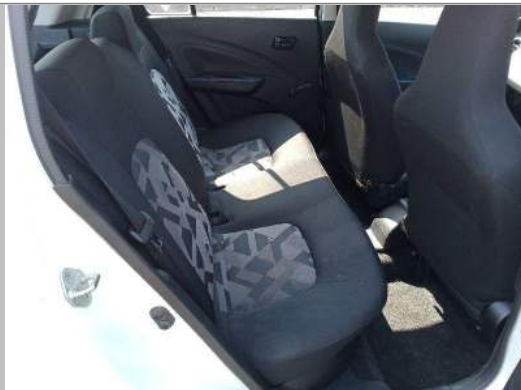
| Seat Rear Loose / Excessive Play | Repair |

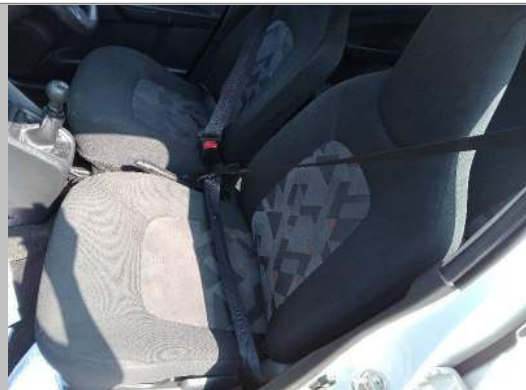
| Seat Front Left Dirty | Repair |

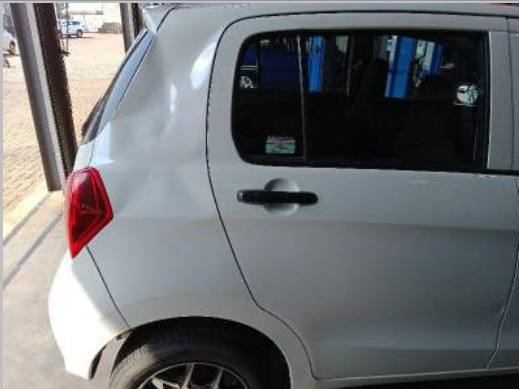
| Rear Fender Right Damaged | Repair |

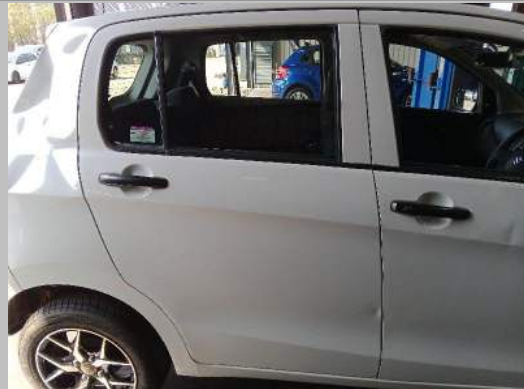
| Door Rear Right Dented | Repair |

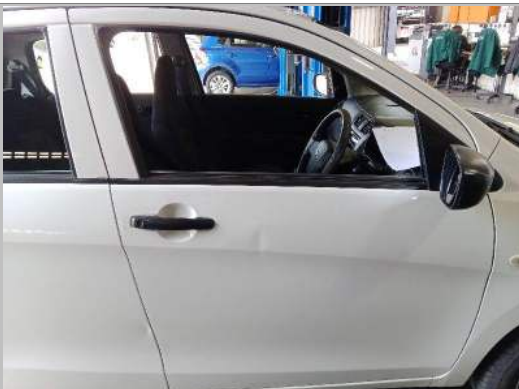
| Door Front Right Damaged | Repair |

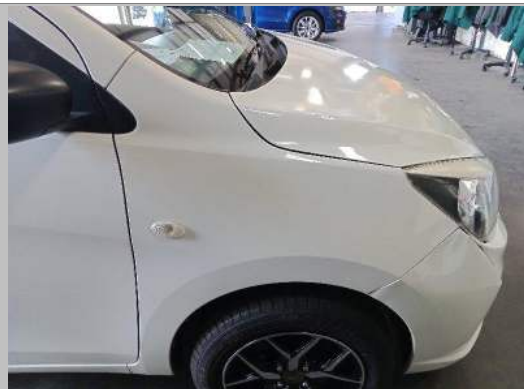
| Front Fender Right Residual Traces of Repair | Repair |

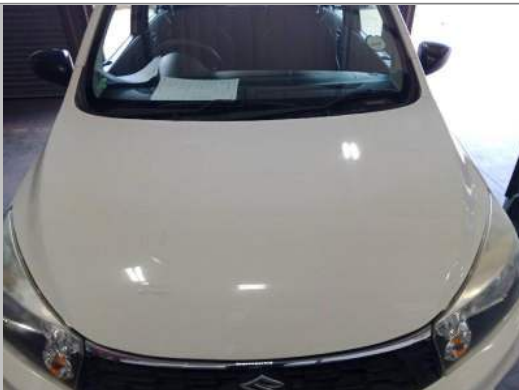
| Bonnet Damaged | Repair |

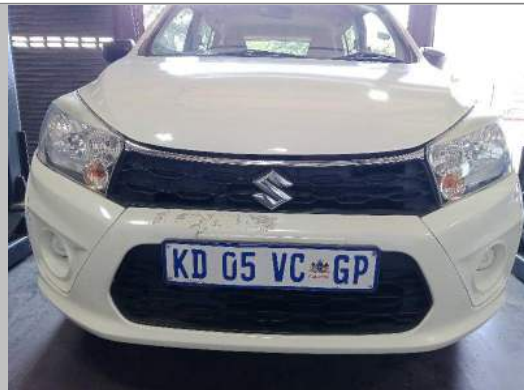
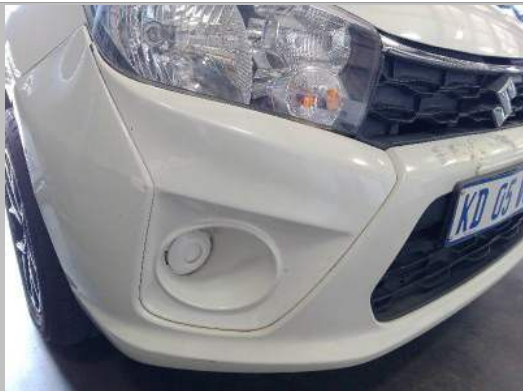
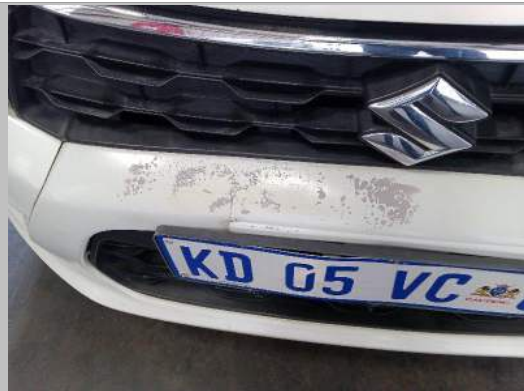
| Front Bumper Damaged | Repair |

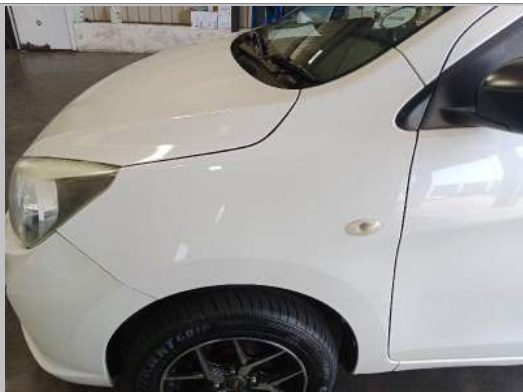
| Front Fender Left Residual Traces of Repair | Repair |

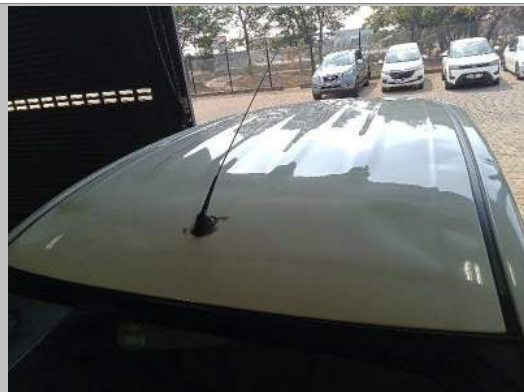
| Roof Damaged | Repair |

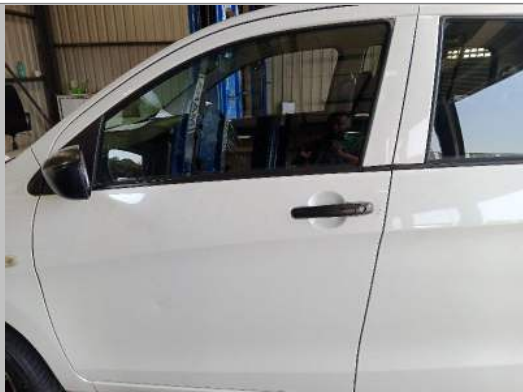
| Door Front Left Damaged | Repair |

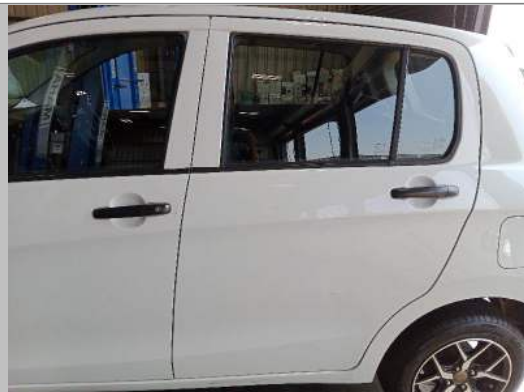
| Door Rear Left Dented | Repair |

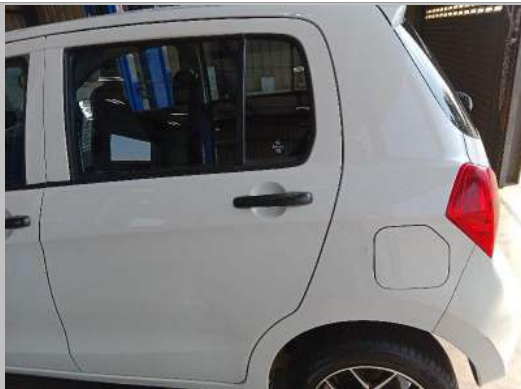
| Rear Fender Left Damaged | Repair |

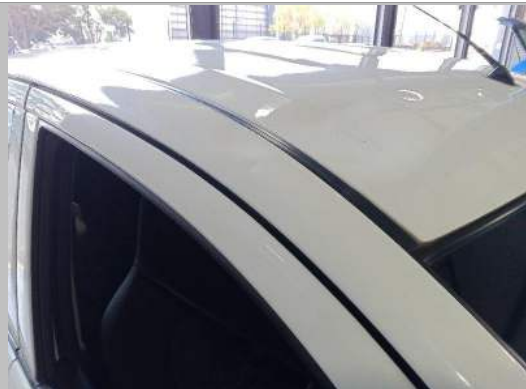
| A • Pillar Right Damaged | Repair |

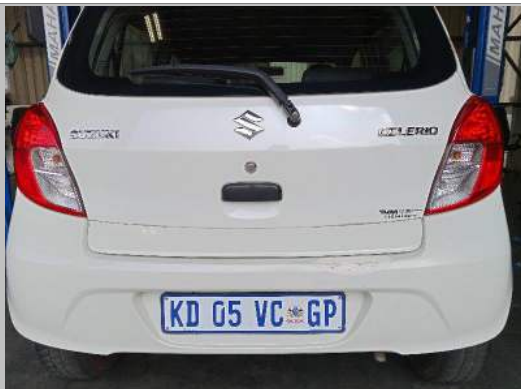
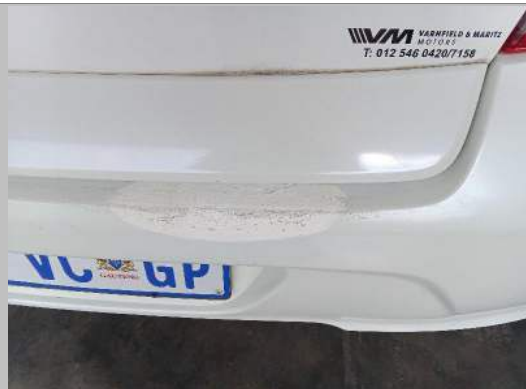
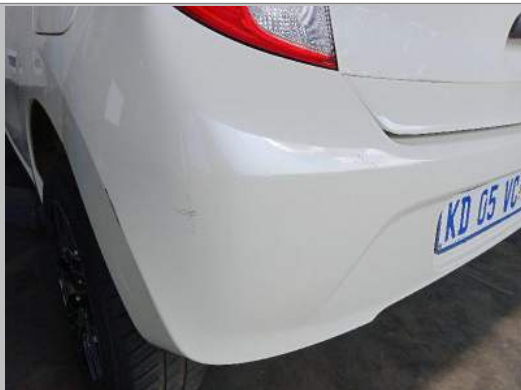
| Rear bumper Paintwork • Scratched | Repair |

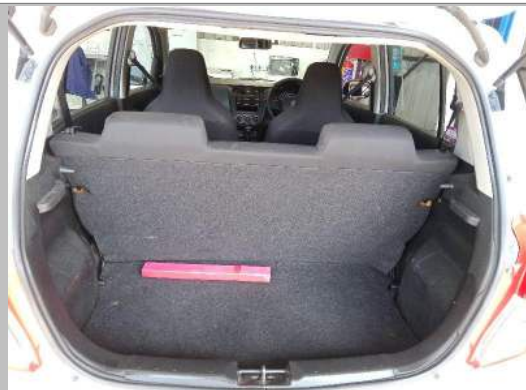
| Parcel Tray Missing | Replace |

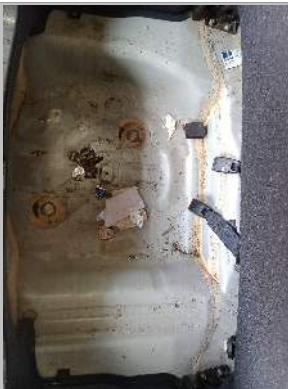
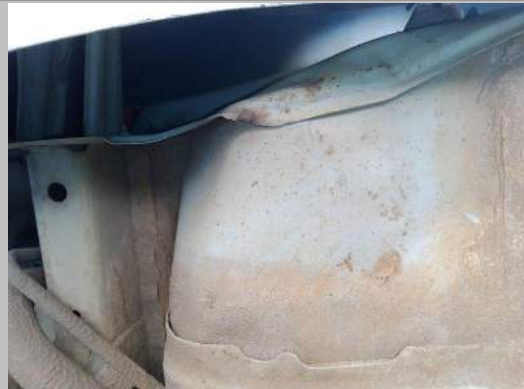
| Inner Boot Floor Pan and Spare Wheel Well Damaged | Repair |

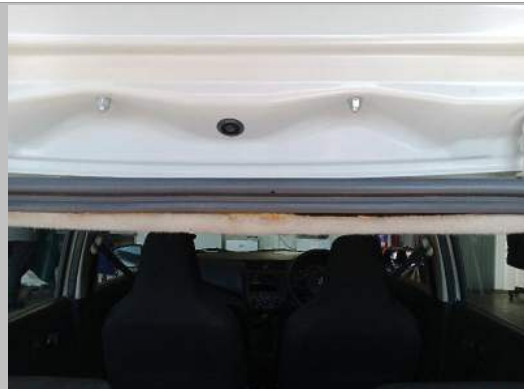
| Hood Lining Defective | Repair |

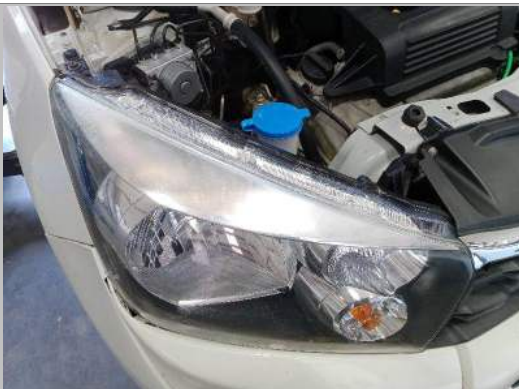
| Headlight Right Defective | Repair |

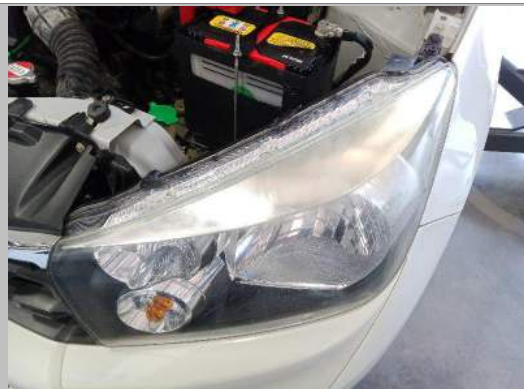
| Headlight Left Defective | Repair |

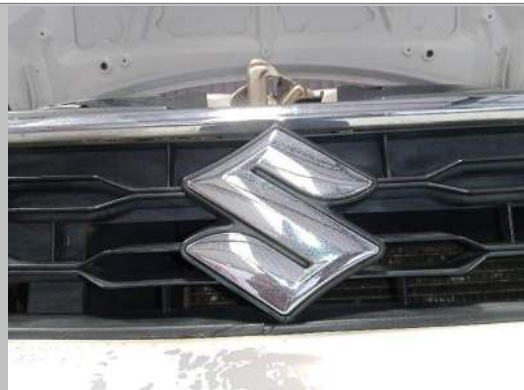
| Grill Cracked | Replace |

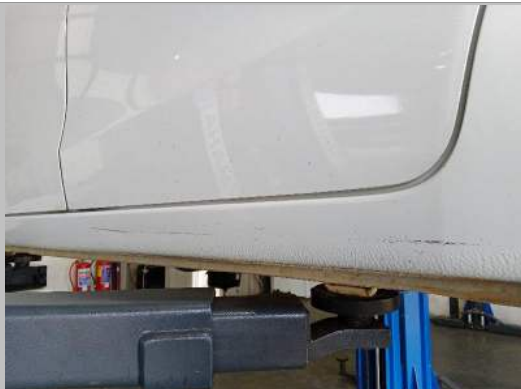
| Sill Panel Left Paintwork • Scratched | Repair |

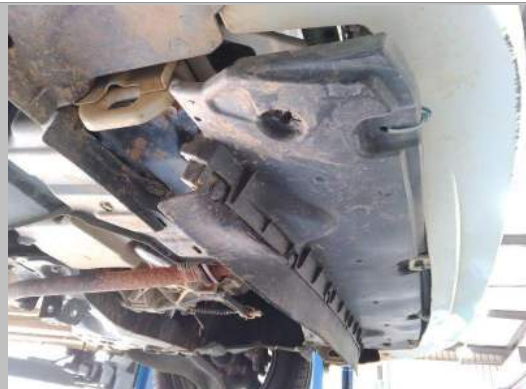
| Belly plates Damaged | Replace |

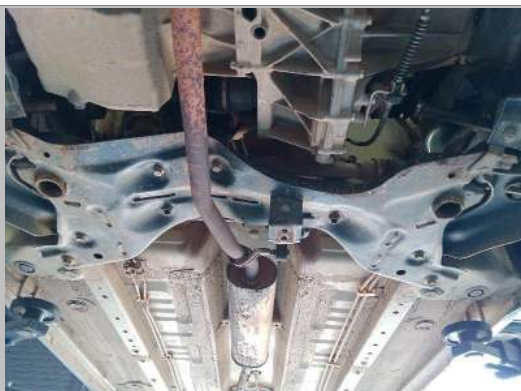
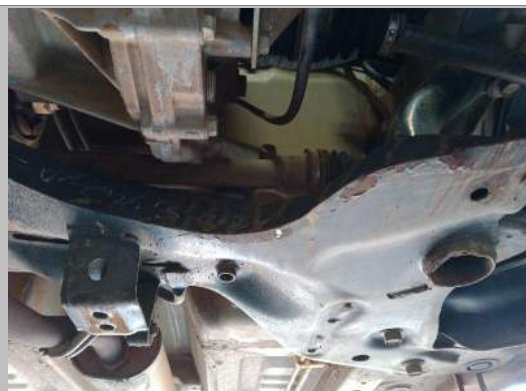
| Sub Frame Scratched | Repair |

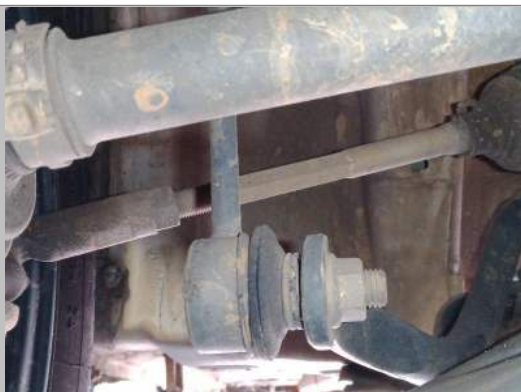
| Stabilizer Mounting Front Right Damaged | Replace |

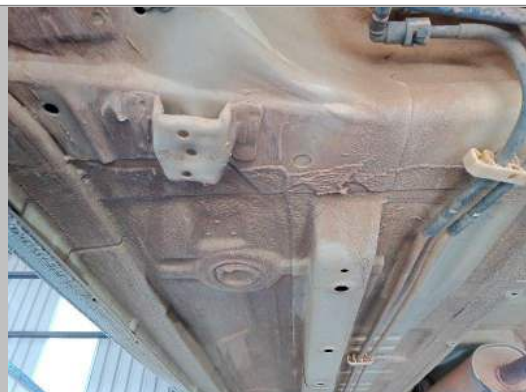
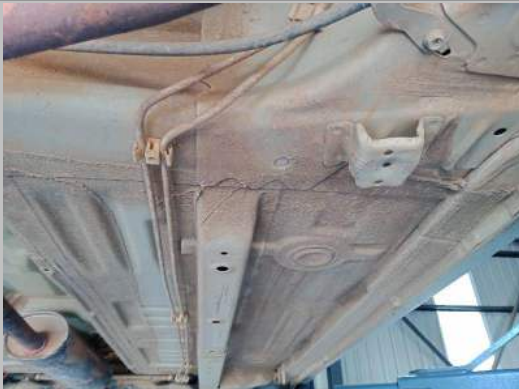
| Chassis Dented | Repair |

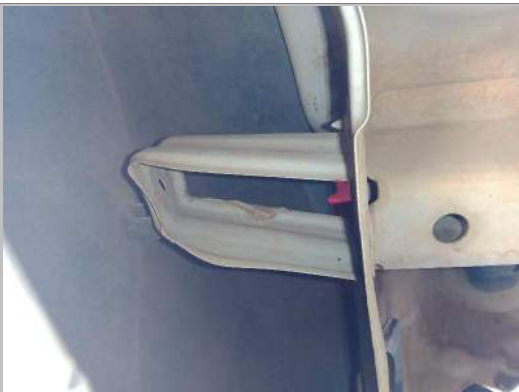
| Rear Bumper / Mounting points Damaged | Repair |
