## CONDITION REPORT

Report No:  
2017298325  
DATE  
14/09/2026

| Manufacturer | FORD | Registration Number | KG75WLGP |
| Model | FIGO 1.4 AMBIENTE BLUETOOTH 5-DR [2014-2016] | Register Number | |

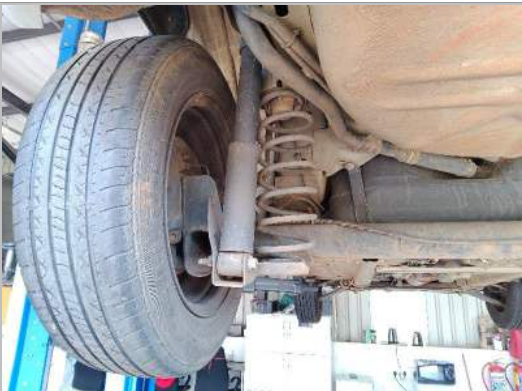
LR TYRE TREAD

| | Size | Load/Speed Index | Manufacture | Model | Type* | Production Date | Tread Depth (mm) |
|---|---|---|---|---|---|---|---|
| Rear Left | 175/65 R14 | 82H | Fullrun | Frun-one | V | 3720 | 1 mm |

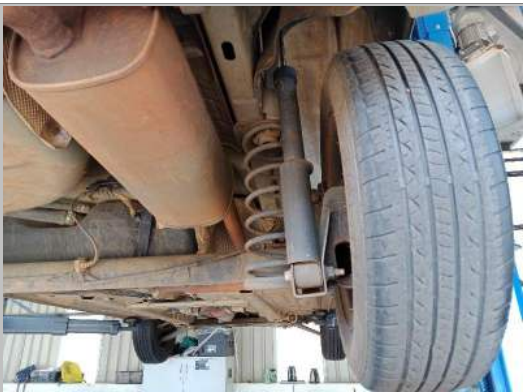
RR TYRE TREAD

| | Size | Load/Speed Index | Manufacture | Model | Type* | Production Date | Tread Depth (mm) |
|---|---|---|---|---|---|---|---|
| Rear Right | 175/65 R14 | 82H | Fullrun | Frun-one | V | 3720 | 1 mm |

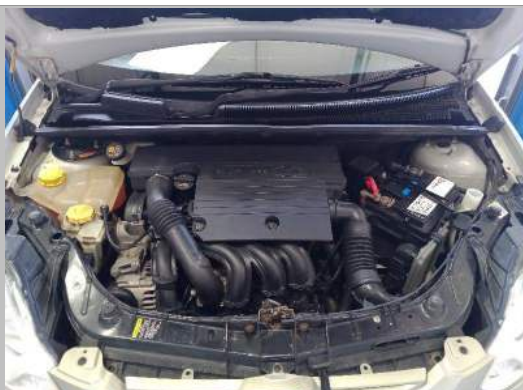
ENGINE 1

| Damage | Repair Way |
|---|---|
| Engine Wiring Defective | Repair |

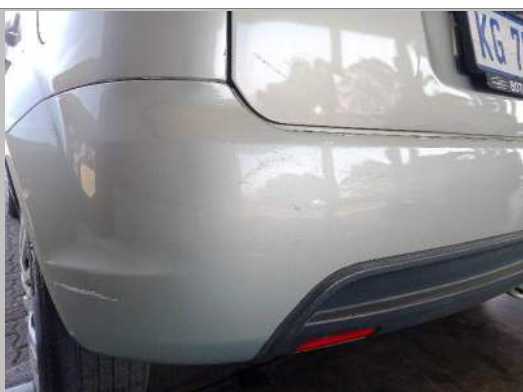
| Damage | Repair Way |
|---|---|
| Rear bumper Damaged | Repair |

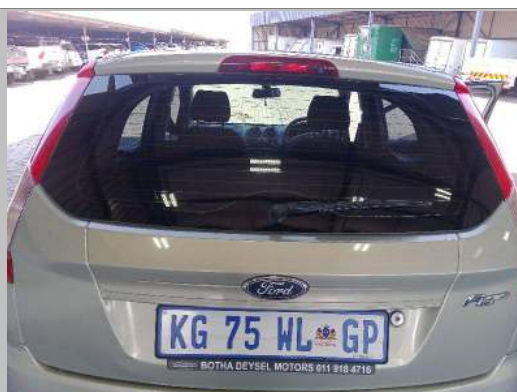
| Damage | Repair Way |
|---|---|
| Boot Lid / Hatch door Residual Traces of Repair | Repair |

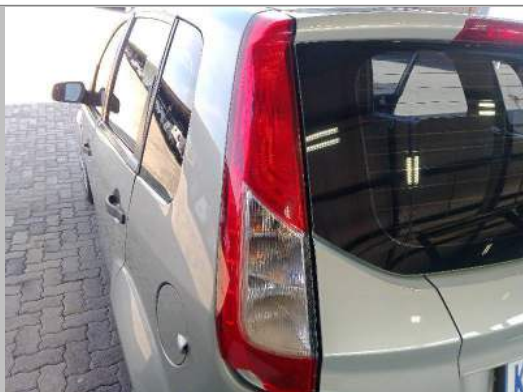
| Damage | Repair Way |
|---|---|
| Tail Light Left Damaged | Replace |

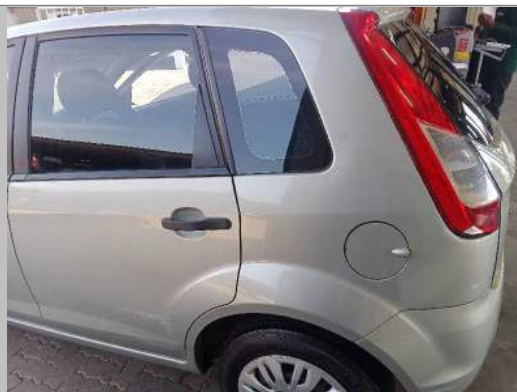
| Damage | Repair Way |
|---|---|
| Rear Fender Left Dented | Repair |

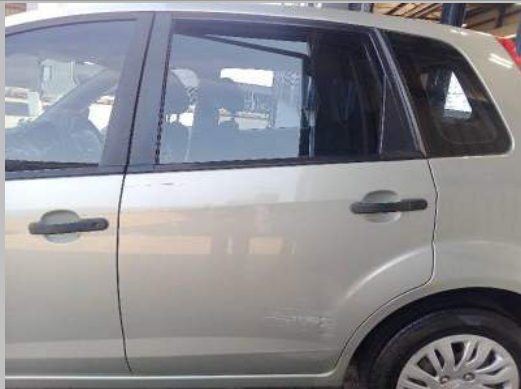
| Damage | Repair Way |
|---|---|
| Door Rear Left Damaged | Repair |

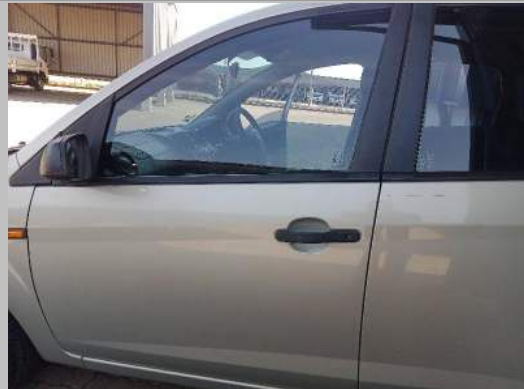
| Damage | Repair Way |
|---|---|
| Door Front Left Dented | Repair |

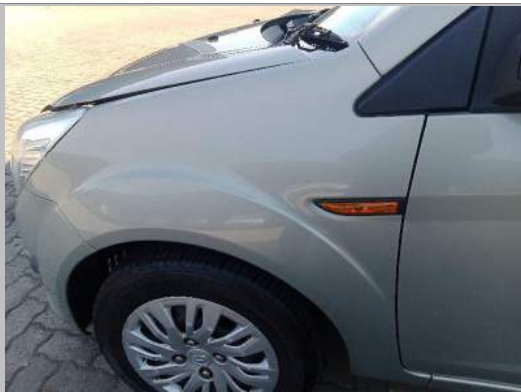
| Damage | Repair Way |
|---|---|
| Front Fender Left Dented | Repair |

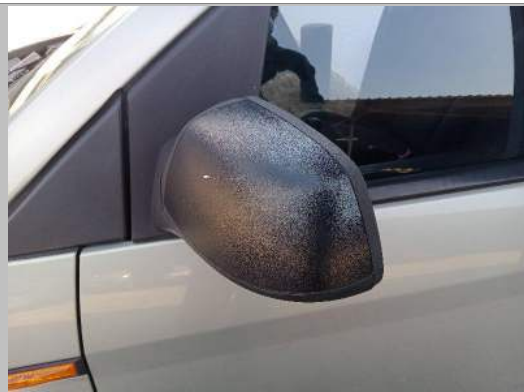
| Damage | Repair Way |
|---|---|
| Side Mirror Left Paintwork • Scratched | Repair |

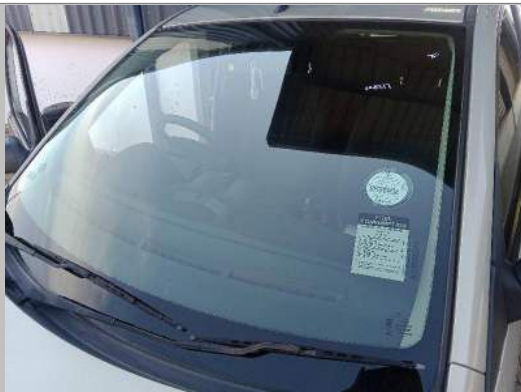
| Damage | Repair Way |
|---|---|
| Windscreen Chipped | Replace |

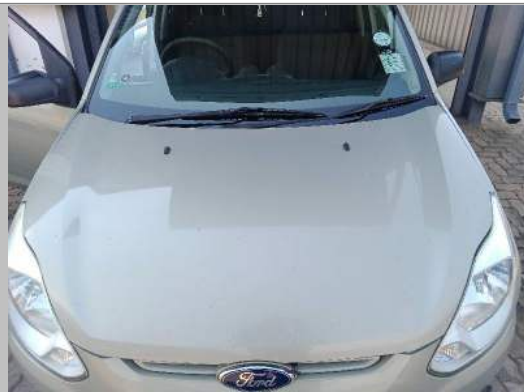
| Damage | Repair Way |
|---|---|
| Bonnet Damaged | Repair |

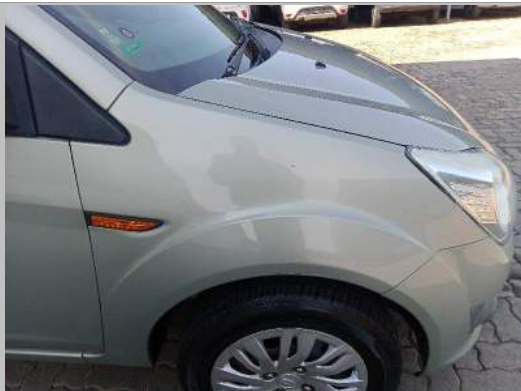
| Damage | Repair Way |
|---|---|
| Front Fender Right Residual Traces of Repair | Repair |

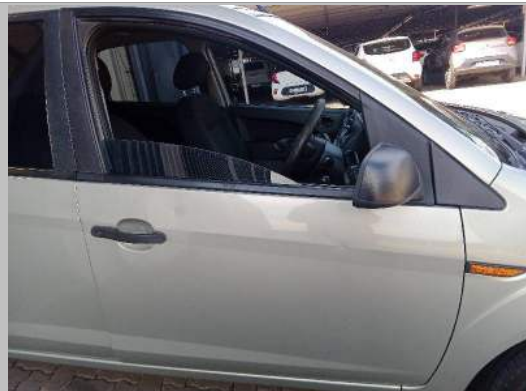
| Damage | Repair Way |
|---|---|
| Door Front Right Damaged | Repair |

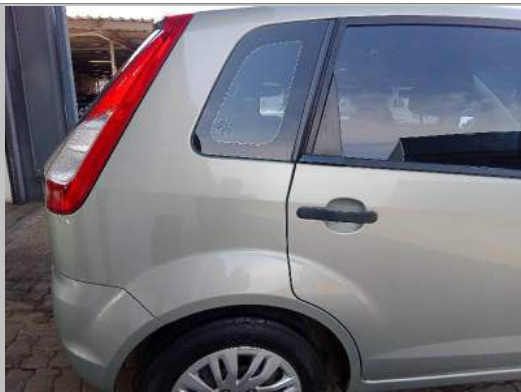
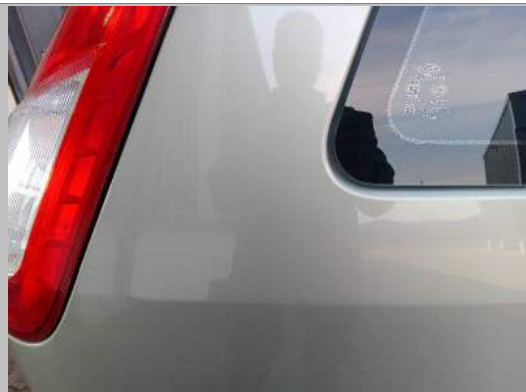
| Damage | Repair Way |
|---|---|
| Rear Fender Right Paintwork • Scratched | Repair |

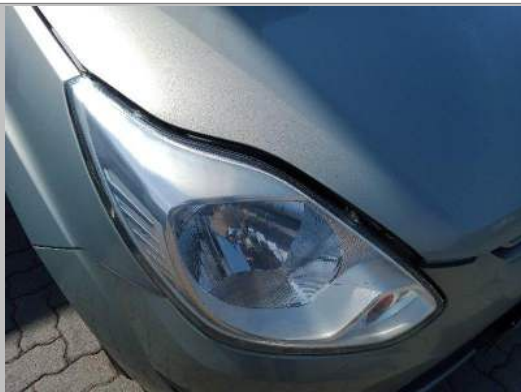
| Damage | Repair Way |
|---|---|
| Headlight Right Defective | Repair |

Lights: Front right headlight lens faded.

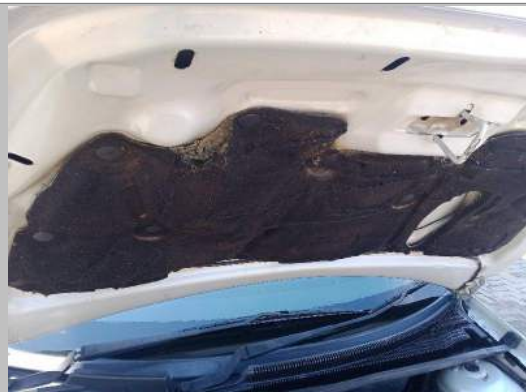
| Damage | Repair Way |
|---|---|
| Under bonnet insulation cover Damaged | Repair |

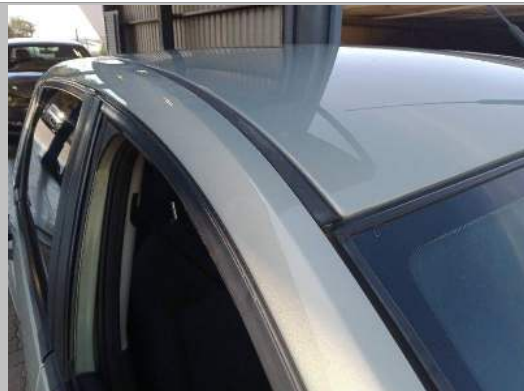
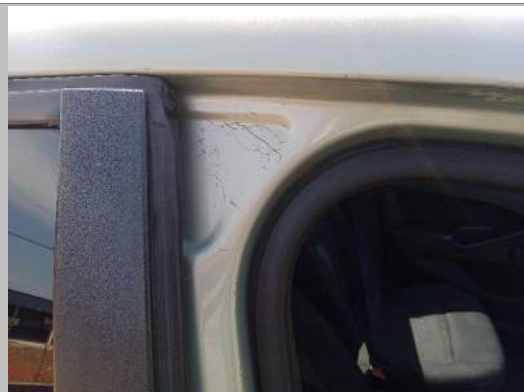
| Damage | Repair Way |
|---|---|
| B • Pillar Right Damaged | Repair |

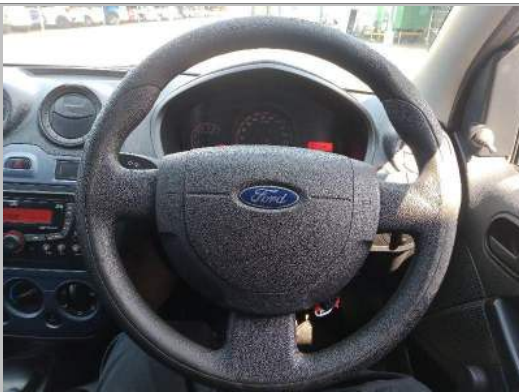
| Damage | Repair Way |
|---|---|
| Steering Wheel Trim Excessive Wear & Tear | Repair |

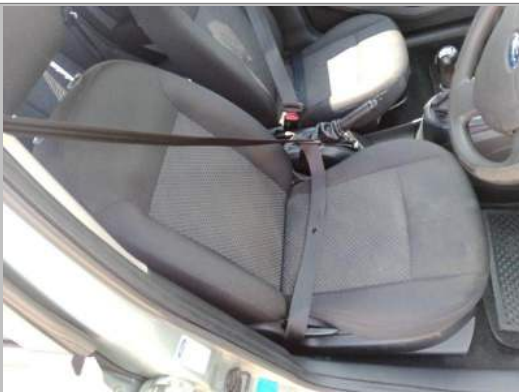
| Damage | Repair Way |
|---|---|
| Seat Front Right Dirty | Repair |

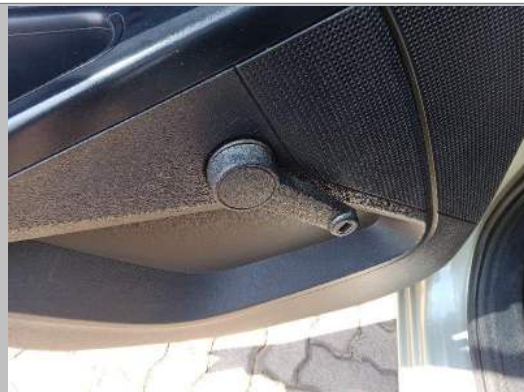
| Damage | Repair Way |
|---|---|
| Window Winder rear left Defective | Replace |

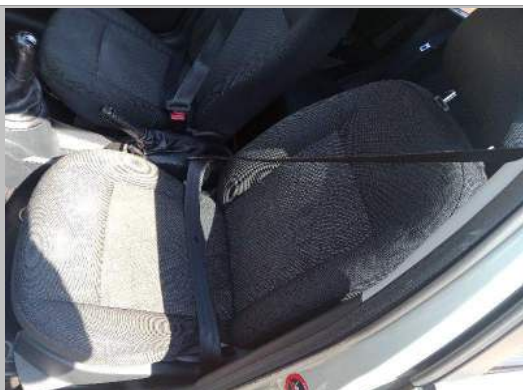
| Damage | Repair Way |
|---|---|
| Seat Front Left Dirty | Repair |

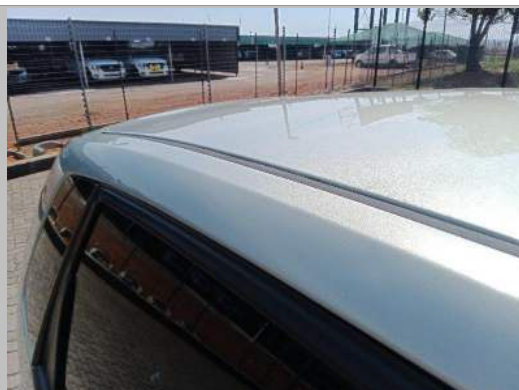
| Damage | Repair Way |
|---|---|
| C • Pillar Right Damaged | Repair |

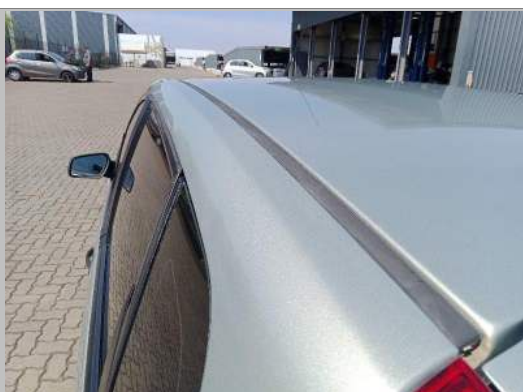
| Damage | Repair Way |
|---|---|
| C • Pillar Left Damaged | Repair |

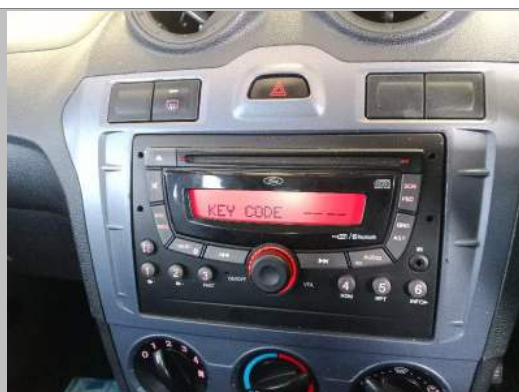
| Damage | Repair Way |
|---|---|
| Radio/CD/USB Defective | Repair |

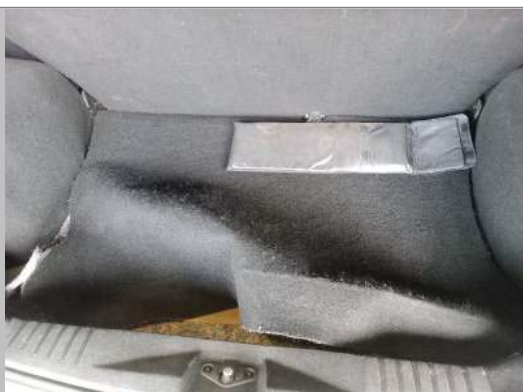
| Damage | Repair Way |
|---|---|
| Boot Carpet Damaged | Repair |

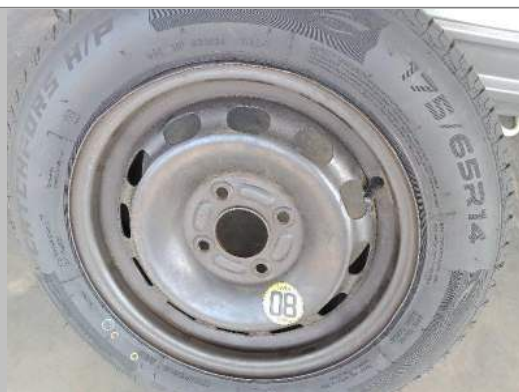
| Damage | Repair Way |
|---|---|
| Rim Spare Wheel Dented | Repair |

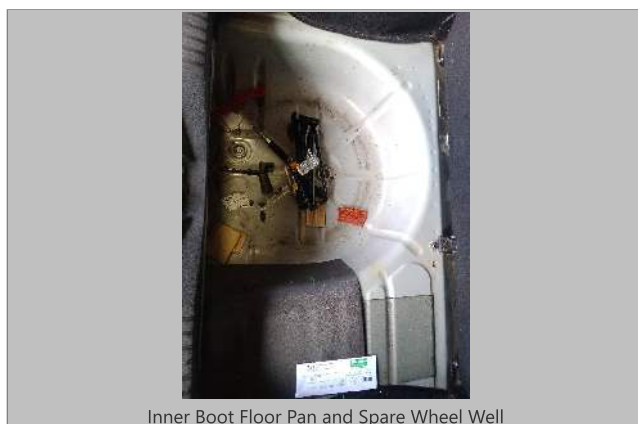
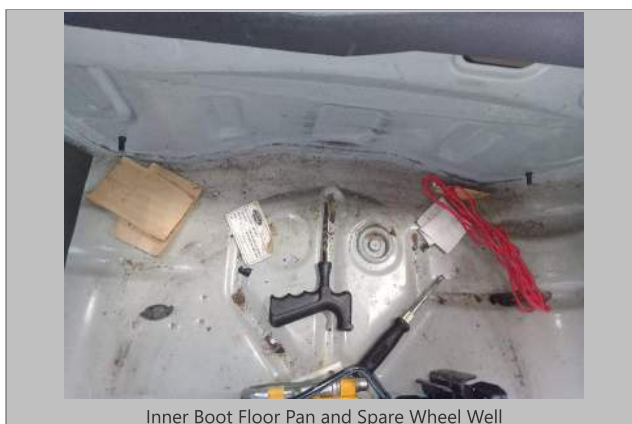
| Damage | Repair Way |
|---|---|
| Inner Boot Floor Pan and Spare Wheel Well Dented | Repair |

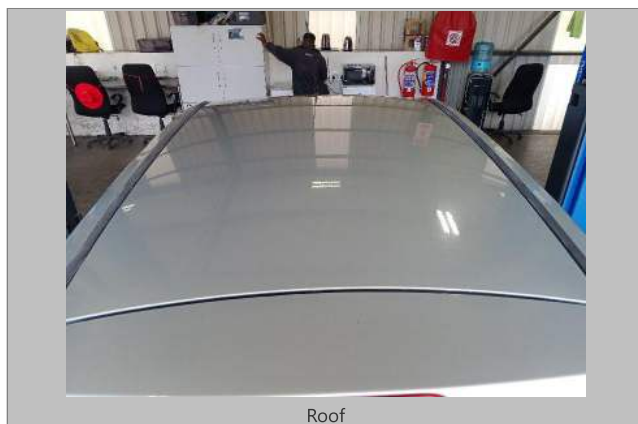
| Damage | Repair Way |
|---|---|
| Roof Dented | Repair |

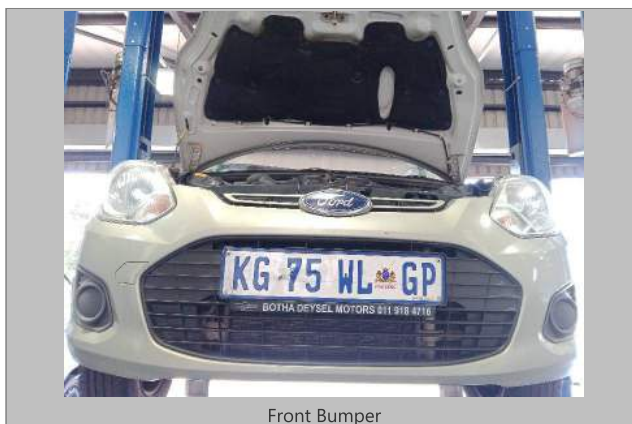
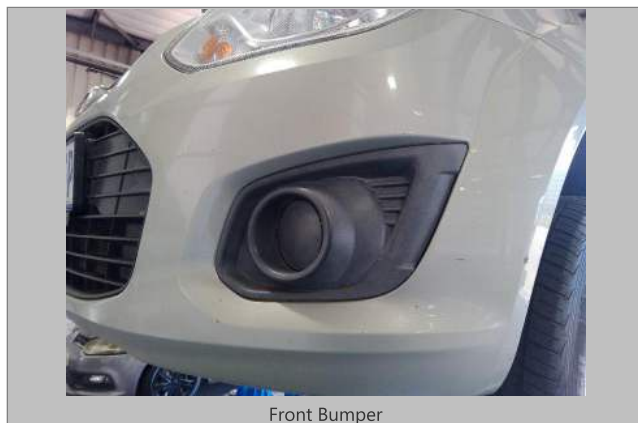
| Damage | Repair Way |
|---|---|
| Front Bumper Paintwork • Scratched | Repair |

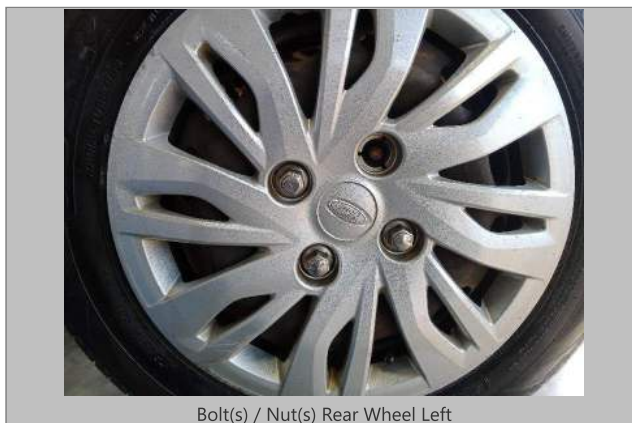
| Damage | Repair Way |
|---|---|
| Bolt(s) / Nut(s) Rear Wheel Left Missing | Replace |

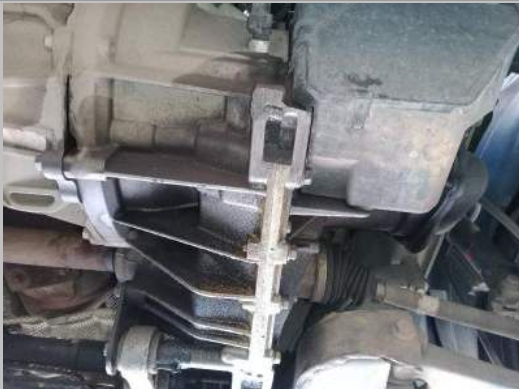
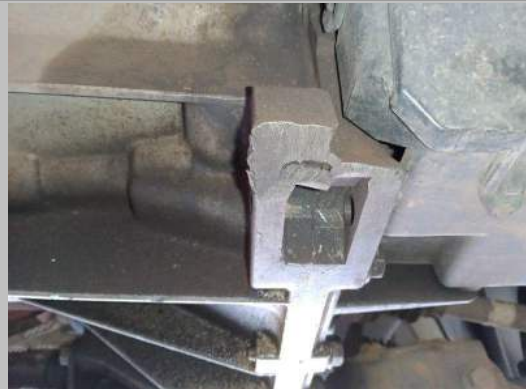
| Damage | Repair Way |
|---|---|
| Gearbox Damaged | Repair |

Undercarriage: Oil leak on gearbox.

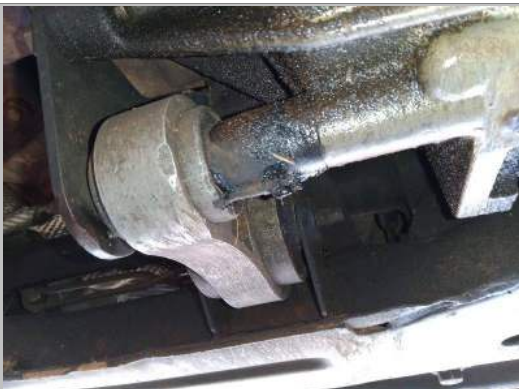
| Damage | Repair Way |
|---|---|
| Gearbox Mountings Damaged | Replace |

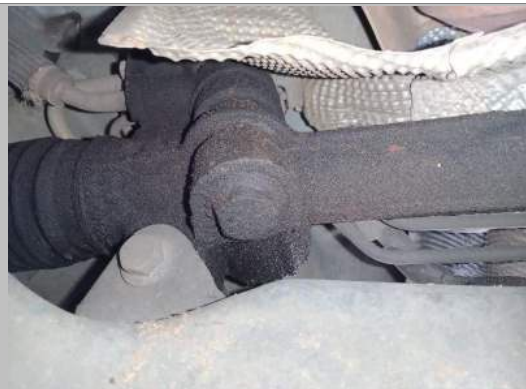
| Damage | Repair Way |
|---|---|
| Steering Rack Defective | Repair |

Steering: Steering rack leak.

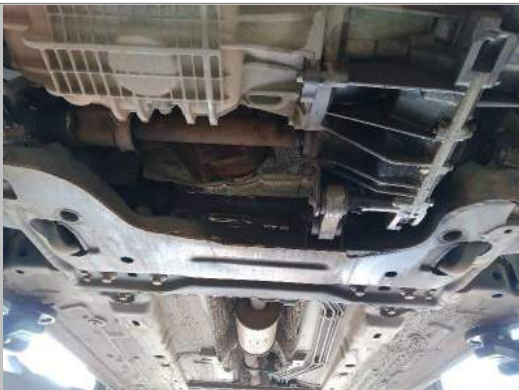
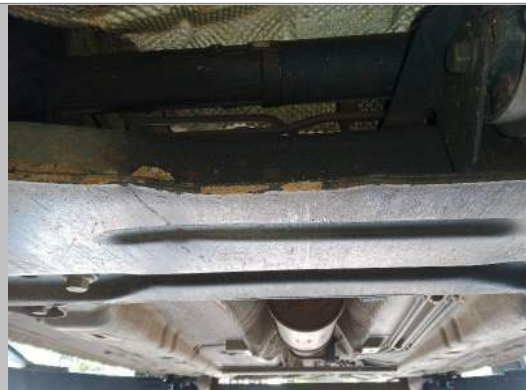
| Damage | Repair Way |
|---|---|
| Sub Frame Dented | Repair |

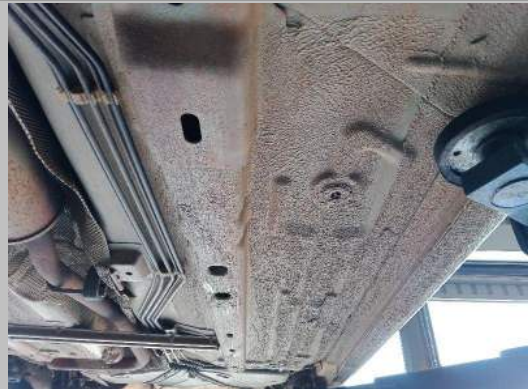
| Damage | Repair Way |
|---|---|
| Chassis Scratched | Repair |

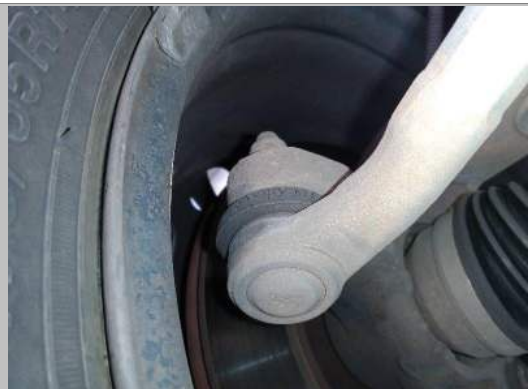
| Damage | Repair Way |
|---|---|
| Tie Rod End left Cracked | Replace |

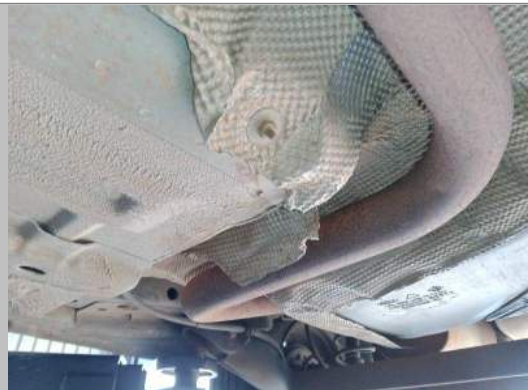
| Damage | Repair Way |
|---|---|
| Belly plates Damaged | Repair |

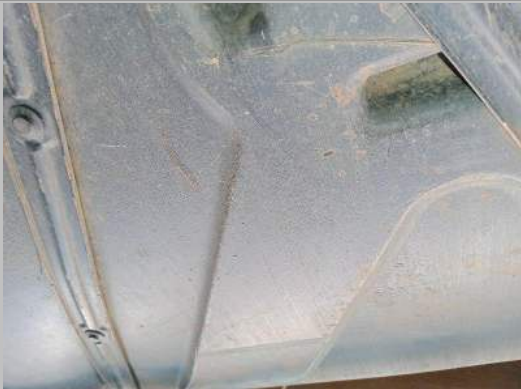
| Damage | Repair Way |
|---|---|
| Fuel Tank Damaged | Repair |

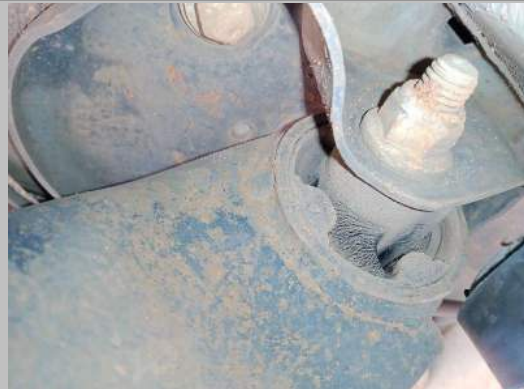
| Damage | Repair Way |
|---|---|
| Mounting Rubber(s) Rear Axle Right Cracked | Replace |

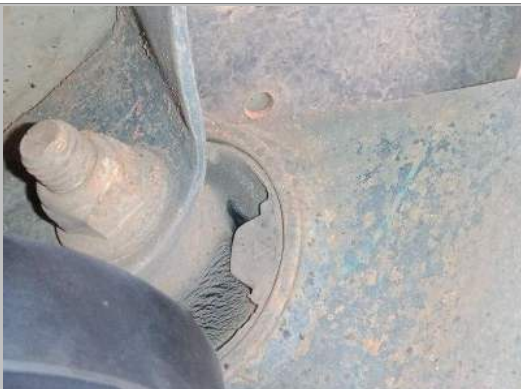
| Damage | Repair Way |
|---|---|
| Mounting Rubber(s) Rear Axle Left Cracked | Replace |

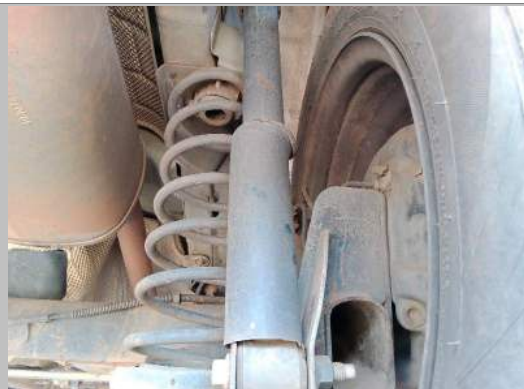
| Damage | Repair Way |
|---|---|
| Shock Absorber Rear Right Defective | Replace |

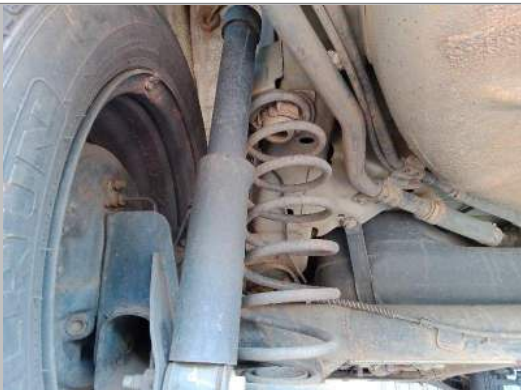
| Damage | Repair Way |
|---|---|
| Shock Absorber Rear Left Defective | Replace |

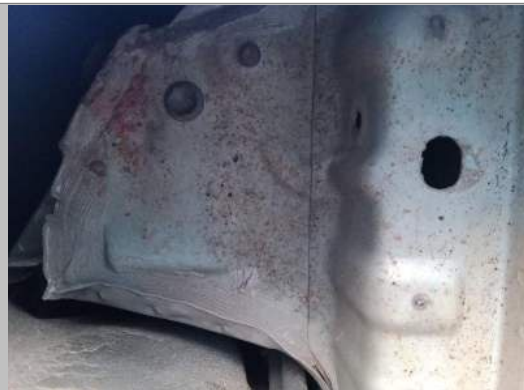
| Damage | Repair Way |
|---|---|
| Rear Fender Left / Inner Tray Dented | Repair |
