MFC Auction House  
M57 Pretoria Rd, Glenmarais, KEMPTON PARK  
Gauteng

DEKRA MFC  
M57 Pretoria Rd - 1619  
KEMPTON PARK - GT  
08610 33572

## Vehicle Data

| Manufacturer | FORD | Registration Number | CT97NCGP |

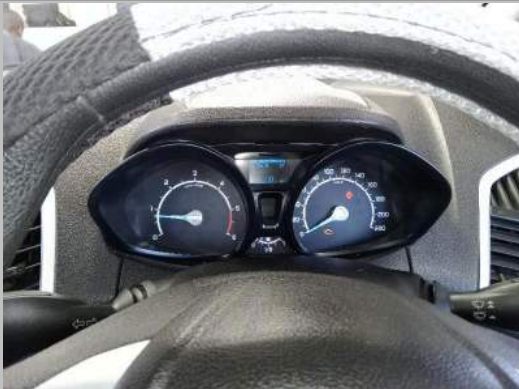
DASHBOARD (W/ ENGINE RUNNING)

| Damage | Repair Way |
|---|---|
| Engine light on | Repair |

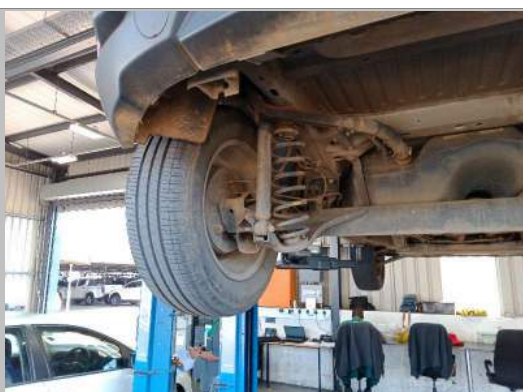
LR TYRE TREAD

| Damage | Repair Way |
|---|---|
| L/R tire deferred name brand | Repair |

| | Size | Load/Speed Index | Manufacture | Model | Type* | Production Date | Tread Depth (mm) |
|---|---|---|---|---|---|---|---|
| Rear Left | 205/60R16 | 92H | Michelin | Energy | V | 3713 | 3 mm |

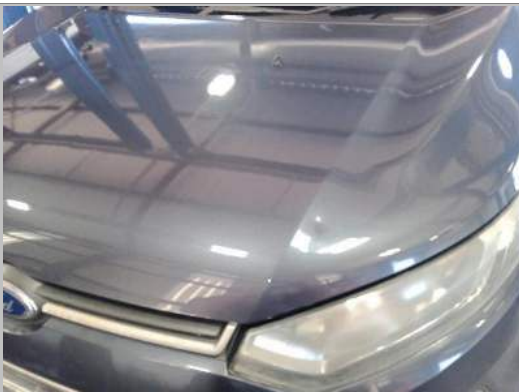
| Damage | Repair Way |
|---|---|
| Bonnet Dented | Repair |

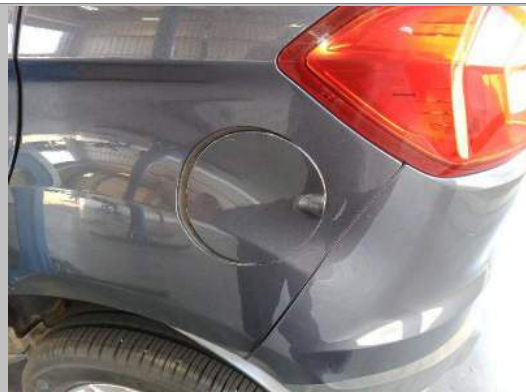
| Damage | Repair Way |
|---|---|
| Fuel Flap Poor Alignment | Repair |

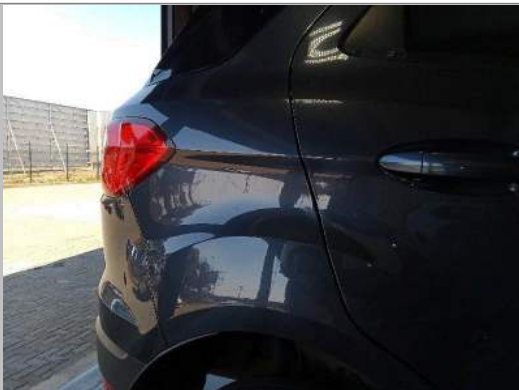
| Damage | Repair Way |
|---|---|
| Rear Fender Right Dented | Repair |

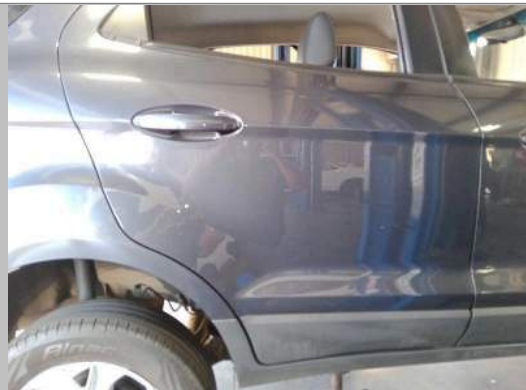
| Damage | Repair Way |
|---|---|
| Door Rear Right Paintwork • Scratched | Repair |

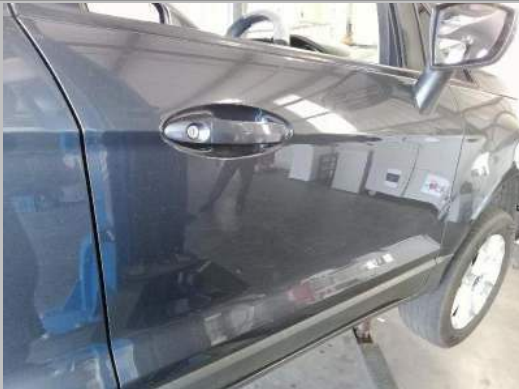
| Damage | Repair Way |
|---|---|
| Door Front Right Paintwork • Chipmarks | Repair |

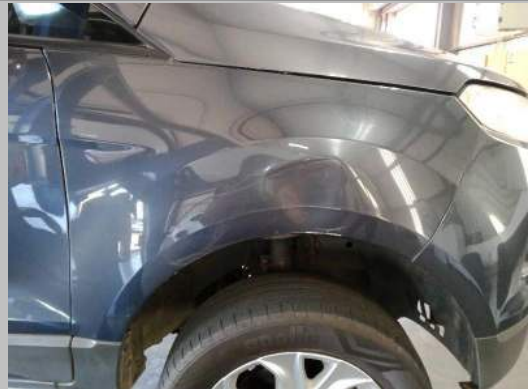
| Damage | Repair Way |
|---|---|
| Front Fender Right Dented | Repair |

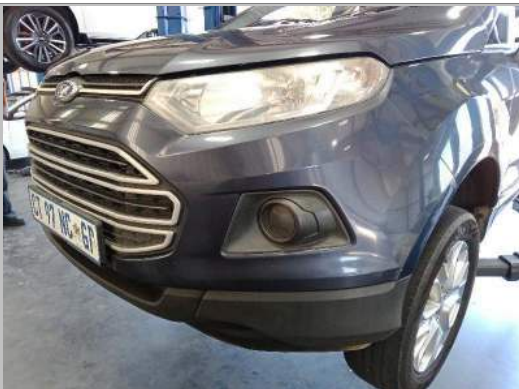
| Damage | Repair Way |
|---|---|
| Front Bumper Paintwork • Scratched | Repair |

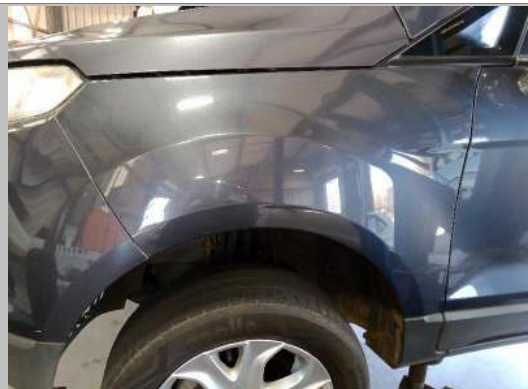
| Damage | Repair Way |
|---|---|
| Front Fender Left Paintwork • Scratched | Repair |

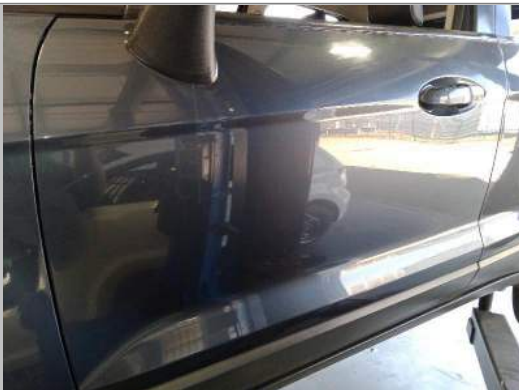
| Damage | Repair Way |
|---|---|
| Door Front Left Paintwork • Scratched | Repair |

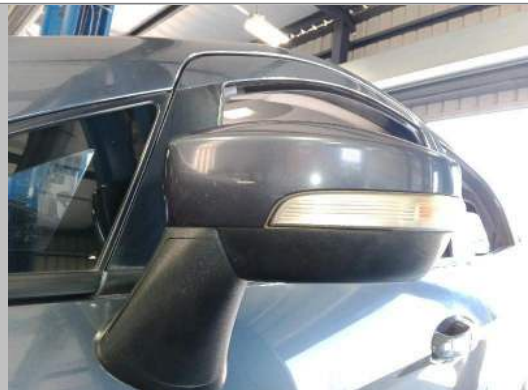
| Damage | Repair Way |
|---|---|
| Side Mirror Left Paintwork • Scratched | Repair |

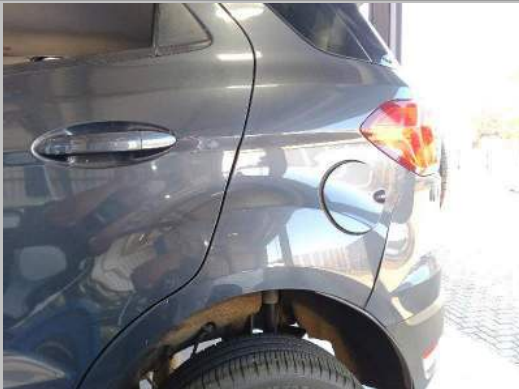
| Damage | Repair Way |
|---|---|
| Rear Fender Left Paintwork • Scratched | Repair |

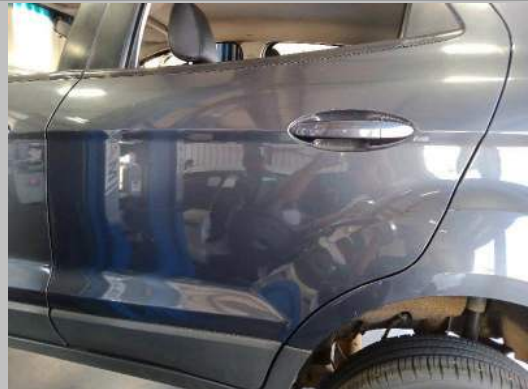
| Damage | Repair Way |
|---|---|
| Door Rear Left Paintwork • Scratched | Repair |

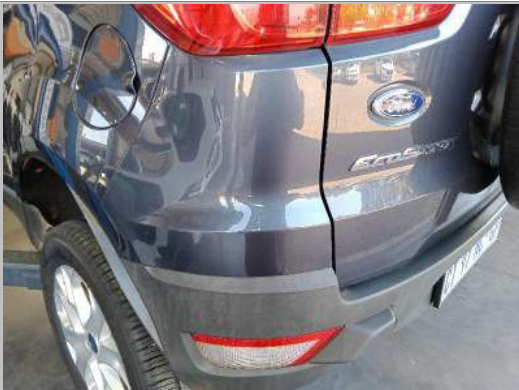
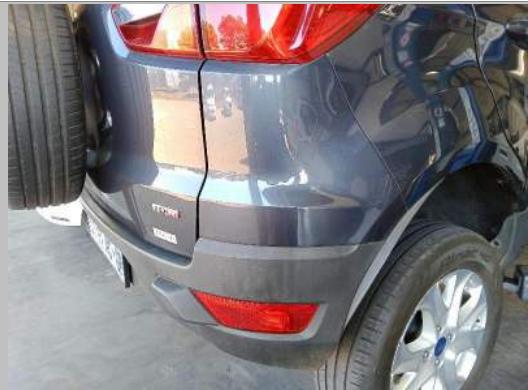
| Damage | Repair Way |
|---|---|
| Rear bumper Paintwork • Scratched | Repair |

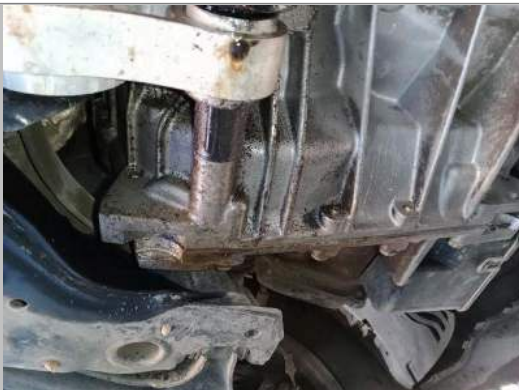
| Damage | Repair Way |
|---|---|
| Gearbox Oil Leak | Repair |
