## CONDITION REPORT

Report No:  
2017299367  
DATE  
16/09/2026

| Manufacturer | FORD | Registration Number | KTC025NW |
| Model | ECOSPORT 1.5 AMBIENTE [2016-2018] | Register Number | |

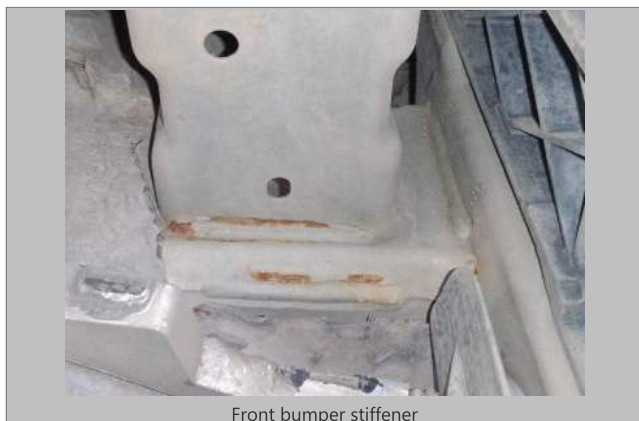
| Damage | Repair Way |
|---|---|
| Front bumper stiffener damaged | Replace |

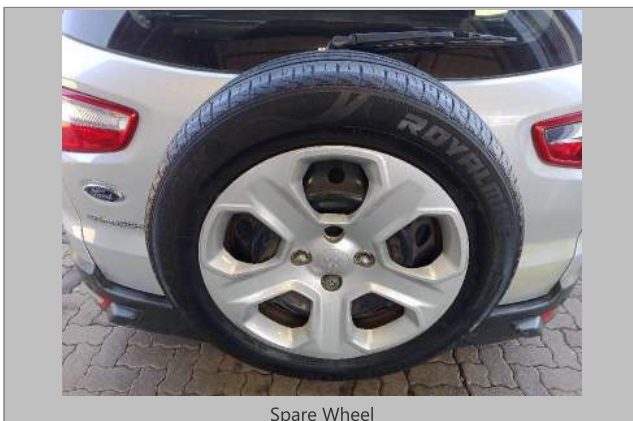
Spare Wheel

| Damage | Repair Way |
|---|---|
| Spare Tyre Torn / Cut | Replace |

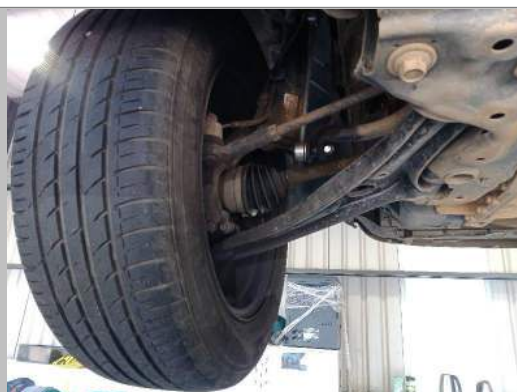
LF TYRE TREAD

| | Size | Load/Speed Index | Manufacture | Model | Type* | Production Date | Tread Depth (mm) |
|---|---|---|---|---|---|---|---|
| Front Left | 205/60R16 | 96V | Velocity | Rota-R | V | 2923 | 1 mm |

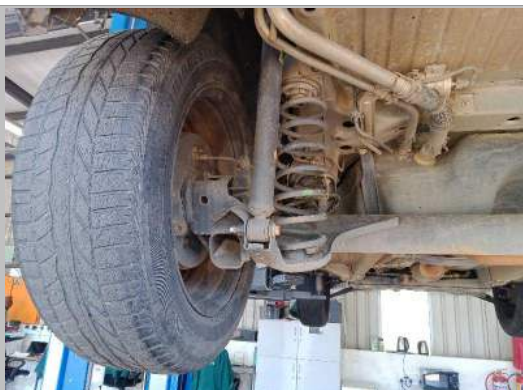
LR TYRE TREAD

| Damage | Repair Way |
|---|---|
| Rear left tyre regrooved | Replace |

| | Size | Load/Speed Index | Manufacture | Model | Type* | Production Date | Tread Depth (mm) |
|---|---|---|---|---|---|---|---|
| Rear Left | 205/60R16 | 92H | Bridgestone | Turanza | V | 2211 | 0 mm |

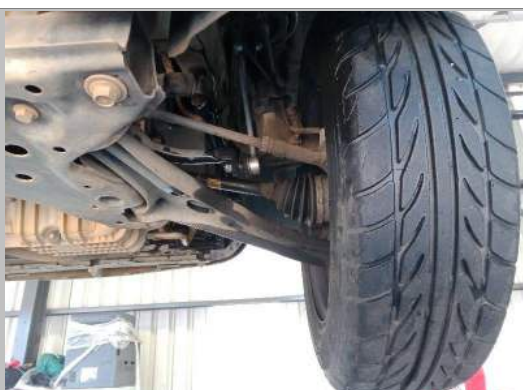
RF TYRE TREAD

| Damage | Repair Way |
|---|---|
| Front left and right tyre sizes different | Repair |

| | Size | Load/Speed Index | Manufacture | Model | Type* | Production Date | Tread Depth (mm) |
|---|---|---|---|---|---|---|---|
| Front Right | 195/65R15 | 91V | Symmetry | SY201 | V | 0421 | 1 mm |

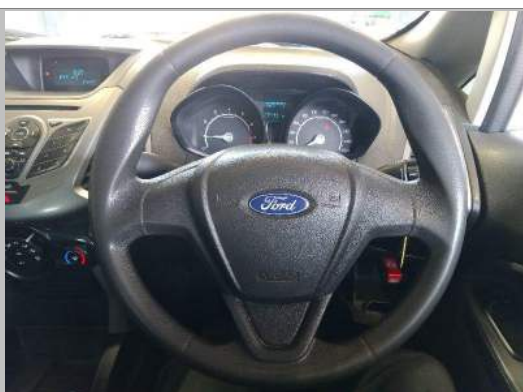
| Damage | Repair Way |
|---|---|
| Steering Wheel Trim Excessive Wear & Tear | Repair |

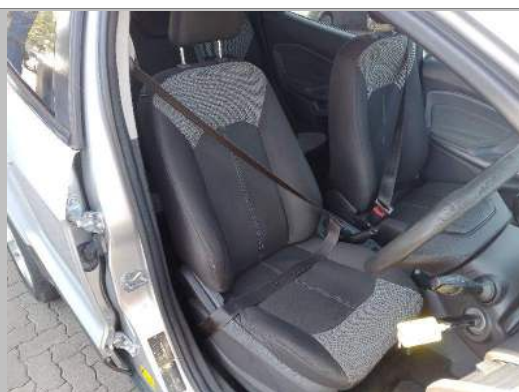
| Damage | Repair Way |
|---|---|
| Seat Front Right Damaged | Repair |

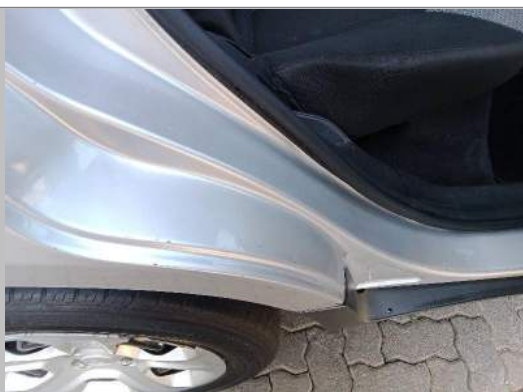
| Damage | Repair Way |
|---|---|
| C • Pillar Right Dented | Repair |

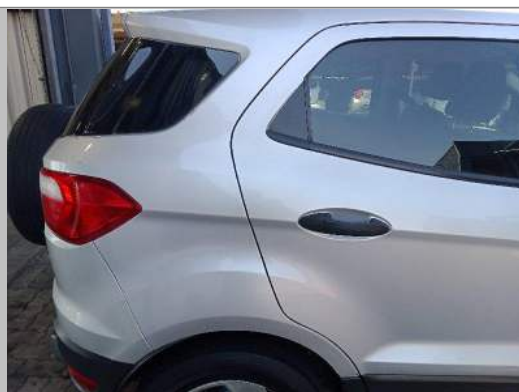
| Damage | Repair Way |
|---|---|
| Rear Fender Right Residual Traces of Repair | Repair |

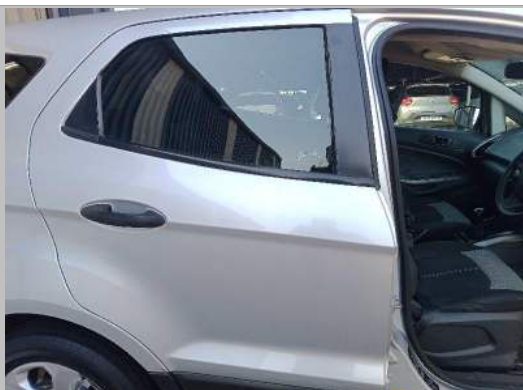
| Damage | Repair Way |
|---|---|
| Door Rear Right Residual Traces of Repair | Repair |

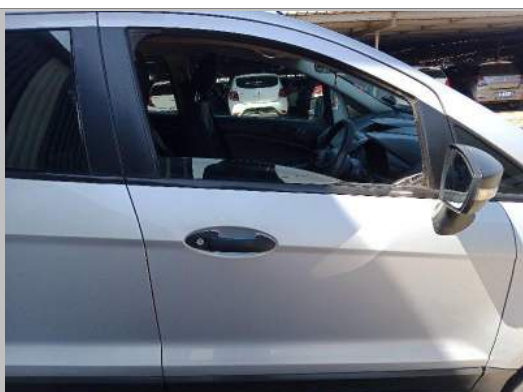
| Damage | Repair Way |
|---|---|
| Door Front Right Dented | Repair |

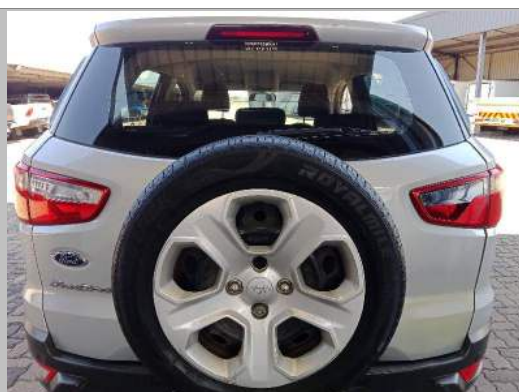
| Damage | Repair Way |
|---|---|
| Boot Lid / Hatch door Residual Traces of Repair | Repair |

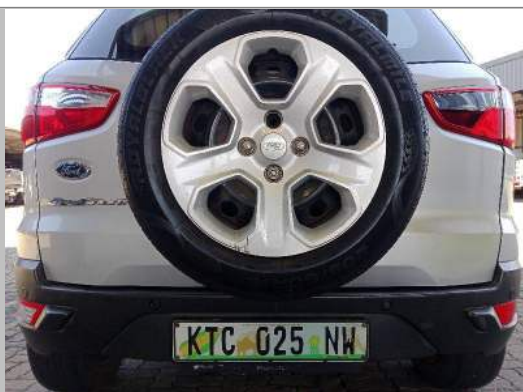
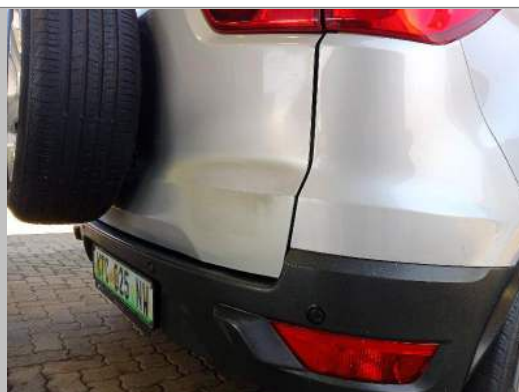
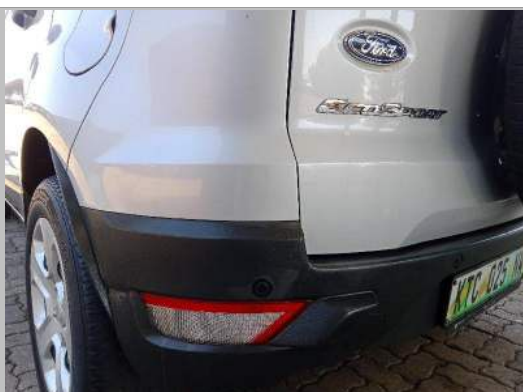
| Damage | Repair Way |
|---|---|
| Rear bumper Damaged | Repair |

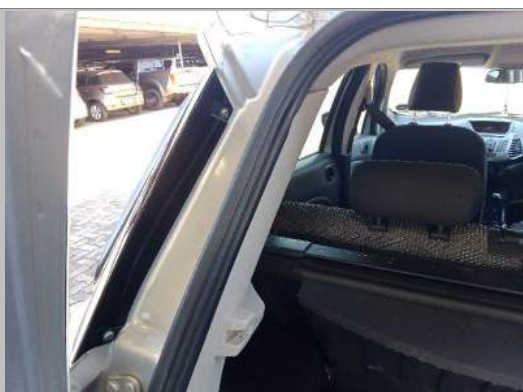
| Damage | Repair Way |
|---|---|
| C • Pillar Left Residual Traces of Repair | Repair |

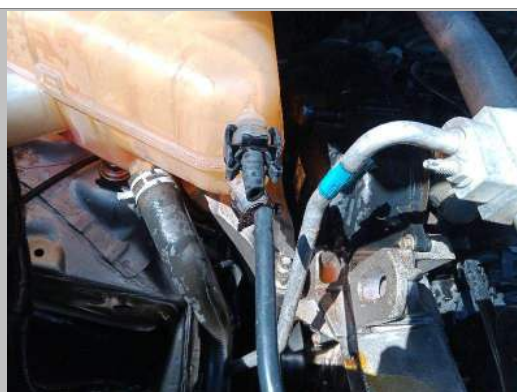
| Damage | Repair Way |
|---|---|
| Hoses Damaged | Replace |

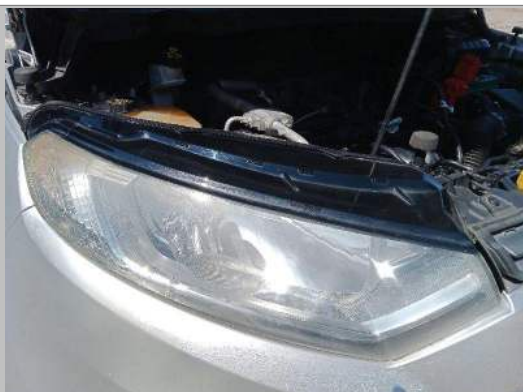
| Damage | Repair Way |
|---|---|
| Headlight Right Scratched | Replace |

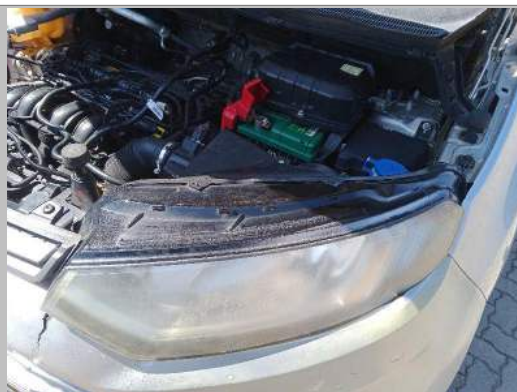
| Damage | Repair Way |
|---|---|
| Headlight Left Damaged | Replace |

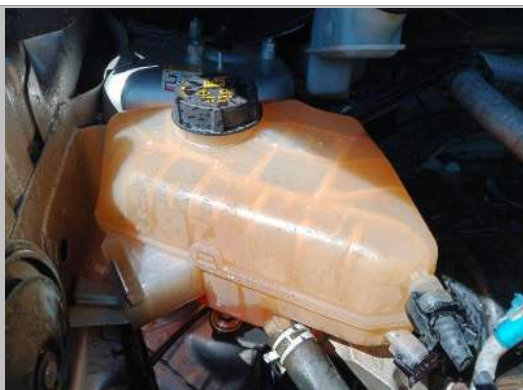
| Damage | Repair Way |
|---|---|
| Water level Insufficient | Replace |

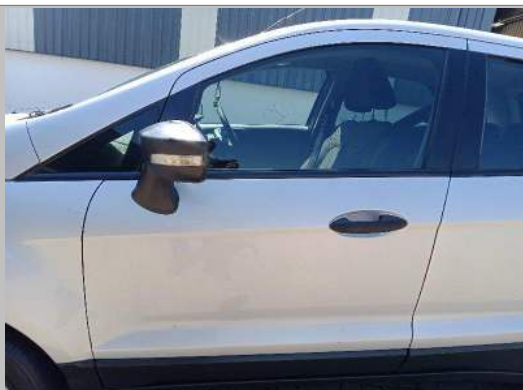
| Damage | Repair Way |
|---|---|
| Door Front Left Paintwork • Chipmarks | Repair |

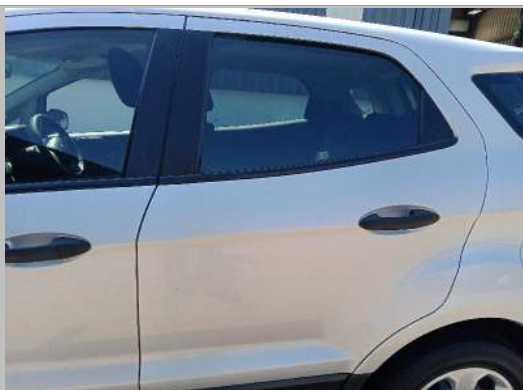
| Damage | Repair Way |
|---|---|
| Door Rear Left Paintwork • Scratched | Repair |

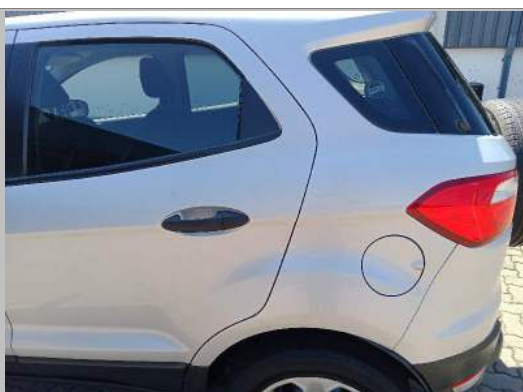
| Damage | Repair Way |
|---|---|
| Rear Fender Left Damaged | Repair |

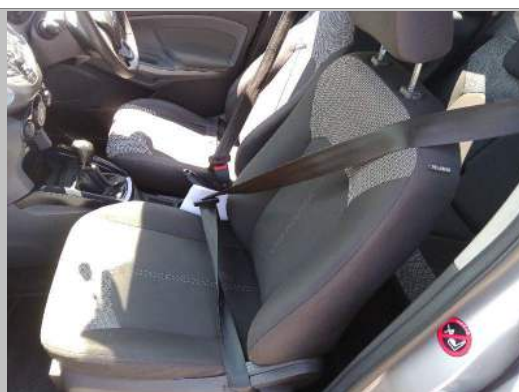
| Damage | Repair Way |
|---|---|
| Seat Front Left Dirty | Repair |

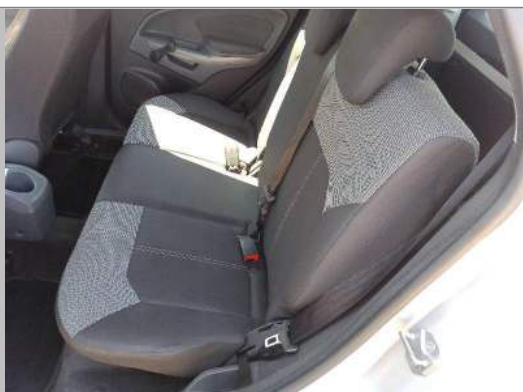
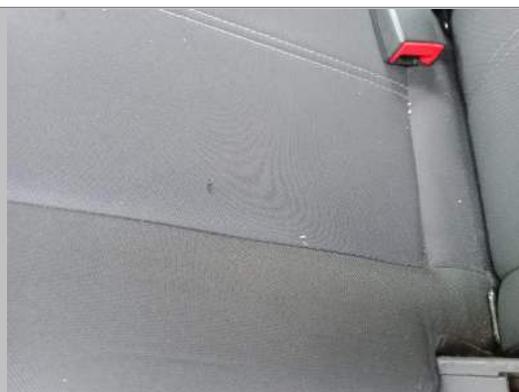
| Damage | Repair Way |
|---|---|
| Seat Rear Torn / Cut | Repair |

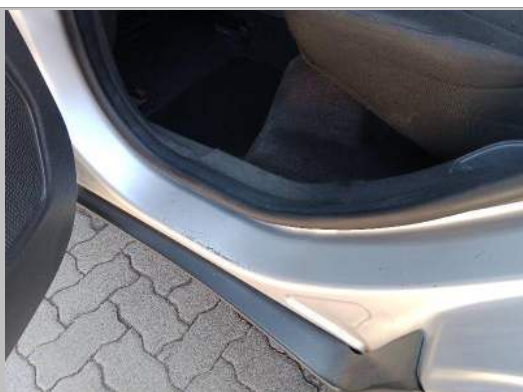
| Damage | Repair Way |
|---|---|
| Sill Panel Left Paintwork • Scratched | Repair |

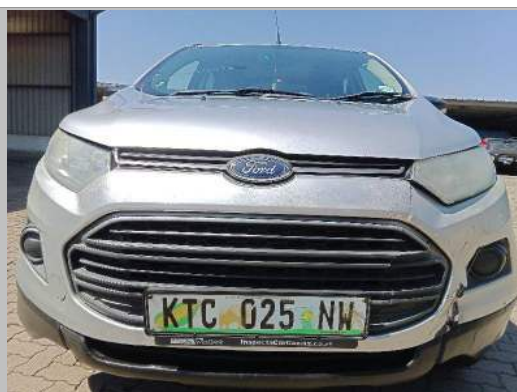
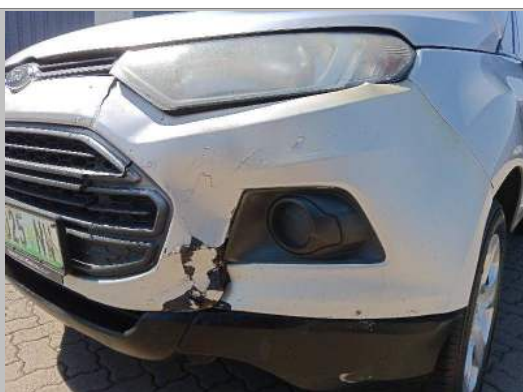
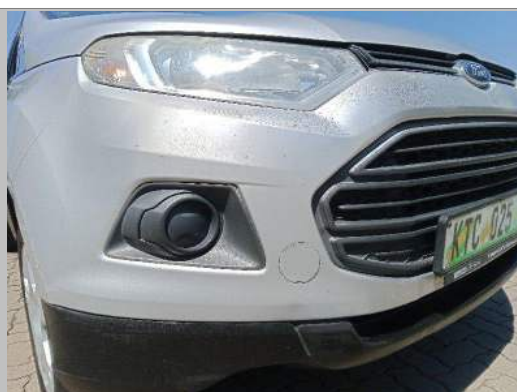
| Damage | Repair Way |
|---|---|
| Front Bumper Damaged | Replace |

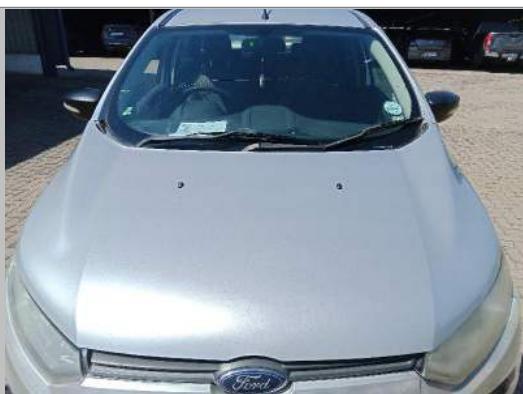
| Damage | Repair Way |
|---|---|
| Bonnet Damaged | Repair |

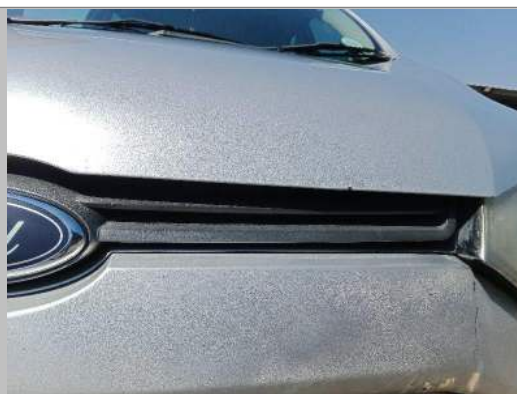
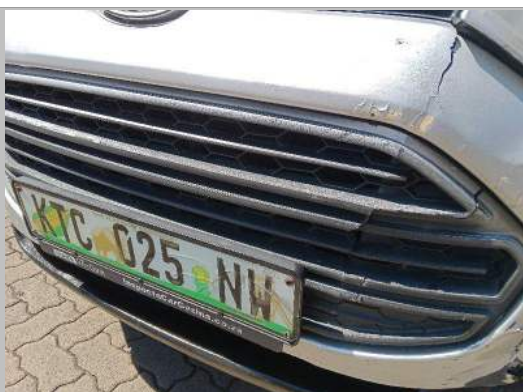
| Damage | Repair Way |
|---|---|
| Grill Damaged | Replace |

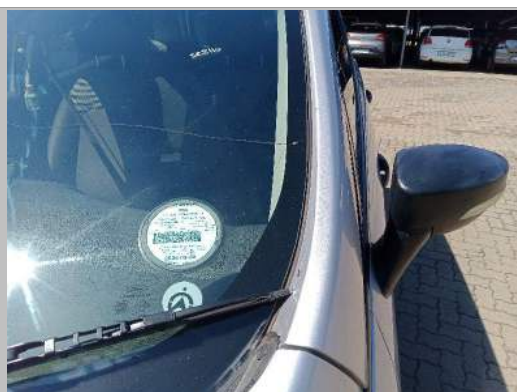
| Damage | Repair Way |
|---|---|
| A • Pillar Left Paintwork • Scratched | Repair |

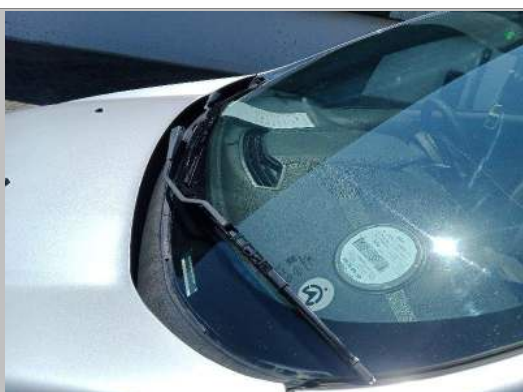
| Damage | Repair Way |
|---|---|
| Windscreen Wiper Defective | Repair |

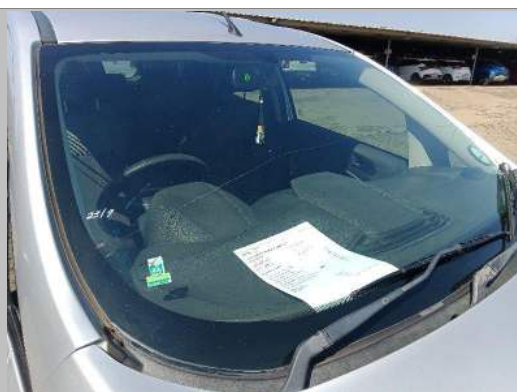
| Damage | Repair Way |
|---|---|
| Windscreen Damaged | Replace |

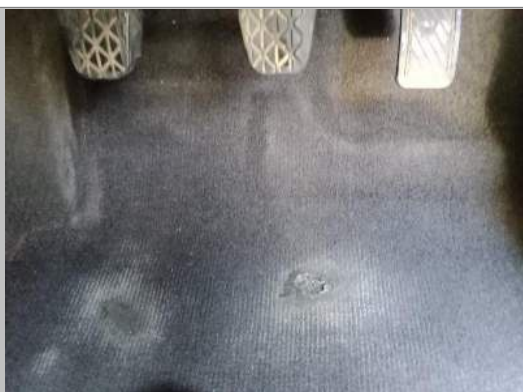
| Damage | Repair Way |
|---|---|
| Carpet Front Damaged | Repair |

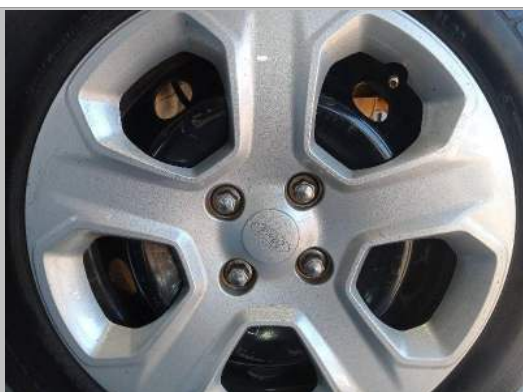
| Damage | Repair Way |
|---|---|
| Rim Rear Left Scratched | Repair |

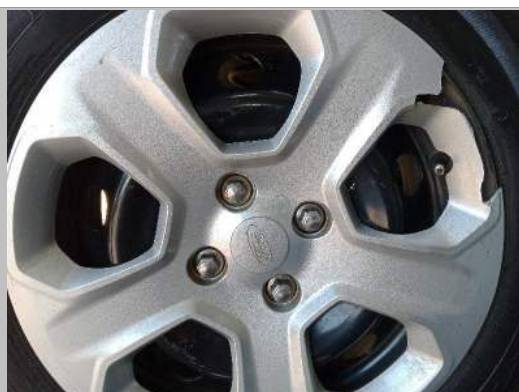
| Damage | Repair Way |
|---|---|
| Rim Rear Right Scratched | Repair |

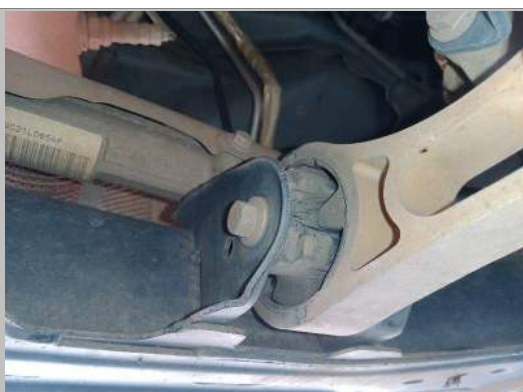
| Damage | Repair Way |
|---|---|
| Gearbox Mountings Cracked | Replace |

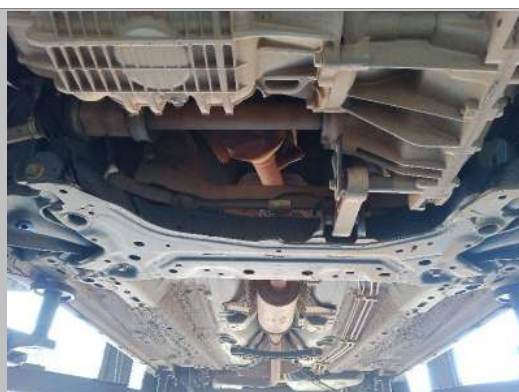
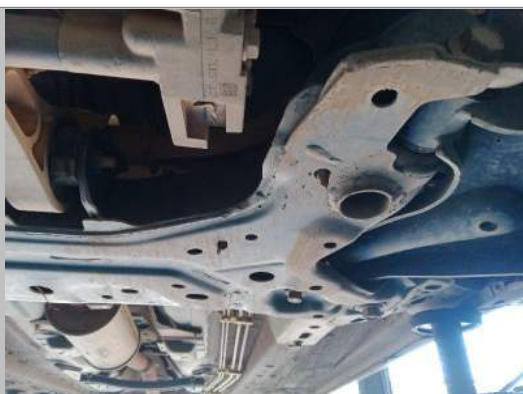
| Damage | Repair Way |
|---|---|
| Sub Frame Scratched | Repair |

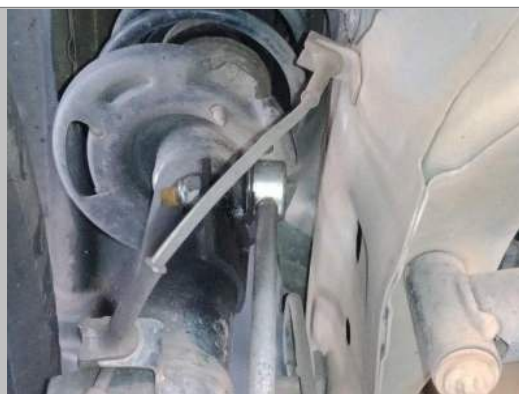
| Damage | Repair Way |
|---|---|
| Stabilizer Mounting Front Left Defective | Replace |

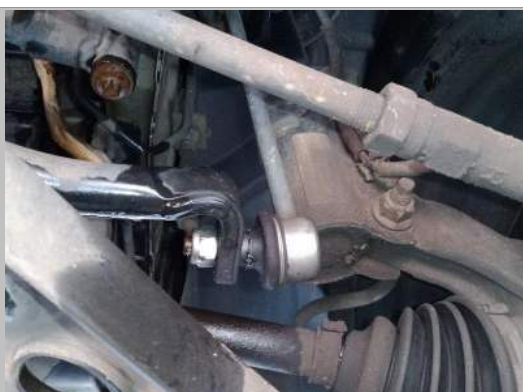
| Damage | Repair Way |
|---|---|
| Stabilizer Mounting Front Right Defective | Replace |

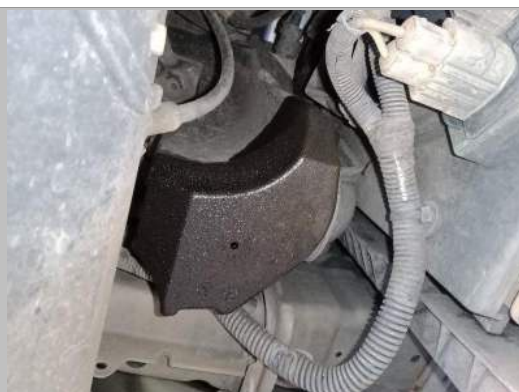
| Damage | Repair Way |
|---|---|
| Air cleaner Damaged | Replace |

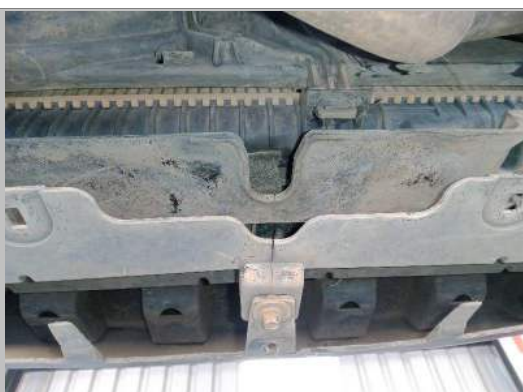
| Damage | Repair Way |
|---|---|
| Radiator Cradle Cracked | Repair |

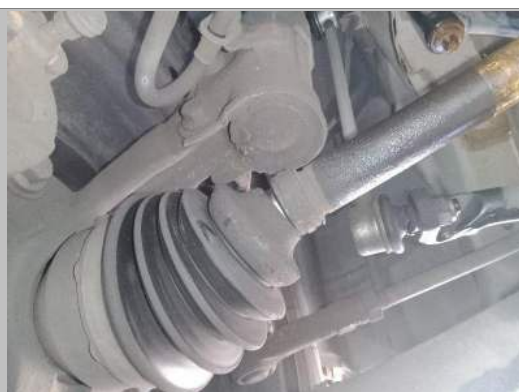
| Damage | Repair Way |
|---|---|
| CV Joint(s) Boot(s) Front Right (inner/outer) Damaged | Replace |

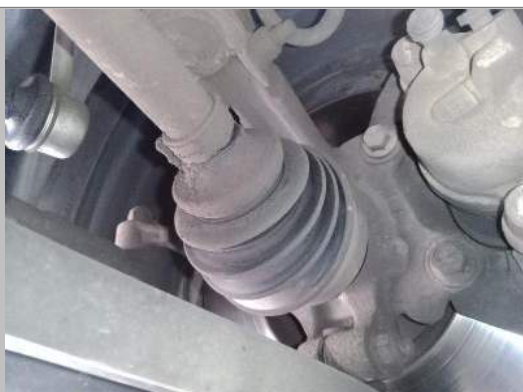
| Damage | Repair Way |
|---|---|
| CV Joint(s) Boot(s) Front Left (inner/outer) Damaged | Replace |

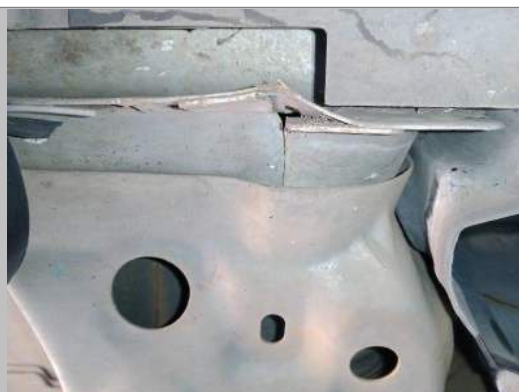
| Damage | Repair Way |
|---|---|
| Sill Panel Right Damaged | Repair |

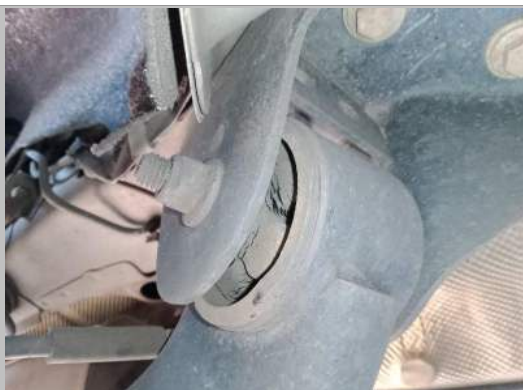
| Damage | Repair Way |
|---|---|
| Mounting Rubber(s) Rear Axle Right Cracked | Replace |

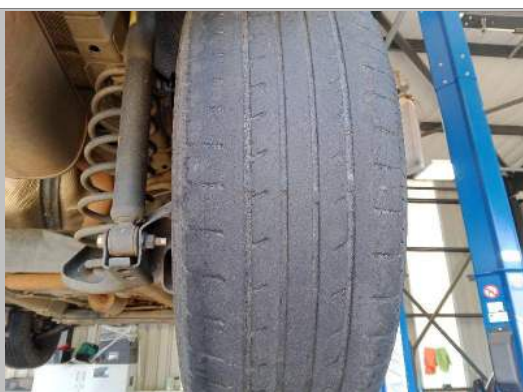
| Damage | Repair Way |
|---|---|
| Tyre Rear Right Worn | Replace |

| | Size | Load/Speed Index | Manufacture | Model | Type* | Production Date | Tread Depth (mm) |
|---|---|---|---|---|---|---|---|
| Rear Right | 205/60R16 | 92H | Westlake | Radial | V | 1322 | 0 mm |

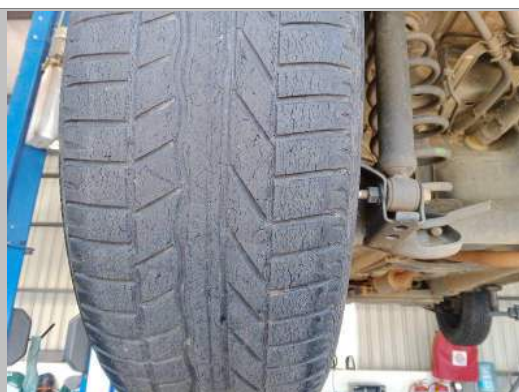
| Damage | Repair Way |
|---|---|
| Tyre Rear Left Damaged | Replace |

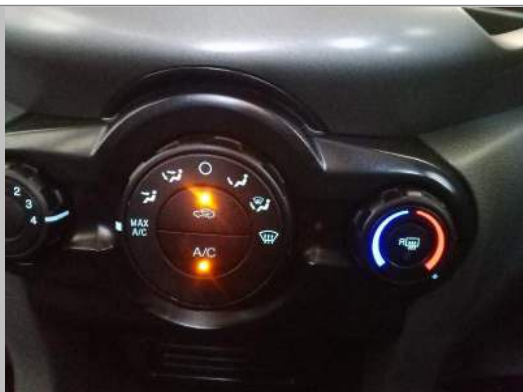
| Damage | Repair Way |
|---|---|
| Air Conditioner Malfunction | Replace |

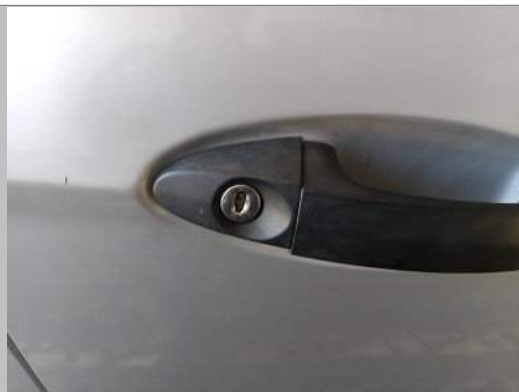
| Damage | Repair Way |
|---|---|
| Door Lock Front Right Damaged | Replace |
