CONDITION REPORT

Report No:  
2017297476  
DATE  
11/09/2026

| Manufacturer | HYUNDAI | Registration Number | JL97JSGP |
| Model | ATOS 1.1 50KW MOTION 5-DR [2019-2024] | Register Number | |

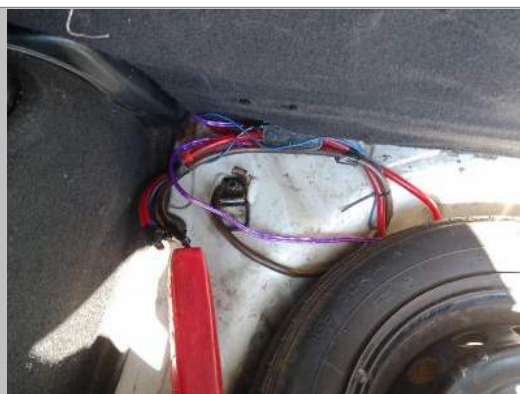
Sound wiring

| Loose sound wiring inside boot of vehicle | Replace |

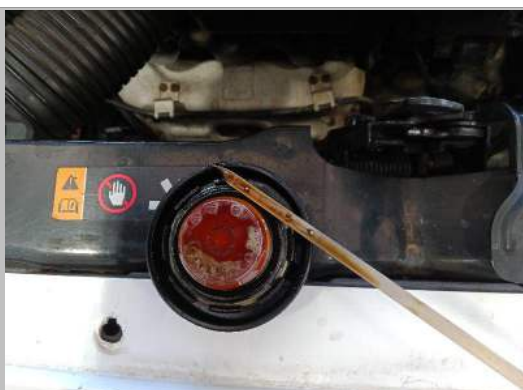
Oil cap and dipstick

| Foreign substance on oil cap | Repair |

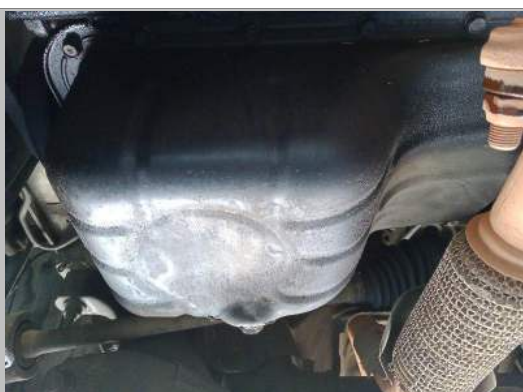
| Engine oil sump dented | Repair |

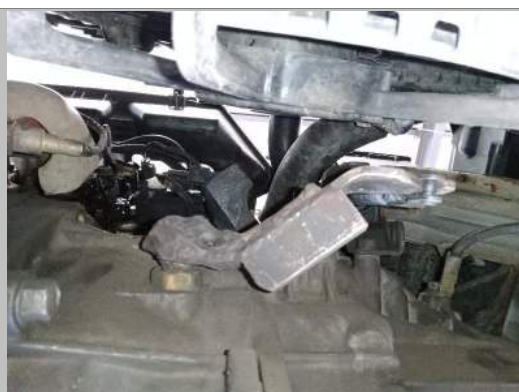
| Clutch fork welded | Replace |

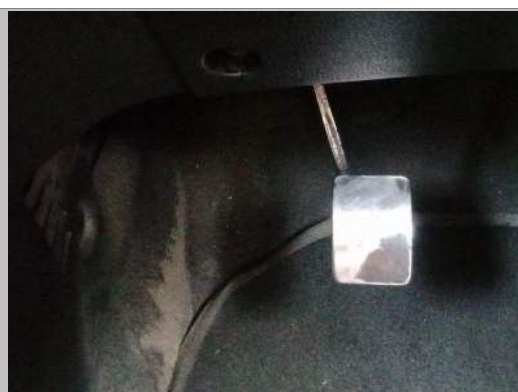
| Damage | Repair Way |
|---|---|
| Clutch Pedal Rubber Missing | Replace |

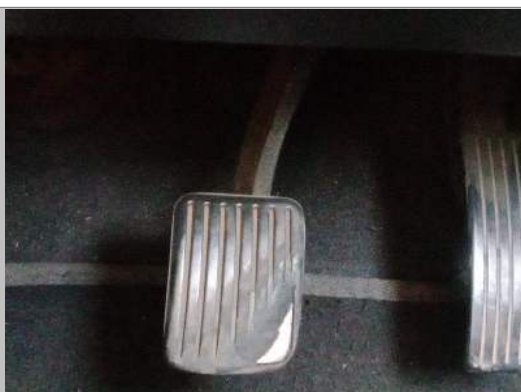
| Damage | Repair Way |
|---|---|
| Brake Pedal Rubber Damaged | Replace |

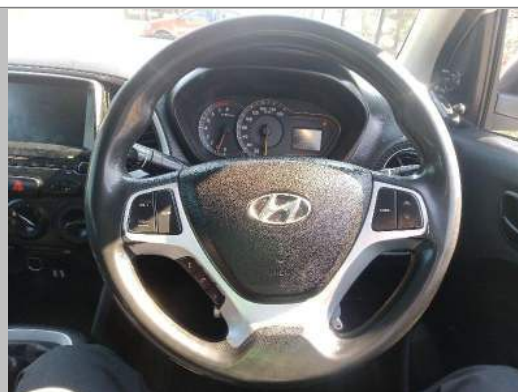
| Damage | Repair Way |
|---|---|
| Steering Wheel Trim Excessive Wear & Tear | Repair |

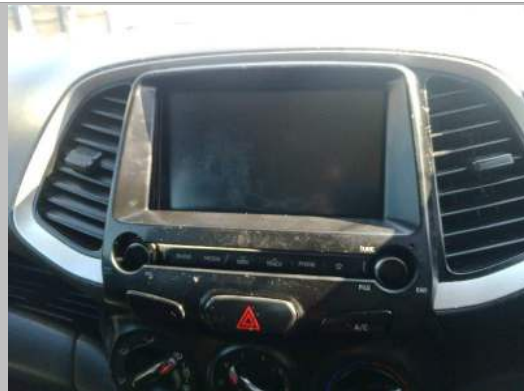
| Damage | Repair Way |
|---|---|
| Center Console / Cubbyhole + Lid Damaged | Repair |

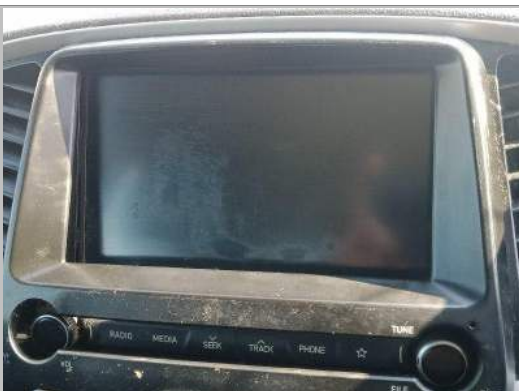
| Damage | Repair Way |
|---|---|
| Radio/CD/USB Defective | Repair |

Electrical Components and Instruments: Radio not working. Non standard switch fitted on driver's side.

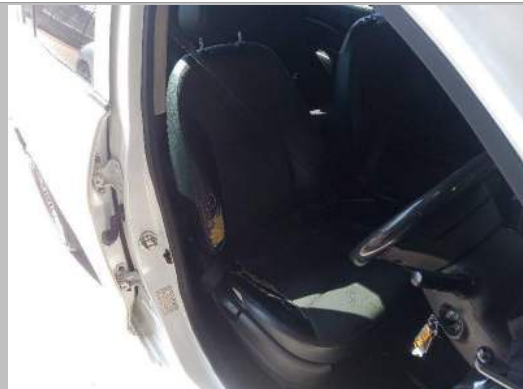
| Damage | Repair Way |
|---|---|
| Seat Front Right Damaged | Repair |

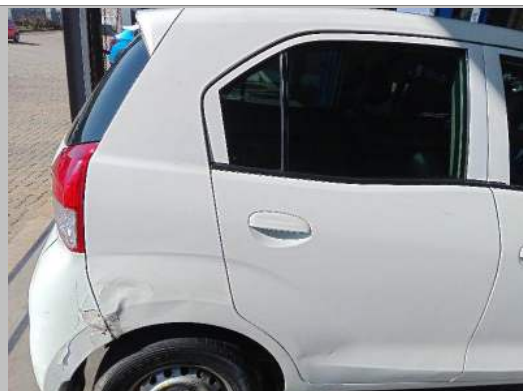
| Damage | Repair Way |
|---|---|
| Rear Fender Right Damaged | Repair |

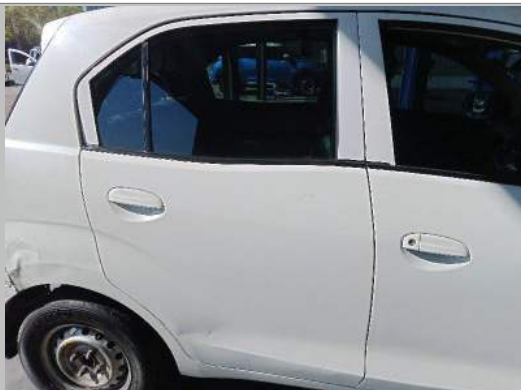
| Damage | Repair Way |
|---|---|
| Door Rear Right Damaged | Repair |

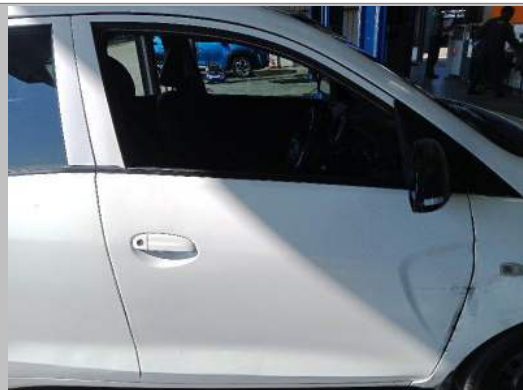
| Damage | Repair Way |
|---|---|
| Door Front Right Damaged | Repair |

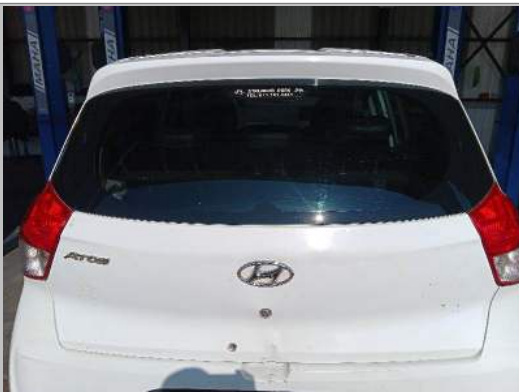
| Damage | Repair Way |
|---|---|
| Boot Lid / Hatch door Damaged | Repair |

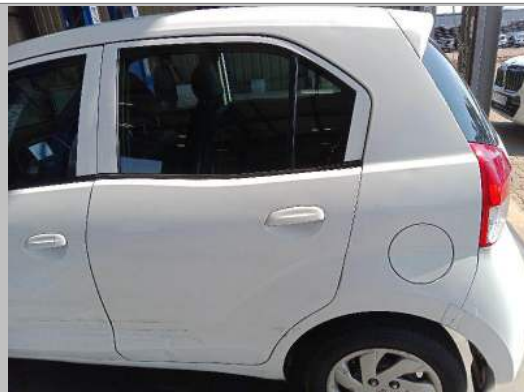
| Damage | Repair Way |
|---|---|
| Rear Fender Left Damaged | Repair |

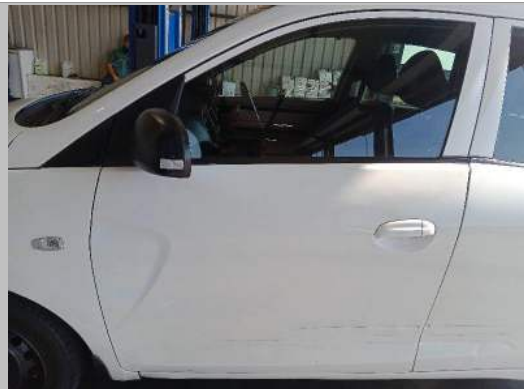
| Damage | Repair Way |
|---|---|
| Door Front Left Damaged | Repair |

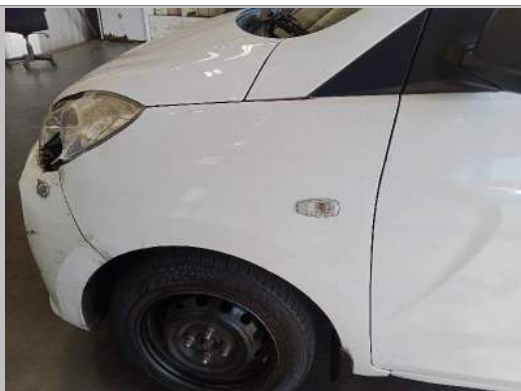
| Damage | Repair Way |
|---|---|
| Front Fender Left Damaged | Repair |

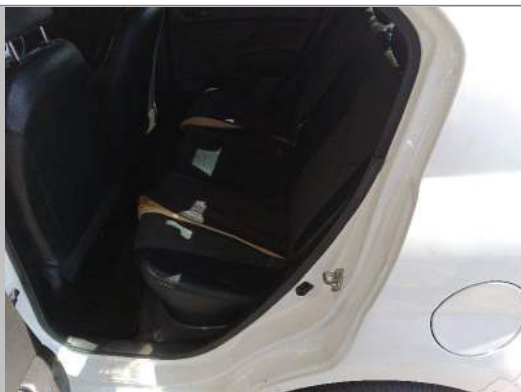
| Damage | Repair Way |
|---|---|
| C • Pillar Left Residual Traces of Repair | Repair |

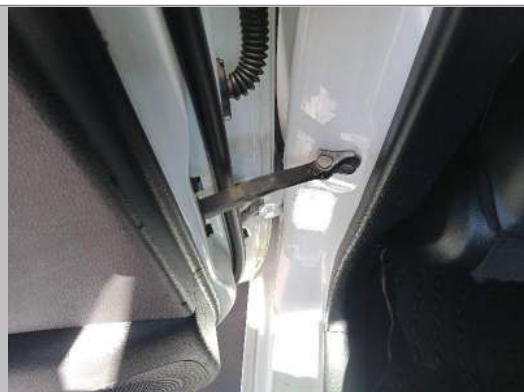
| Damage | Repair Way |
|---|---|
| Doorstopper Rear Left Damaged | Replace |

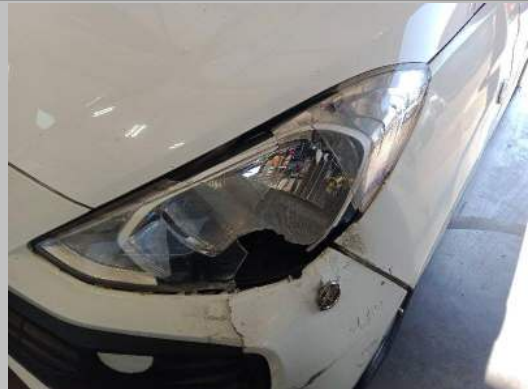
| Damage | Repair Way |
|---|---|
| Headlight Left Damaged | Replace |

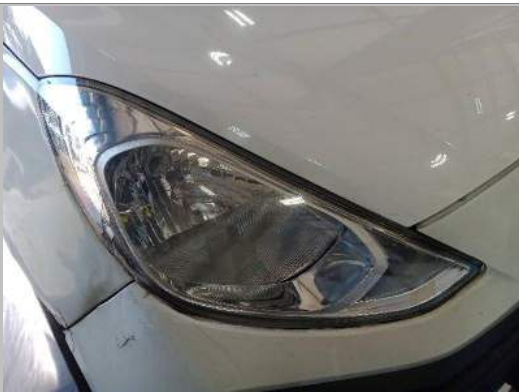
| Damage | Repair Way |
|---|---|
| Headlight Right Damaged | Replace |

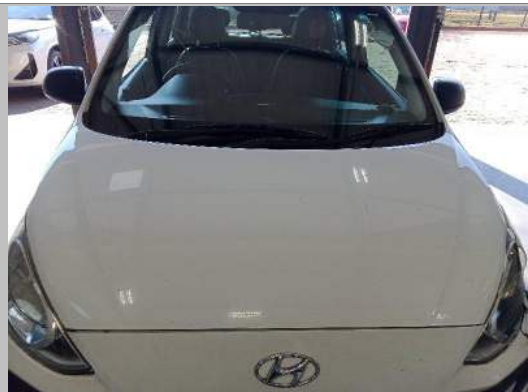
| Damage | Repair Way |
|---|---|
| Bonnet Damaged | Repair |

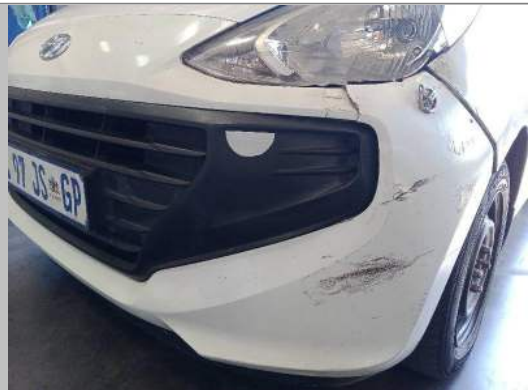
| Damage | Repair Way |
|---|---|
| Front Bumper Damaged | Replace |

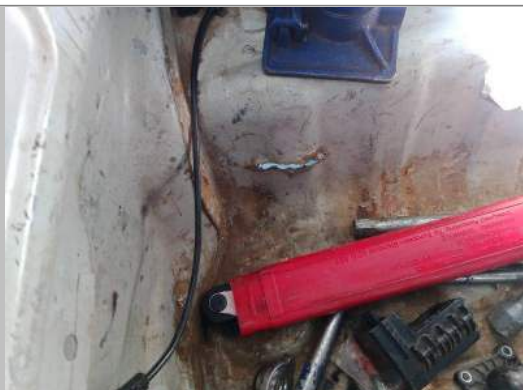
| Damage | Repair Way |
|---|---|
| Inner Boot Floor Pan and Spare Wheel Well Damaged | Repair |

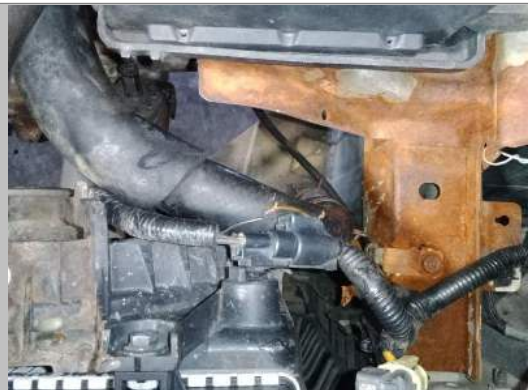
| Damage | Repair Way |
|---|---|
| Engine Wiring Defective | Repair |

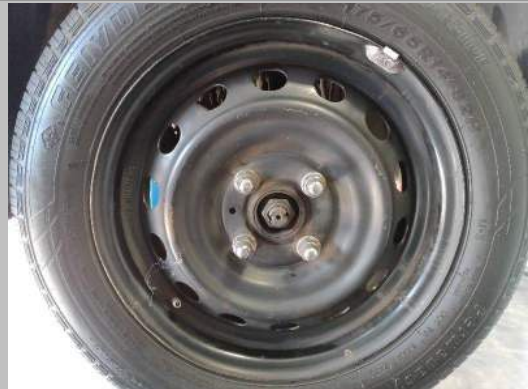
| Damage | Repair Way |
|---|---|
| Rim Front Right Dented | Repair |

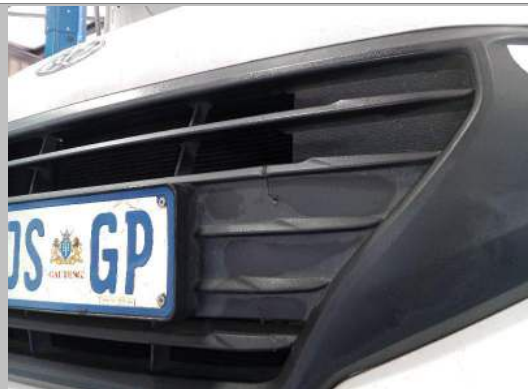
| Damage | Repair Way |
|---|---|
| Grill Cracked | Replace |

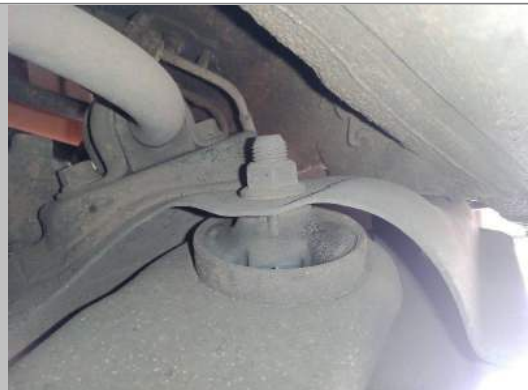
| Damage | Repair Way |
|---|---|
| Control Arm Bush(es) Front Axle Left Cracked | Replace |

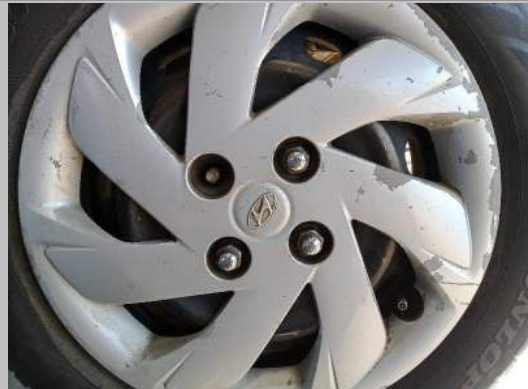
| Damage | Repair Way |
|---|---|
| Bolt(s) / Nut(s) Rear Wheel Left Missing | Replace |

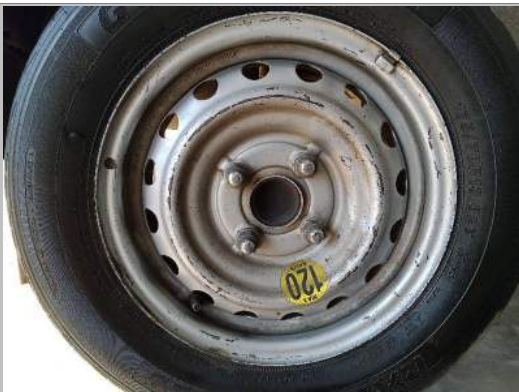
| Damage | Repair Way |
|---|---|
| Rim Rear Right Scratched | Repair |

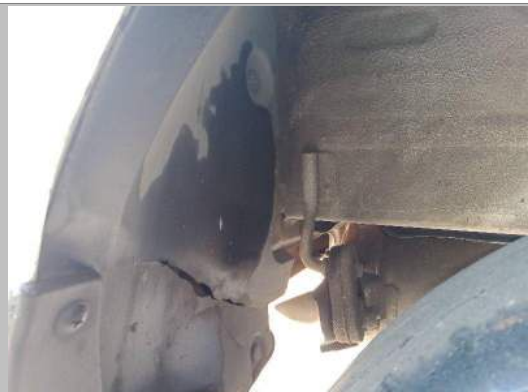
| Damage | Repair Way |
|---|---|
| Rear Fender Right / Inner Tray Damaged | Replace |

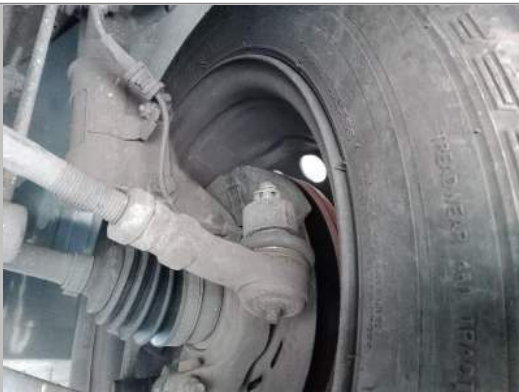
| Damage | Repair Way |
|---|---|
| Tie Rod End right Loose / Excessive Play | Replace |

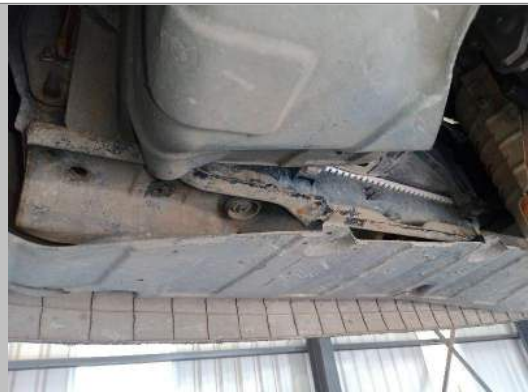
| Radiator Cradle Damaged | Replace |

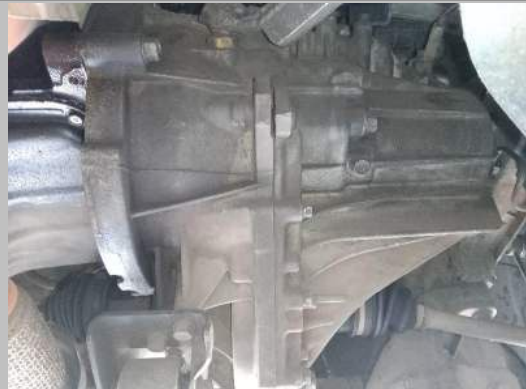
| Gearbox Oil Leak | Repair |

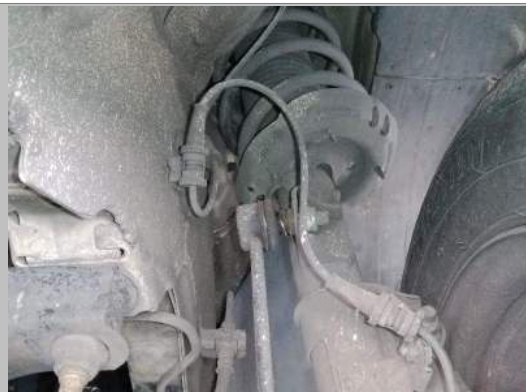
| Damage | Repair Way |
|---|---|
| Stabilizer Mounting Front Right Damaged | Replace |

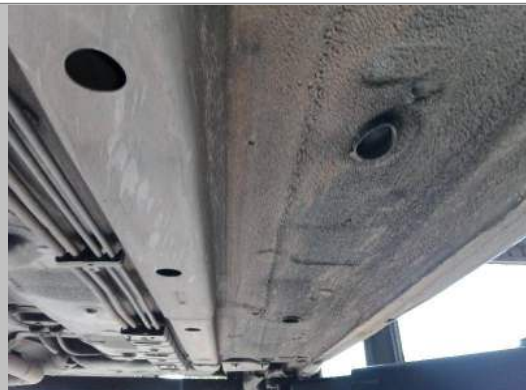
| Damage | Repair Way |
|---|---|
| Chassis Dented | Repair |

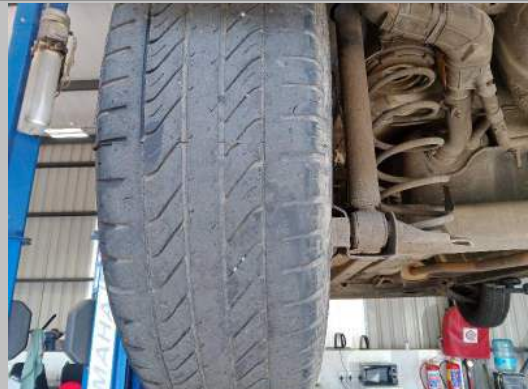
| Damage | Repair Way |
|---|---|
| Tyre Rear Left Worn | Replace |

| | Size | Load/Speed Index | Manufacture | Model | Type* | Production Date | Tread Depth (mm) |
|---|---|---|---|---|---|---|---|
| Rear Left | 175/65 R14 | 82T | Dunlop | Sp-Sport | V | 1724 | 0 mm |

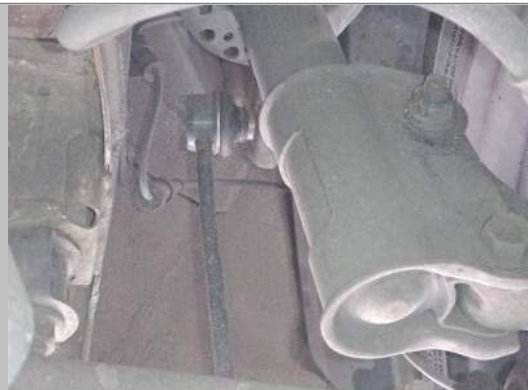
| Damage | Repair Way |
|---|---|
| Stabilizer Mounting Front Left Damaged | Replace |

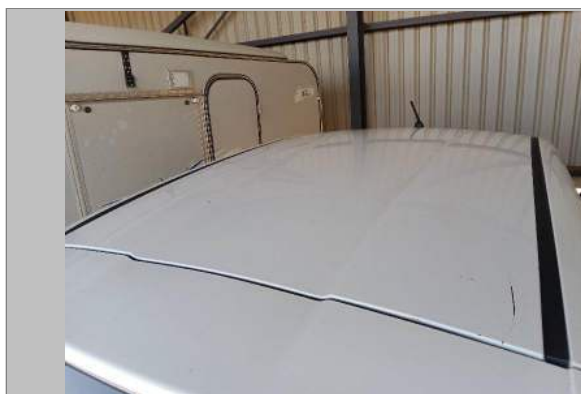
| Damage | Repair Way |
|---|---|
| Roof Paintwork • Scratched | Repair |
