## CONDITION REPORT

Report No:  
2017297774  
DATE  
11/09/2026

| Manufacturer | HYUNDAI | Registration Number | CL37NCGP |
| Model | I10 1.1 MOTION 5-DR [2011-2018] | Register Number | |

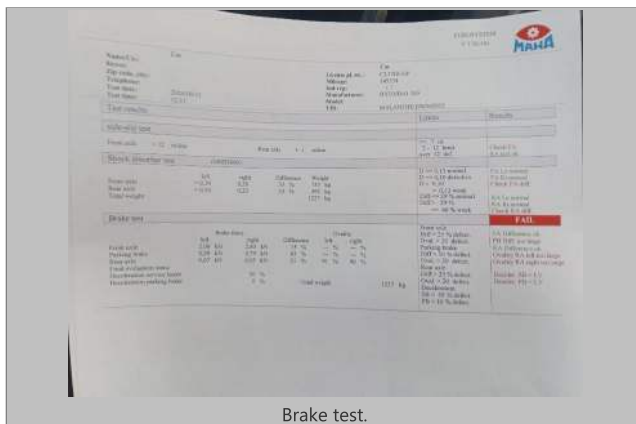
Brake test.

| Parking Brake Performance Left / Right Difference out of legal range | Repair |

| | Left | Right | | |
|---|---|---|---|---|
| Emergency / Parking | 0.29 | 0.79 | - | |

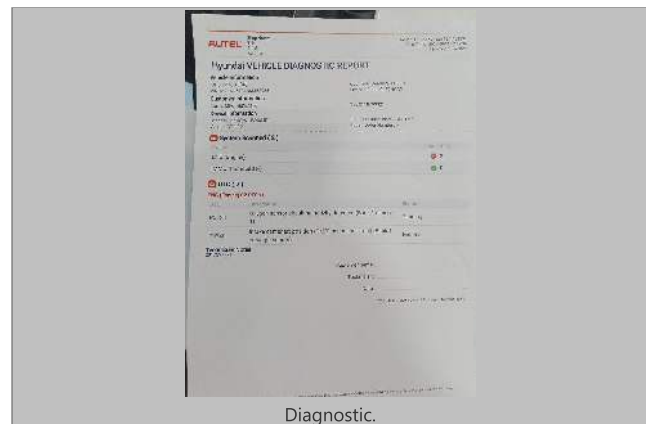
Diagnostic.

| No | System | Code | Description | Status |
|---|---|---|---|---|
| 1 | ENG | P0134 | OXYGEN SENSOR CIRCUIT NO ACTIVITY DETECTED | |
| 2 | ENG | P0340 | INTAKE CAMSHAFT POSITION | |

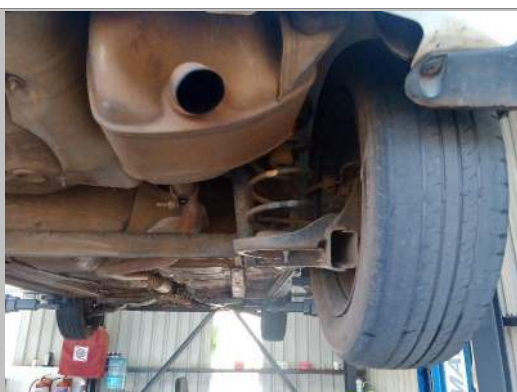
RR TYRE TREAD

| Tyre Rear Right Worn | Replace |

| | Size | Load/Speed Index | Manufacture | Model | Type* | Production Date | Tread Depth (mm) |
|---|---|---|---|---|---|---|---|
| Rear Right | 165/60R14 | 75H | Goodride | Radial | V | 5124 | 0 mm |

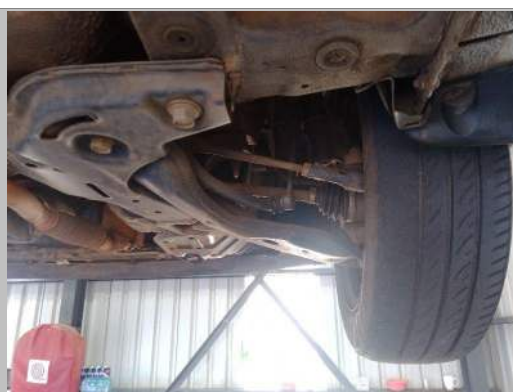
RF TYRE TREAD

| Tyre Front Right Worn | Replace |

| | Size | Load/Speed Index | Manufacture | Model | Type* | Production Date | Tread Depth (mm) |
|---|---|---|---|---|---|---|---|
| Front Right | 165/60R14 | 75H | Hifly | Radial | V | 1223 | 0 mm |

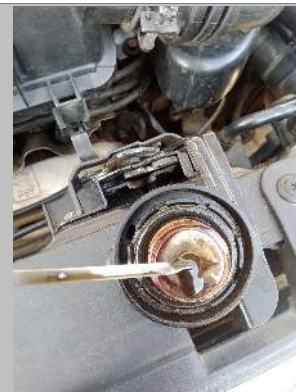
Oil cap and dipstick.

General Comments: ACCORDING TO THE AGE AND MILEAGE OF THE VEHICLE, NORMAL WEAR AND TEAR MARKS ARE VISIBLE ON THE INTERIOR, EXTERIOR, ELECTRICAL AND MECHANICAL PARTS. Engine Compartment: Foreign substance on oil filler cap.

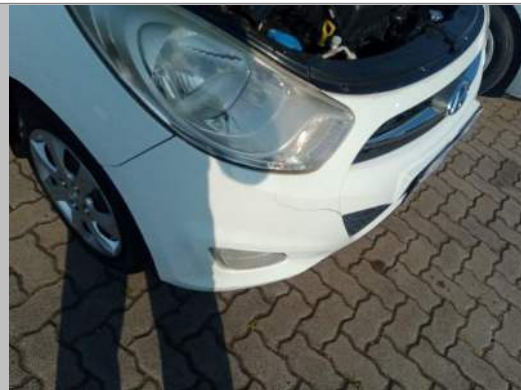
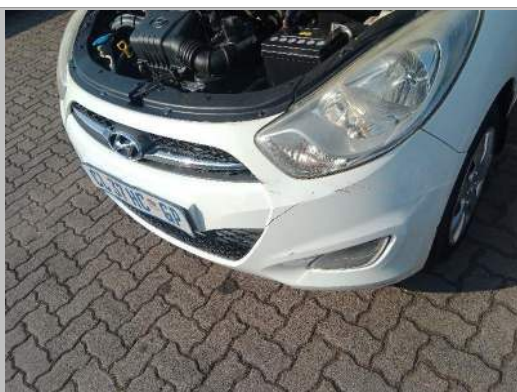
| Front Bumper Damaged | Repair |

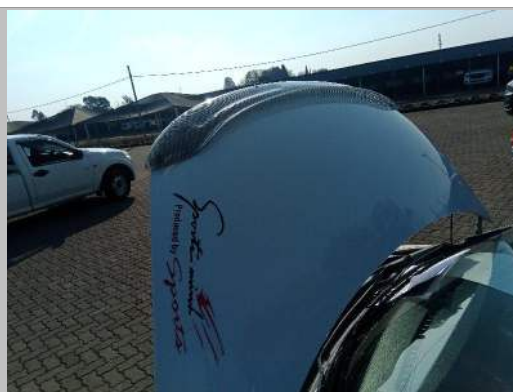
| Bonnet Damaged | Repair |

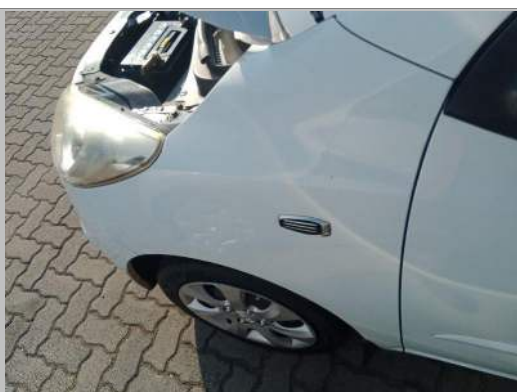
| Front Fender Left Damaged | Repair |

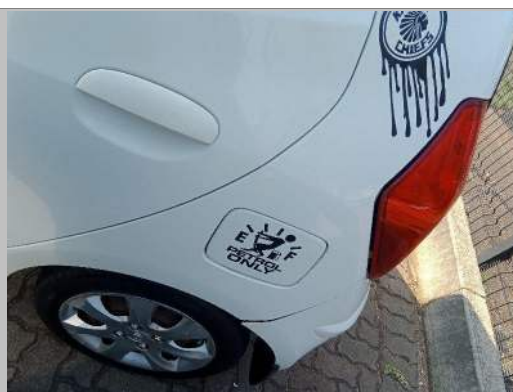
| Rear Fender Left Damaged | Repair |

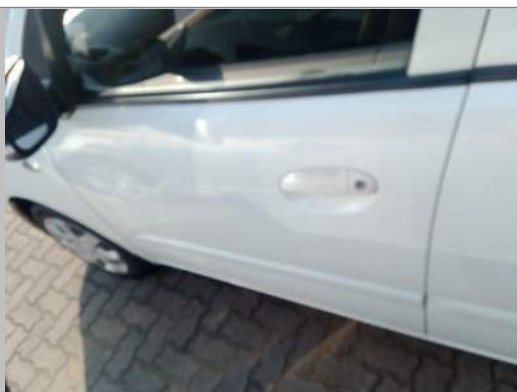
| Door Front Left Damaged | Repair |

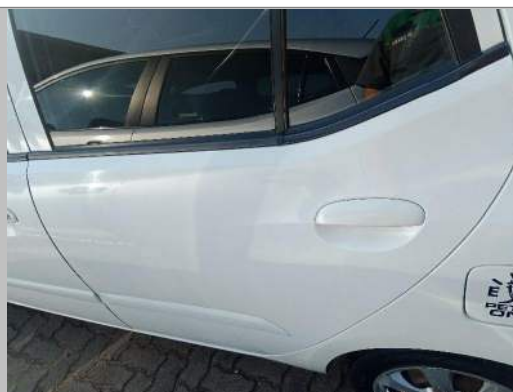
| Door Rear Left Damaged | Repair |

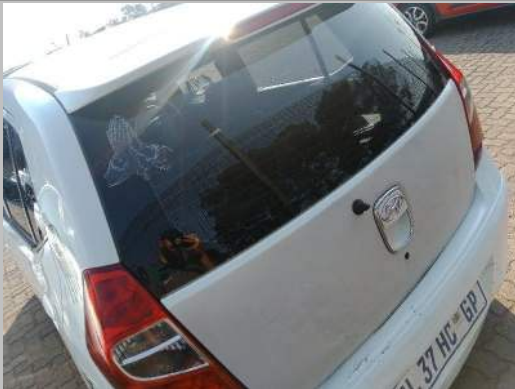
| Boot Lid / Hatch door Damaged | Repair |

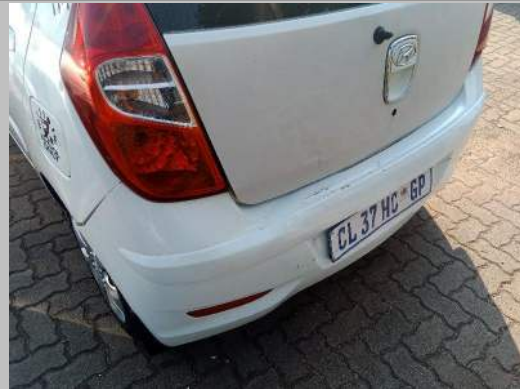
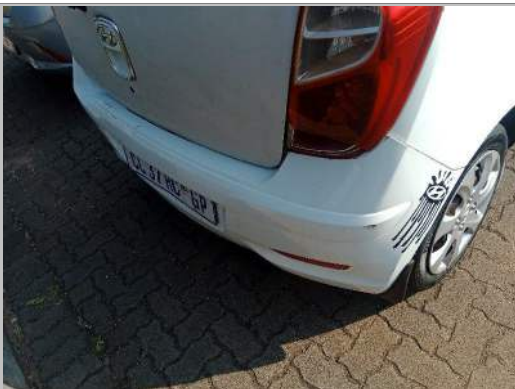
| Rear bumper Damaged | Repair |

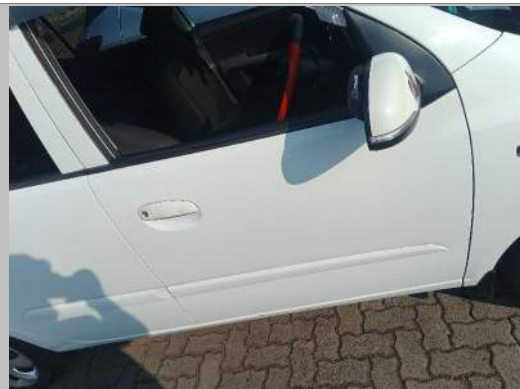
| Door Front Right Damaged | Repair |

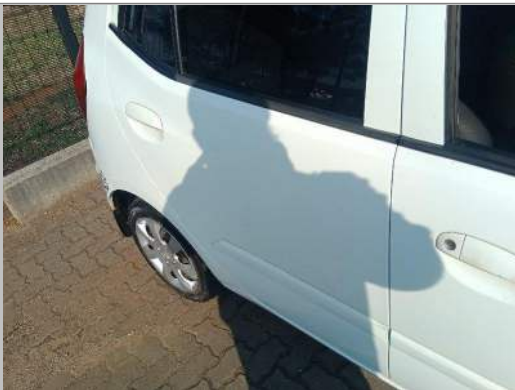
| Door Rear Right Damaged | Repair |

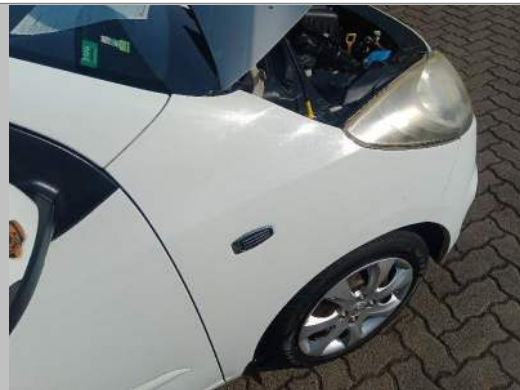
| Front Fender Right Damaged | Repair |

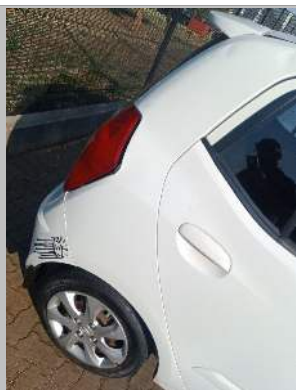
| Rear Fender Right Damaged | Repair |

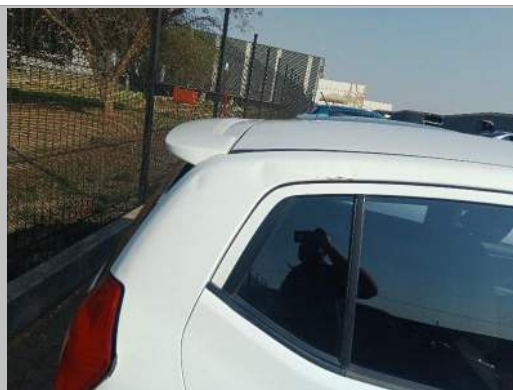
| C • Pillar Right Damaged | Repair |

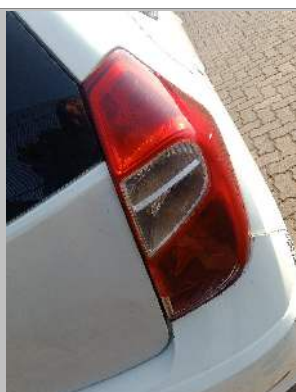
| Tail Light Right Damaged | Repair |

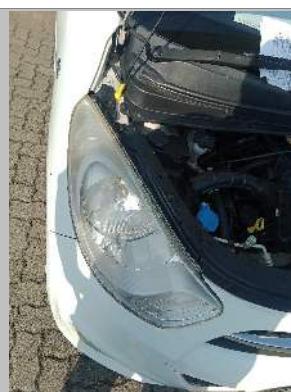
| Headlight Right Damaged | Replace |

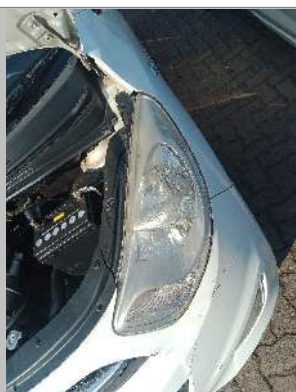
| Headlight Left Damaged | Replace |

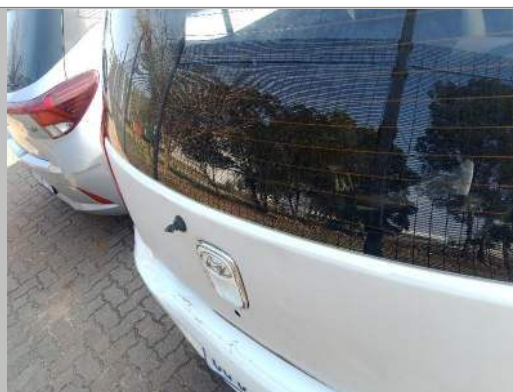
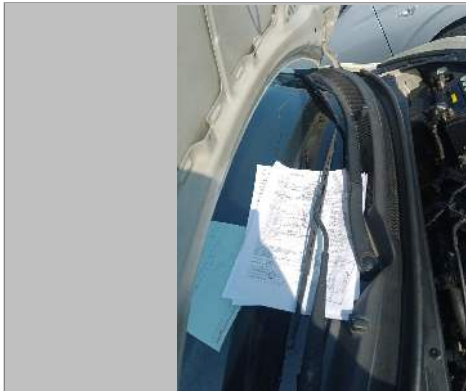
| Windscreen Wiper Damaged | Repair |

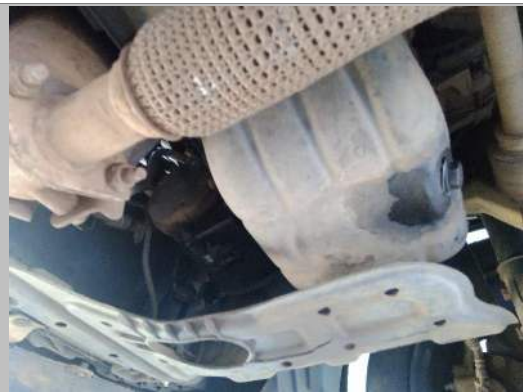
| Engine Oil Leak | Repair |
