## CONDITION REPORT

Report No:  
2017297766  
DATE  
11/09/2026

| Manufacturer | HYUNDAI | Registration Number | CF125-560 |
| Model | I10 1.1 MOTION 5-DR [2011-2018] | Register Number | |

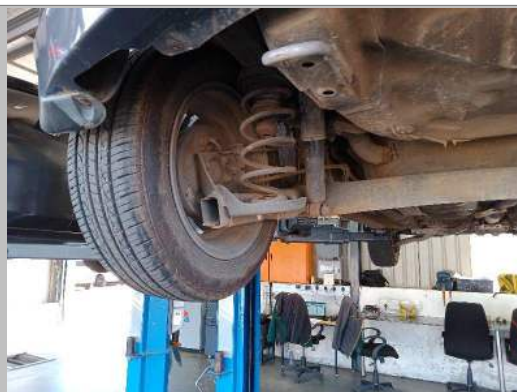
LR TYRE TREAD

| Rear left tyre size differ | Replace |

| | Size | Load/Speed Index | Manufacture | Model | Type* | Production Date | Tread Depth (mm) |
|---|---|---|---|---|---|---|---|
| Rear Left | 185/60R14 | 82H | Annaite | An600 | V | 3025 | 3 mm |

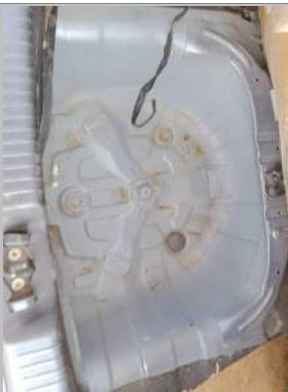
No spare wheel

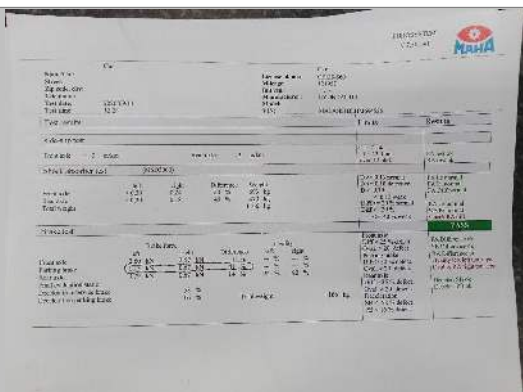
SHOCK AND BRAKE REPORT

| Parking Brake Performance Left / Right Difference out of legal range | Repair |

| | Left | Right | | |
|---|---|---|---|---|
| Emergency / Parking | 1.1 | 0.6 | - | |

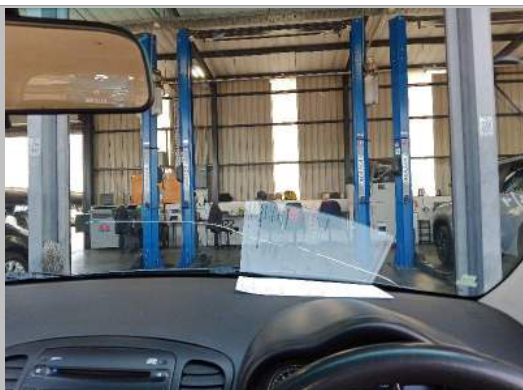
| Windscreen Cracked | Replace |

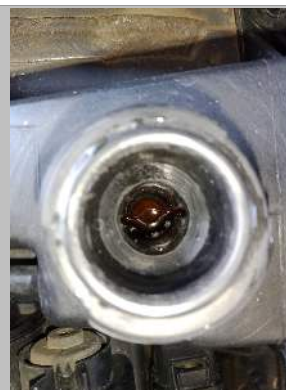
Water level

| Signs of water leak can not pin point water leak | Repair |

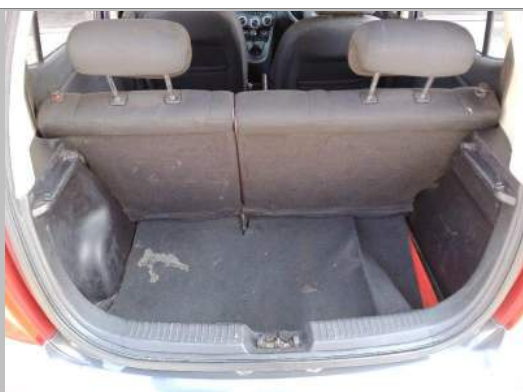
| Parcel Tray Missing | Replace |

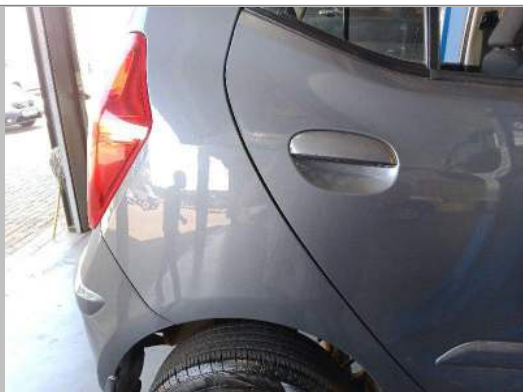
| Rear Fender Right Dented | Repair |

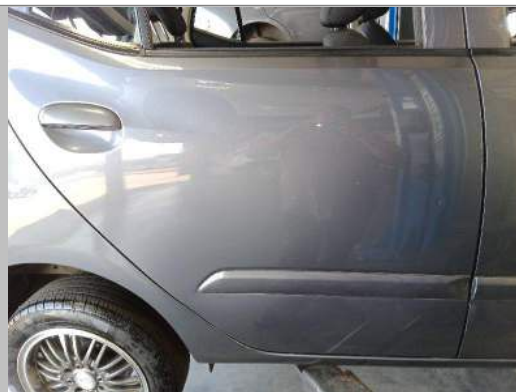
| Door Rear Right Paintwork • Scratched | Repair |

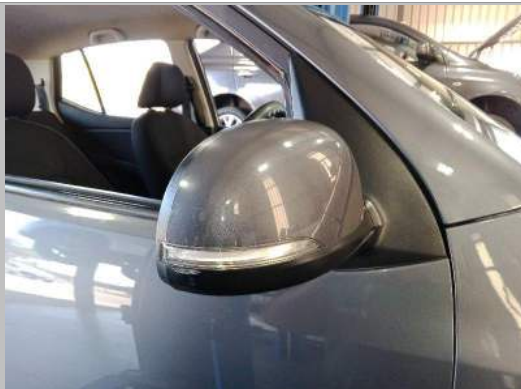
| Side Mirror Right Paintwork • Scratched | Repair |

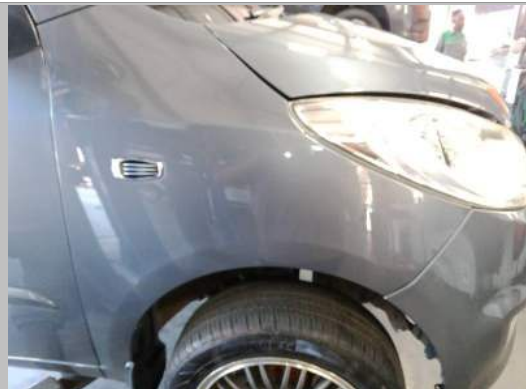
| Front Fender Right Dented | Repair |

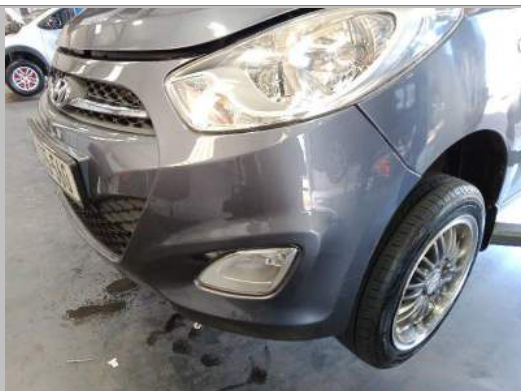
| Front Bumper Paintwork • Scratched | Repair |

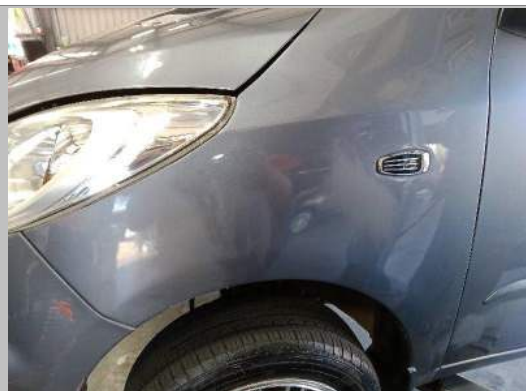
| Front Fender Left Paintwork • Discoloured | Repair |

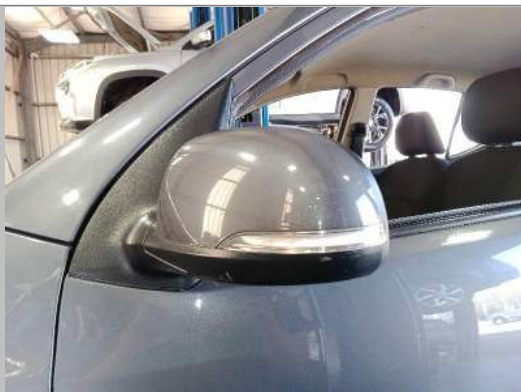
| Side Mirror Left Paintwork • Scratched | Repair |

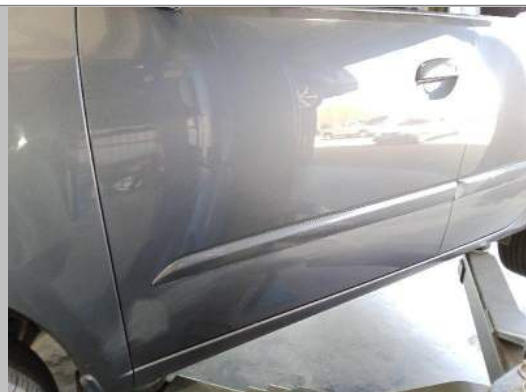
| Door Front Left Paintwork • Scratched | Repair |

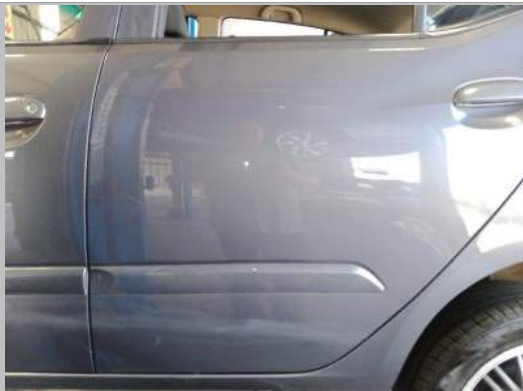
| Door Rear Left Paintwork • Scratched | Repair |

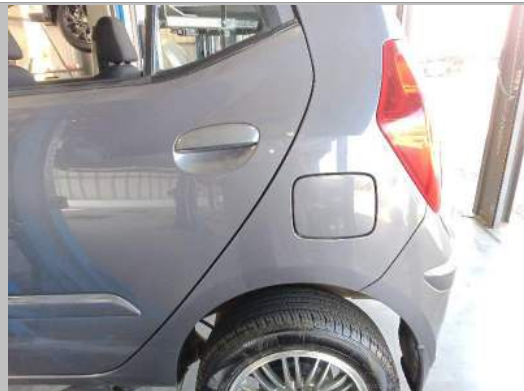
| Rear Fender Left Paintwork • Scratched | Repair |

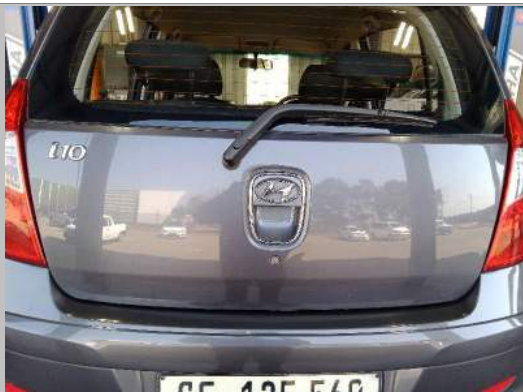
| Boot Lid / Hatch door Dented | Repair |

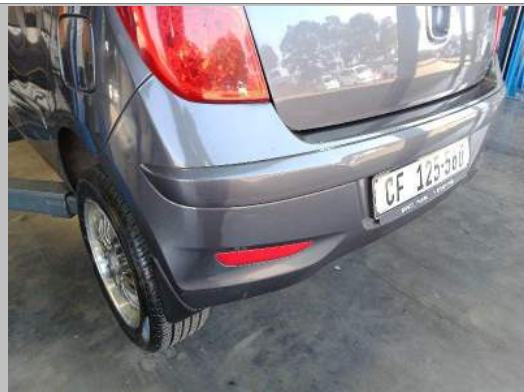
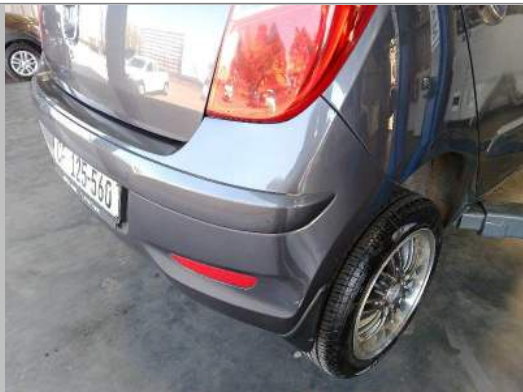
| Rear bumper Paintwork • Scratched | Repair |
