CONDITION REPORT

Report No:  
2017299103  
DATE  
15/09/2026

| Manufacturer | HYUNDAI | Registration Number | LD48ZDGP |
| Model | GRAND I10 1.0 MOTION 5-DR [2020-2024] | Register Number | |

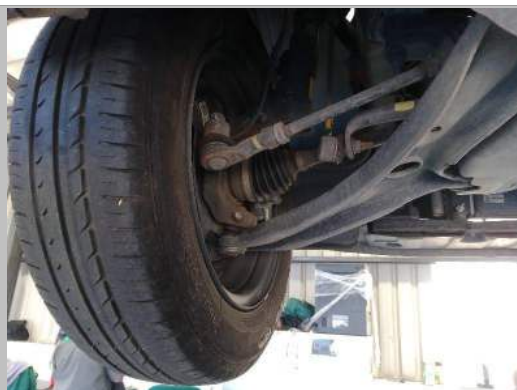
LF TYRE TREAD

| | Size | Load/Speed Index | Manufacture | Model | Type* | Production Date | Tread Depth (mm) |
|---|---|---|---|---|---|---|---|
| Front Left | 165/70 R14 | 81T | Goodyear | Assurance | V | 4822 | 1 mm |

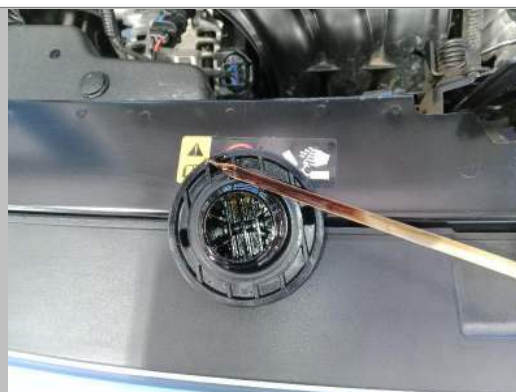
Oil cap and dipstick

| Foreign substance on oil cap | Repair |

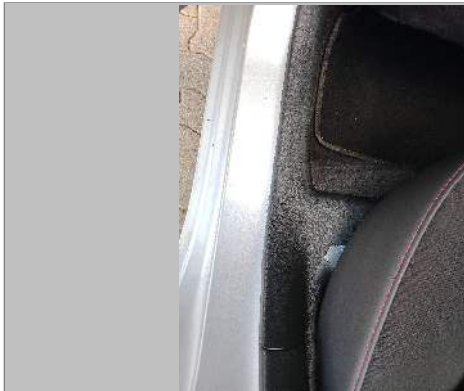
| Rear left interior sill panel plastic trim damaged | Replace |

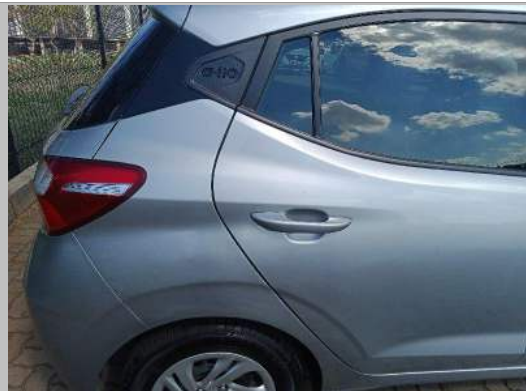
| Rear Fender Right Residual Traces of Repair | Repair |

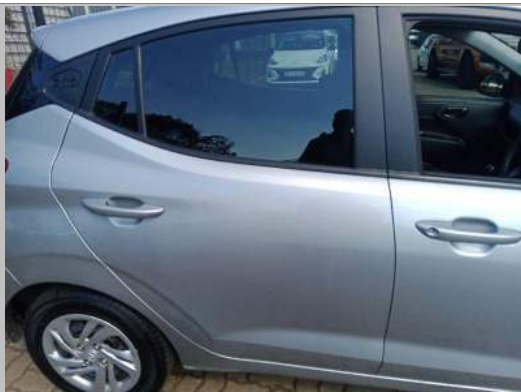
| Door Rear Right Residual Traces of Repair | Repair |

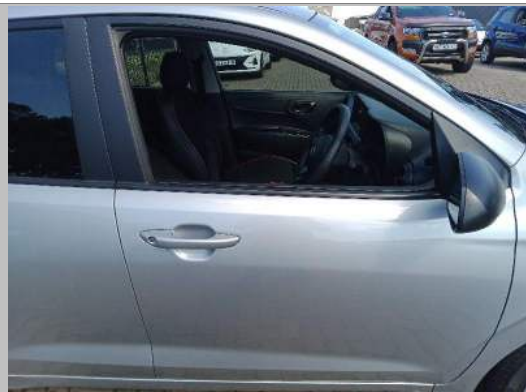
| Door Front Right Dented | Repair |

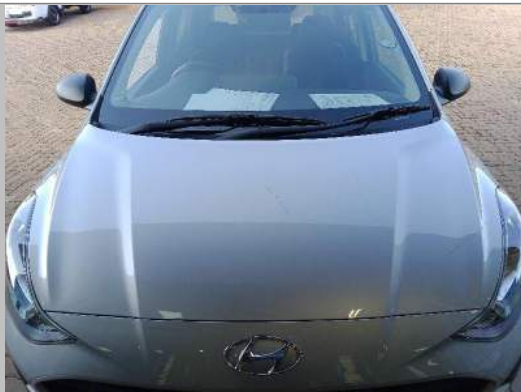
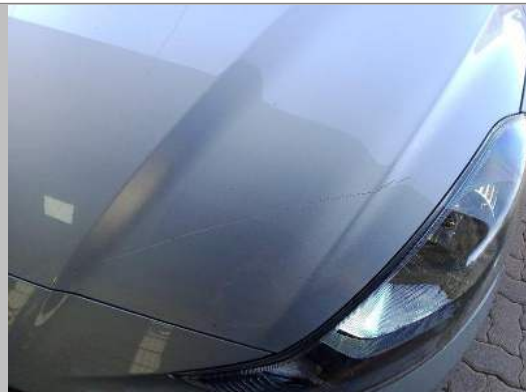
| Bonnet Paintwork • Scratched | Repair |

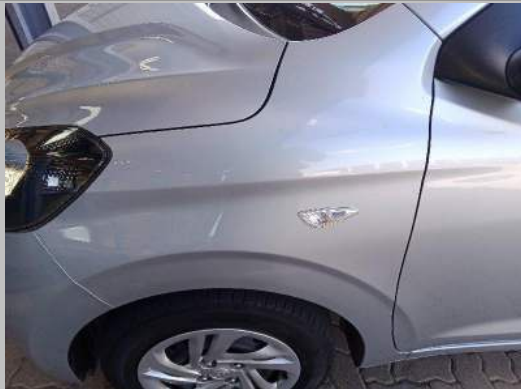
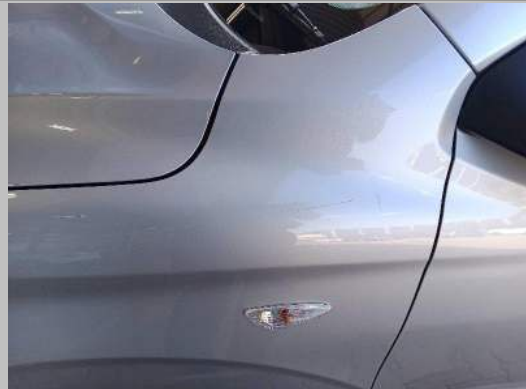
| Front Fender Left Paintwork • Scratched | Repair |

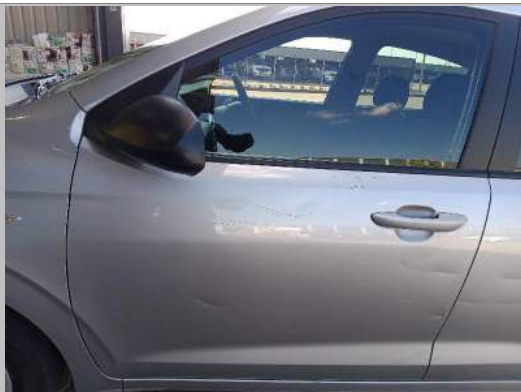
| Door Front Left Damaged | Repair |

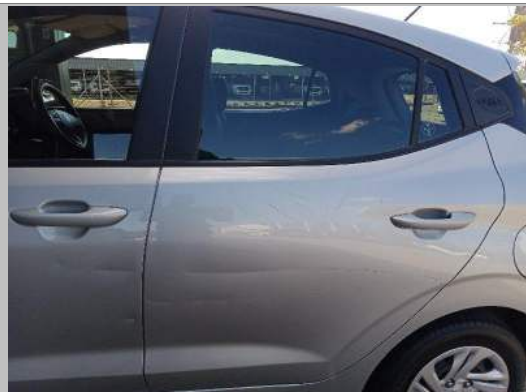
| Door Rear Left Damaged | Repair |

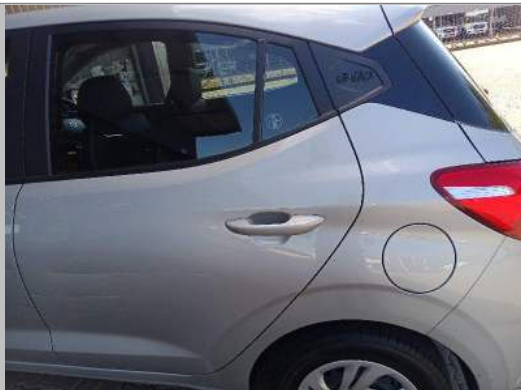
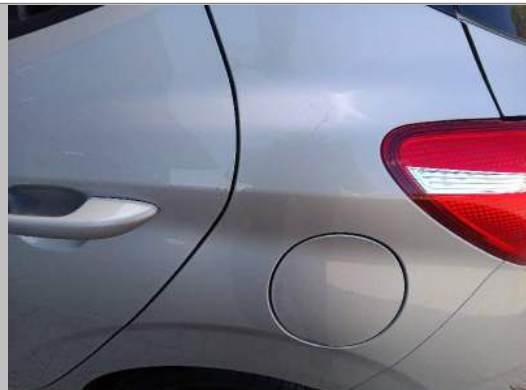
| Rear Fender Left Paintwork • Scratched | Repair |

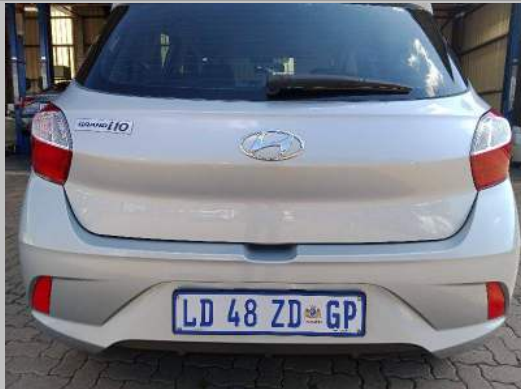
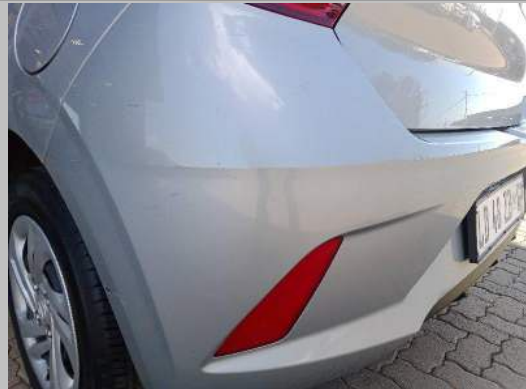
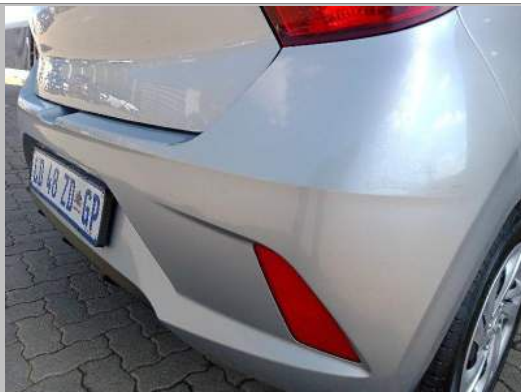
| Rear bumper Paintwork • Scratched | Repair |

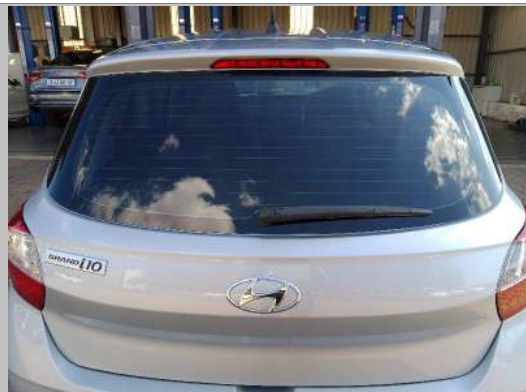
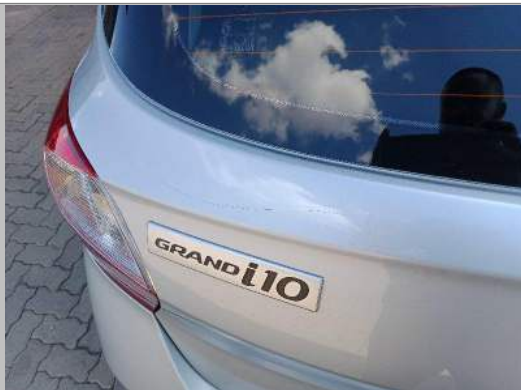
| Boot Lid / Hatch door Paintwork • Scratched | Repair |

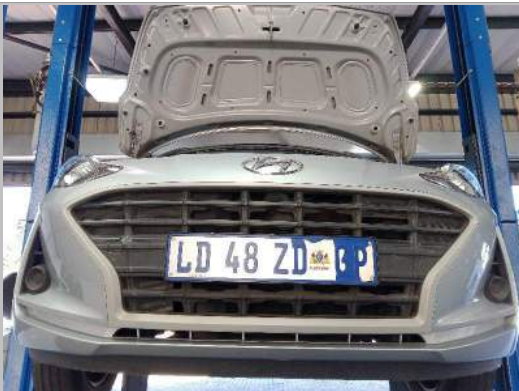
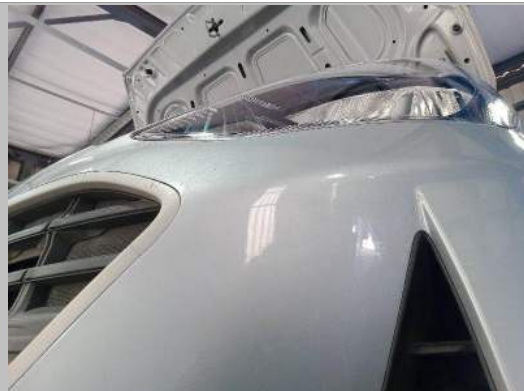
| Front Bumper Dented | Repair |

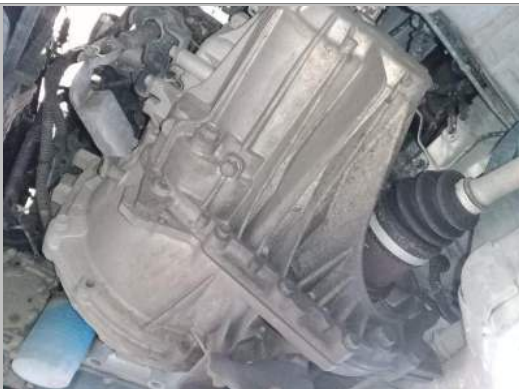
| Gearbox Oil Sweat | Repair |

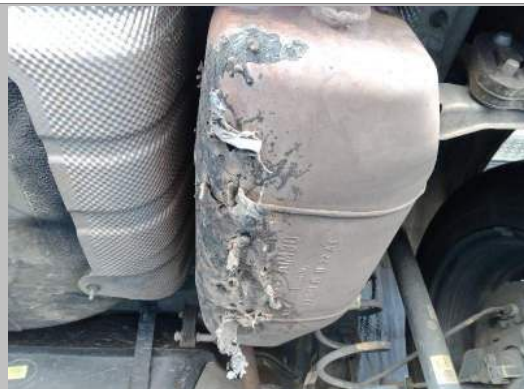
| Silencer Defective | Repair |

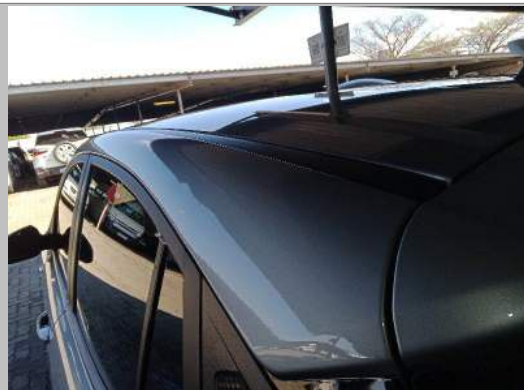
| C • Pillar Left Dented | Repair |
