## CONDITION REPORT

Report No:  
2017299411  
DATE  
16/09/2026

| Manufacturer | HYUNDAI | Registration Number | LS68RZGP |
| Model | GRAND I10 | Register Number | |

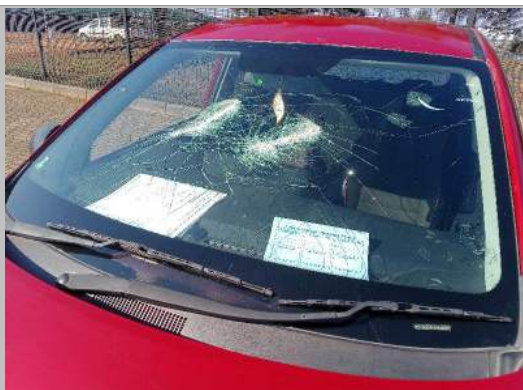
| Damage | Repair Way |
|---|---|
| Vehicle license disk missing | Replace |

No license disc

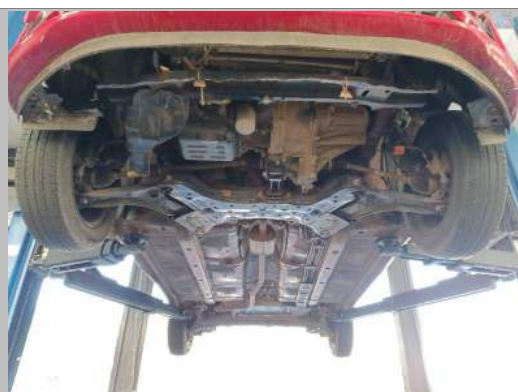
Front chassis

| Damage | Repair Way |
|---|---|
| Chassis Damaged | Repair |

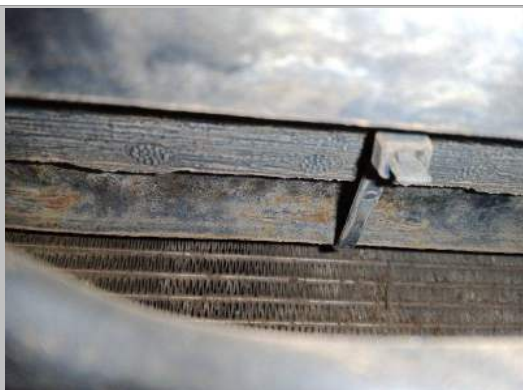
| Damage | Repair Way |
|---|---|
| Front bumper stiffener damaged | Repair |

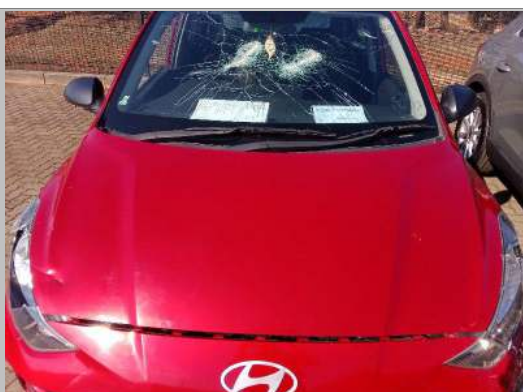
| Damage | Repair Way |
|---|---|
| Bonnet Damaged | Repair |

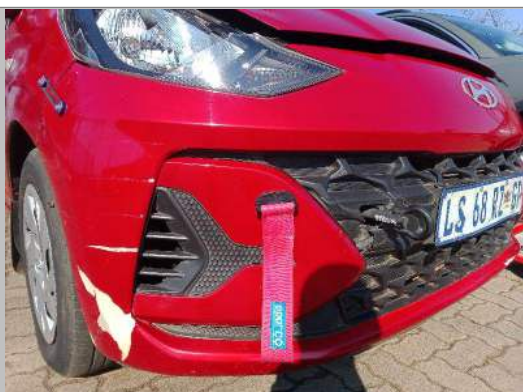
| Damage | Repair Way |
|---|---|
| Front Bumper Damaged | Replace |

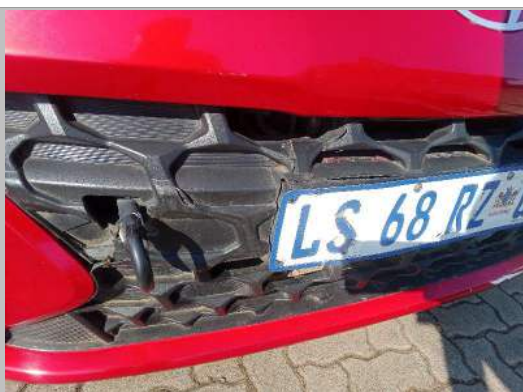
| Damage | Repair Way |
|---|---|
| Grill Damaged | Replace |

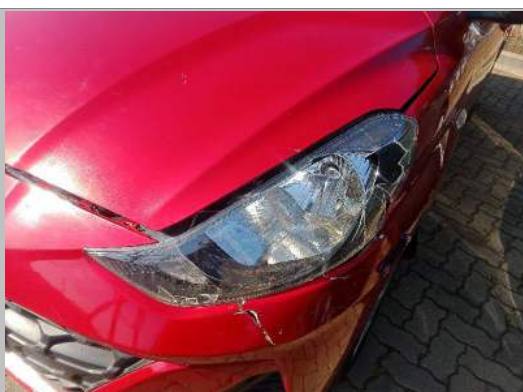
| Damage | Repair Way |
|---|---|
| Headlight Left Damaged | Replace |

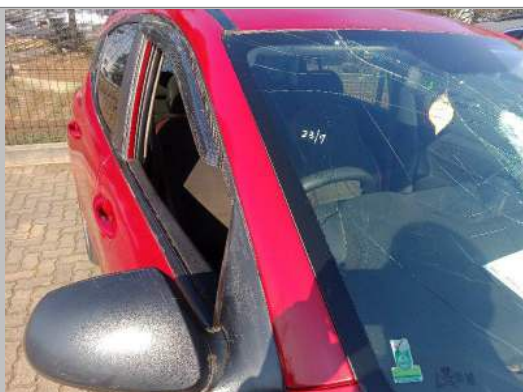
| Damage | Repair Way |
|---|---|
| A • Pillar Right Residual Traces of Repair | Repair |

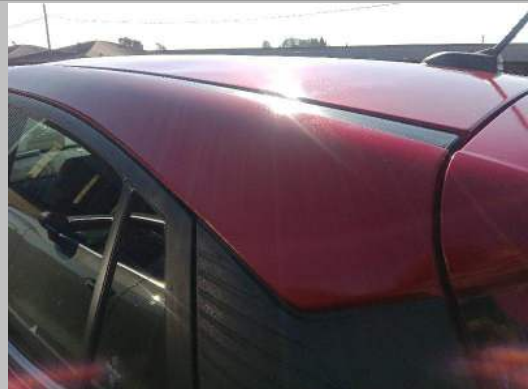
| Damage | Repair Way |
|---|---|
| C • Pillar Left Residual Traces of Repair | Repair |

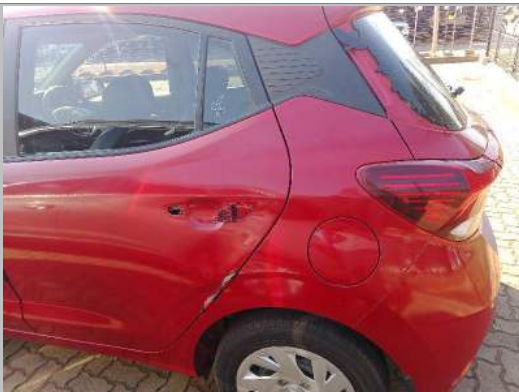
| Damage | Repair Way |
|---|---|
| Rear Fender Left Residual Traces of Repair | Repair |

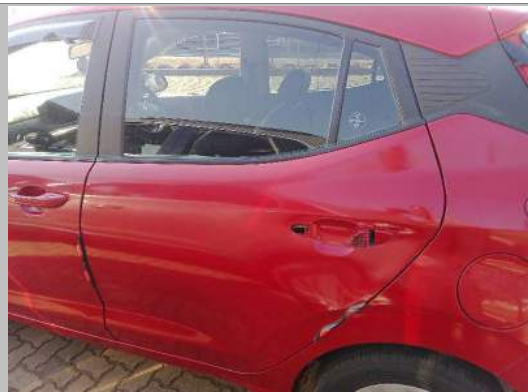
| Damage | Repair Way |
|---|---|
| Door Rear Left Residual Traces of Repair | Replace |

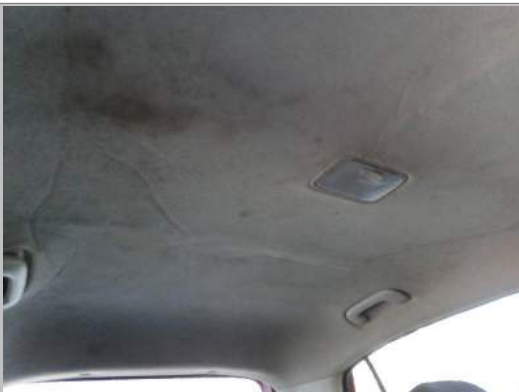
| Damage | Repair Way |
|---|---|
| Hood Lining Damaged | Repair |

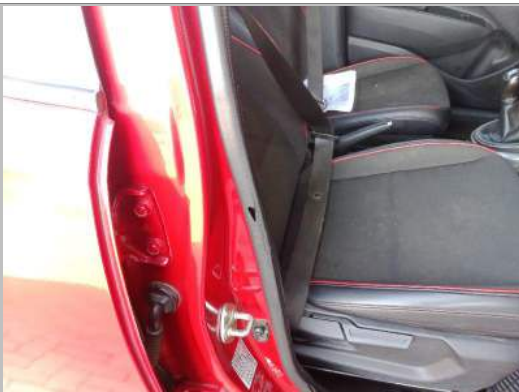
| Damage | Repair Way |
|---|---|
| Door Sealing Rubber Front Right Damaged | Replace |

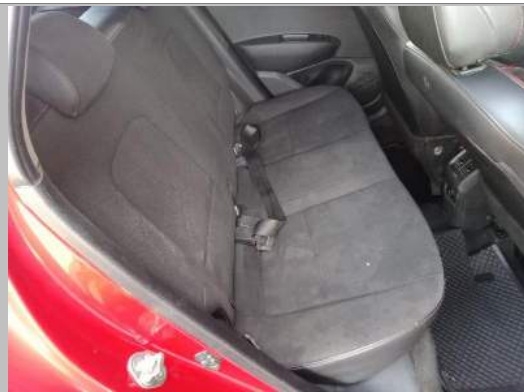
| Damage | Repair Way |
|---|---|
| Seat Rear Damaged | Repair |

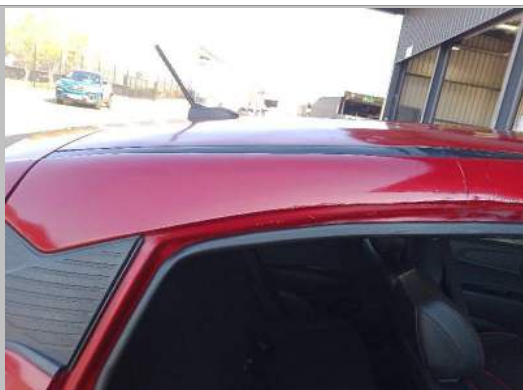
| Damage | Repair Way |
|---|---|
| C • Pillar Right Damaged | Repair |

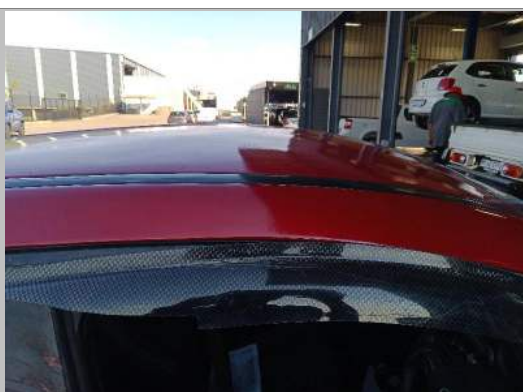
| Damage | Repair Way |
|---|---|
| B • Pillar Right Residual Traces of Repair | Repair |

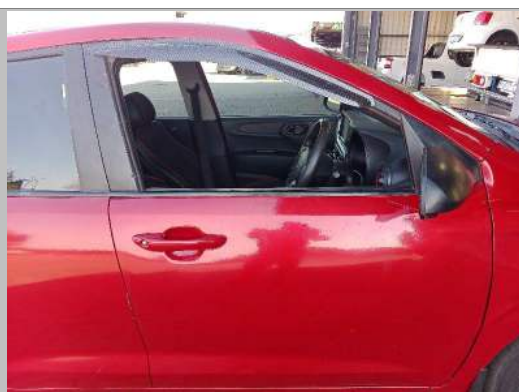
| Damage | Repair Way |
|---|---|
| Door Front Right Damaged | Replace |

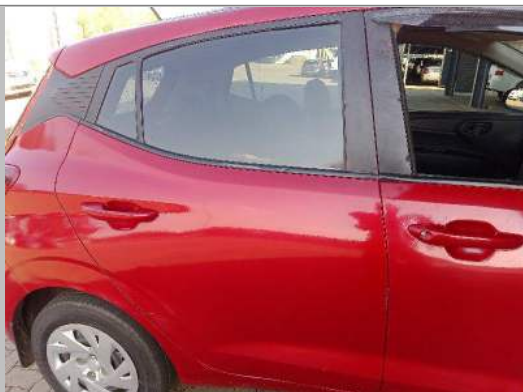
| Damage | Repair Way |
|---|---|
| Door Rear Right Residual Traces of Repair | Replace |

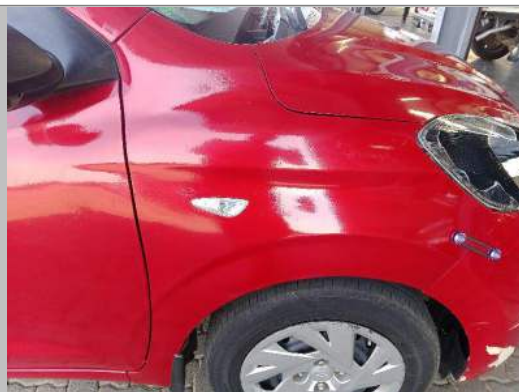
| Damage | Repair Way |
|---|---|
| Front Fender Right Residual Traces of Repair | Replace |

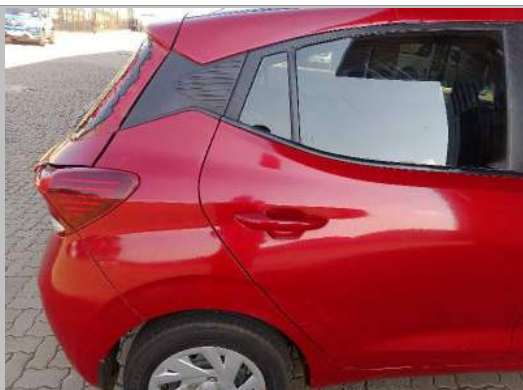
| Damage | Repair Way |
|---|---|
| Rear Fender Right Residual Traces of Repair | Repair |

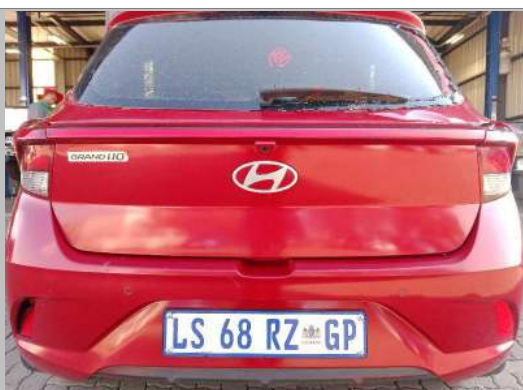
| Damage | Repair Way |
|---|---|
| Rear bumper Residual Traces of Repair | Repair |

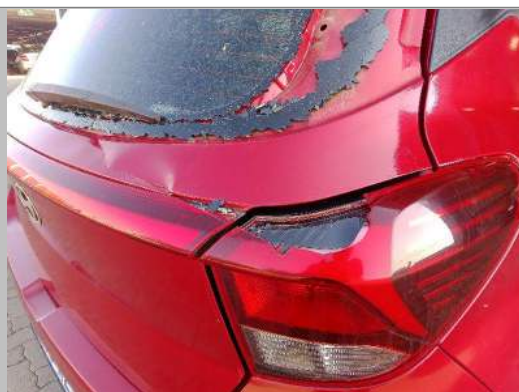
| Damage | Repair Way |
|---|---|
| Tail Light Right Damaged | Replace |

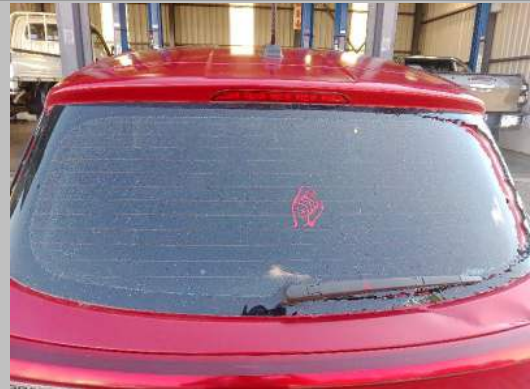
| Damage | Repair Way |
|---|---|
| Back Window Damaged | Replace |

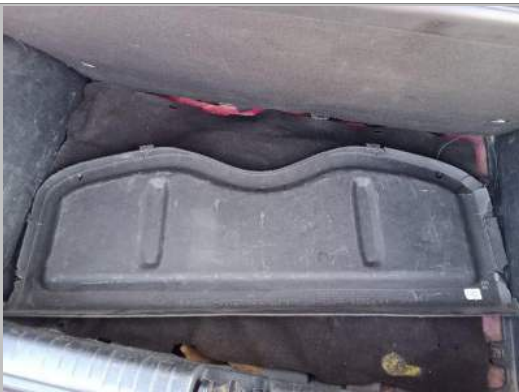
| Damage | Repair Way |
|---|---|
| Parcel Tray Damaged | Replace |

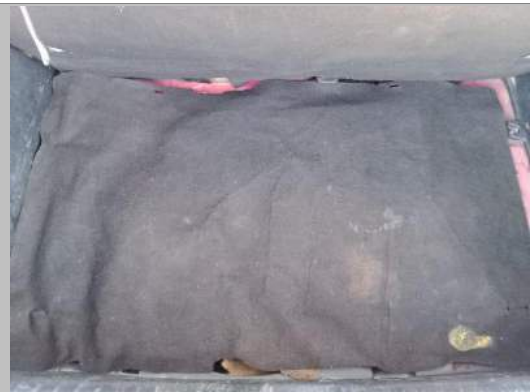
| Damage | Repair Way |
|---|---|
| Boot Carpet Damaged | Replace |

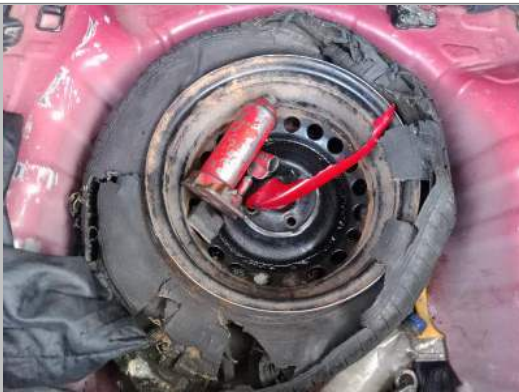
| Damage | Repair Way |
|---|---|
| Spare Tyre Damaged | Replace |

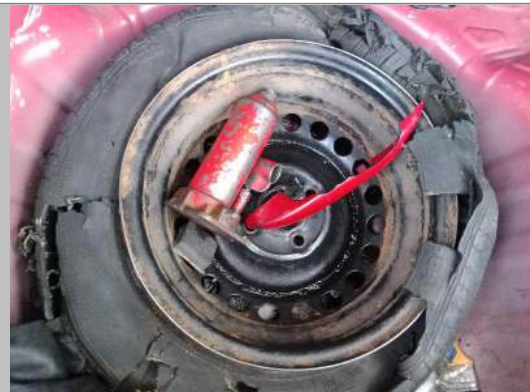
| Damage | Repair Way |
|---|---|
| Rim Spare Wheel Damaged | Repair |

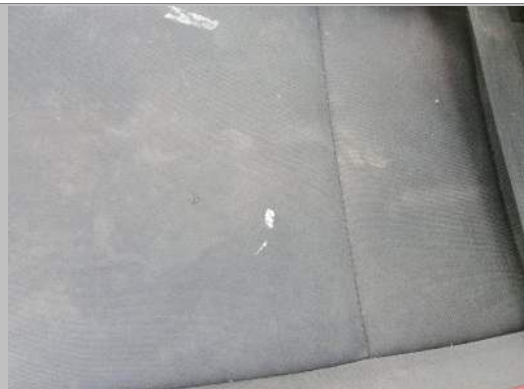
| Damage | Repair Way |
|---|---|
| Seat Front Left Damaged | Repair |

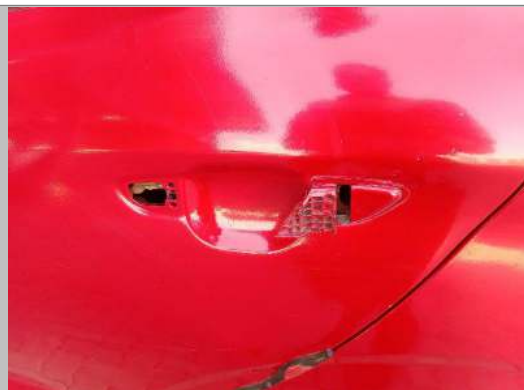
| Damage | Repair Way |
|---|---|
| Door Handle Rear Left Damaged | Replace |

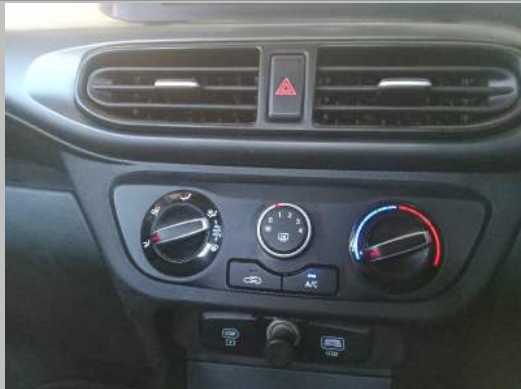
| Damage | Repair Way |
|---|---|
| Air Conditioner Insufficient | Replace |

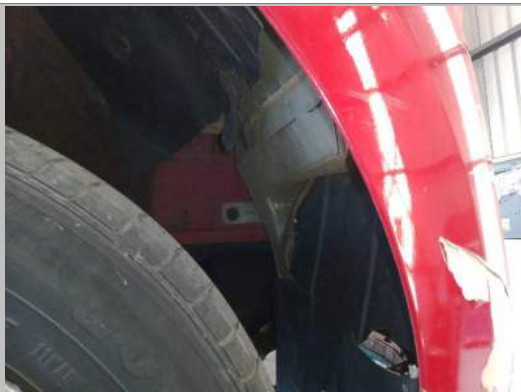
| Damage | Repair Way |
|---|---|
| Front Fender Right / Inner Tray Damaged | Replace |

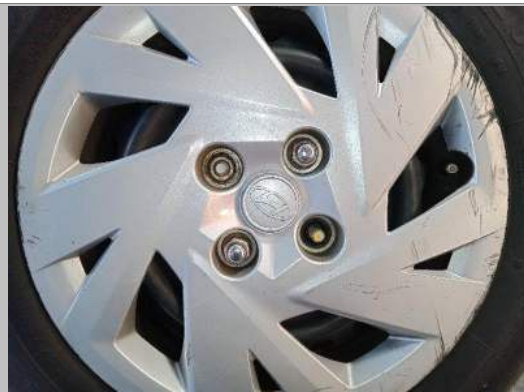
| Damage | Repair Way |
|---|---|
| Bolt(s) / Nut(s) Front Wheel Right Missing | Replace |

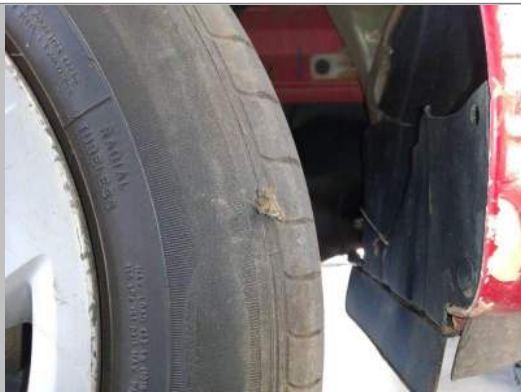
| Damage | Repair Way |
|---|---|
| Tyre Front Right Damaged | Replace |

| | Size | Load/Speed Index | Manufacture | Model | Type* | Production Date | Tread Depth (mm) |
|---|---|---|---|---|---|---|---|
| Front Right | 165/70 R14 | 81T | Goodyear | Assurance | V | 0124 | 0 mm |

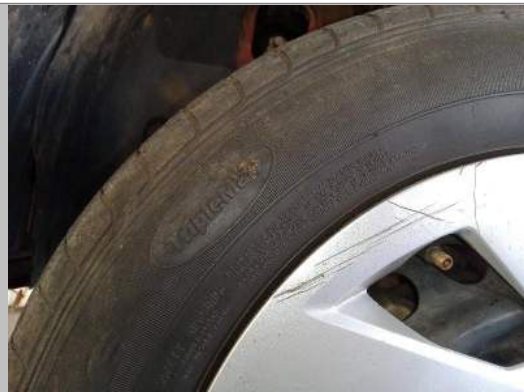
| Damage | Repair Way |
|---|---|
| Tyre Front Left Damaged | Replace |

| | Size | Load/Speed Index | Manufacture | Model | Type* | Production Date | Tread Depth (mm) |
|---|---|---|---|---|---|---|---|
| Front Left | 165/70 R14 | 81T | Goodyear | Assurance | V | 0124 | 0 mm |

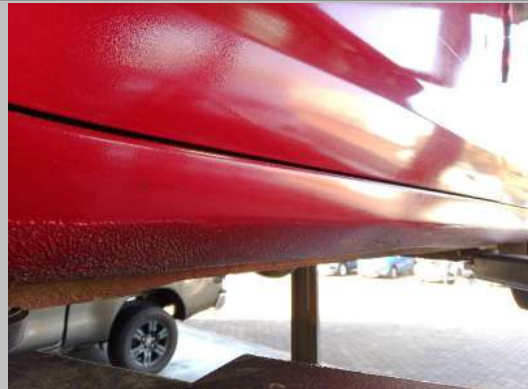
| Damage | Repair Way |
|---|---|
| Sill Panel Left Damaged | Repair |

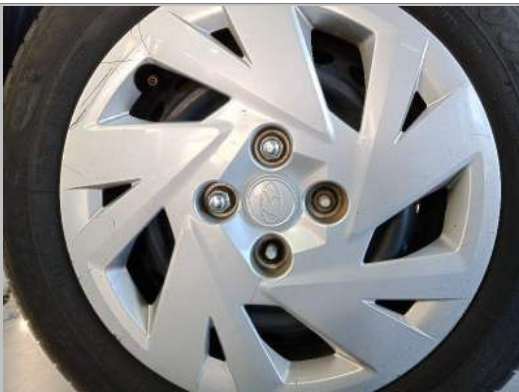
| Damage | Repair Way |
|---|---|
| Bolt(s) / Nut(s) Front Wheel Left Missing | Replace |

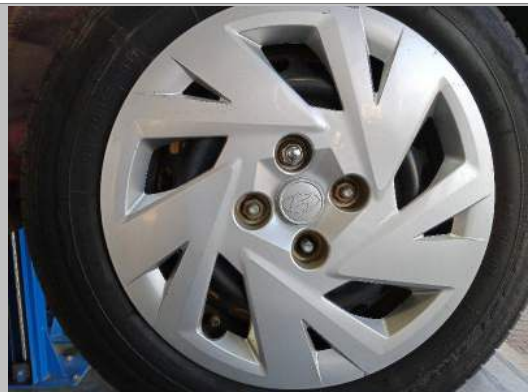
| Damage | Repair Way |
|---|---|
| Bolt(s) / Nut(s) Rear Wheel Left Missing | Replace |

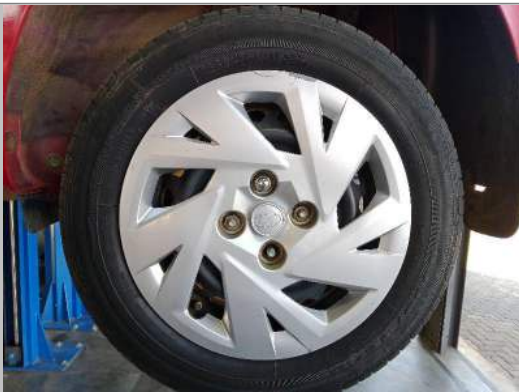
| Damage | Repair Way |
|---|---|
| Tyre Rear Left Damaged | Replace |

| | Size | Load/Speed Index | Manufacture | Model | Type* | Production Date | Tread Depth (mm) |
|---|---|---|---|---|---|---|---|
| Rear Left | 165/70 R14 | 81T | Goodyear | Assurance | V | 0124 | 1 mm |

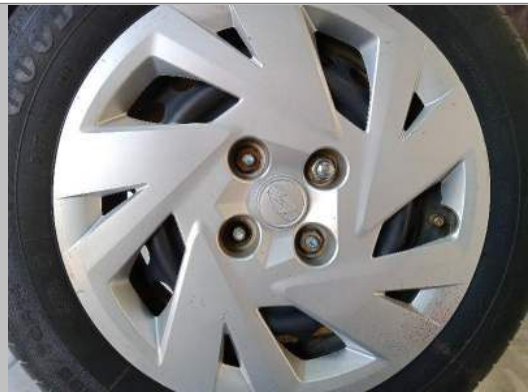
| Damage | Repair Way |
|---|---|
| Bolt(s) / Nut(s) Rear Wheel Right Missing | Replace |

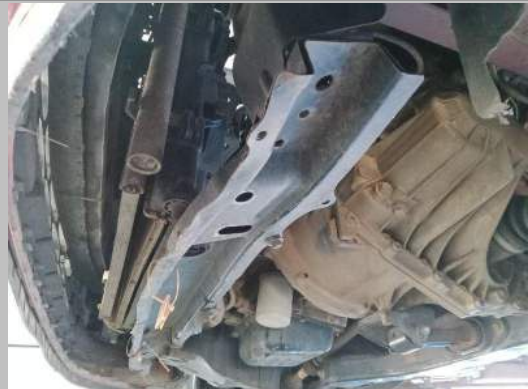
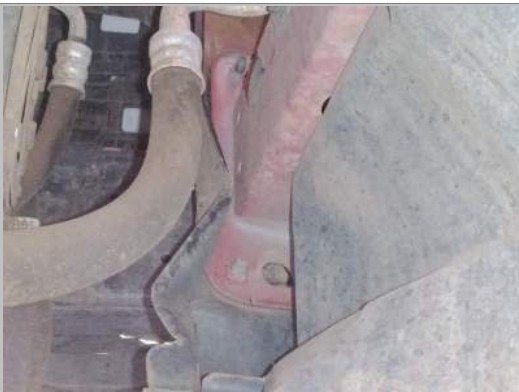
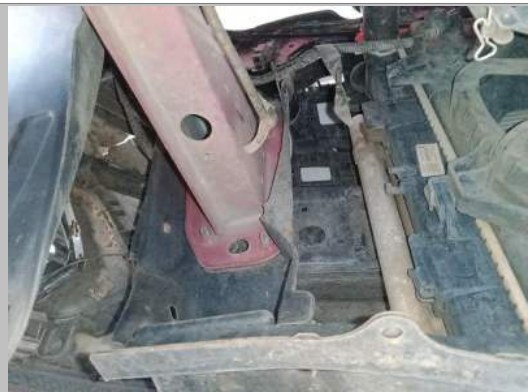
| Damage | Repair Way |
|---|---|
| Radiator Cradle Damaged | Replace |

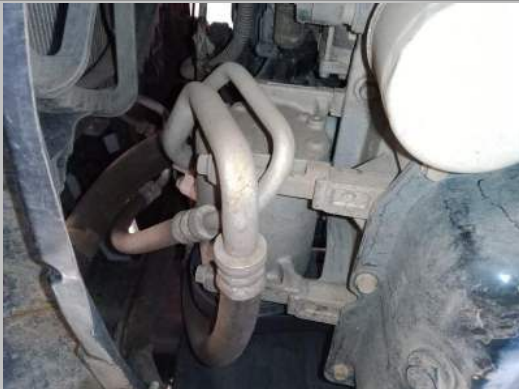
| Damage | Repair Way |
|---|---|
| Air conditioner pipes Damaged | Replace |

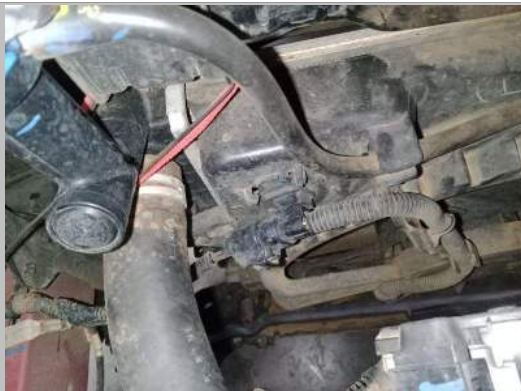
| Damage | Repair Way |
|---|---|
| Radiator Defective | Repair |

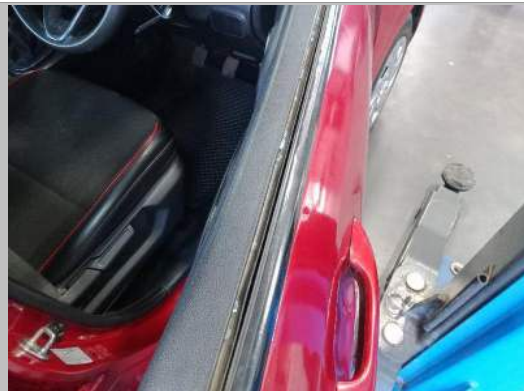
| Damage | Repair Way |
|---|---|
| Window Front Door Right Damaged | Replace |

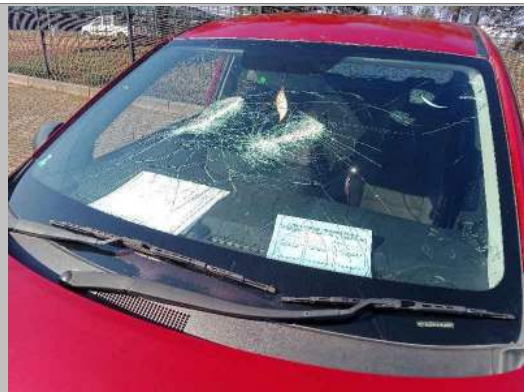
| Damage | Repair Way |
|---|---|
| Windscreen Damaged | Replace |
