## CONDITION REPORT

Report No:  
2017295814  
DATE  
08/09/2026

| Manufacturer | HYUNDAI | Registration Number | KB11VVGP |
| Model | I20 1.2 MOTION 5-DR [2021-2024] | Register Number | |

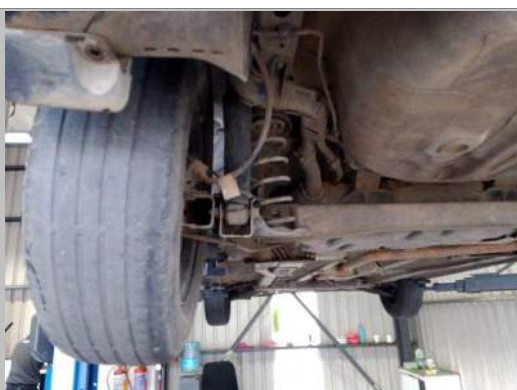
LR TYRE TREAD

| Damage | Repair Way |
|---|---|
| Rear tyres size differs | Replace |

| | Size | Load/Speed Index | Manufacture | Model | Type* | Production Date | Tread Depth (mm) |
|---|---|---|---|---|---|---|---|
| Rear Left | 195/65R15 | 91V | Dunlop | Sp | V | 0823 | 0 mm |

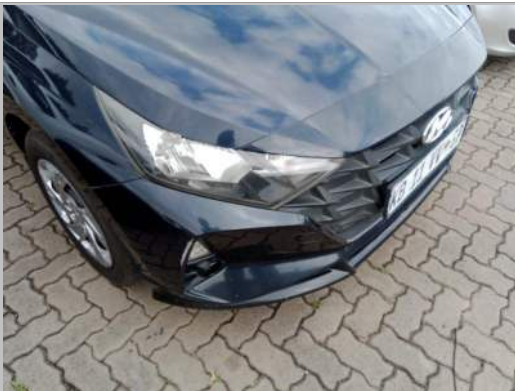
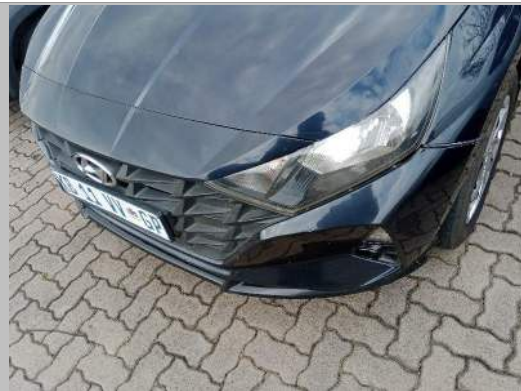
| Damage | Repair Way |
|---|---|
| Front Bumper Damaged | Repair |

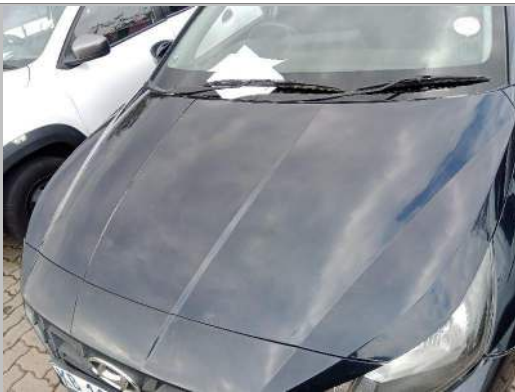
| Damage | Repair Way |
|---|---|
| Bonnet Damaged | Repair |

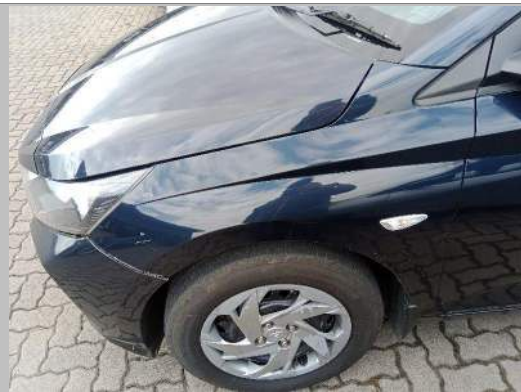
| Damage | Repair Way |
|---|---|
| Front Fender Left Damaged | Repair |

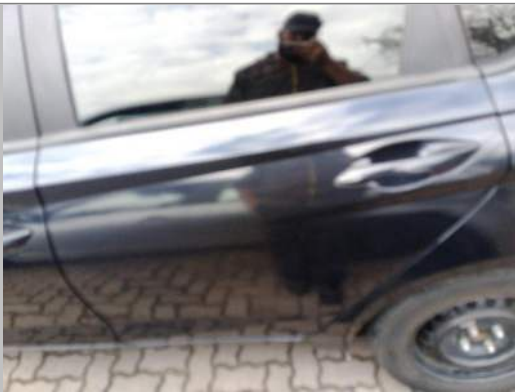
| Damage | Repair Way |
|---|---|
| Door Rear Left Damaged | Repair |

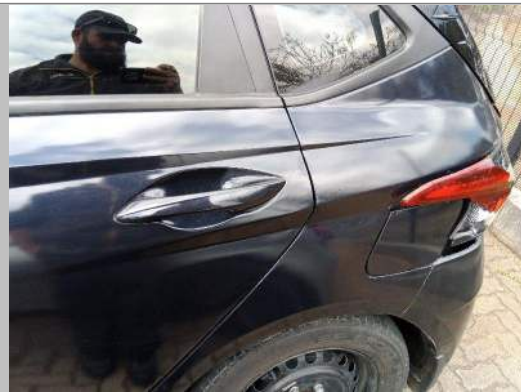
| Damage | Repair Way |
|---|---|
| Rear Fender Left Damaged | Repair |

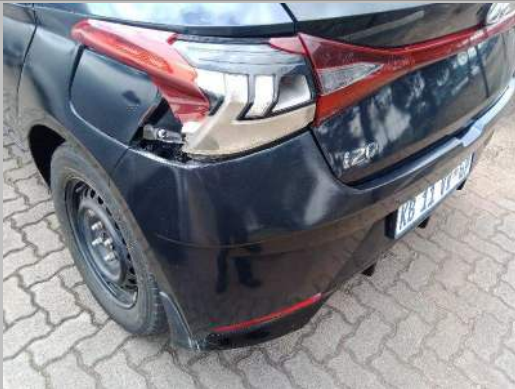
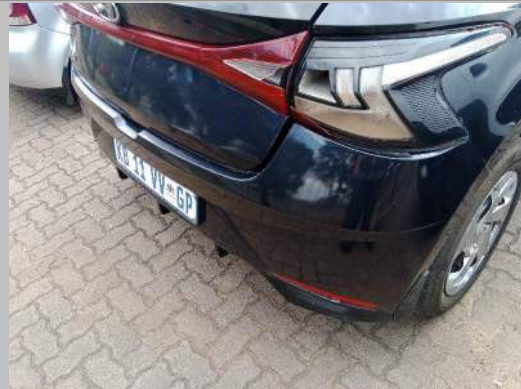
| Damage | Repair Way |
|---|---|
| Rear bumper Damaged | Repair |

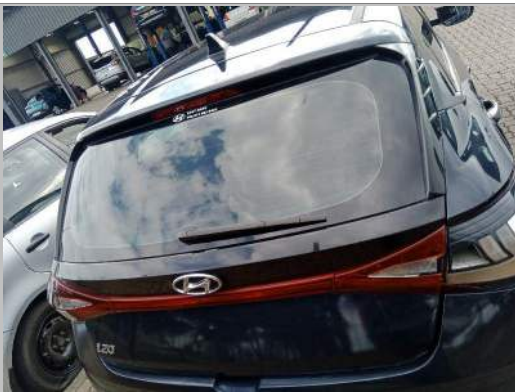
| Damage | Repair Way |
|---|---|
| Boot Lid / Hatch door Damaged | Repair |

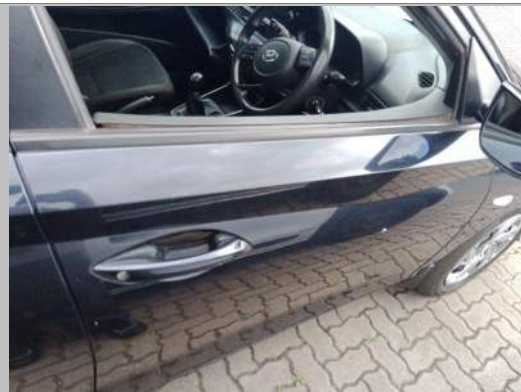
| Damage | Repair Way |
|---|---|
| Door Front Right Damaged | Repair |

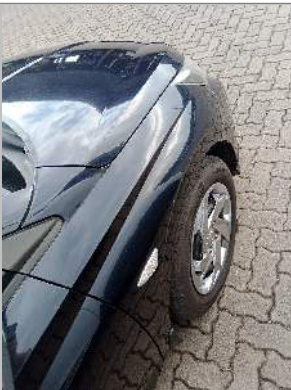
| Damage | Repair Way |
|---|---|
| Front Fender Right Damaged | Repair |

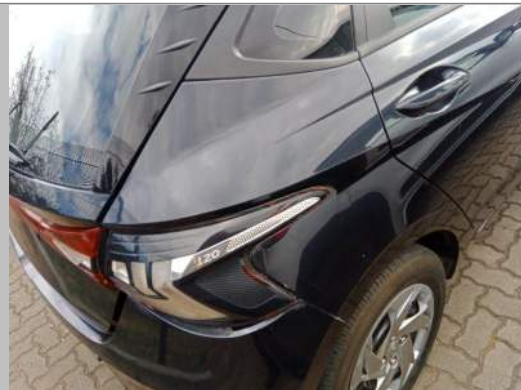
| Damage | Repair Way |
|---|---|
| Rear Fender Right Damaged | Repair |

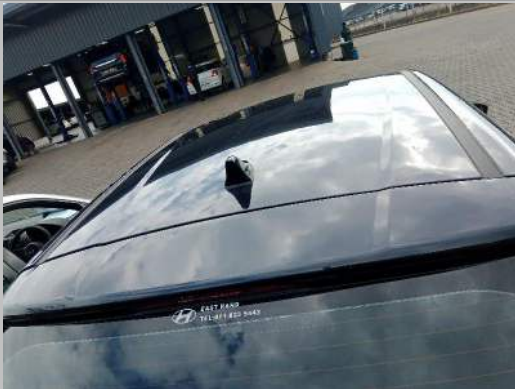
| Damage | Repair Way |
|---|---|
| Roof Damaged | Repair |

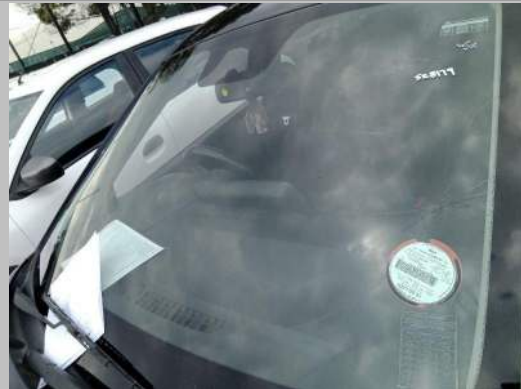
| Damage | Repair Way |
|---|---|
| Windscreen Damaged | Replace |

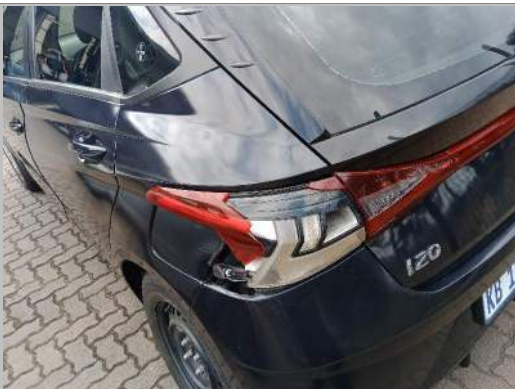
| Damage | Repair Way |
|---|---|
| Tail Light Left Damaged | Repair |

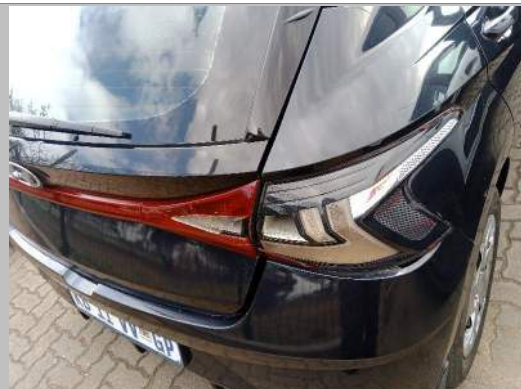
| Damage | Repair Way |
|---|---|
| Tail Light Right Damaged | Replace |

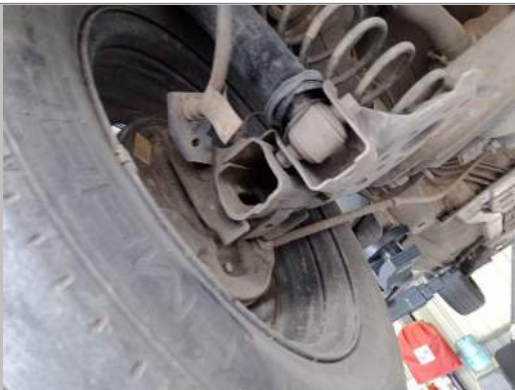
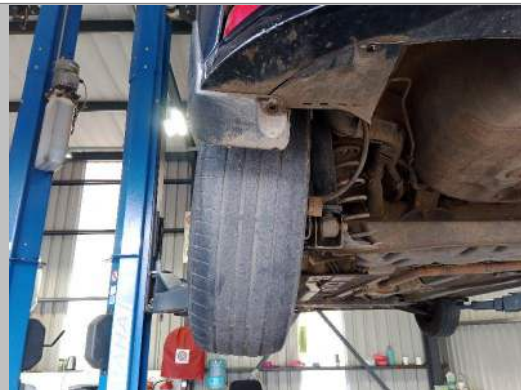
| Damage | Repair Way |
|---|---|
| Rear Axle Deformed | Replace |

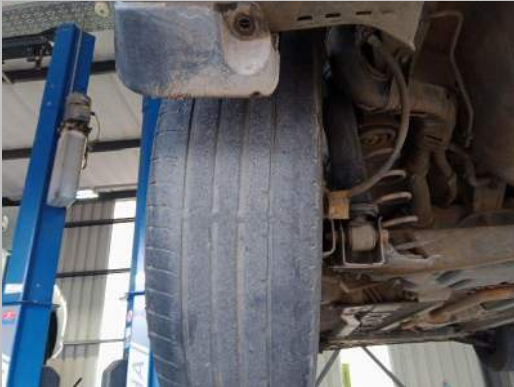
| Damage | Repair Way |
|---|---|
| Tyre Rear Left Worn | Replace |

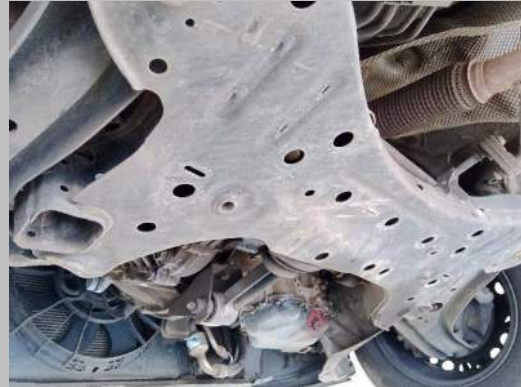
| Damage | Repair Way |
|---|---|
| Sub Frame Damaged | Repair |
