## CONDITION REPORT

Report No:  
2017294622  
DATE  
07/09/2026

| Manufacturer | HYUNDAI | Registration Number | MS63RFGP |
| Model | I20 | Register Number | |

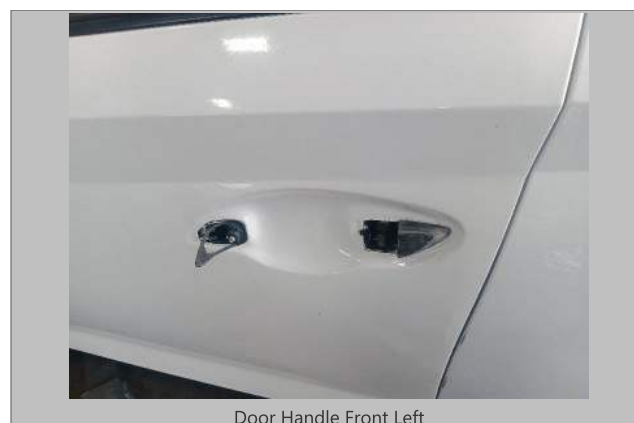
| Door Handle Front Left Missing | Replace |

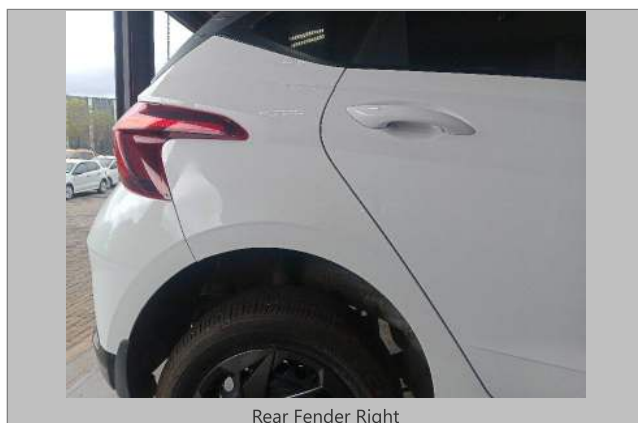
| Rear Fender Right Residual Traces of Repair | Repair |

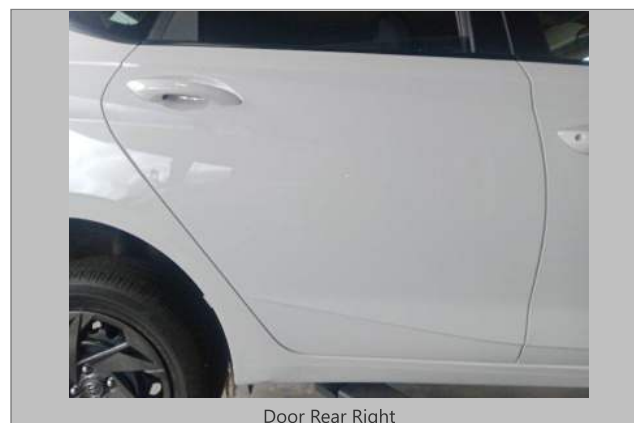
| Door Rear Right Dented | Repair |

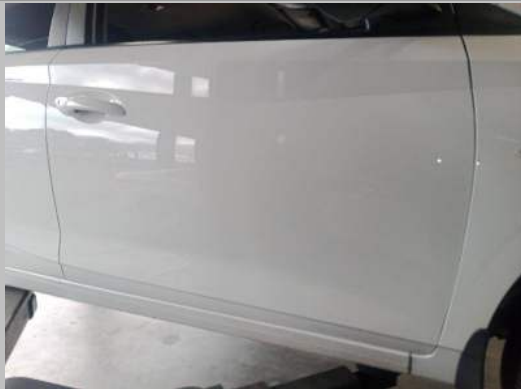
| Door Front Right Paintwork • Scratched | Repair |

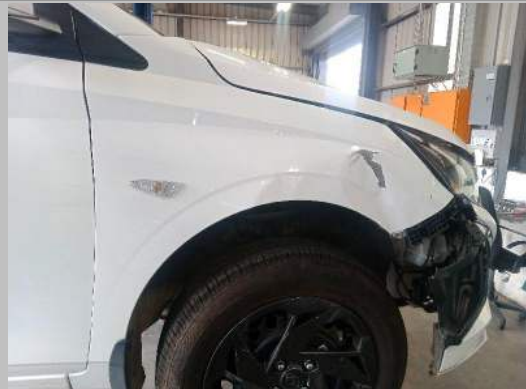
| Front Fender Right Dented | Repair |
| Body exterior | Impact damage at right front of vehicle |

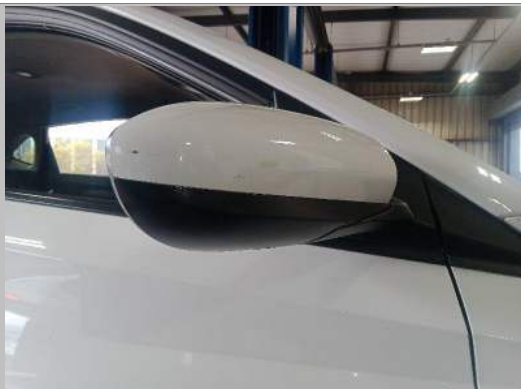
| Side Mirror Right Paintwork • Scratched | Repair |

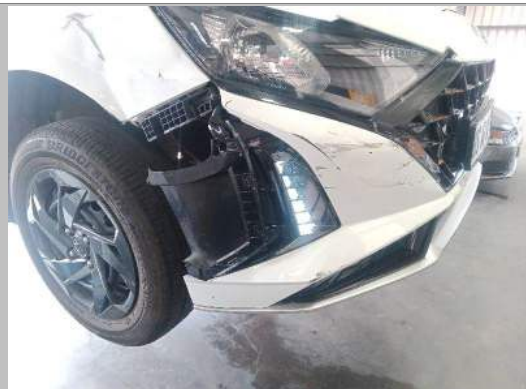
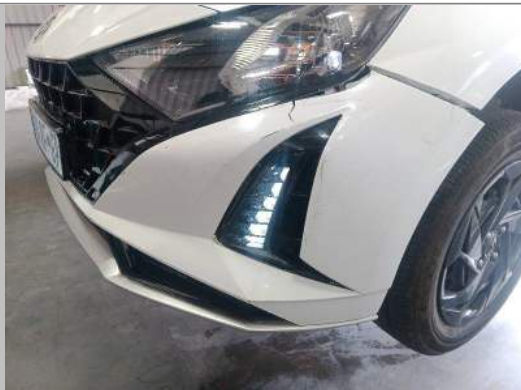
| Front Bumper Damaged | Repair |

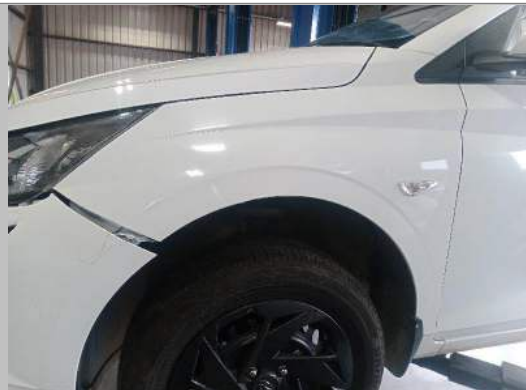
| Front Fender Left Residual Traces of Repair | Repair |

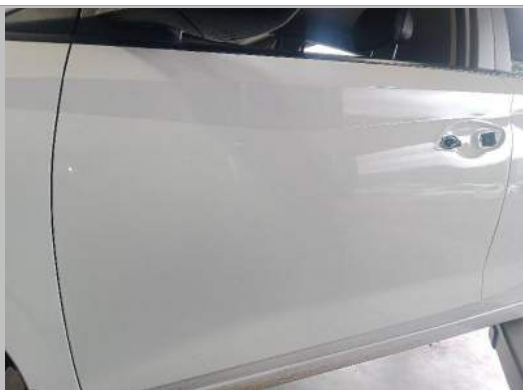
| Door Front Left Residual Traces of Repair | Repair |

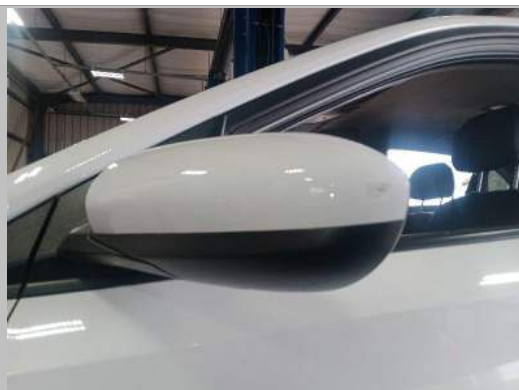
| Side Mirror Left Paintwork • Scratched | Repair |

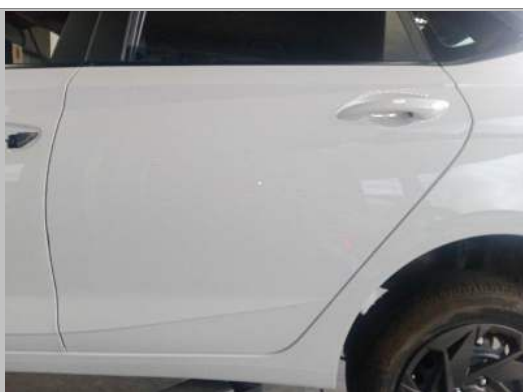
| Door Rear Left Paintwork • Scratched | Repair |

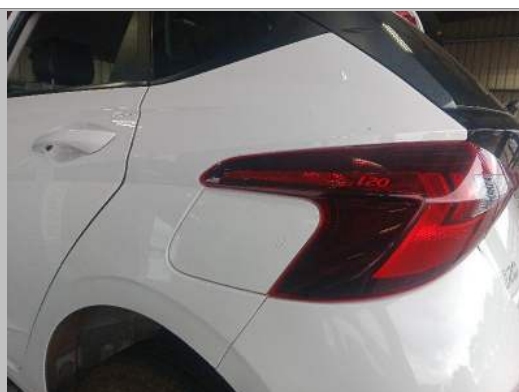
| Rear Fender Left Paintwork • Scratched | Repair |

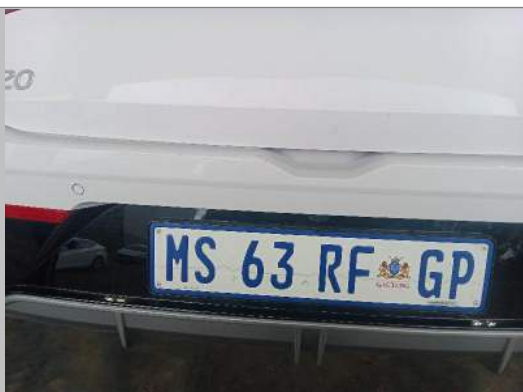
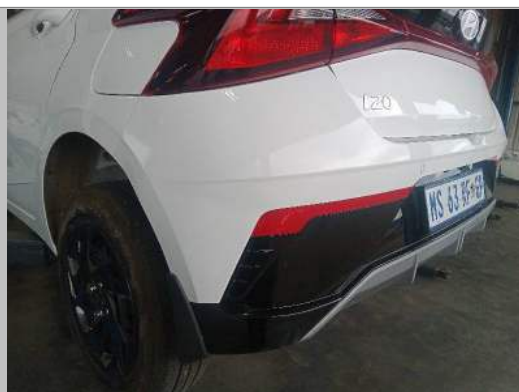
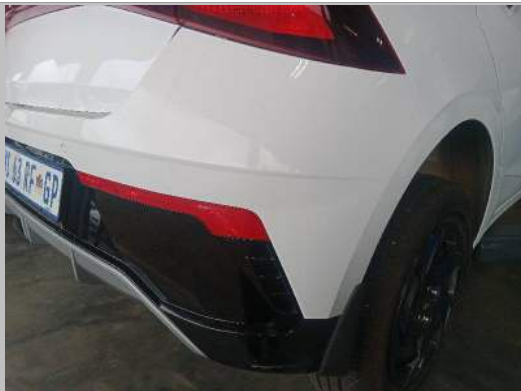
| Rear bumper Paintwork • Scratched | Repair |

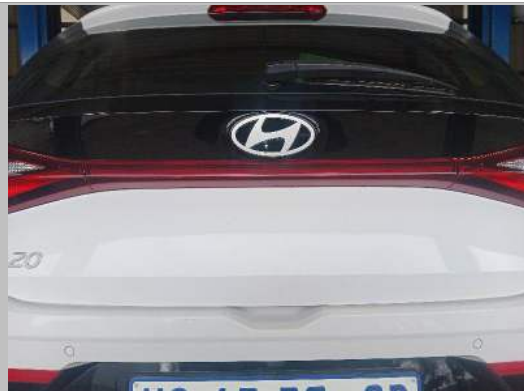
| Boot Lid / Hatch door Paintwork • Scratched | Repair |

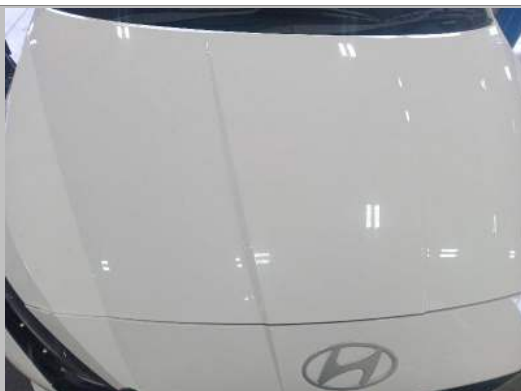
| Bonnet Paintwork • Scratched | Repair |
