## CONDITION REPORT

Report No:  
2017297487  
DATE  
11/09/2026

| Manufacturer | HYUNDAI | Registration Number | DW28RDGP |
| Model | I20 1.4 FLUID 5-DR [2015-2017] | Register Number | |

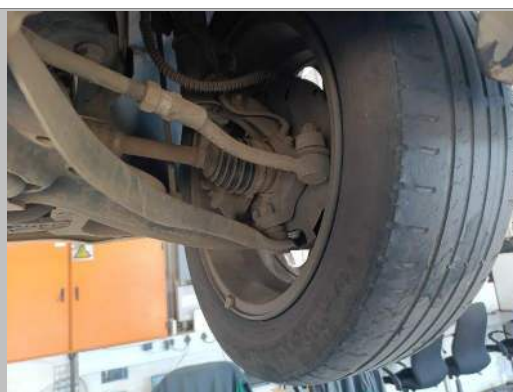
RF TYRE TREAD

| | Size | Load/Speed Index | Manufacture | Model | Type* | Production Date | Tread Depth (mm) |
|---|---|---|---|---|---|---|---|
| Front Right | 195/55R16 | 87H | Continental | Contact | V | 2619 | 0 mm |

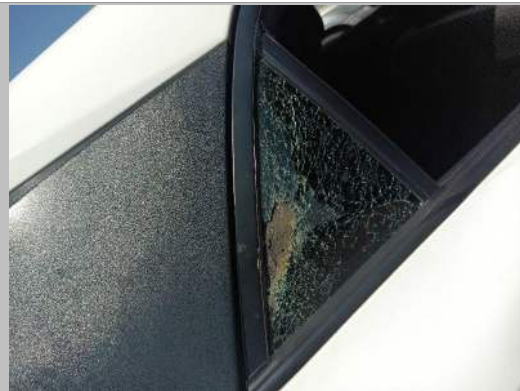
| Damage | Repair Way |
|---|---|
| R/R quarter window broken | Replace |

R/R window broken

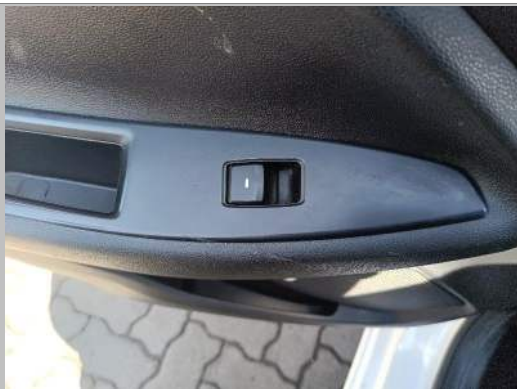
| Damage | Repair Way |
|---|---|
| Switch Electrical Window Winder rear left Defective | Repair |

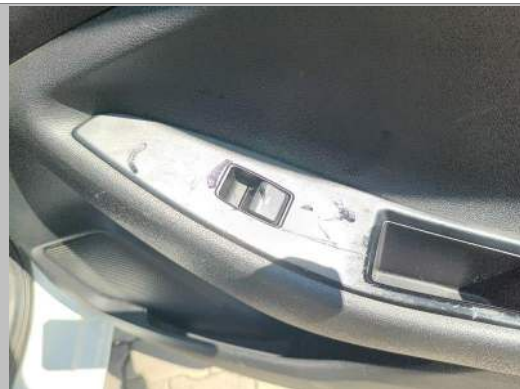
| Damage | Repair Way |
|---|---|
| Switch Electrical Window Winder rear right Defective | Repair |

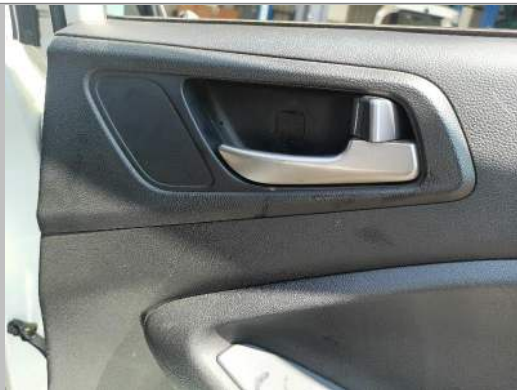
| Damage | Repair Way |
|---|---|
| Door Handle Rear Right Damaged | Replace |

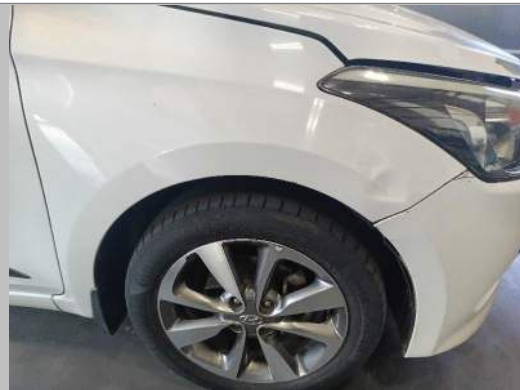
| Damage | Repair Way |
|---|---|
| Front Fender Right Dented | Repair |

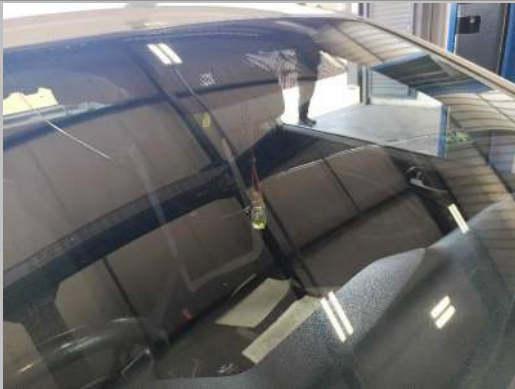
| Damage | Repair Way |
|---|---|
| Windscreen Cracked | Replace |

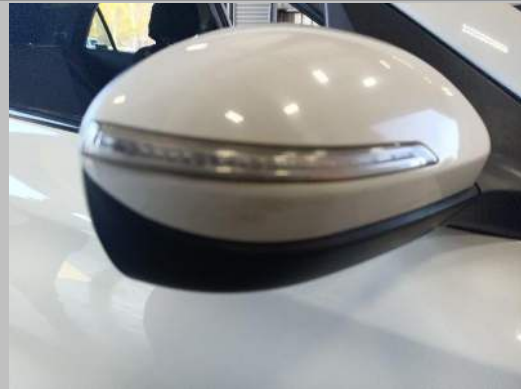
| Damage | Repair Way |
|---|---|
| Side Mirror Right Paintwork • Scratched | Repair |

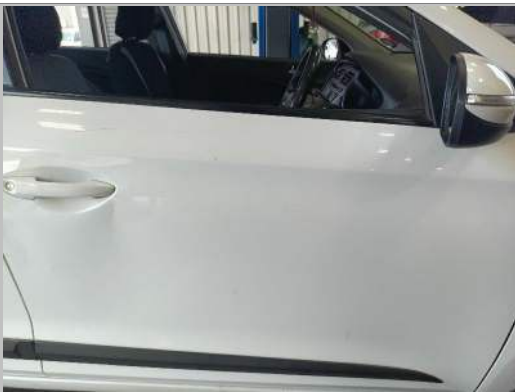
| Damage | Repair Way |
|---|---|
| Door Front Right Dented | Repair |

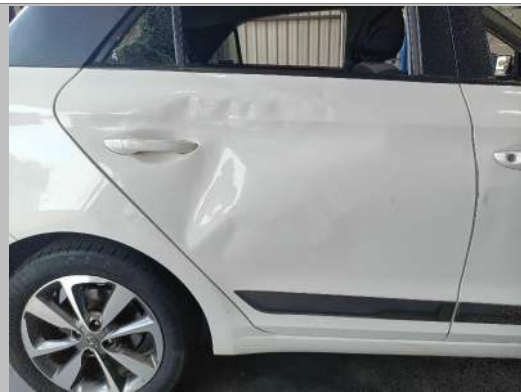
| Damage | Repair Way |
|---|---|
| Door Rear Right Dented | Repair |

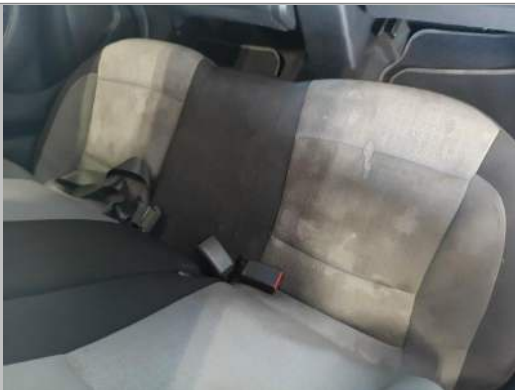
| Damage | Repair Way |
|---|---|
| Seat Rear Dirty | Repair |

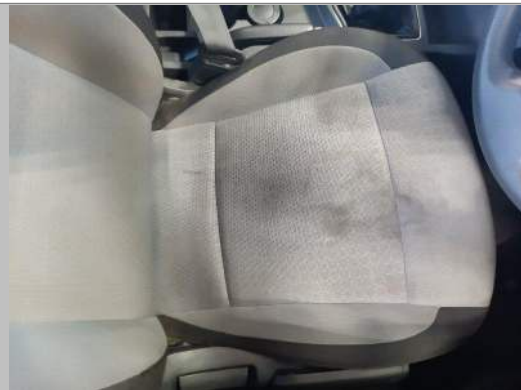
| Damage | Repair Way |
|---|---|
| Seat Front Right Dirty | Repair |

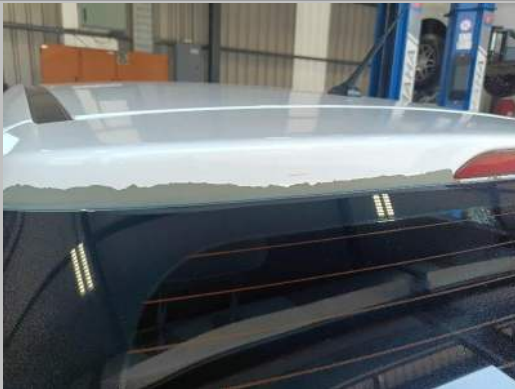
| Damage | Repair Way |
|---|---|
| Boot Lid / Hatch door Paintwork • Flaking | Repair |

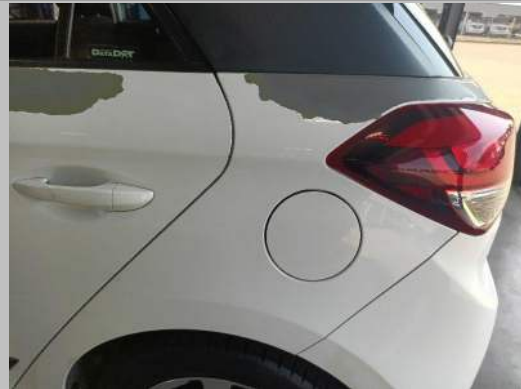
| Damage | Repair Way |
|---|---|
| Rear Fender Left Paintwork • Flaking | Repair |

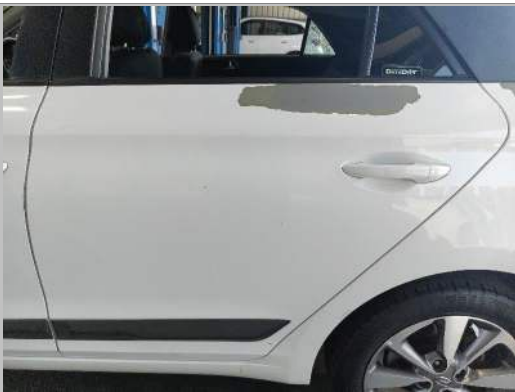
| Damage | Repair Way |
|---|---|
| Door Rear Left Paintwork • Flaking | Repair |

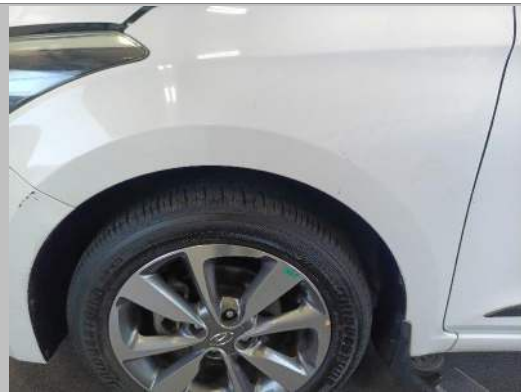
| Damage | Repair Way |
|---|---|
| Front Fender Left Paintwork • Scratched | Repair |

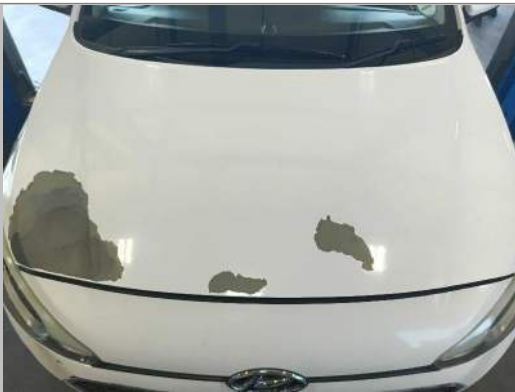
| Damage | Repair Way |
|---|---|
| Bonnet Paintwork • Flaking | Repair |

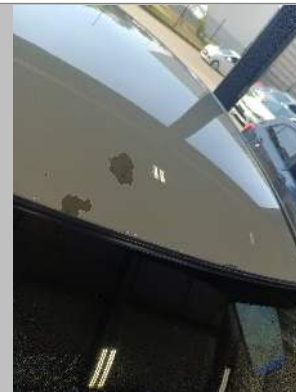
| Damage | Repair Way |
|---|---|
| Roof Paintwork • Flaking | Repair |

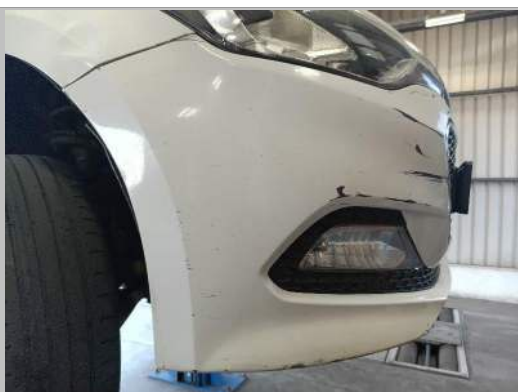
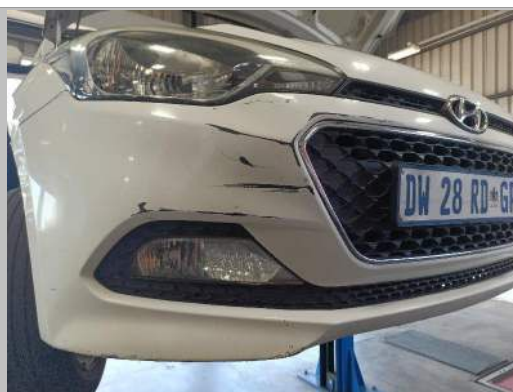
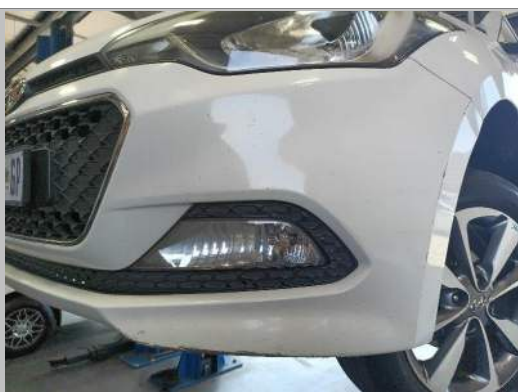
| Damage | Repair Way |
|---|---|
| Front Bumper Paintwork • Scratched | Repair |

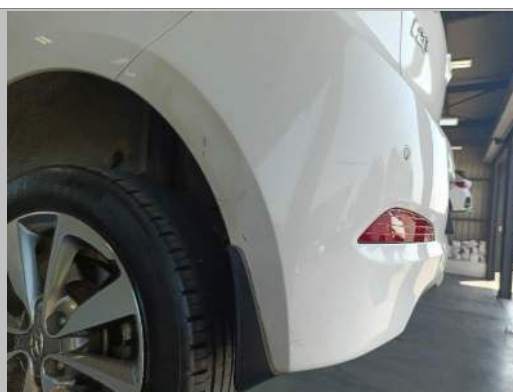
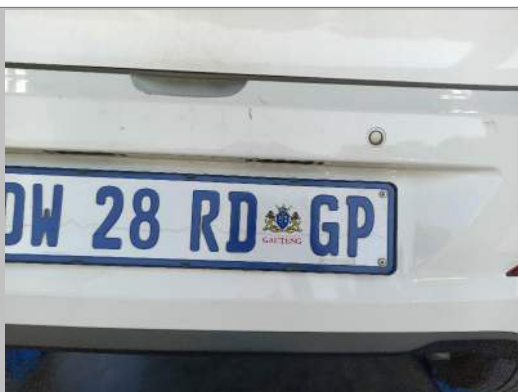
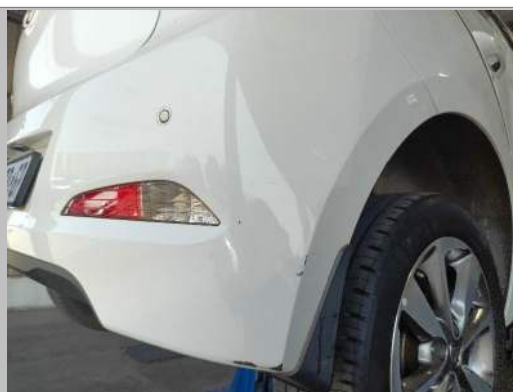
| Damage | Repair Way |
|---|---|
| Rear bumper Paintwork • Scratched | Repair |

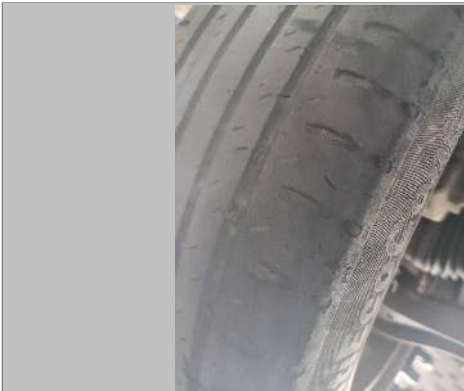
| Damage | Repair Way |
|---|---|
| Tyre Front Right Smooth | Replace |

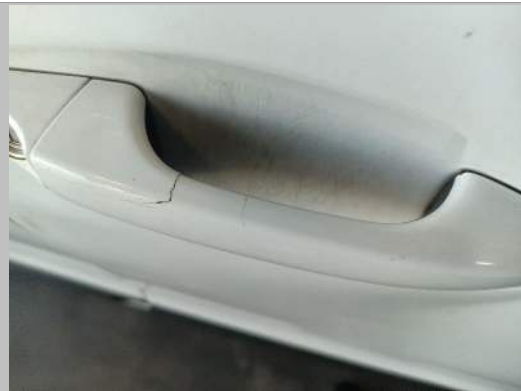
| Damage | Repair Way |
|---|---|
| Door Handle Front Right Damaged | Replace |
